## GENERAL REPORT SUMMARY SHEET

| 1. COMPONENT/PART NAME PER GENERIC CODE<br>Antennas-Radio, Command & Telemetering,<br>Fixed Position, 3000, 30,000 MC SHF | | 2. PROGRAM OR WEAPON SYSTEM<br>Apollo | | 3. DATE<br>25/4/66 | |
| 7. THIS TEST (SUPPLEMENTS) REPORT NO: 081.50.70.00-F1-02S (MC481-0005) | | | | | |
| <p>SCOPE</p> <p>(11) May 66</p> <p>(10) I. Freedman (12) 111 p.</p> <p>The tests <del>herein</del> reported were undertaken as part of a comprehensive program to prove the design of a C-Band Beacon Antenna and to determine its capability of performing its primary mission during subjection to the environmental stresses to be encountered by an earth-moon-earth vehicle.</p> <p>TEST PROCEDURES</p> <p>Connector Breakdown Under Radiation, High Altitude and High Power Condition Test</p> <p>Corona Discharge Test</p> <p>Sinusoidal Vibration Test</p> <p>Combined Vibration and High Temperature Test</p> <p>Sand and Dust Test</p> <p>Helium Leak Test</p> <p>Off-Limits Vibration Test</p> <p>Acoustic Test</p> <p>Antenna to Backcap Bond Test</p> <p>Combined Vibration and High Low Temperature Test</p> <p>Humidity Test</p> <p>Random Vibration Test</p> <p>Compression Tests</p> <p>Thermal Shock

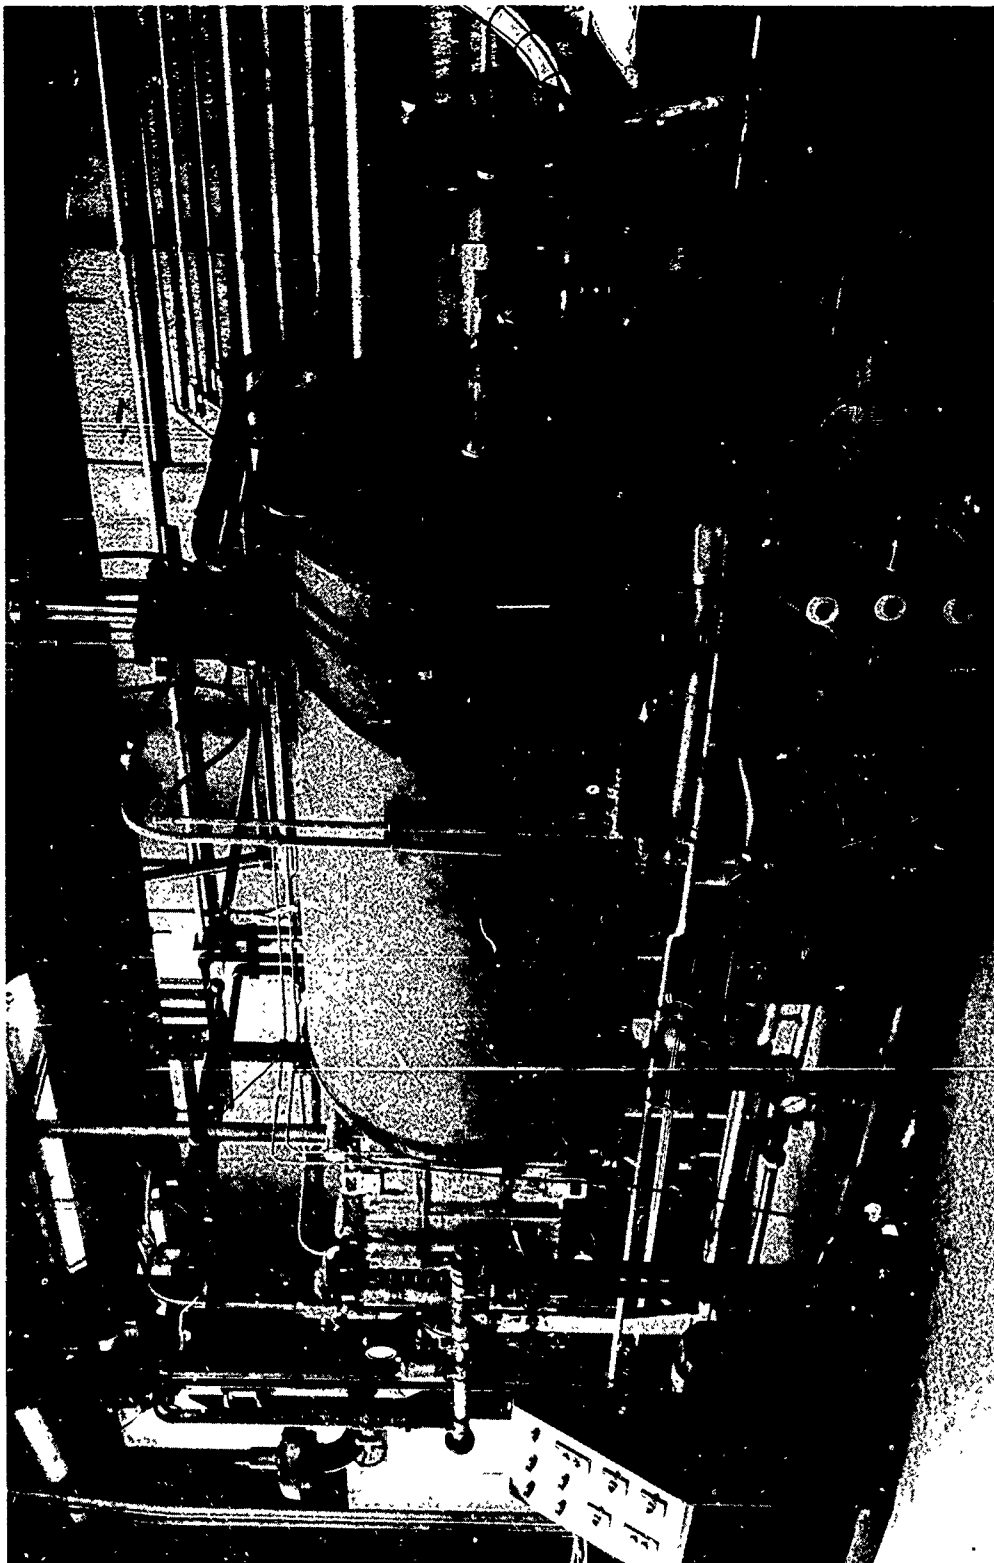
Figure 52. Overall View of Hyperthermal Electric Arc Tunnel

2.14.2.2 In Figure 52, the arc-head, and nozzle assemblies are at the right, and a heat exchanger, for cooling the gas after it leaves the test chamber, is at the left. As shown in Figure 53, provision is made for injecting a secondary gas downstream of the arc. By using

2.14.2.1 The Hyperthermal Electric Arc Facility is an essentially continuous-running wind tunnel which produces subsonic to Mach 3 gas flows at very high temperatures. The flow is produced by passing any of several gases, such as nitrogen, argon, or helium, through a high-current d.c. electric arc, and exhausting the resultant plasma through either a Mach 3 contoured nozzle, or a sonic orifice, to impinge on the test model of specimen.
