**AIRCRAFT GROUND-FLOTATION INVESTIGATION
PART VI DATA REPORT ON TEST SECTION 5**

**TECHNICAL REPORT AFFDL-TR-66-43, PART VI
AUGUST 1966**

This data report describes work undertaken as part of an overall program to develop ground-flotation criteria for the C-5A aircraft. A test section was constructed to a width adequate for two test lanes. Each lane was divided into three items having different subgrade CBR values and different traffic surfaces. Item 1 was surfaced with modified T11 aluminum landing mat, item 2 with M8 steel landing mat, and item 3 was unsurfaced. Traffic was applied using a 140,000-lb test load with a twin-twin wheel configuration on one lane and a twin-tandem wheel configuration on the other lane. The twin-twin wheel spacings were 37-68-37 in. c-c and the twin-tandem spacings were 37-in. c-c twin, 60-in. c-c tandem. Each assembly consisted of four 56x16, 24-ply aircraft tires with an inflation pressure of 100 psi.

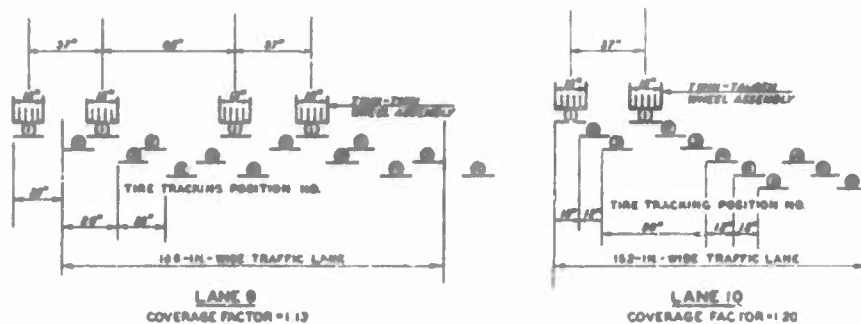
Figure 1. Sequence of traffic application for uniform coverages

The load vehicles were operated to produce uniform traffic coverage on the test lanes. Each load cart was driven forward and backward along the same track longitudinally along the respective test lanes, then shifted laterally and the forward-backward operation repeated. Figure 1 shows the general method of applying uniform coverages to the test lanes. Typically, the lane widths used were not exact multiples of the tracking tire widths and spacings so that it was necessary to determine a coverage factor for each lane to compensate for overlaps or gaps in the traffic pattern. Coverage factors were 1.13 and 1.20 for lanes 9 and 10, respectively. In all cases, the coverage levels indicated in the text and tables herein represent the corrected coverage levels.

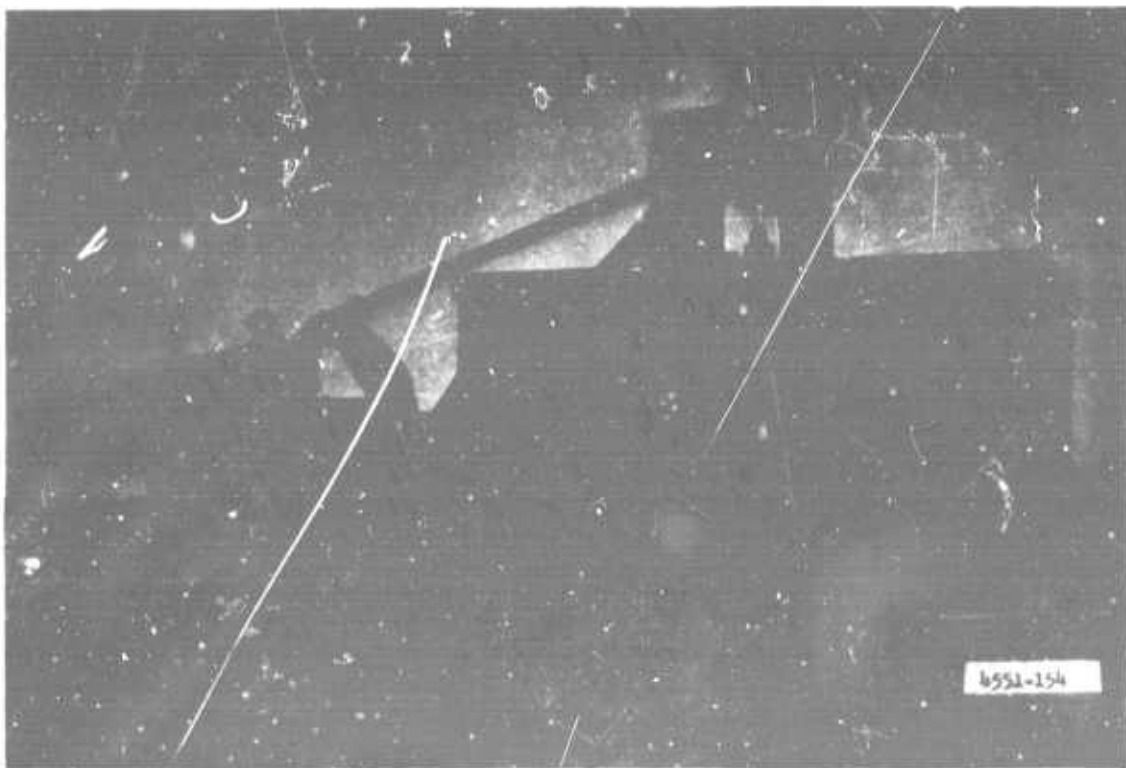
Figure 3. Test load vehicle used on lane 10

The load vehicles used in tracking Section 5 are shown in figures 2 and 3 for lanes 9 and 10, respectively. For trafficking both lanes the load compartments were weighted to 140,000 lb. On lane 9 a twin-twin wheel assembly spaced 37-68-37 in. c-c was used and on lane 10 a twin-tandem assembly was used with spacings 37-in. c-c twin, 60-in. c-c tandem. Each assembly consisted of four 56x16, 24-ply aircraft tires with inflation pressure of 100 psi. Tire-print data and pertinent tire characteristics are given in figure 22.

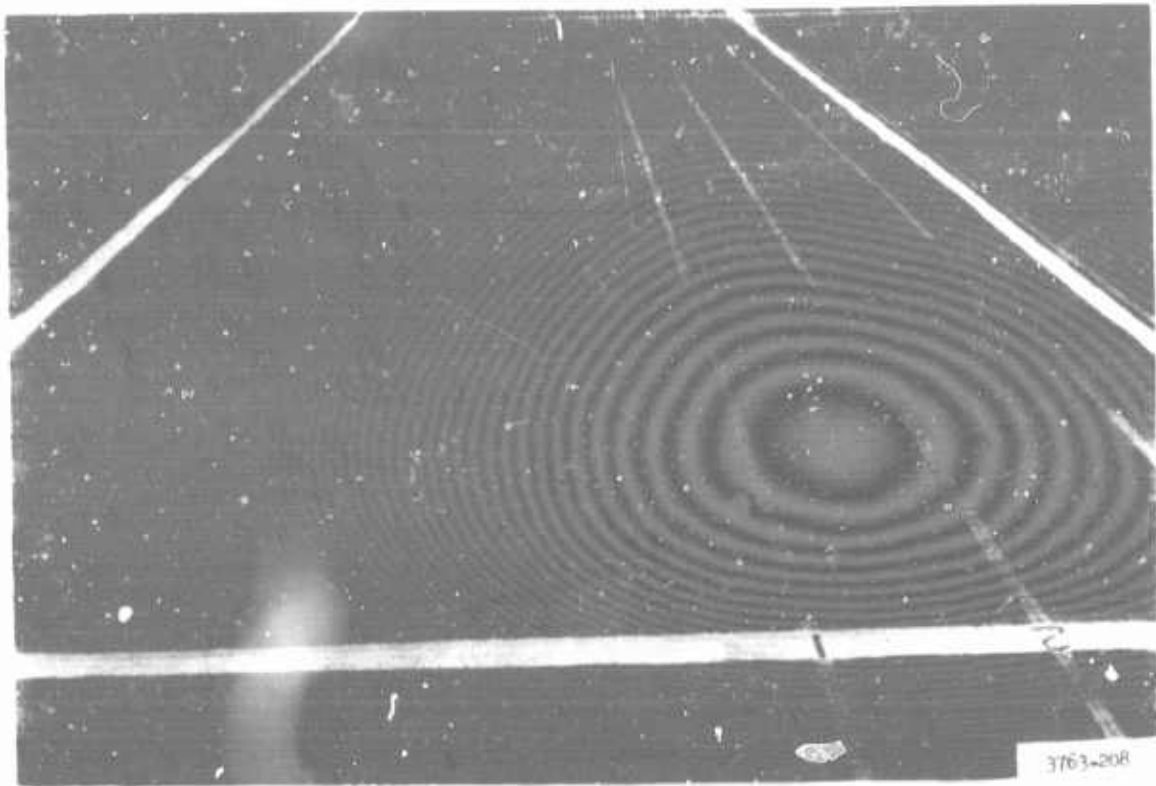
Figure 4. Lane 9, item 1, prior to traffic

Item 1. Figure 4 shows item 1 prior to traffic. Mat breaks first became apparent at about 45 coverages; differential deformations developed slowly, averaging less than 1 in. for each of the three straightedge positions at 90 coverages. At 109 coverages, mat runs 16 through 19 at the transition between item 1 and the previously failed item 2 were removed for subgrade repairs. After repairs and replacement of mat panels, traffic was continued. The item was considered failed due to roughness at 199 coverages (figures 5 and 6). The rated CBR was 2.4.

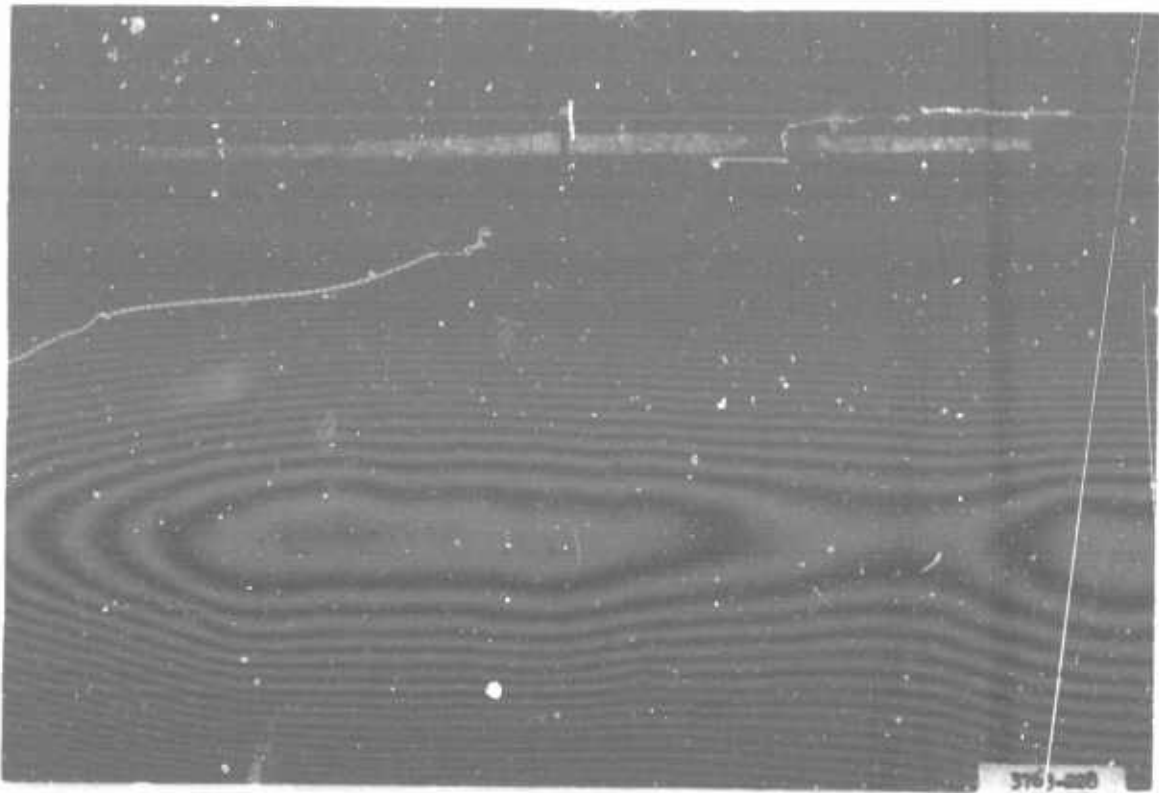
Figure 6. Lane 9, item 1. Diagonal straightedge shows roughness at 199 coverages (failure)

- a. Roughness. Table 1 shows the steady increase in differential deformations with increased traffic coverages. At failure the average transverse, diagonal, and longitudinal differential deformations were 1.90, 1.80, and 1.23 in., respectively. Dishing, shown in table 1, averaged 0.54 in. at failure.

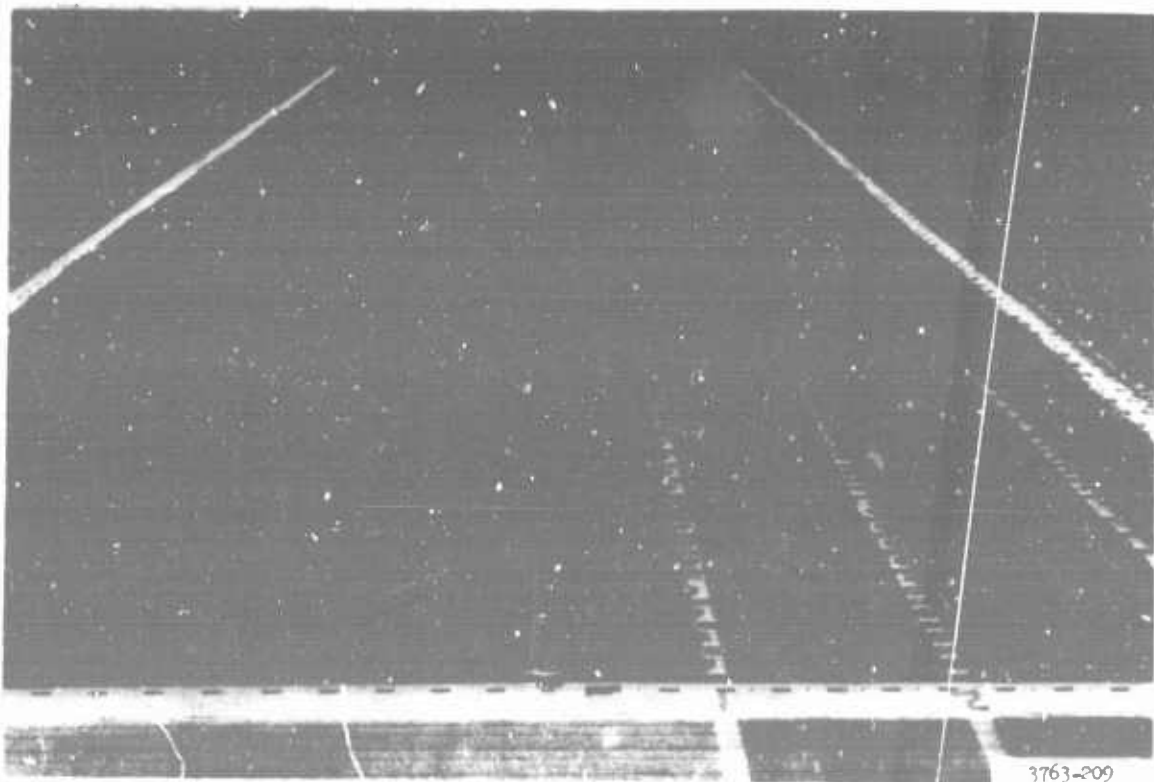
Figure 7. Lane 9, item 2, prior to traffic

Item 2. Figure 7 shows item 2 prior to traffic. By 20 coverages average differential deformations generally exceeded 1 in. on the item surface. It was observed during trafficking that at each pass of the load vehicle when the longitudinal mat-joint line was straddled by two load wheels, the overlapping ends of the planks at the joint would protrude upward. However, when a load wheel passed directly over the joint line, the plank ends were pressed flat again. Thus, the worst condition of mat roughness occurred when the former situation existed. The item was considered failed due to roughness at 102 coverages (figures 8 and 9). The rated CBR was 4.1.

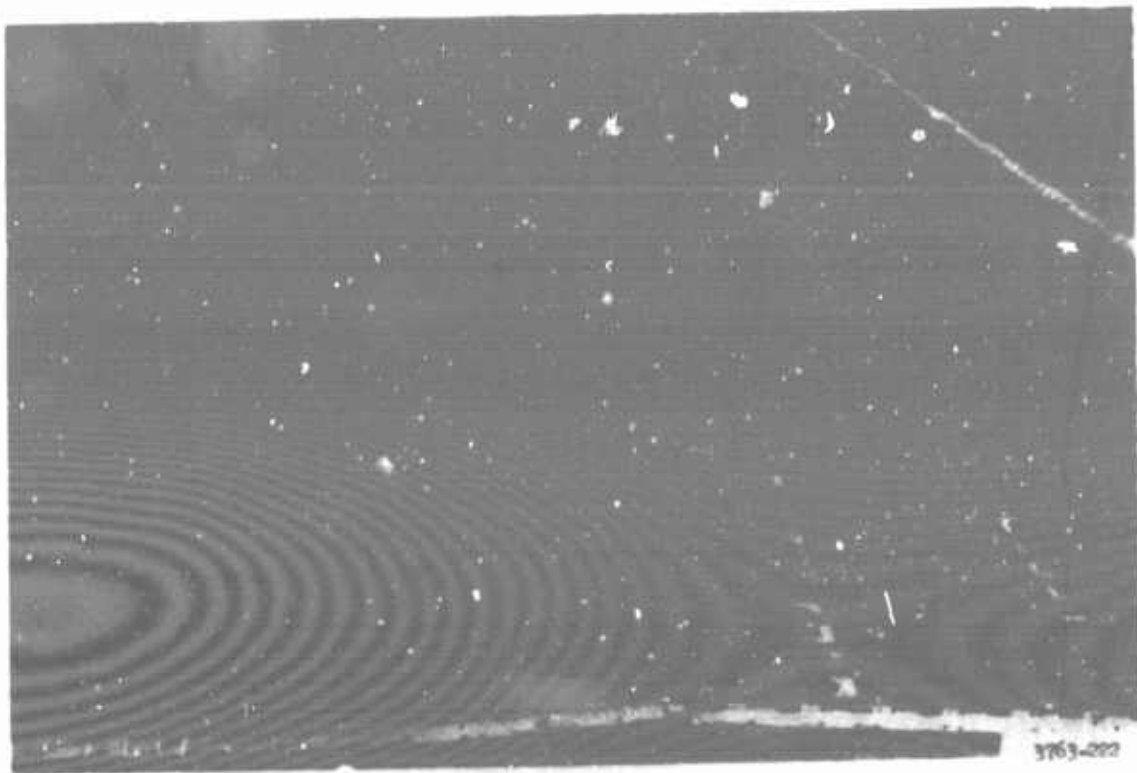
Figure 8. Lane 9, item 2; general view at 102 coverages (failure)

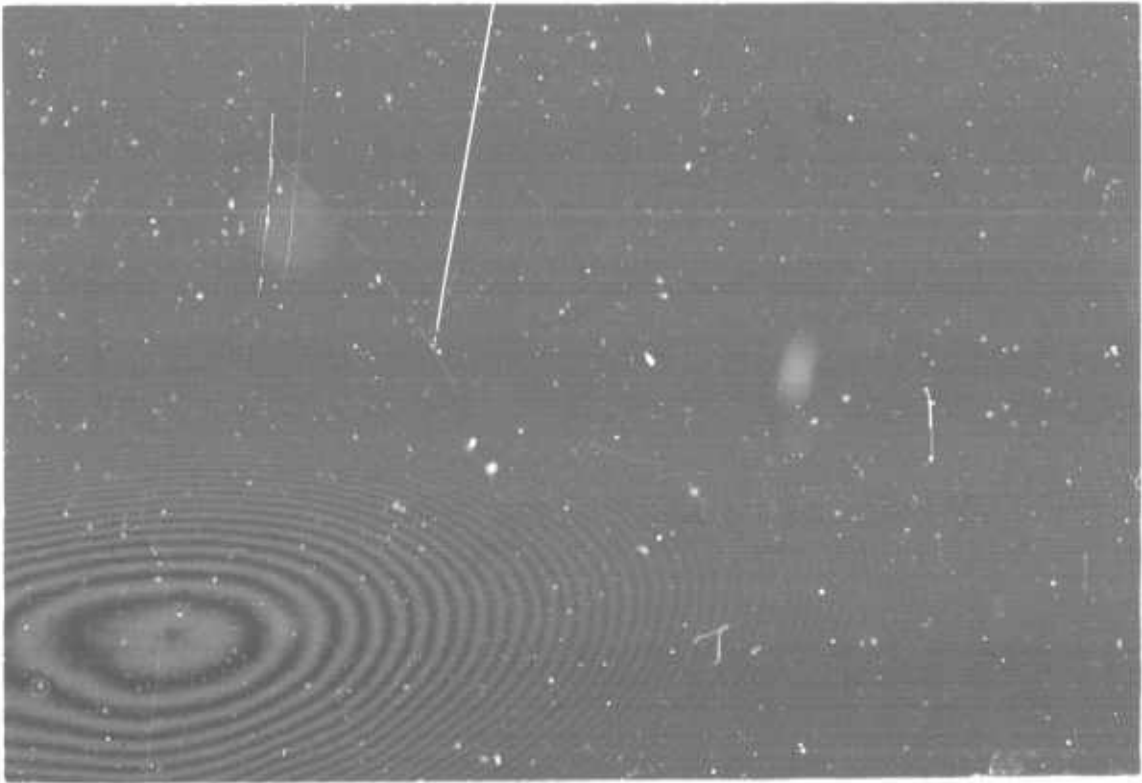
Figure 10. Lane 9, item 3, prior to traffic

Item 3. Figure 10 shows item 3 prior to traffic. The soil surface rutted easily and the item was considered failed due to rutting at 20 coverages (figure 11). The rated CBR was 9.8.

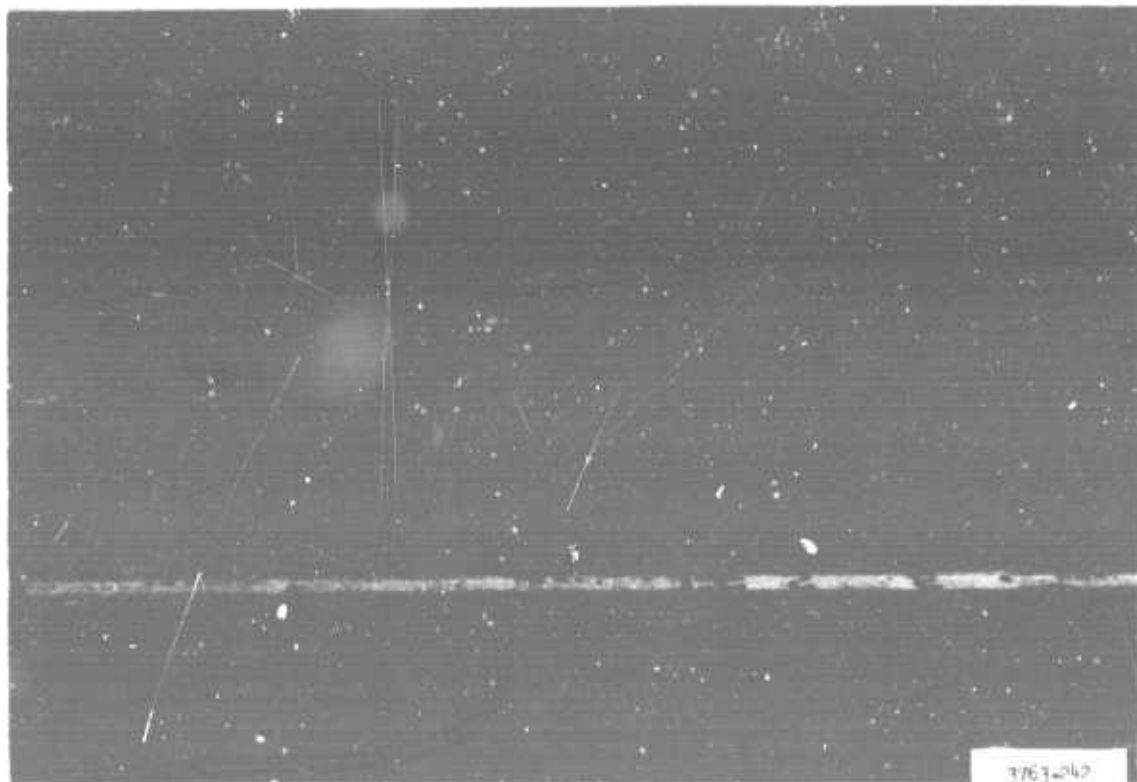
Figure 13. Lane 10, item 1; general view at 74 coverages (failure)

Item 1. Figure 12 shows item 1 prior to traffic. During early trafficking of the item, mat breaks began to develop and differential deformation averaged slightly greater than 1 in. at 19 traffic coverages. The item was considered failed due to roughness at 74 coverages (figures 13 and 14). The rated CBR of the item was 2.6.

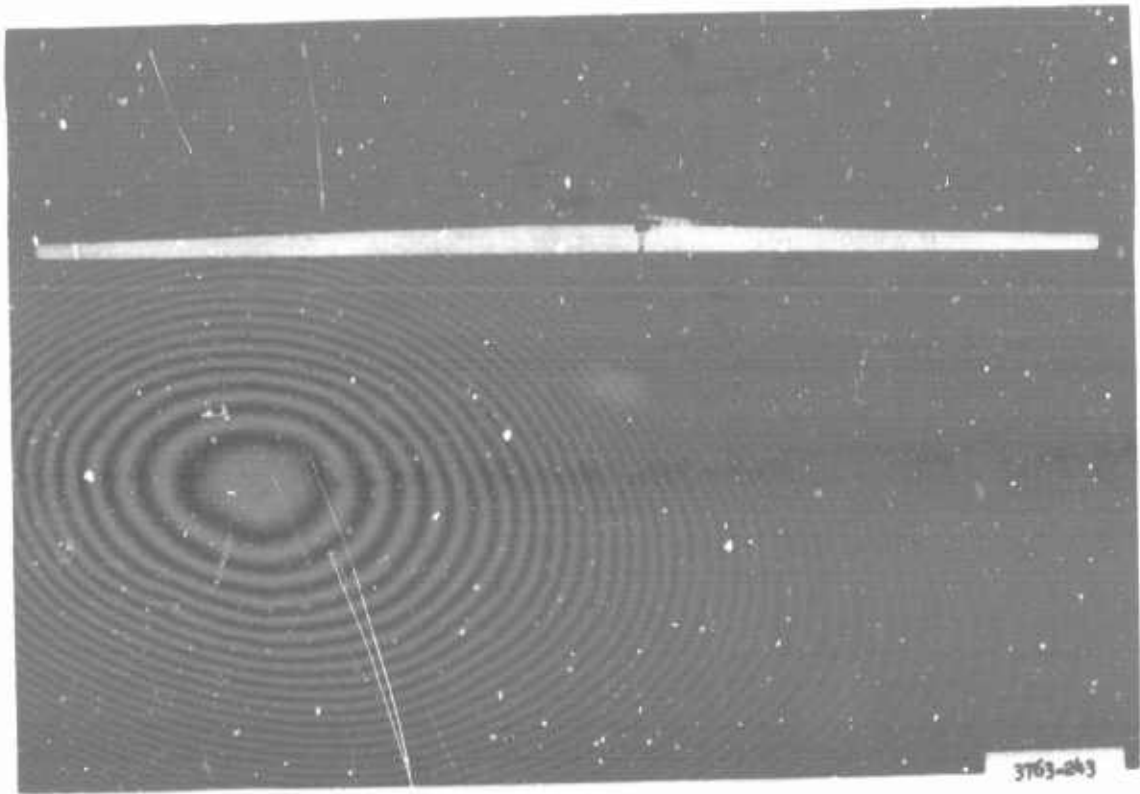
Figure 14. Lane 10, item 1. Transverse straightedge shows roughness at 74 coverages (failure)

- a. Roughness. Differential deformations for numerous coverage levels are shown in table 1. At failure, the average transverse, diagonal, and longitudinal differential deformations were 2.65, 2.55, and 1.50 in., respectively. Dishing of individual panels averaged 0.63 in.

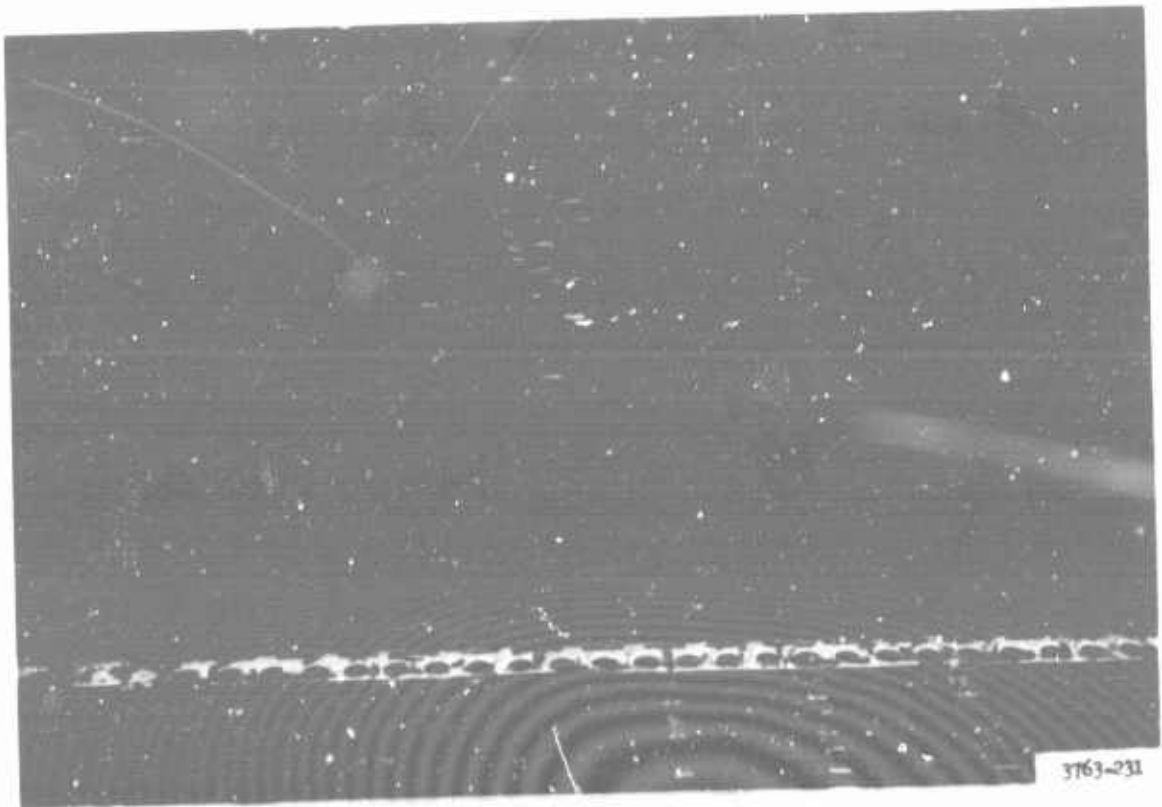
Figure 16. Lane 10, item 2; general view at 48 coverages (failure)

Item 2. Figure 15 shows item 2 prior to traffic. Upward displacement of the panel ends at the mat joints was the principal sign of deterioration during trafficking of the item. The item was considered

failed due to roughness at 48 coverages due primarily to displacement at the end joints (figures 16 and 17). The rated CBR was 4.0.

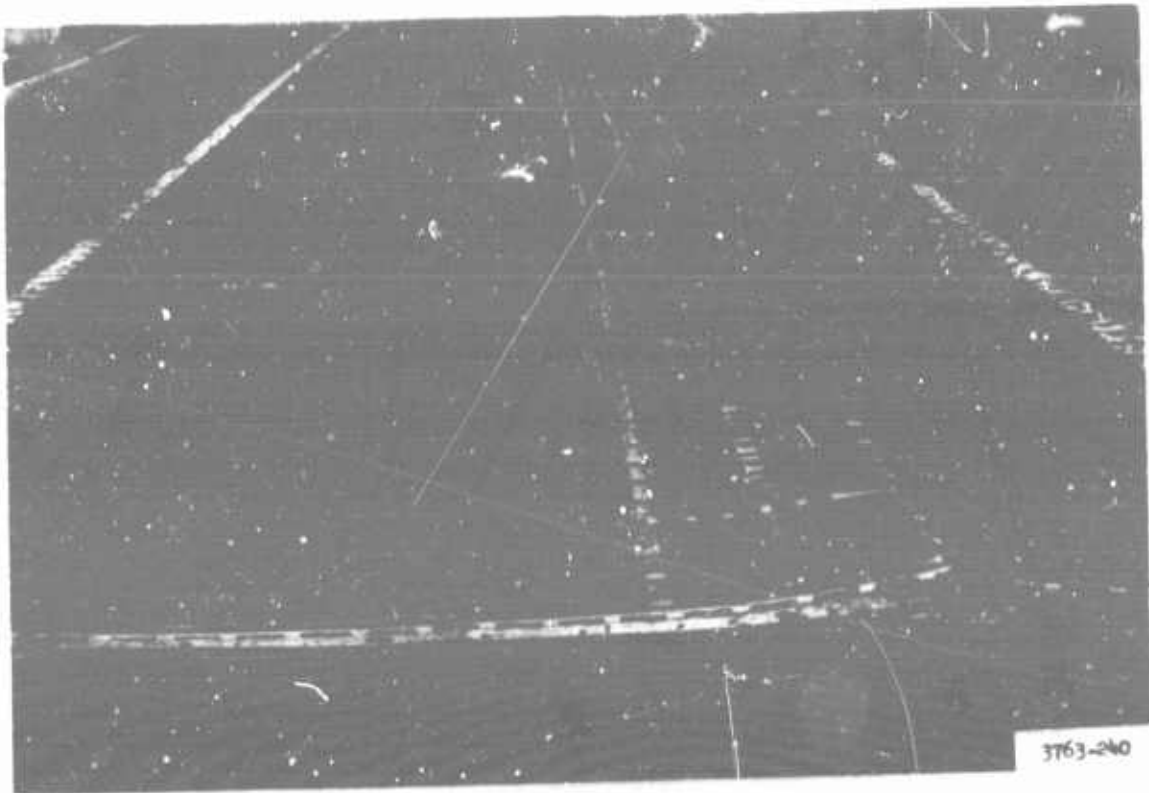
Figure 18. Lane 10, item 3, prior to traffic

Item 3. Figure 18 shows item 3 prior to traffic. The surface deformed easily under traffic and the item was considered failed due to rutting at 24 coverages (figure 19). The rated CBR of the item was 9.8.

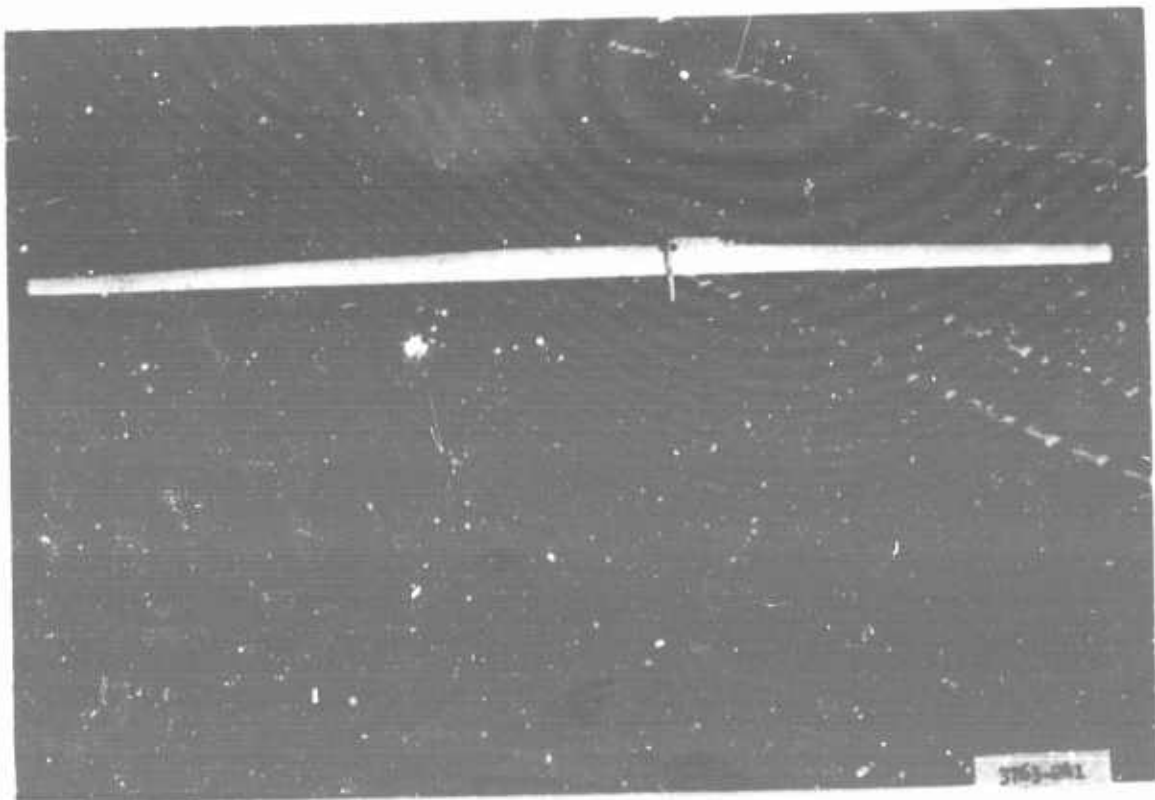
Figure 19. Lane 10, item 3. Transverse straightedge shows roughness at 24 coverages (failure)

- a. Roughness. Table 1 shows differential deformations and rut depths measured at 19 and 24 coverages. The transverse and diagonal differential deformations averaged 3.90 and 4.17 in., respectively, at failure. Rut depths at failure averaged 3.90 in.
- b. Deformation. Average cross-section deformations at 24 coverages are represented in figure 23. Center-line profile deformations are plotted in figure 24. The absence of severe longitudinal deformations allows a relatively smooth profile curve which illustrates the general subsidence along the traffic lane.
- c. Deflection. Average total soil deflections measured at 0 and 24 coverages are plotted in figure 25. A large increase in total deflection occurred with trafficking. Elastic deflections, shown in table 1, decreased slightly with trafficking, measuring 0.4 and 0.2 in. at 0 and 24 coverages, respectively.

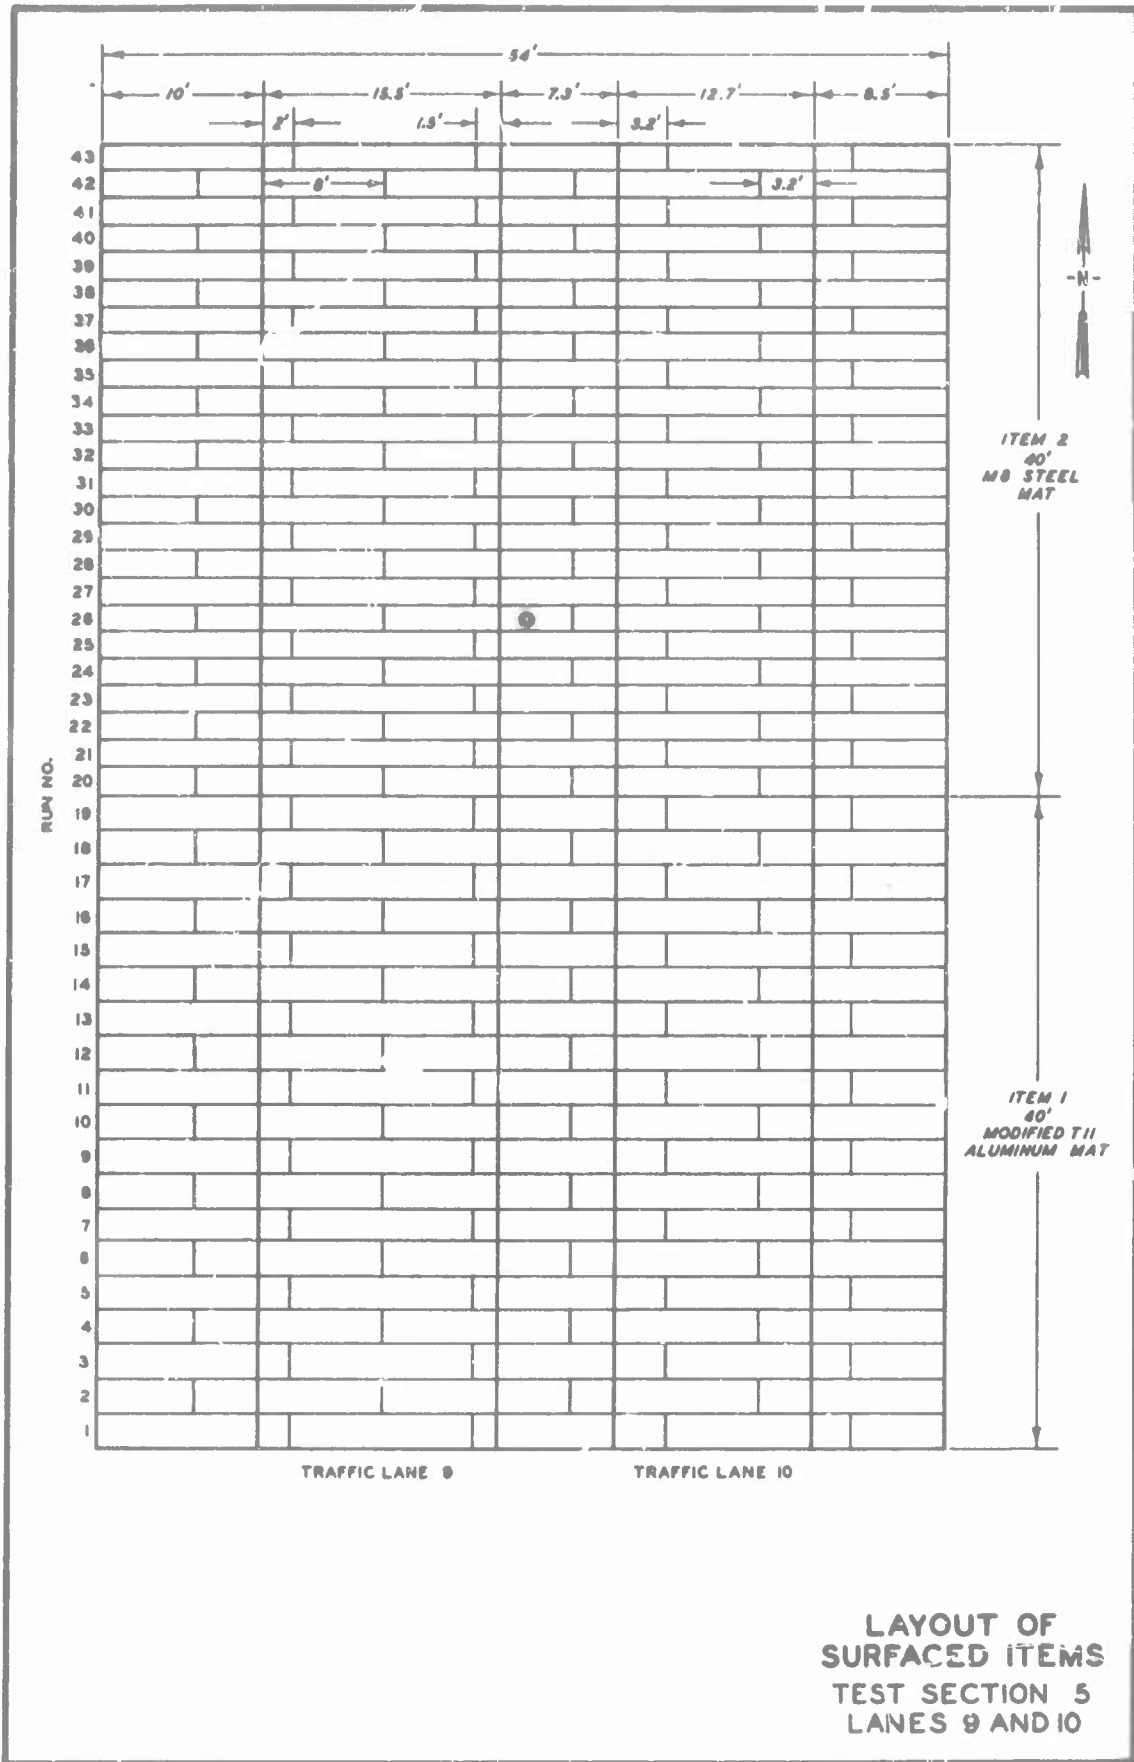
Figure 21

Two traffic lanes, each divided into three items, were constructed in the test section. Different subgrade strengths were obtained in the items (figure 20) by controlling the water content and compaction effort. Items 1 and 2 were surfaced with modified T11 aluminum and M8 steel landing mat, respectively (figure 21). Item 3 remained unsurfaced. The landing mats used are described and illustrated in Part I.

Tests on Section 5 are one phase of a comprehensive research program to develop ground-flotation criteria for heavy cargo-type aircraft. Section 5 consisted of two similar traffic lanes, lanes 9 and 10, each of which was divided into three items (figure 20). Each item was constructed to a different subgrade CBR value and had a different traffic surface. Item 1 was surfaced with modified T11 aluminum landing mat, item 2 with M8 steel landing mat, and item 3 remained unsurfaced.

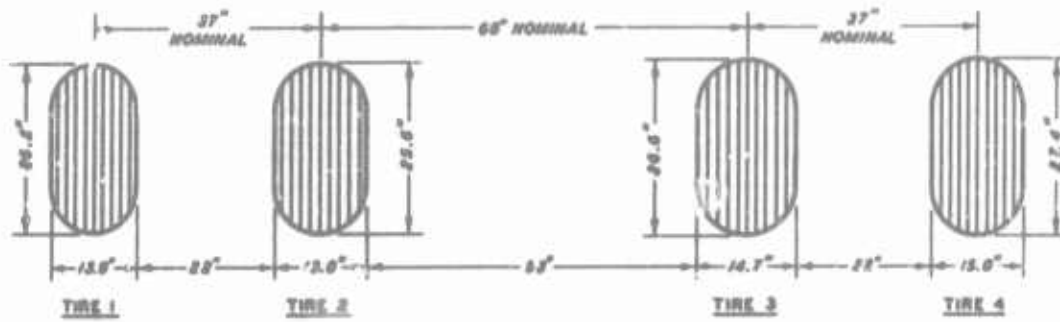
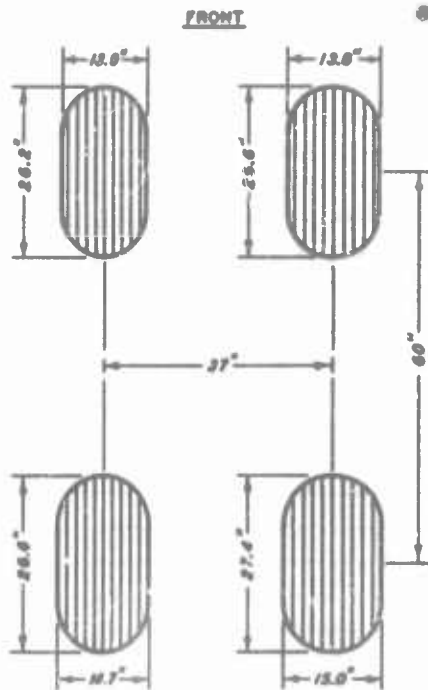
Figure 22

TIRE 1	TIRE 2	TIRE 3	TIRE 4
TIRE SIZE	56X16	56X16	56X16	56X16
NO. OF PLYS	24	24	24	24
CONTACT AREA, SQ IN.	309	308	341	314
CONTACT PRESSURE, PSI	113	114	103	112
INFLATION PRESSURE, PSI	100	100	100	100
DEFLECTION, %	38.9	38.1	42.6	40.9

LANE 9
TWIN-TWIN ASSEMBLY

LEFT FRONT	RIGHT FRONT	LEFT REAR	RIGHT REAR
TIRE SIZE	56X16	56X16	56X16	56X16
NO. OF PLYS	24	24	24	24
CONTACT AREA, SQ IN.	309	308	341	314
CONTACT PRESSURE, PSI	113	114	103	112
INFLATION PRESSURE, PSI	100	100	100	100
DEFLECTION, %	38.9	38.1	42.6	40.9

LANE 10
TWIN-TANDEM ASSEMBLY

TEST SECTION 5
LANES 9 AND 10
140-KIP LOAD
