# **AIRCRAFT GROUND-FLOTATION INVESTIGATION**

## **PART XIII. DATA REPORT ON TEST SECTION 13**

TECHNICAL REPORT AFFDL-TR-66-43, PART XIII

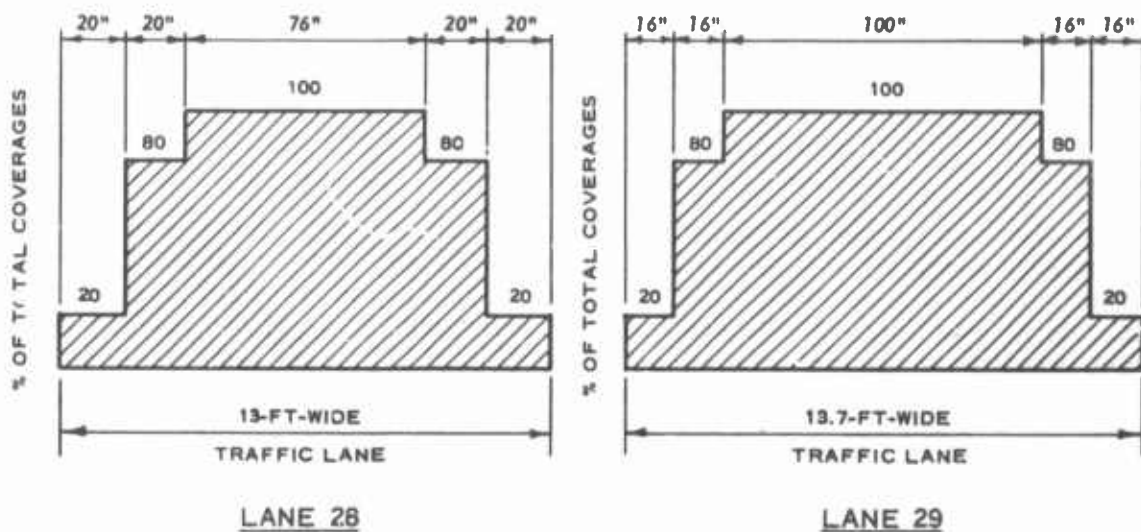
Figure 1. Traffic distribution patterns on Test Section 13

Traffic was applied to the test lanes in a nonuniform pattern with intensity of traffic being varied within each lane to produce three zones of approximately 100, 80, and 20 percent traffic coverage. Traffic so distributed within a traffic lane simulates as nearly as possible the bell-shaped traffic distribution curve which results from the wander of aircraft from the lane center line. The coverage levels referred to in the tables and text herein are the total number of coverages applied to the 100 percent coverage zone. The corresponding number of coverages applied to the outer traffic zones is proportional to the percentage factor for the respective zones as shown in figure 1. Typically, the lane widths used were not exact multiples of the tracking tire widths and spacings so that it was necessary to determine a coverage factor for each lane to compensate for overlap or gaps in the traffic pattern.

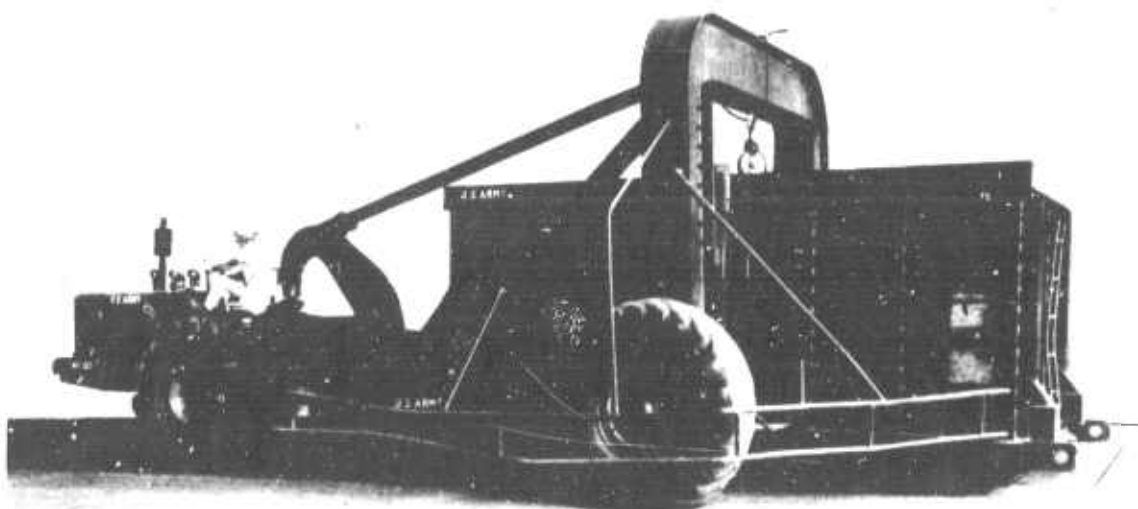
Figure 2. Load vehicle

The load vehicle used for trafficking test lanes in Section 13 is shown in figure 2. Load cart construction, details of linkage between the load compartment and prime mover, and method of applying load are explained in Part I. For trafficking lanes 28 and 29, a twin-wheel assembly was used with a 70,000-lb test load. The assembly consisted of two 25.00x28, 30-ply aircraft tires inflated to 50 psi with wheel spacing 58.5 and 29.5 in. c-c for lanes 28 and 29, respectively. Tire-print data and pertinent tire characteristics are given in figure 17.

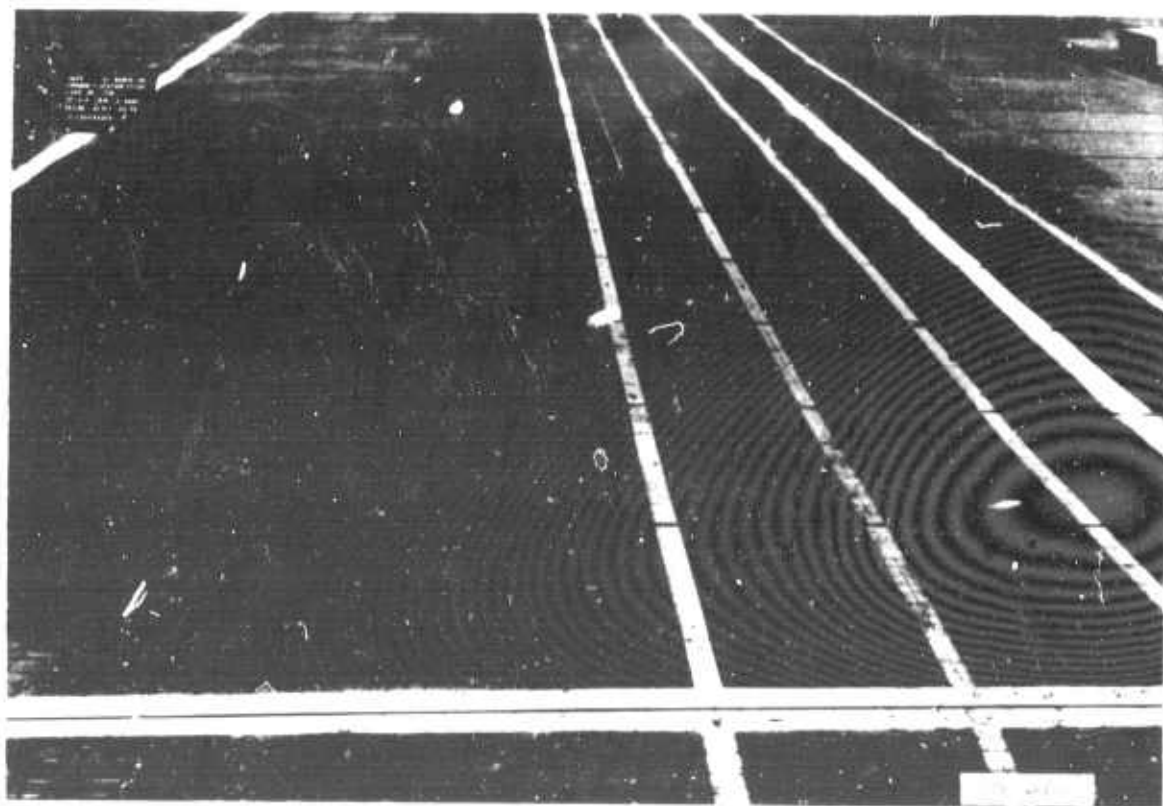
Figure 3. Lane 28, item 1, prior to traffic

Item 1. Figure 3 shows item 1 prior to traffic. At 550 coverages traffic was temporarily halted because the tires were rubbing the saddle of the load cart. At this point all pertinent data were gathered including CBR determinations. The tires were respaced to 56 in. c-c and traffic continued. Item 1 was considered failed at 700 coverages due to elastic deflection (figure 4). The rated CBR was 2.1.

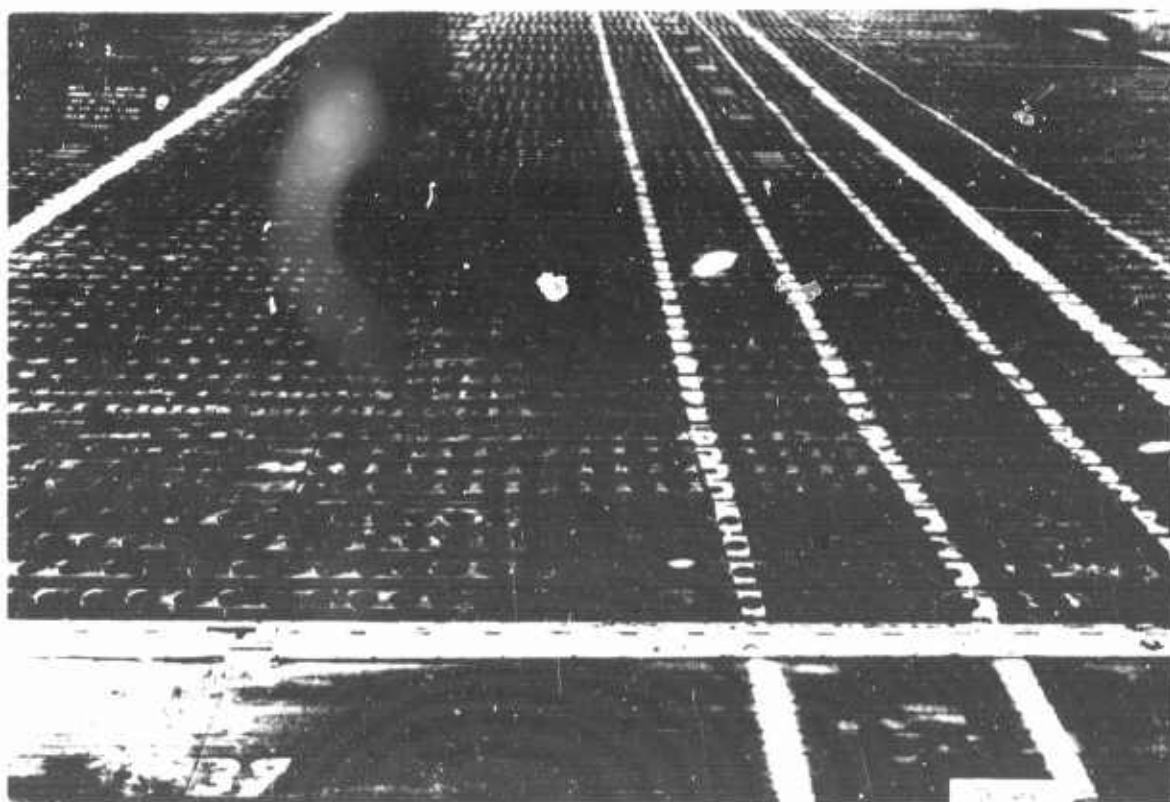
Figure 5. Lane 28, item 2, prior to traffic

Item 2. Figure 5 shows item 2 prior to traffic. The item held up well under traffic with relatively few mat breaks and deformation which developed slowly. Item 2 was considered failed at 700 coverages due to roughness (figure 6). The rated CBR was 2.8.

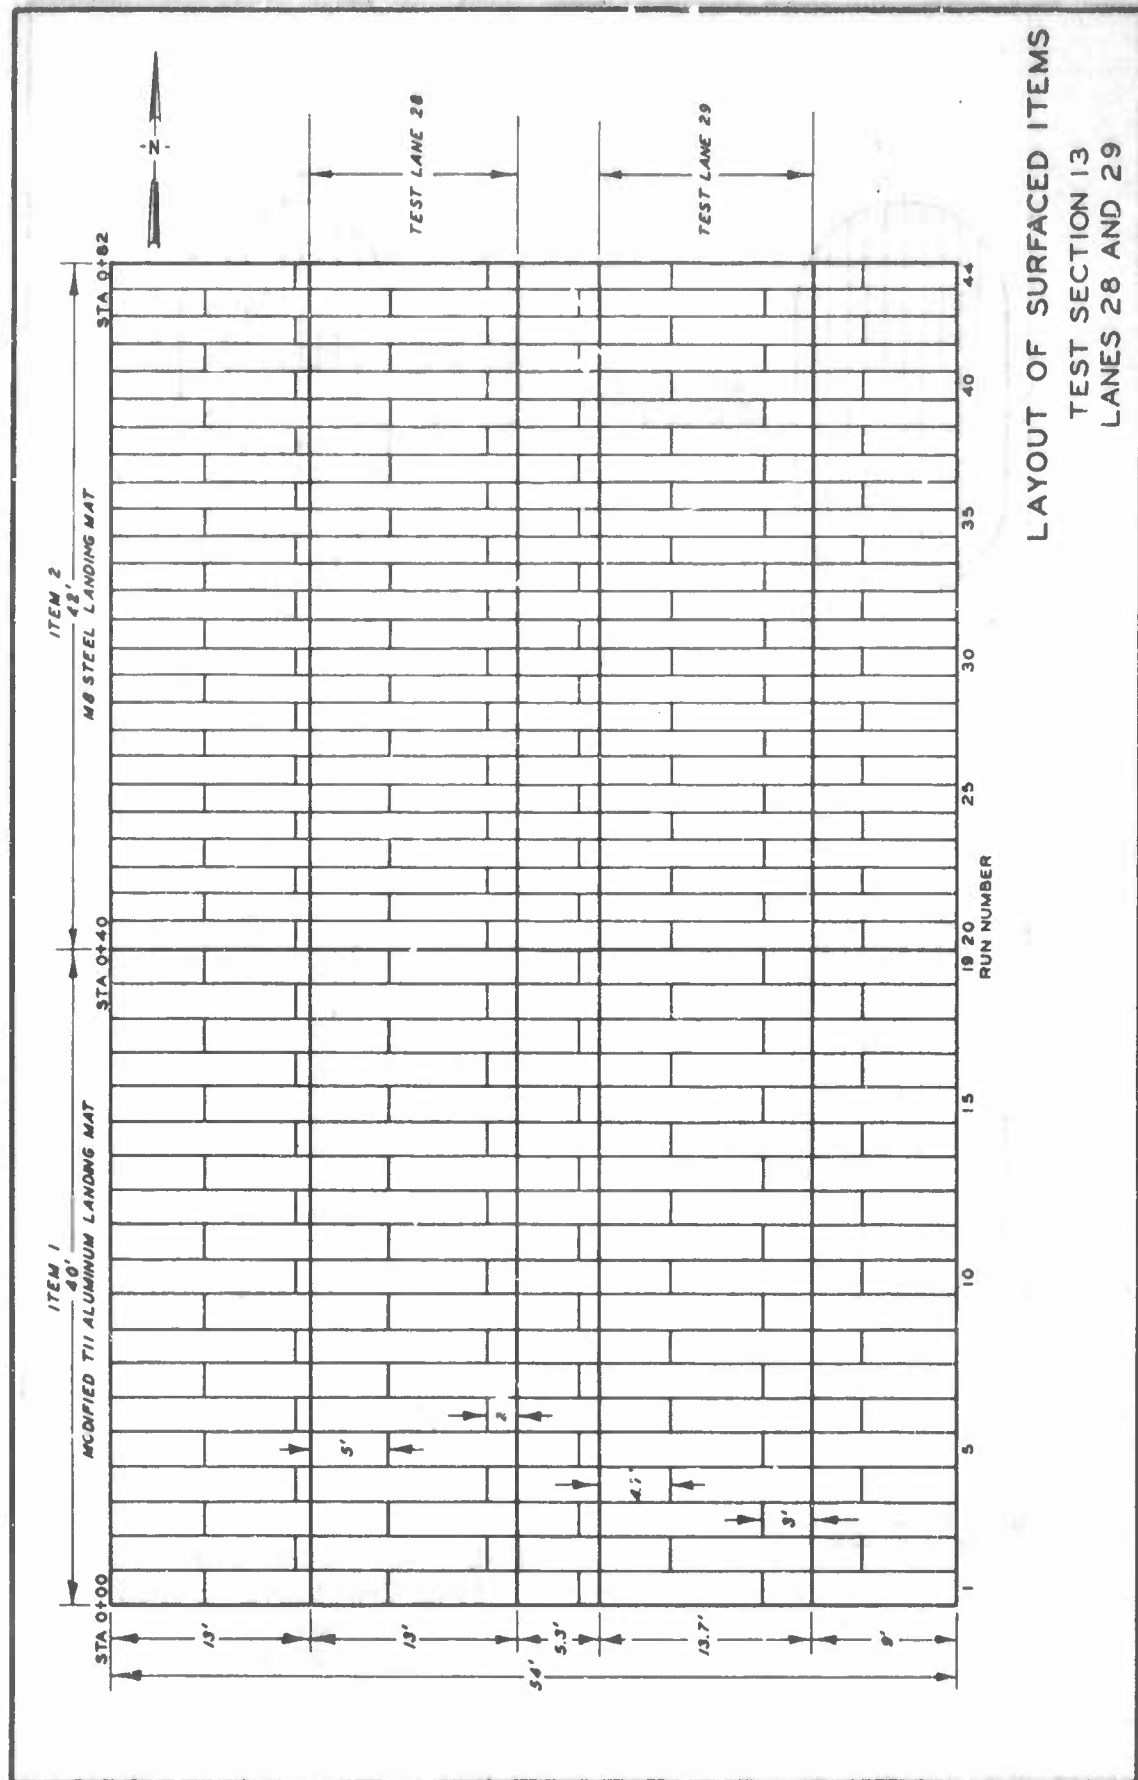
LAYOUT OF SURFACED ITEMS  
TEST SECTION 13  
LANES 28 AND 29

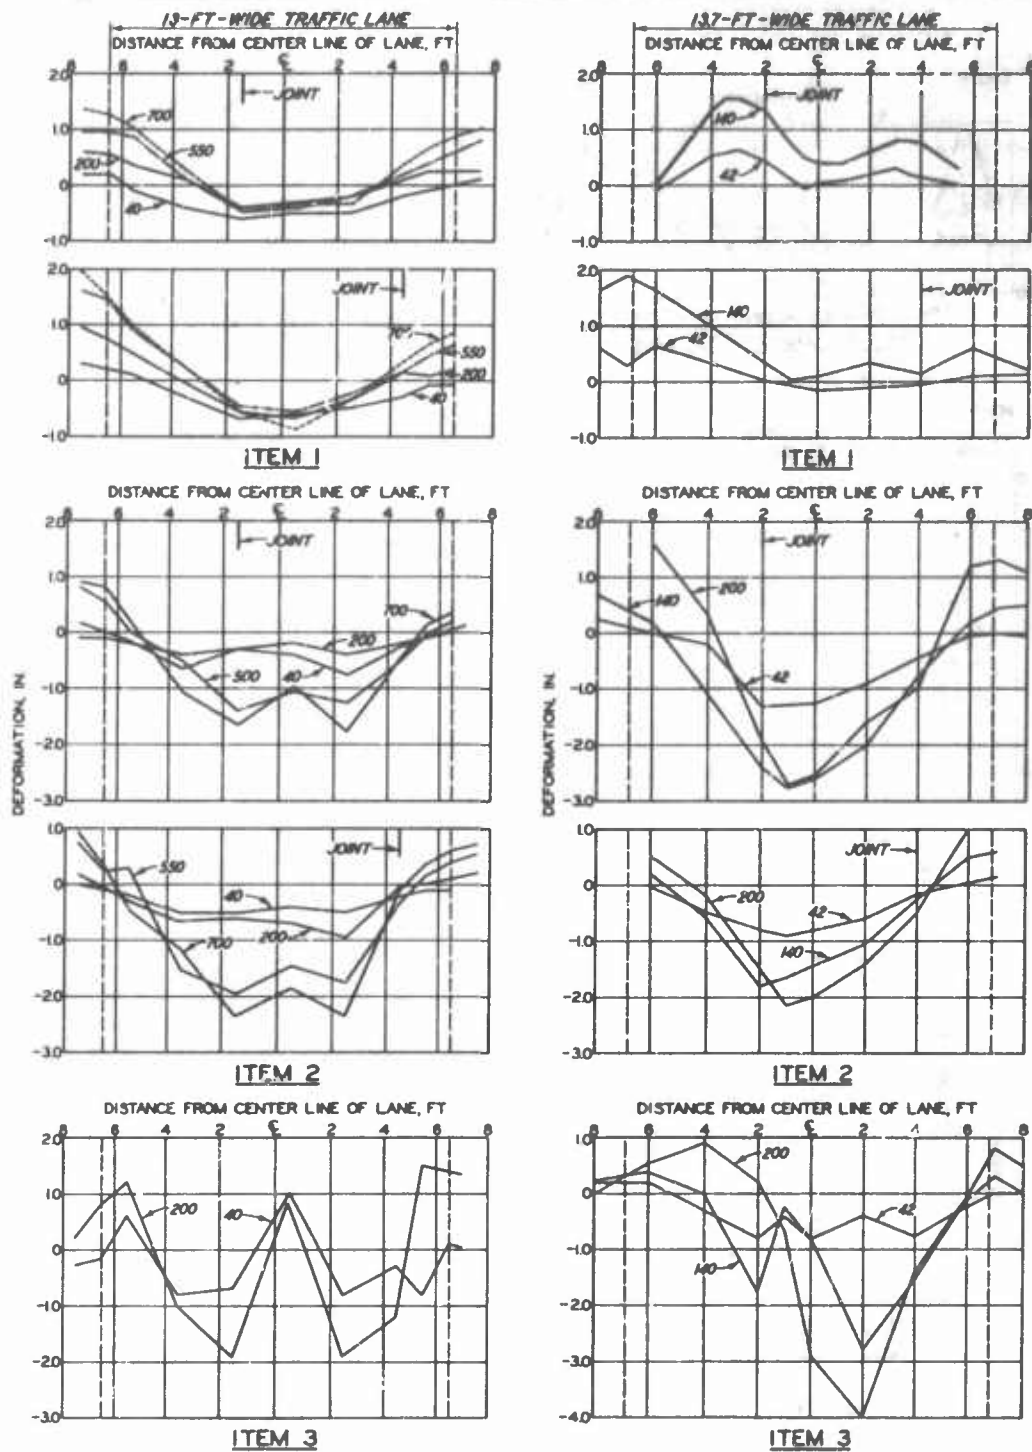
AVERAGE  
CROSS-SECTIONAL  
DEFORMATIONS  
TEST SECTION 13  
LANES 28 AND 29

- b. Deformation. Average cross-section deformations are shown in figure 18. The maximum average cross-section deformation at failure was 2.35 in. approximately 2 ft either side of the traffic lane center line. Profiles in figure 19 indicate the severe longitudinal deformations that existed in the item at failure, especially at the end adjacent to item 1.

coverages are shown in figure 18. Considerable rutting developed between the two coverage levels. Figure 19 shows profiles for 40 and 200 coverages and illustrates the progressive subsidence of the item with traffic.

shown in figures 18 and 19, respectively. The maximum average cross-section deformation was +1.9 in. and occurred along the west side of the lane. This positive deformation was due to lateral displacement of the subgrade under traffic. Figure 19 shows deformations at 42 and 140 coverages. Displacement and subsidence of the subgrade under traffic caused bridging of the mat surface and consequently a number of positive deformation readings were recorded at 140 coverages.

- b. Deformations. Average cross-section deformations at 42, 140, and 200 coverages are shown in figure 18 for the two typical mat runs. The magnitude of deformations at 140 and 200 coverages is approximately the same, with both showing large increases over the 42-coverage values. Profiles along the item are shown in figure 19 for 42, 140, and 200 coverages. Very consistent increases in profile deformations occurred with traffic. The most severe deformation occurred at the south end of the item adjacent to the previously failed item 1.

- b. Deformation. Average cross-section deformations for 42, 140, and 200 coverages are shown in figure 18. Deformations became increasingly severe with traffic, reaching 4.0 in. at failure. Figure 19 shows profile deformations for the same coverage levels, illustrating the very large increase that occurred between 140 and 200 coverages, especially on the end adjacent to mat-surfaced item 2.

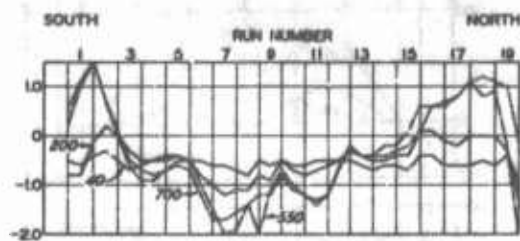
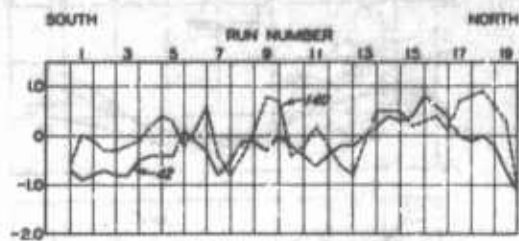
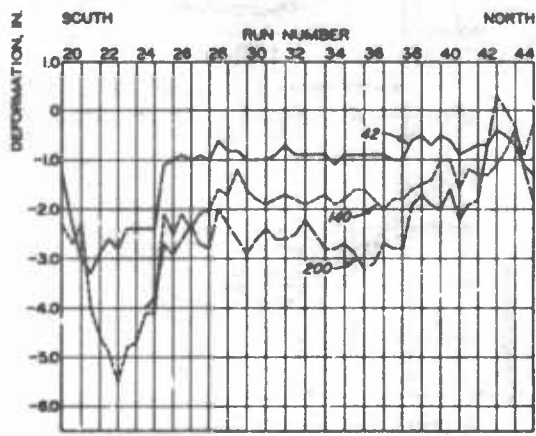
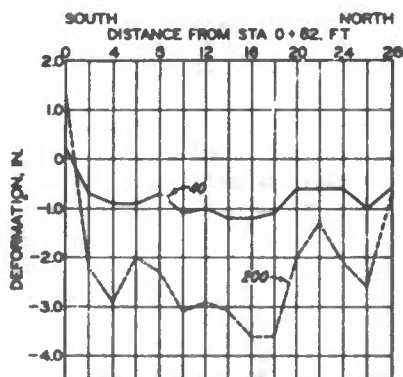
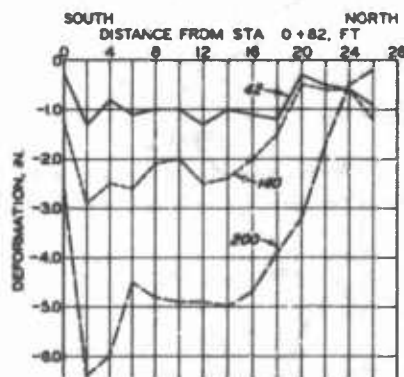
Figure 19

PERMANENT PROFILE  
DEFORMATIONS  
TEST SECTION 13  
LANES 28 AND 29

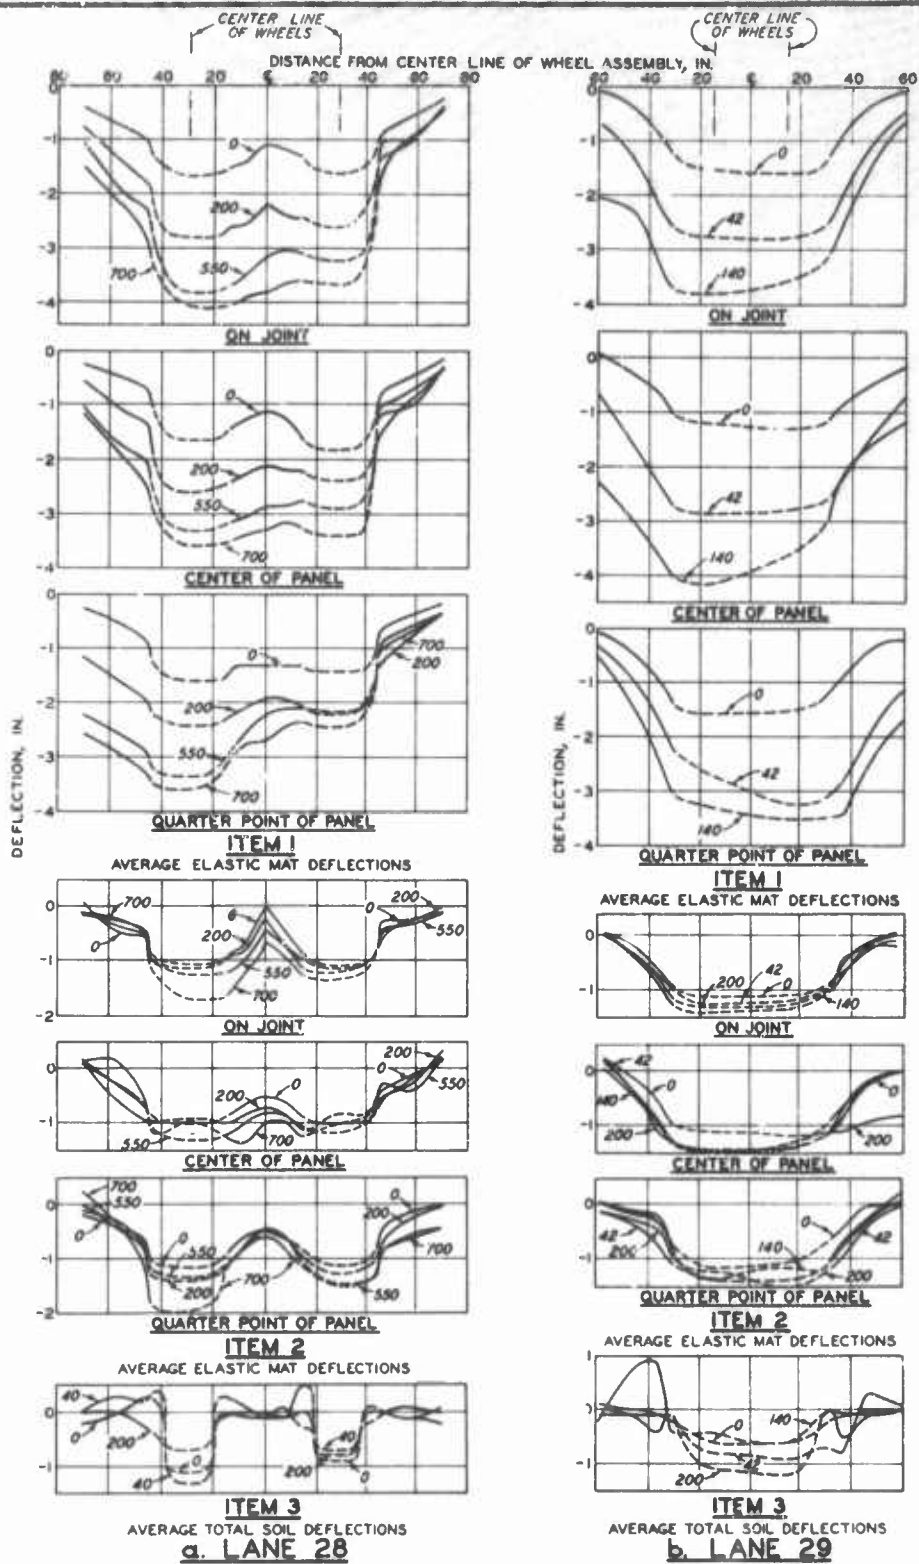
- c. Deflections. Average elastic mat deflections shown in figure 20 increased generally with traffic. The largest average deflection (4.10 in.) was recorded with the load wheels centered on a panel end joint at the 700-coverage level. At the same coverage level, the elastic subgrade deflection was 1.1 in. Elastic mat deflections were greatly exaggerated by the mat standoff, or bridging effect resulting from settlement of the subgrade with traffic.
- d. Rolling resistance. Table 1 shows drawbar pull values at several coverages. Initial, peak, and rolling drawbar pull values showed consistent increases with continued traffic.
- e. Mat breaks. The number and types of mat breaks are given in table 1. Relatively few mat breaks occurred with most of these being rivet failures.

- c. Deflection. Average elastic mat deflections are shown in figure 20. Table 1 shows elastic subgrade deflections beneath a load wheel for several coverage levels. Elastic subgrade deflection at failure was 0.70 in.

- c. Deflection. Total subgrade deflections are shown in figure 20 for 0, 40, and 200 coverages. Maximum deflection occurred at 40 coverages. Elastic subgrade deflections shown in table 1 decreased with traffic.
- d. Rolling resistance. Consistent increases in initial, peak, and rolling drawbar pull were measured as coverage levels increased (table 1).

- c. Deflections. Deflections shown in figure 20 increased consistently with traffic. The large deflection measurements were due to the mat standoff effect resulting from subsidence of the subgrade. Elastic subgrade deflection at failure was 2.2 in. (table 1).
- d. Rolling resistance. Initial, peak, and rolling drawbar pull values at several coverage levels are shown in table 1. Rolling and peak drawbar pull increased consistently with traffic, while initial drawbar pull decreased slightly at 140 coverages.
- e. Mat breaks. Number of breaks by type are shown in table 1. There were a large number of rivet failures at 140 coverages.

- c. Deflection. Average elastic mat deflections for three positions of the wheel assembly relative to mat joints are plotted in figure 20. Deflections did not vary greatly at the different coverage levels shown. Elastic subgrade deflection at failure was 1.50 in. (table 1).

- c. Deflection. Total subgrade deflections shown in figure 20 somewhat erratic at intermediate coverage levels but yielded greatest values at failure. Table 1 shows elastic subgrade deflections with a value of 0.65 in. at failure.
