**USAAVLABS TECHNICAL REPORT 67-33**

**AIRCRAFT FUEL SYSTEMS DESIGN STUDY**

This report presents the results of crashworthiness evaluations of the fuel systems of the UH-1B, UH-1D, CH-47, and OH-6A aircraft, with effort also directed to the study of ballistic threat. Work was also conducted in testing and developing component modifications to eliminate weaknesses existing in the present systems, with special effort devoted to highly extensible, self-closing fuel lines. This research effort resulted in a series of recommendations for changes and established guidelines for future aircraft fuel-system designs.

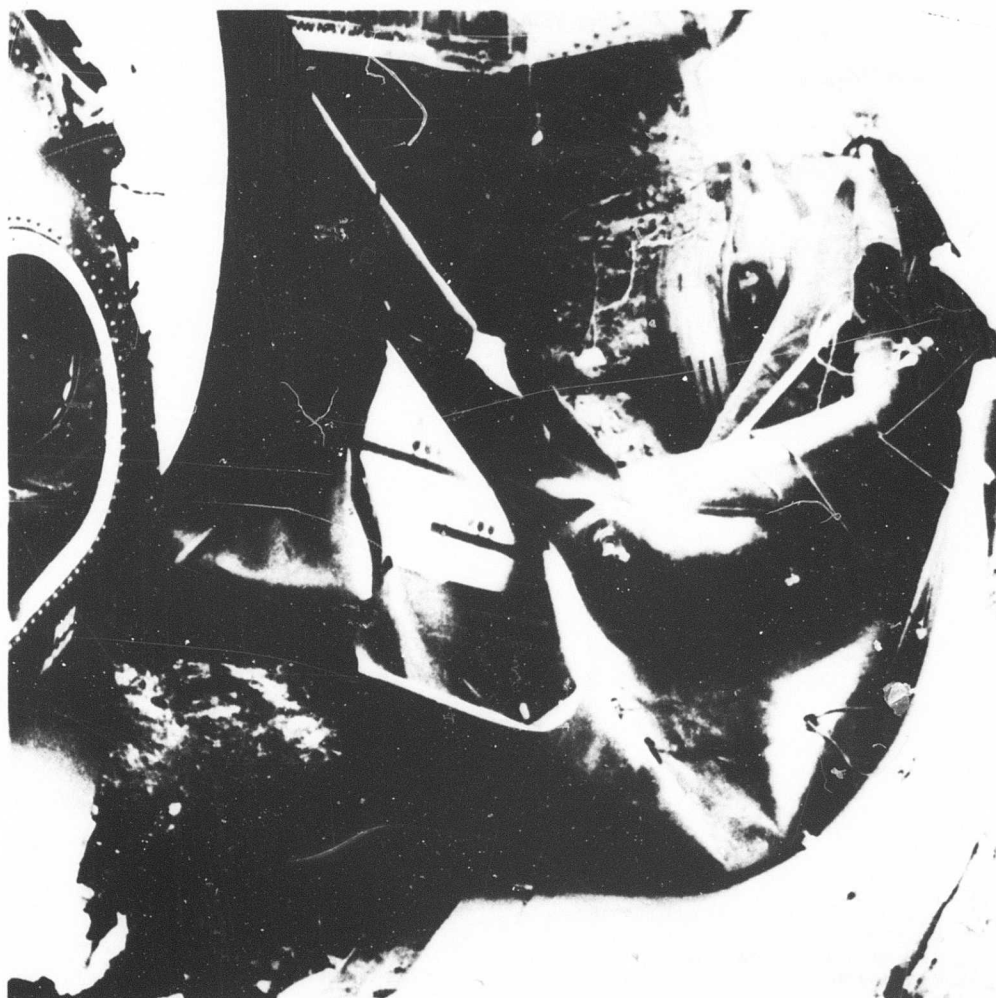
Figure 2. Pod Failure after CH-47 Crash.

There is considerable physical separation between the fuel tanks and the engines, a desirable arrangement in that fuel spillage occurring at impact is kept from the engine ignition-source area. Locating the tanks outside the occupiable area is also a sound concept as it minimizes the chances of spilled fuel entering the cockpit or cabin areas. However, the pods themselves lack satisfactory strength. The pod structure has failed in moderate crashes, allowing the fuel tank to drop from the helicopter, thus causing bladder failure and total fuel spillage (Figure 2).

Aluminum honeycomb structural panels surround the flexible fuel cells in all of the aircraft except the OH-6A. A fiber glass backing on the honeycomb, between the cell and the structural panel, provides a smooth surface adjacent to the cell wall. These honeycomb panels provide a degree of protection to the fuel cells during crash conditions by absorbing some energy before the impact forces are transmitted to the tank. However, the honeycomb structure itself is inadequate in preventing fuel cell rupture during survivable crash impact, as witnessed in the crash of the CH-47 helicopter mentioned earlier (Figure 2).

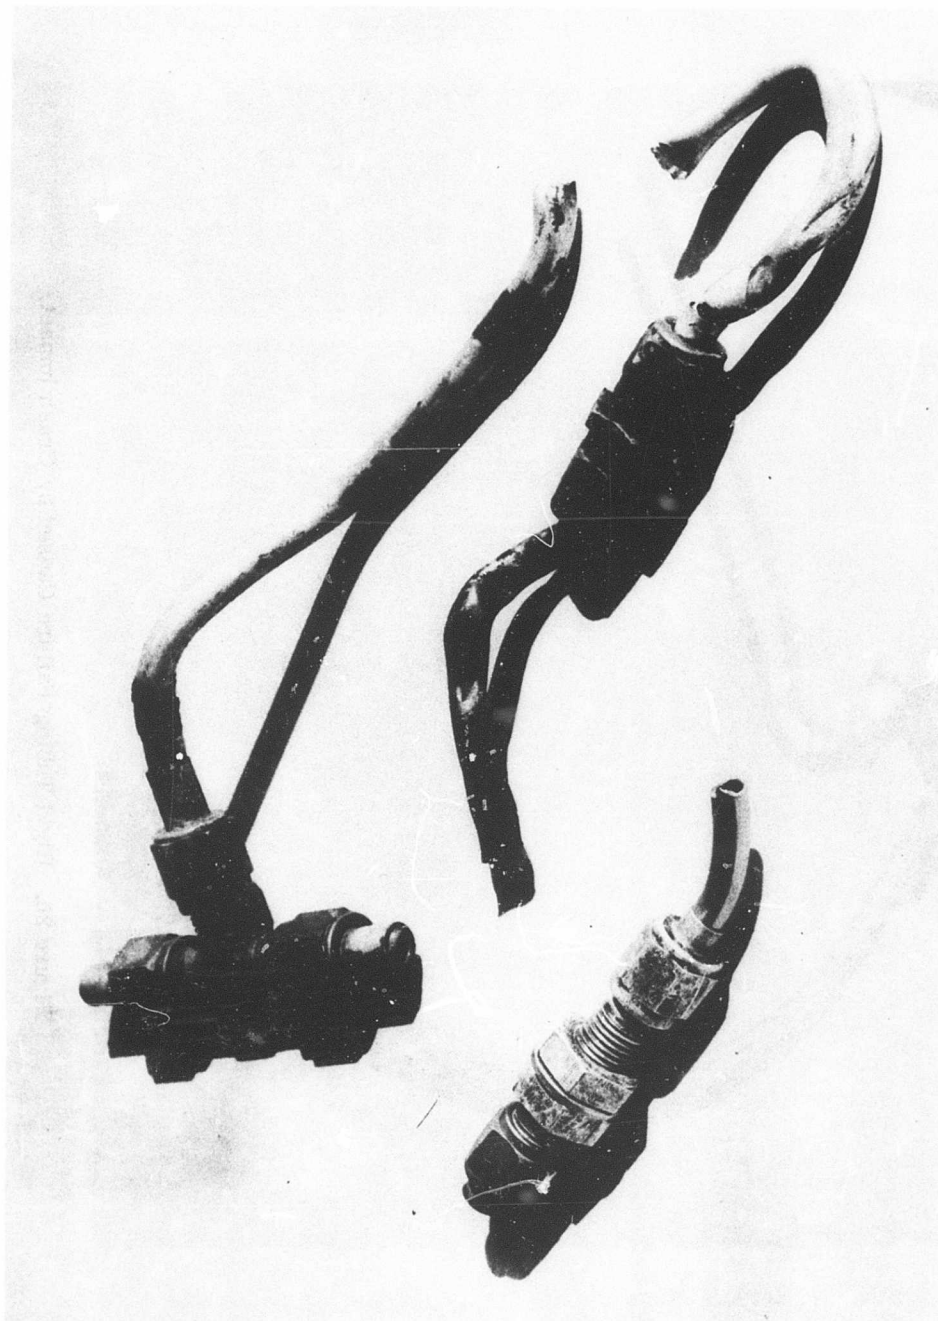
**Figure 25. Rigid Tubing Failures Caused by Crash Impact.**

Most of the fuel-transfer lines in all four aircraft are made of rigid aluminum tubing which is routed directly between connections. As previously noted, these rigid lines readily fail when deformed during crash-induced structural displacement. Figures 25 and 26 show typical failures of rigid tubing that occurred under

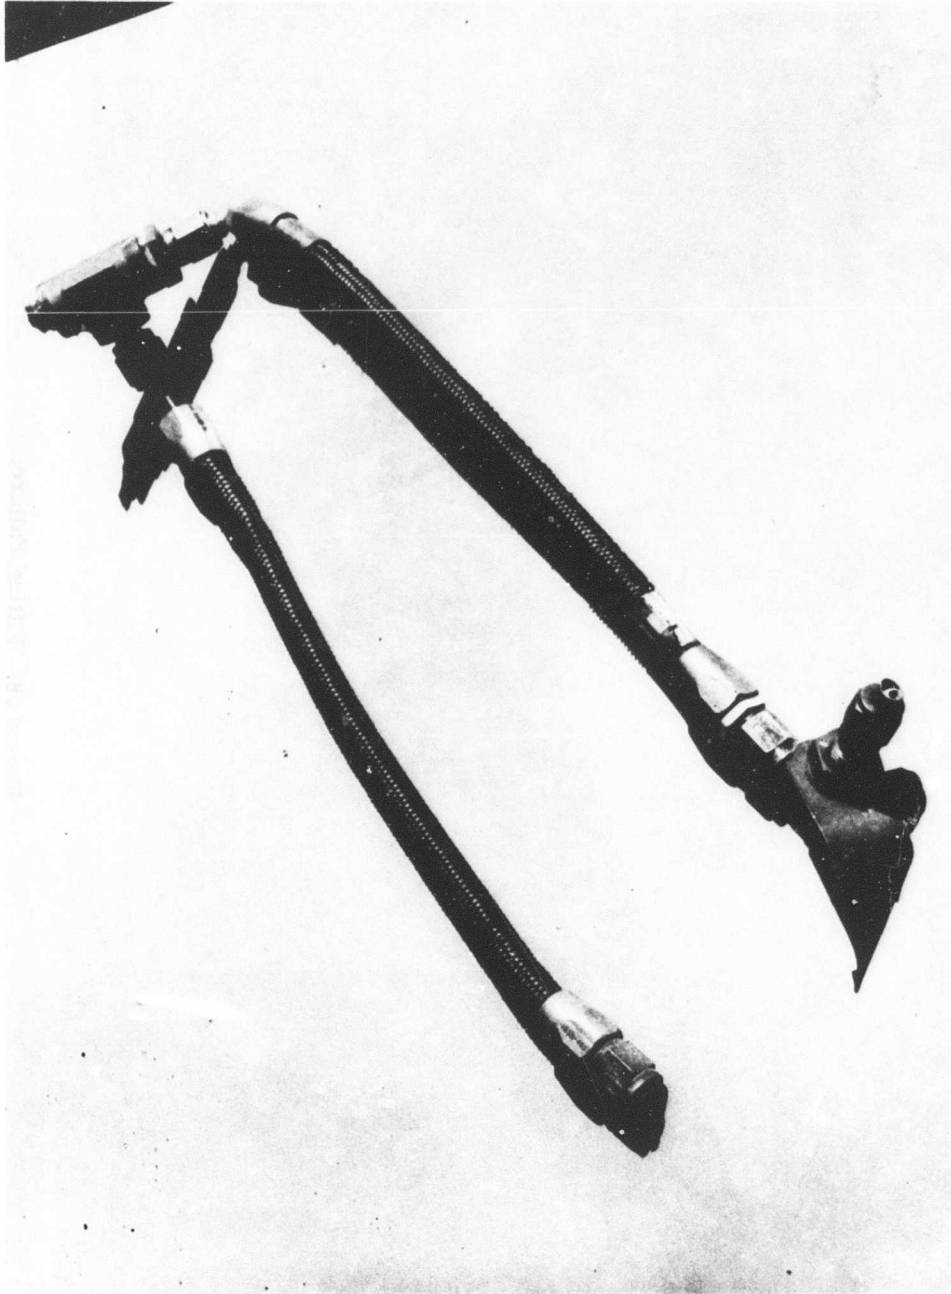
Figure 27. Fitting Failure Caused by Crash Impact.

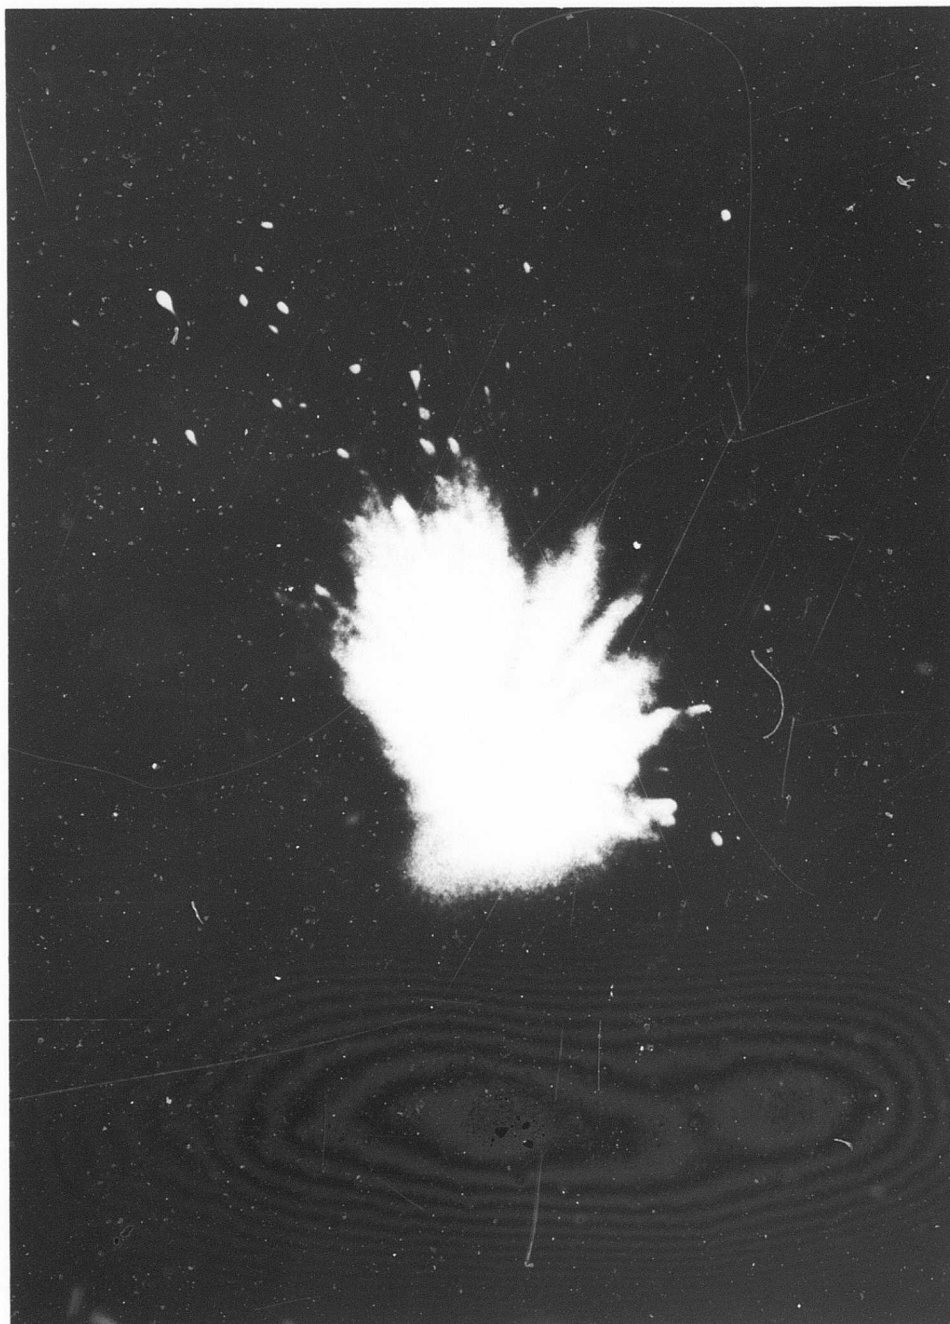
Figure 31. Ballistic Flash Impact From Projectile Penetration of an 0.125-Inch Thick Aluminum Sheet.

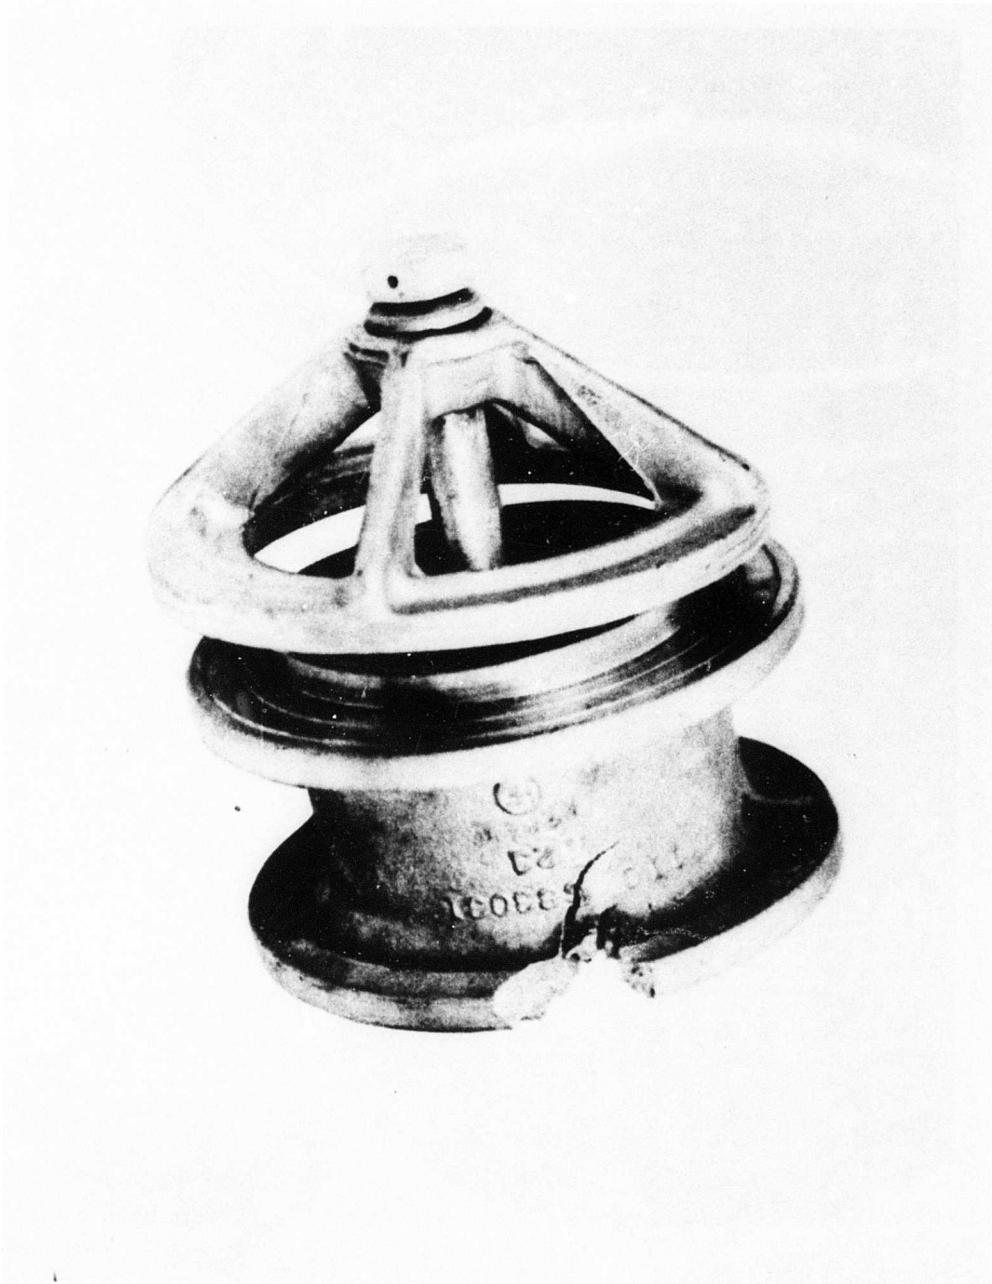
**Figure 43. Cast Aluminum Fuel Cell Interconnect After Being Struck by a Small Arms Projectile.**

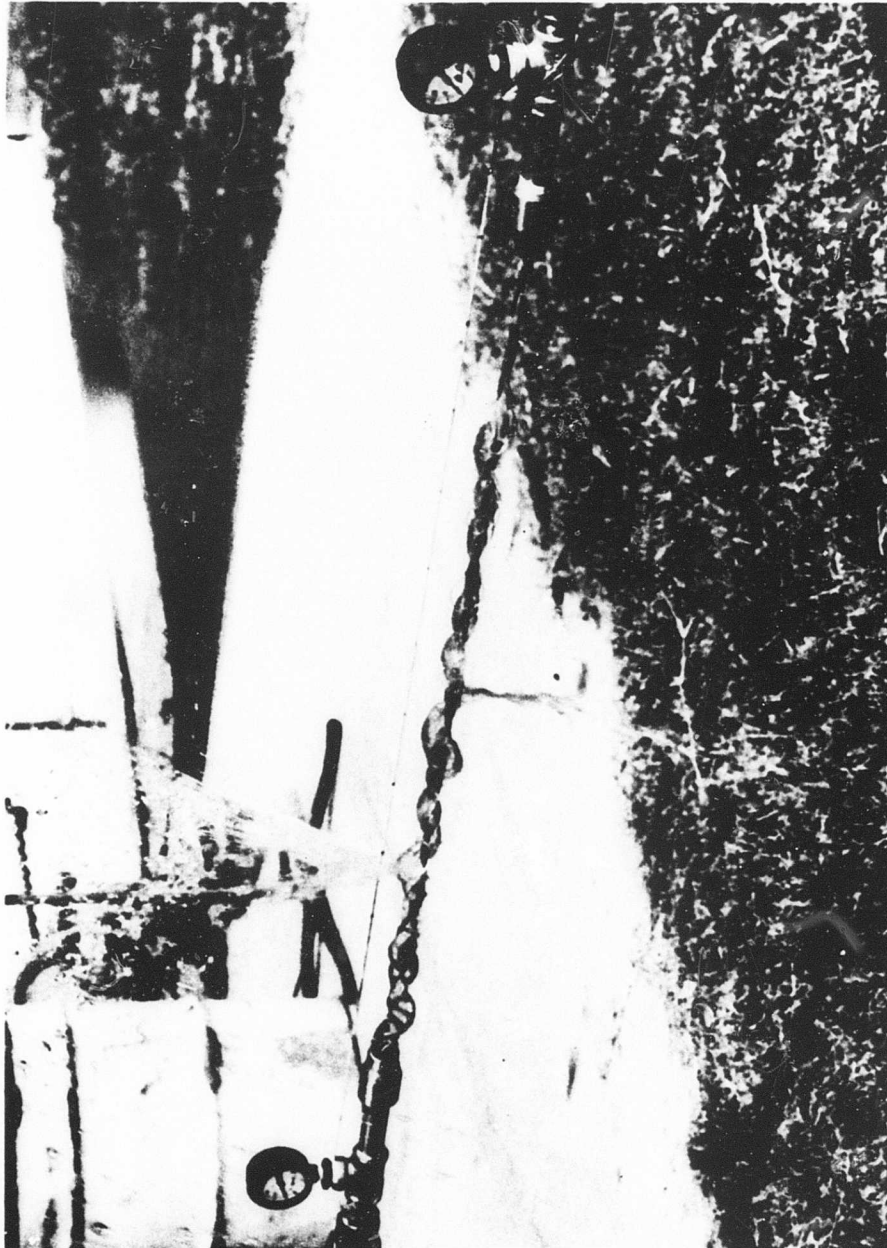
Figure 73. Failure of Configuration B Self-Closing Fuel Line.

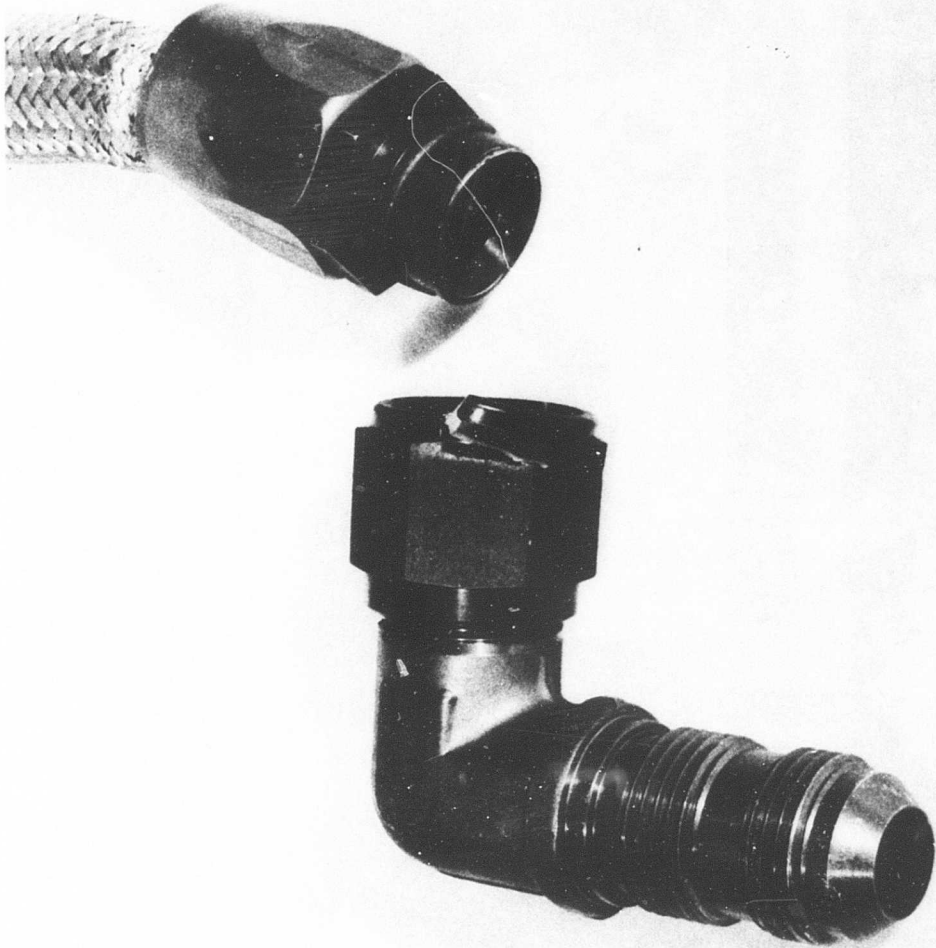
Figure 100. Hose-Fitting Failure (Test Series 4-1).
