SEMI-RIGID OR NON-RIGID STRUCTURES
FOR RE-ENTRY APPLICATIONS

Space-General, a Division of
Aerofjet-General Corporation

FINAL TECHNICAL REPORT AFML-TR-67-310

Part 2 Fabrication and Test

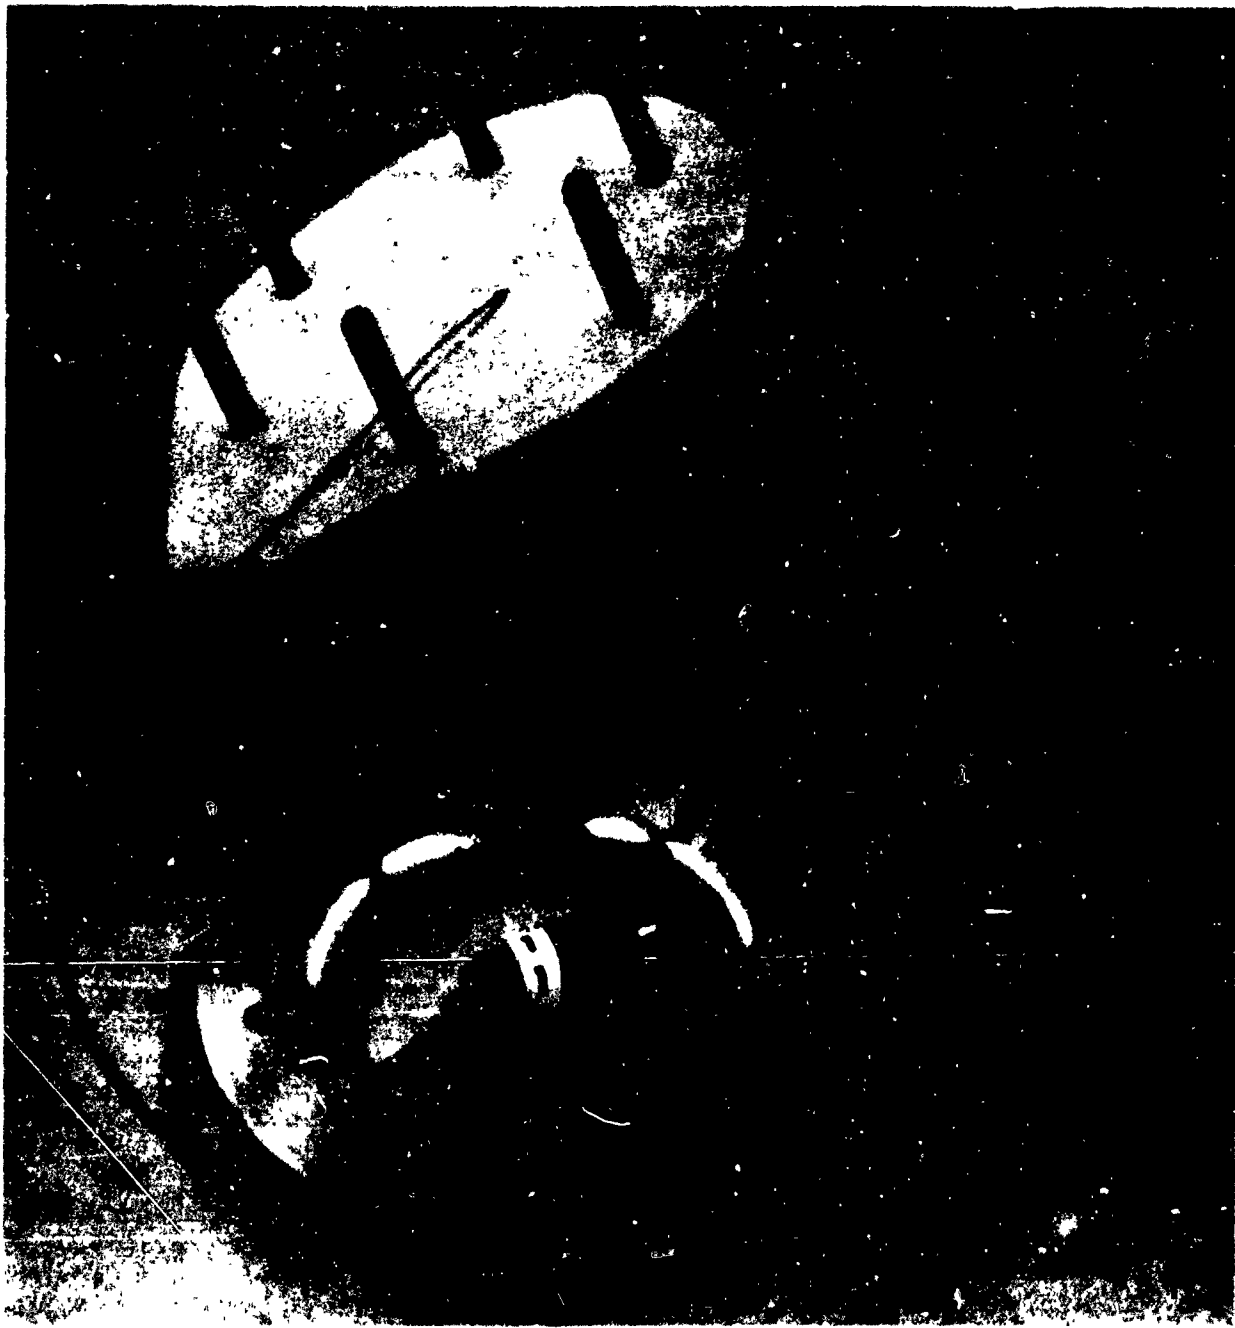
Figure 196. Permeability Test Fixture and Specimen

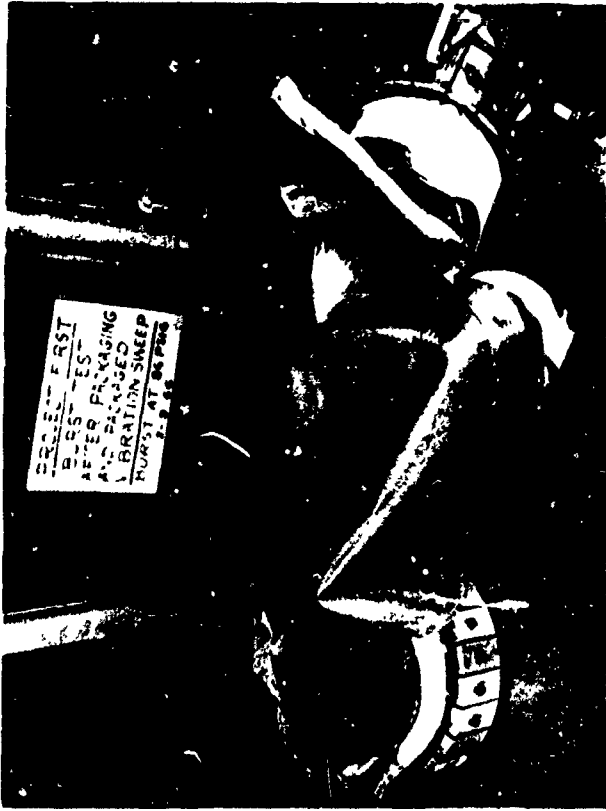
Figure 226. Frustum S/N 6 After Burst Test (Test 4)

After the above testing, the specimen was burst-tested with no external loads except the loading jig counterweight of 22.0 lb. The internal pressure was increased at a rate of approximately 2 psi per second. At 60 psig, a blister began to form in the S-6510 coating. Between 60 and 75 psig the pressure rise rate averaged 1 psi per second. At 75 psig the blister ruptured. Between 75 and 85
