March 6, 1967
DMIC Memorandum 228

ACCELERATED CRACK PROPAGATION OF
TITANIUM BY METHANOL, HALOGENATED
HYDROCARBONS, AND OTHER SOLUTIONS

DEFENSE METALS INFORMATION CENTER
BATTELLE MEMORIAL INSTITUTE
COLUMBUS, OHIO 43201

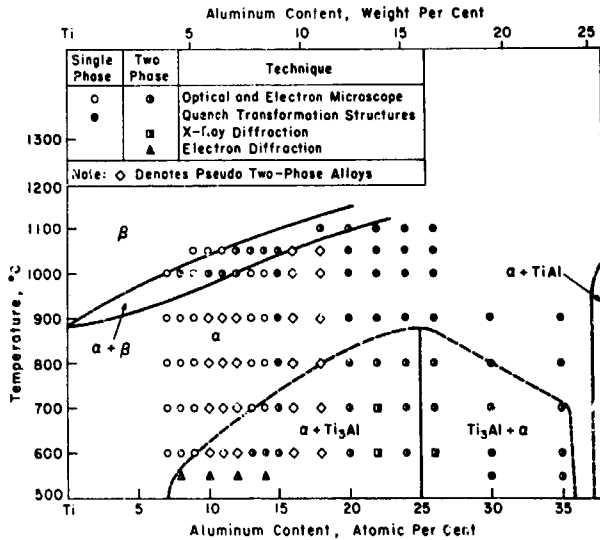
FIGURE 1. BINARY Ti-Al PHASE DIAGRAM, AFTER CROSSLEY⁽³⁾

The only metallurgical variable that has been studied to date is the aluminum content of Ti-Al binary alloys. The equilibrium diagram of the titanium-aluminum system, as determined by Crossley⁽³⁾, is shown in Figure 1. Alloys containing 0 to 7.5 weight percent Al were studied, and it should be noted (Figure 1) that on slow cooling from temperatures in the alpha range precipitation of Ti₃Al is possible at aluminum contents in excess of 4.5 weight percent. With respect to Ti₃Al, Lane⁽⁴⁾ has found that binary Ti-Al alloys of a composition within the $\alpha + Ti_3Al$ phase region, heat treated to produce Ti₃Al, show susceptibility to accelerated crack propagation in seawater, whereas alloys with a lower aluminum content are not susceptible. Accordingly, it was decided to determine whether a similar dependence of susceptibility on aluminum content existed in methanol solutions. The results obtained using U-bend specimens, prepared from binary Ti-Al sheet alloys that had been vacuum annealed at 850 C and slowly cooled in the vacuum furnace to room temperature, are shown in Table 5. These show that cracking may be obtained in both pure titanium and Ti-2 weight percent Al in methanol solutions containing bromine and iodine. Consequently, the presence of Ti₃Al does not seem to be a requirement for embrittlement to occur. Increasing the aluminum content does, however, increase susceptibility to cracking. This increase is better demonstrated in Figure 2, which shows data obtained in constant-load tensile test in methanol-HCl solutions using binary Ti-Al alloys containing 3, 5, and 7 weight percent Al. No data are yet available on tests of pure titanium or Ti-2 weight percent Al alloy.

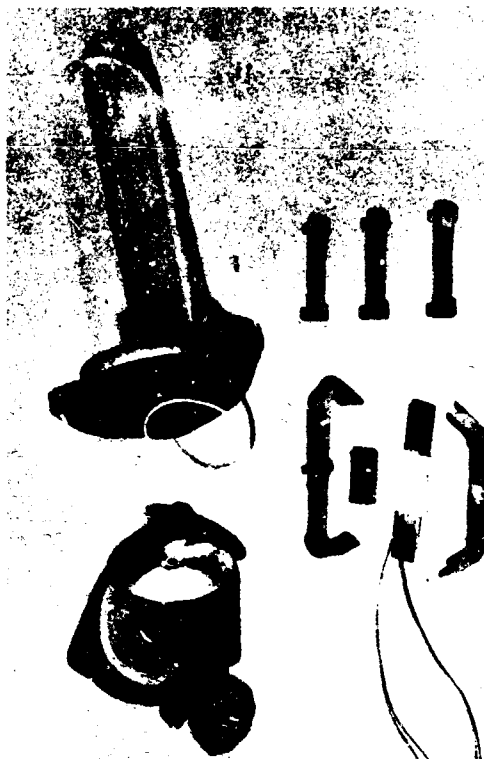
FIGURE 2. STRESS-CORROSION SAMPLE AND FIXTURE

Glass ampoules shown in Figure 2 (2 inches in diameter and 8 inches long) were used to hold the specimens and contain the various alcohol solutions during the exposure period. A maximum of two samples were loaded into each ampoule. The open end of the ampoules were sealed with a T321 stainless steel closure and a Teflon "O" ring. The closure plate has a shut-off valve and a connection for attachment to a combination vacuum and filling manifold. The specimens were loaded into the ampoules, which were then pressure checked to avoid loss of the solution or changes in its composition due to a bad seal. The ampoules were evacuated and backfilled with the desired solution. This filling technique was used for all of the ampoules, with the exception of the isopropyl alcohol base dye penetrant developer. The developer solution was poured over the specimens in an ampoule before the closure plate was attached. This ampoule was not pressure checked; however, the liquid level did not change during the 28-day exposure period. The solids in the developer solution had a tendency to settle out of solution and required daily agitation. The ampoules were maintained in an upright position between 70 and 80 F for the duration of the exposure period (see Table 1). The ampoule was visually examined at the start and close of each workday for failures or initiation of cracks.
