SP-120

SPECIAL PUBLICATION

# CHASE VI SEARCH OPERATIONS

NAVAL OCEANOGRAPHIC OFFICE  
WASHINGTON, D. C. 20390

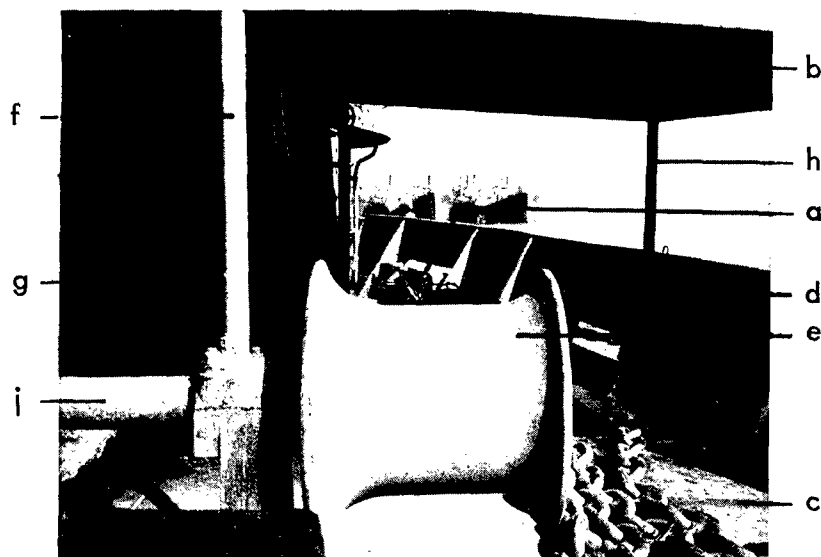
PHOTO 8, NICHOLS PORT AFTER PASSAGE AND DECKHOUSE

- a. After closed and open vertical roller chocks and freeing port
- b. Gun deck wing for port after gun tub
- c. After passage portside
- d. Bulwark
- e. Gypsy head, portside, steam warping winch
- f. Stanchion supporting after gun deck
- g. After deck house bulkhead
- h. Stanchion supporting after gun deck
- i. Shaft from steam winch
