**USAAVLABS TECHNICAL REPORT 68-51**

**AN EVALUATION OF ARMORED  
AIRCREW CRASH SURVIVAL SEATS**

**U. S. ARMY AVIATION MATERIEL LABORATORIES  
FORT EUSTIS, VIRGINIA**

**CONTRACT DAAJO2-68-C-0027  
DYNAMIC SCIENCE  
DIVISION OF MARSHALL INDUSTRIES  
PHOENIX, ARIZONA**

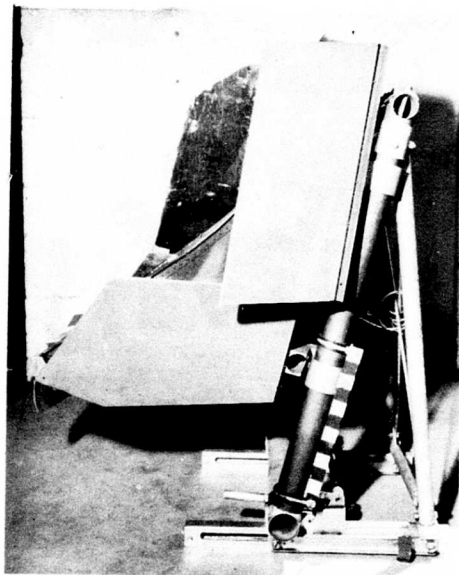
Figure 5. Side View - Hayes Armored Aircrew Survival Seat.

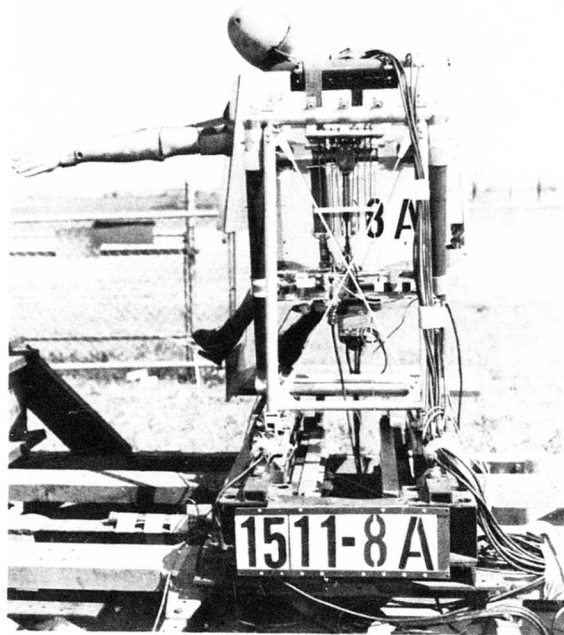
Figure 35. Posttest View of Seat -  
Test 8A.

No seat damage or stroking of the energy absorbers occurred in this test, although the seat-pan and occupant pelvic accelerations peaked at 33.5G and 65G, respectively.

Figure 35 shows a view of the rear of the seat after this test.

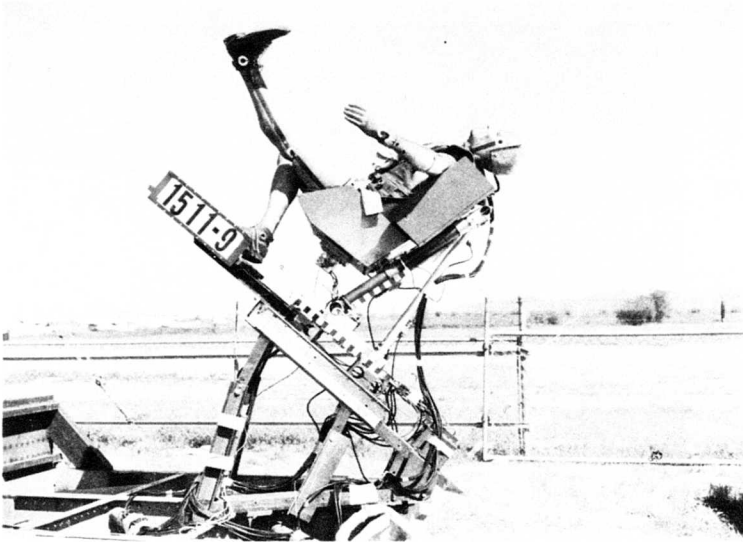
Figure 38. Posttest Side View - Test 9.

of 46.2 feet per second. No seat damage occurred. The vertical energy absorber stroked 2.72 inches, while the longitudinal and lateral energy absorbers did not stroke. The high seat-pan and occupant pelvic accelerations in the vertical axis reflect the limited energy absorber travel. These vertical accelerations were approximately in phase with the vertical input pulse, particularly during the early part of the pulse.

Figures 38 and 39 show posttest side and rear views of the seat.
