**CR 69.008**

FERRO CEMENT PANELS  
VOLUME I

Experimental Evaluation  
and Protective Potential

An Investigation Conducted by  
**T. Y. LIN AND ASSOCIATES**  
Consulting Engineers  
Van Nuys, California

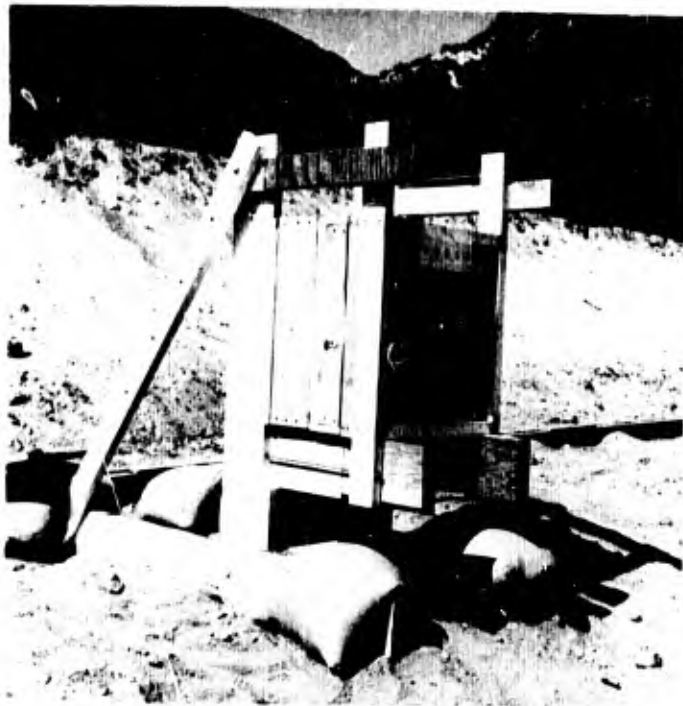
Figure 3-1 Panel Support and Spacers,  
Parametric Experiments

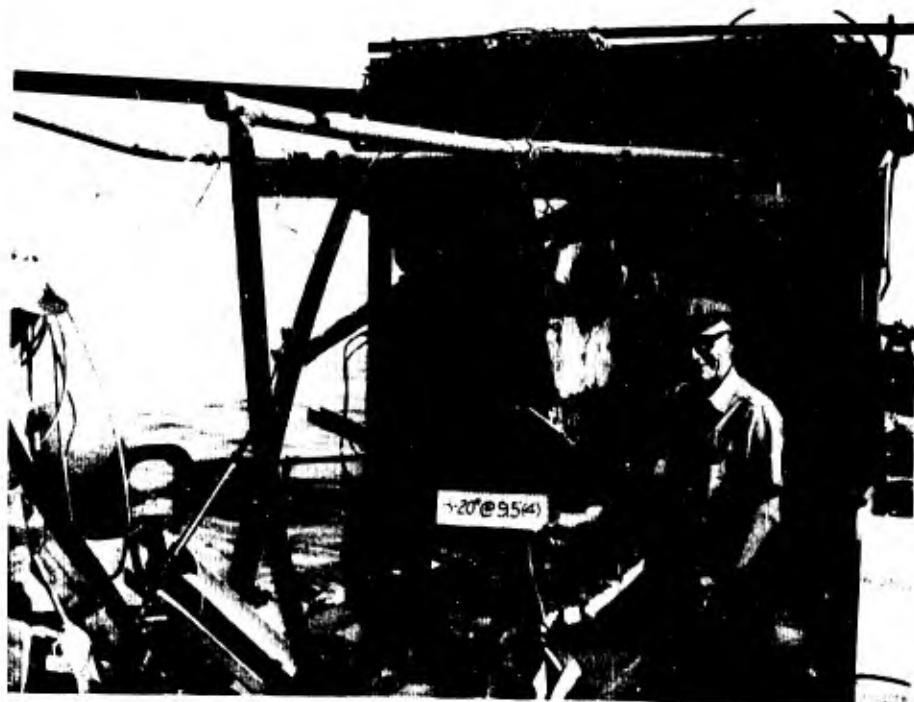
Figure 4-7.902 Further Damage to  
Support Frame

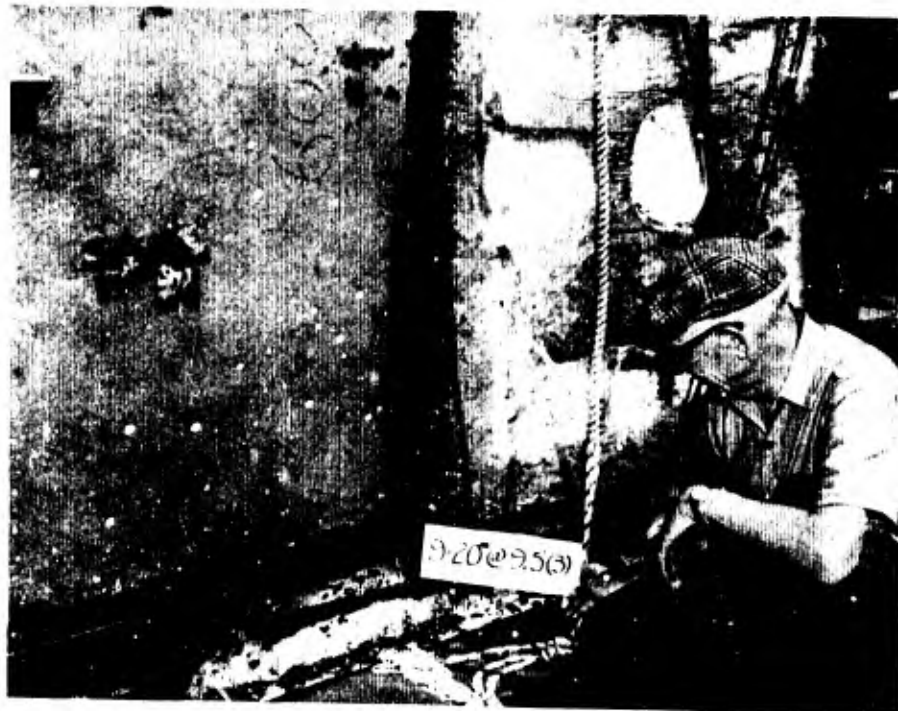
Figure 4-7.1004 Shifting of Blocks in Pier Simulator

The lower right anchor block shifted toward the blast about 4" and the lower left block shifted toward it about 1". (Figure 4-7.1004) The blocks returned to about the position of the seventh experiment.
