# THE USE OF CHEMICAL VAPOR DEPOSITED ALUMINUM FOR PROPELLANT TANK LINERS AND EXPULSION BLADDERS

CHINA LAKE, CALIFORNIA \* APRIL 1969

NWC Technical Publication 4607

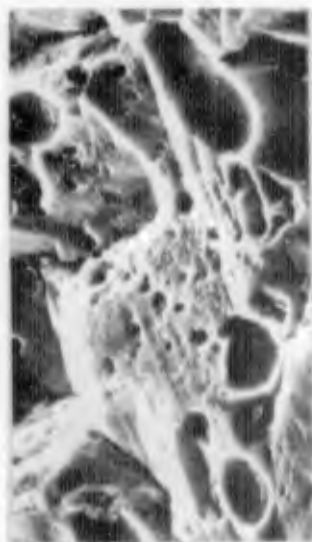
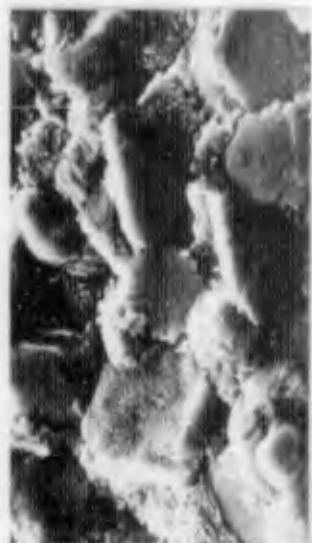
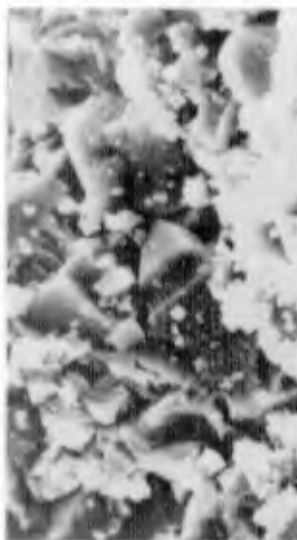
FIG. 7. CVD Aluminum Surface Structure of Four Samples at 2000 X.

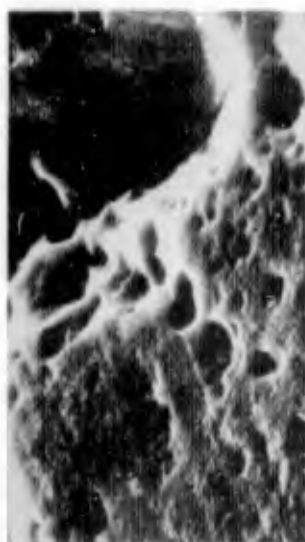
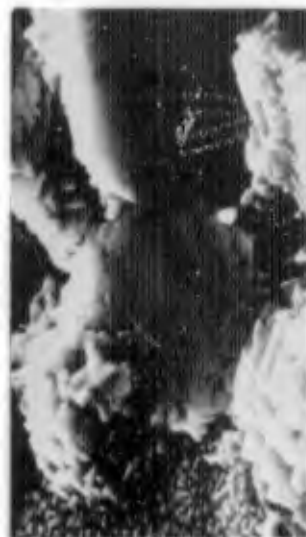
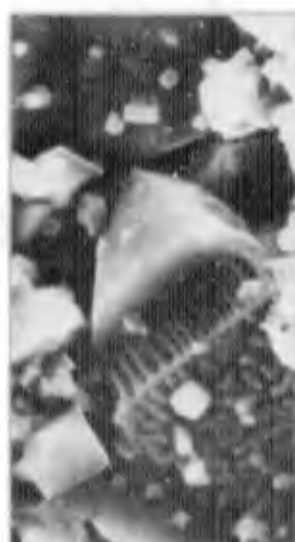
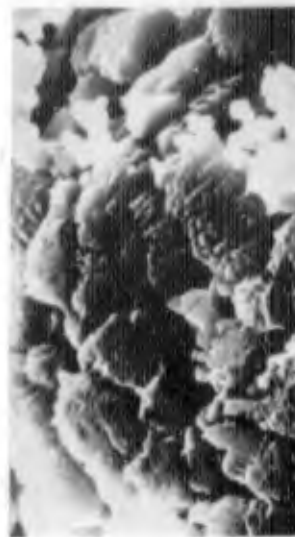
FIG. 8. CVD Aluminum Surface Structure of Four Samples at 5000 X.

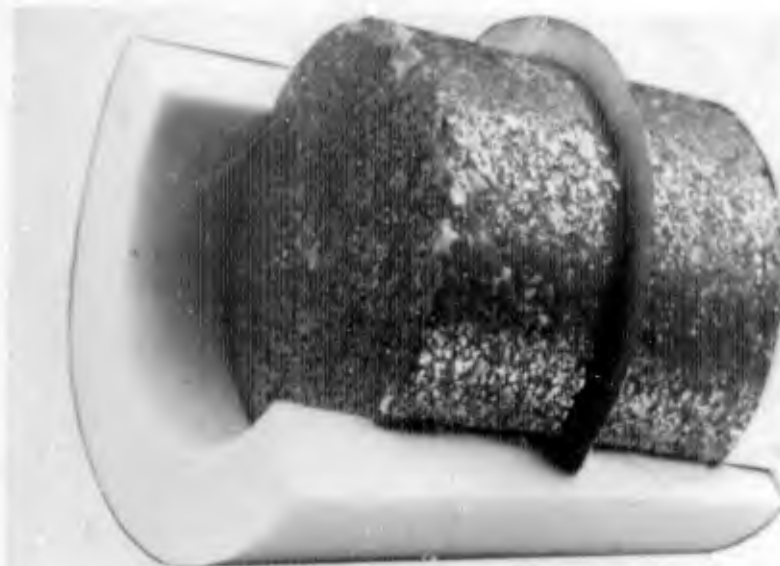
LHL 128592

FIG. 9. Permeability Sample at 5 X.

Permeability of the CVD aluminum was of prime concern since the aluminum was being developed for long term propellant storage. Samples 0.014 and 0.003 inch in thickness were mounted between two cylinders of porous sintered nickel and then potted in a tapered cylinder using silicone rubber (Fig. 9). This assembly was pressurized with argon to 100 psi; the gas flow to be measured by a water displacement technique. Neither thickness of material showed gas passage during a 60-minute pressurization cycle.

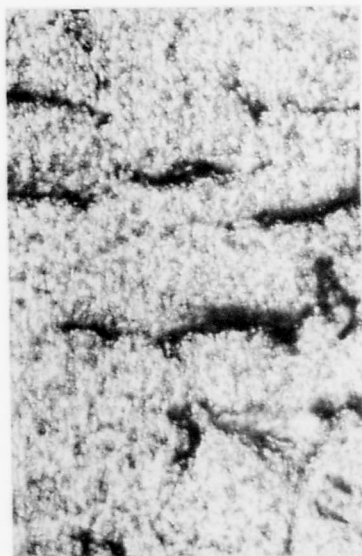
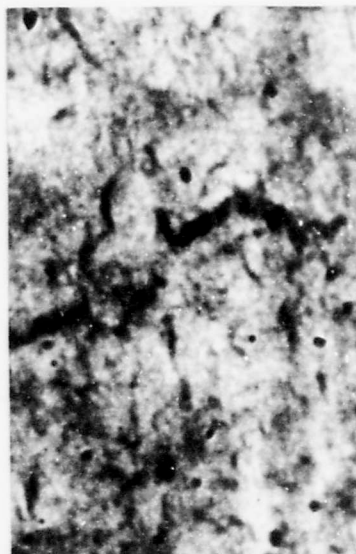
FIG. 11.

Figure 11 shows two views of a polished and etched cross section. The third view is a microradiograph representing the condition of the sample near the surface away from the wall on which the deposition was made. Note the large size of some of the grains and the dark areas at some of the grain boundaries.

Polished and Etched Specimen at 500 X.

X-ray Absorption Pattern at 140 X.
