NWC TP 4720

## EVALUATION OF EXPLOSIVES SIMULTANEITY TESTS

URS Research Company  
for the  
Systems Development Department

**NAVAL WEAPONS CENTER**  
CHINA LAKE, CALIFORNIA \* MAY 1969

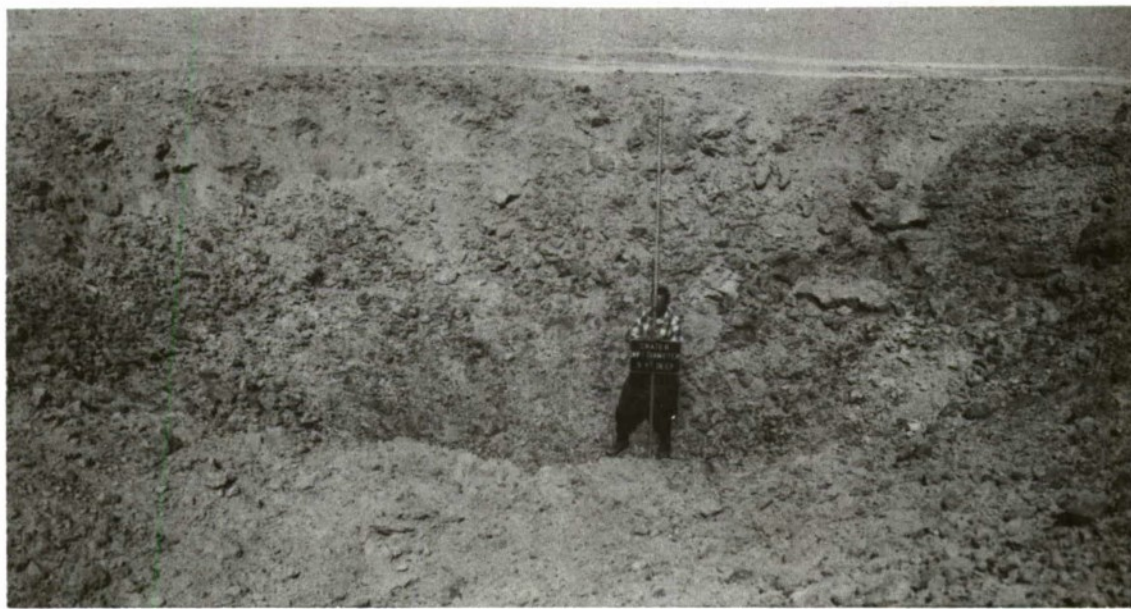
FIG. 6. Crater Formed by Detonation of Single 10,000-Pound Charge.

The first test was a control test in which a single 10,000-pound charge, built of cast blocks of TNT stacked to approximate a hemisphere (Fig. 5), was placed in the center of the 20-foot-square donor bay and detonated. The bay was completely destroyed by the blast (Fig. 6), and a crater about 38 feet in diameter by 9 feet deep was formed.

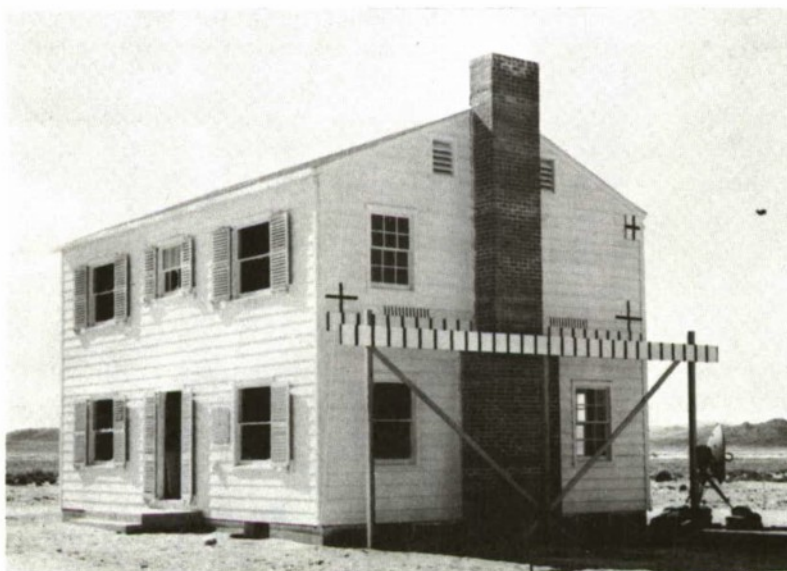
FIG. 7. Front and West Sides of Test House  
After Test No. 1.

After the blast, all the front windows of the house, except the small one above the front door, were completely removed (Fig. 7). The door was torn off its hinges and blown into the front hall, and all basement windows forward of the centerline of the house were blown in. Figure 8 is a view of the east and south sides of the house. Note the window damage on the east (right side) wall and that only one pane of glass on the back (south) wall was broken. This pane was broken by a wooden fragment from the front window, rather than by the blast. There were also chimney damages, some of which are indicated by the chalk marks in Fig. 9.

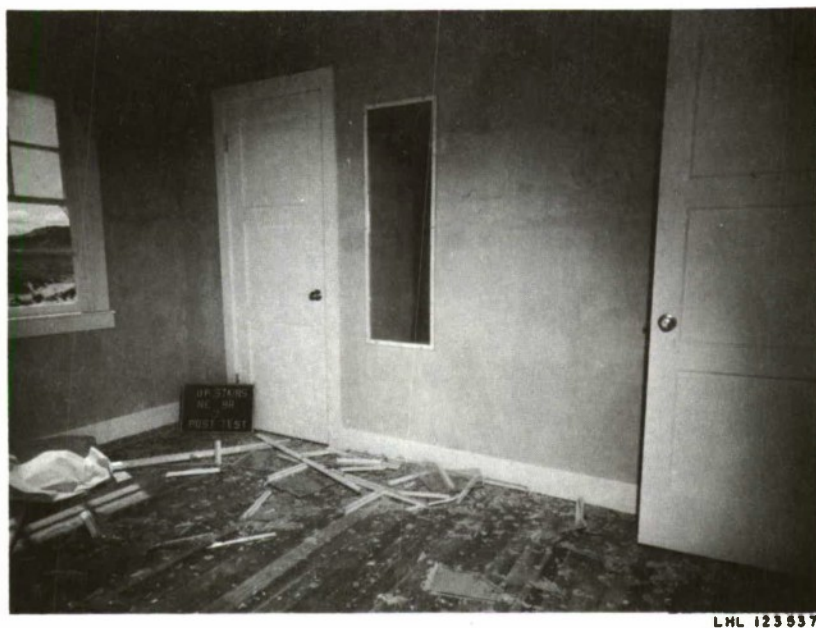
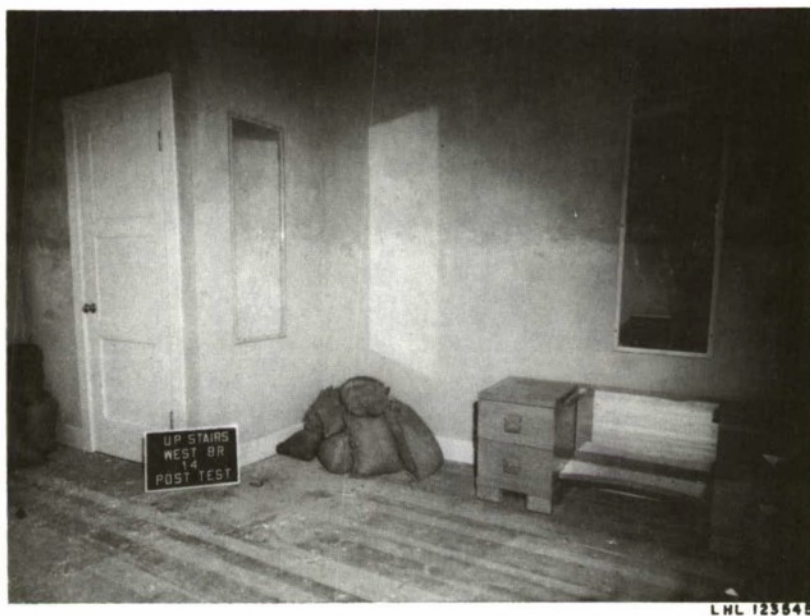
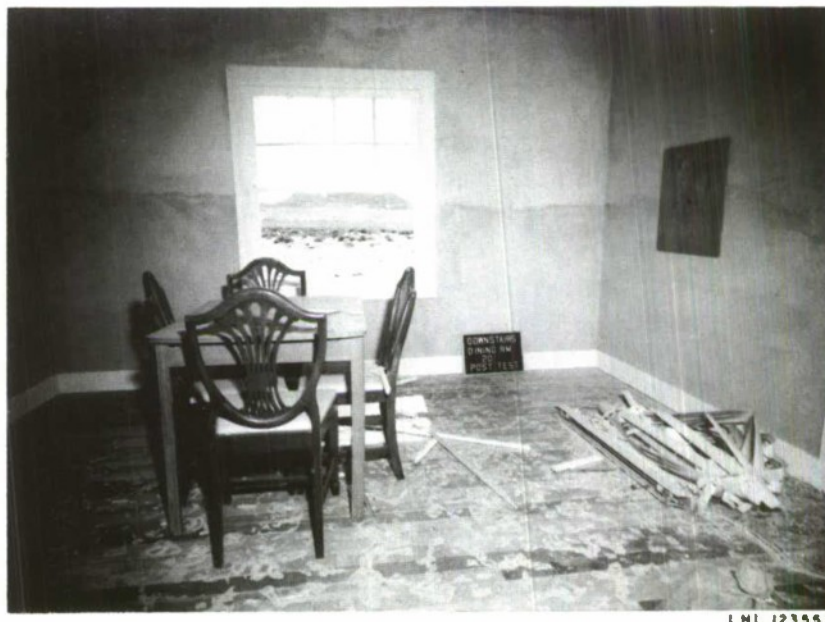
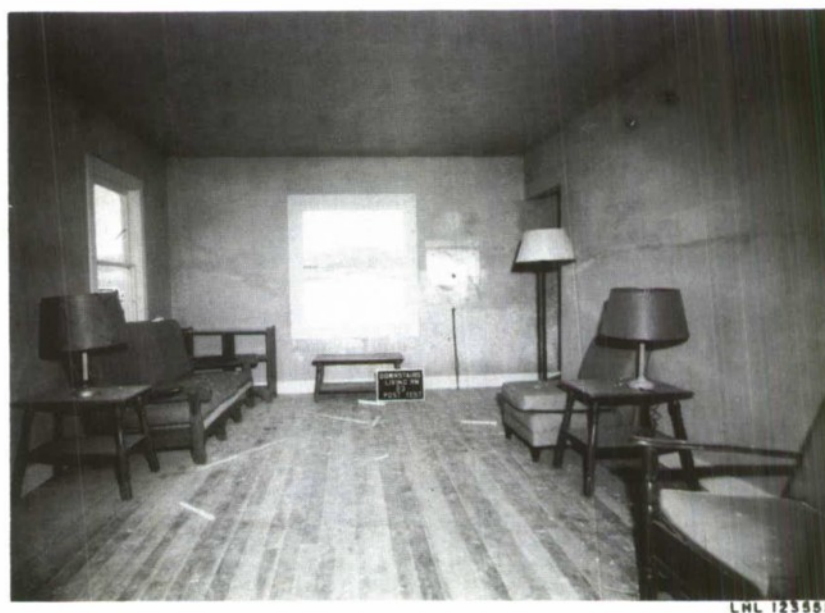
FIG. 10. Damage to Upstairs Northeast Bedroom, Test No. 1.

FIG. 11. Damage to Upstairs West Bedroom, Test No. 1.

FIG. 12. Dining Room Damage, Test No. 1.

FIG. 13. Living Room Damage, Test No. 1.

Large quantities of glass and pieces of window frames and shades were scattered throughout the interior of the house (Fig. 10-13), and some plaster cracking was visible in several of the rooms. Very little furniture movement or damage occurred and, as shown in Fig. 13, even the lampshades were only slightly jarred. None of the wall-mounted mirrors was damaged.

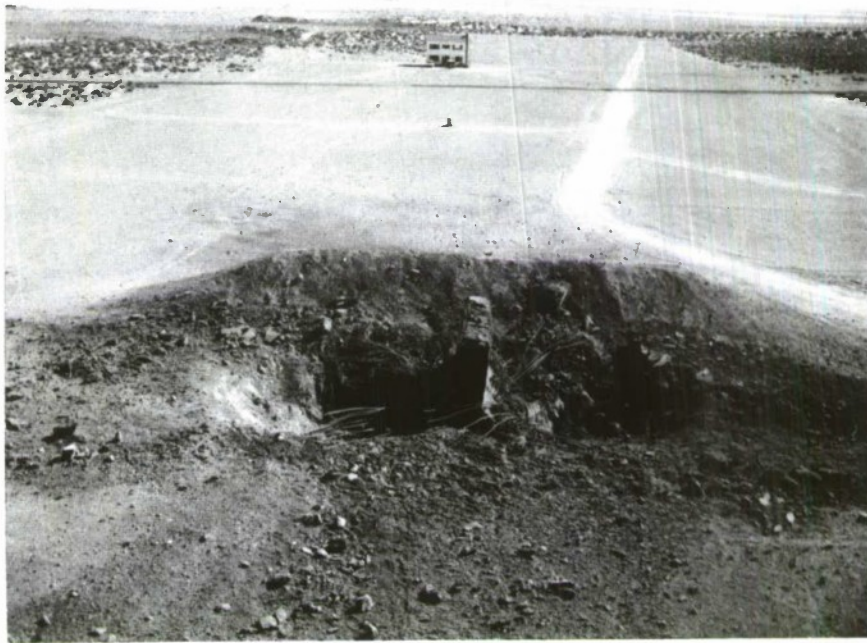
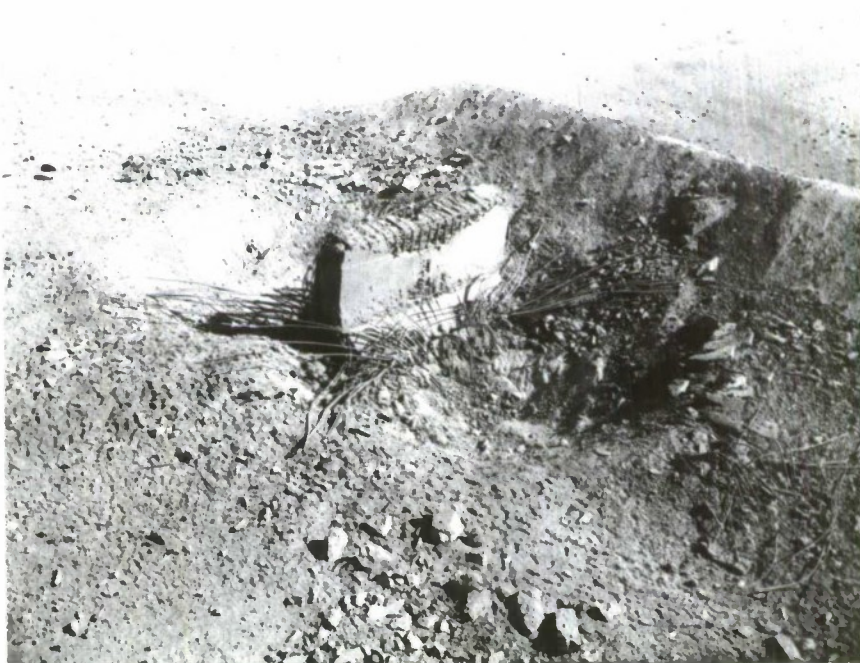
FIG. 14. Views of Dividing Wall and Craters After Programmed Detonation of Two 5,000-Pound Charges, Test No. 2.

The setup for this test was like that used in Test No. 1, except that two 5,000-pound cast hemispherical charges of TNT, separated by a specially designed heavily reinforced substantial dividing wall (see Fig. 3), were placed in the donor structure and detonated 20 msec apart. Most of the donor structure was destroyed, the special wall between the charges was damaged, and craters approximately 10 feet deep and 20 feet in diameter were formed (Fig. 14).

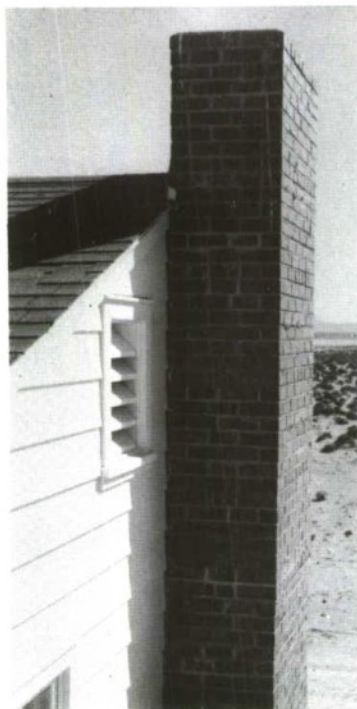
FIG. 17. Views of Chimney Damage, Test No. 2.

Damage to the chimney (Fig. 17) was also more severe after the second test than after the first. Cracks were larger, more spalling occurred, and a large portion of the chimney was separated from the wall by an inch or more.

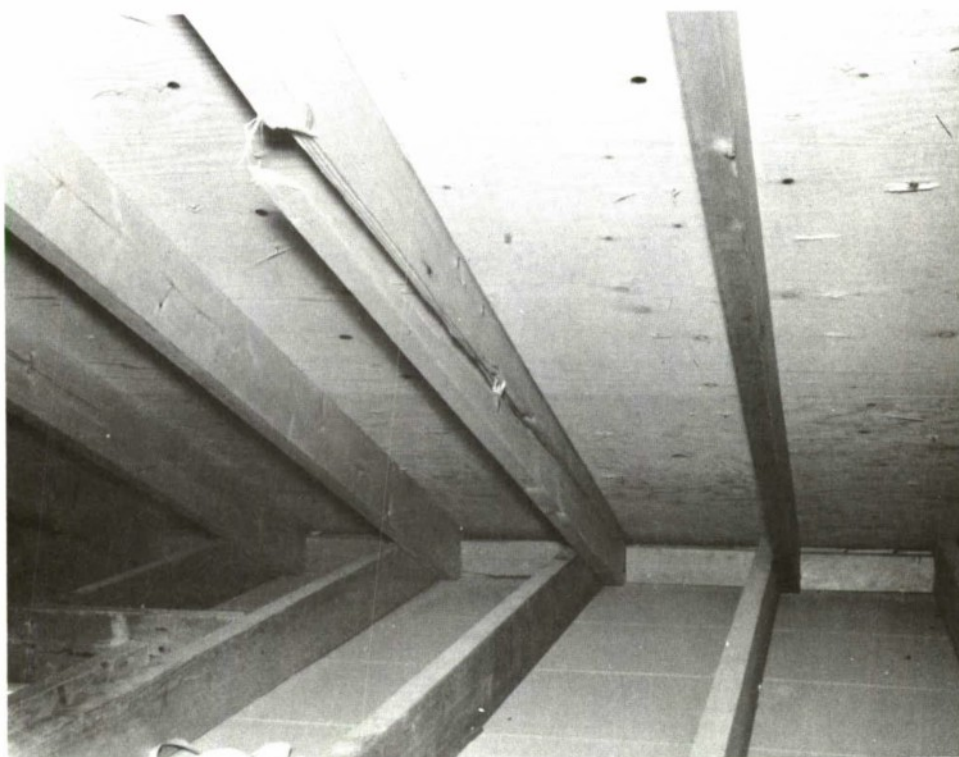
FIG. 19. Rafter Broken in Test No. 2.

Inside the house, plaster cracking was also generally more severe. The door between the dining room and kitchen was badly damaged (Fig. 18), and the rafter damage, shown in Fig. 19, was apparently the most significant damage to a structural element in the house from either test.

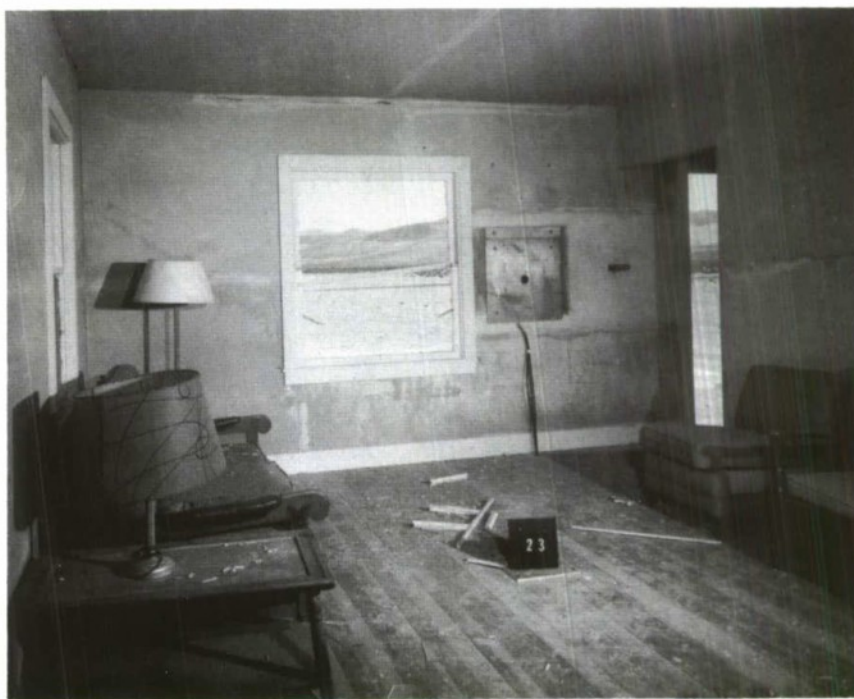
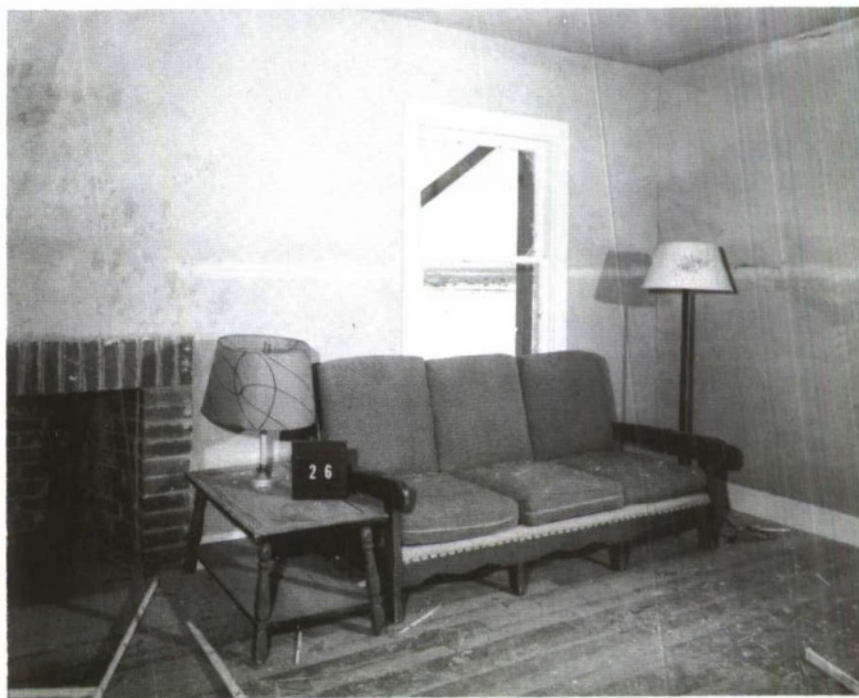
FIG. 20. Views of Living Room Damage, Test No. 2.

Damage to the interior of the upstairs was about the same as that observed in Test No. 1, except that much of the flying glass was intercepted by styrofoam glass-traps and never reached the floor. Again, no mirrors were cracked and no furniture was moved. Damage to the downstairs interior was also comparable to that in the first test, with neither flying glass, pieces of window frame, nor the blast itself significantly disturbing furniture position (Fig. 20).
