FTC-TR-69-26

USAF EVALUATION OF THE HARRIER GR Mk 1

TECHNICAL REPORT No. 69-26

**AIR FORCE FLIGHT TEST CENTER
EDWARDS AIR FORCE BASE, CALIFORNIA
AIR FORCE SYSTEMS COMMAND
UNITED STATES AIR FORCE**

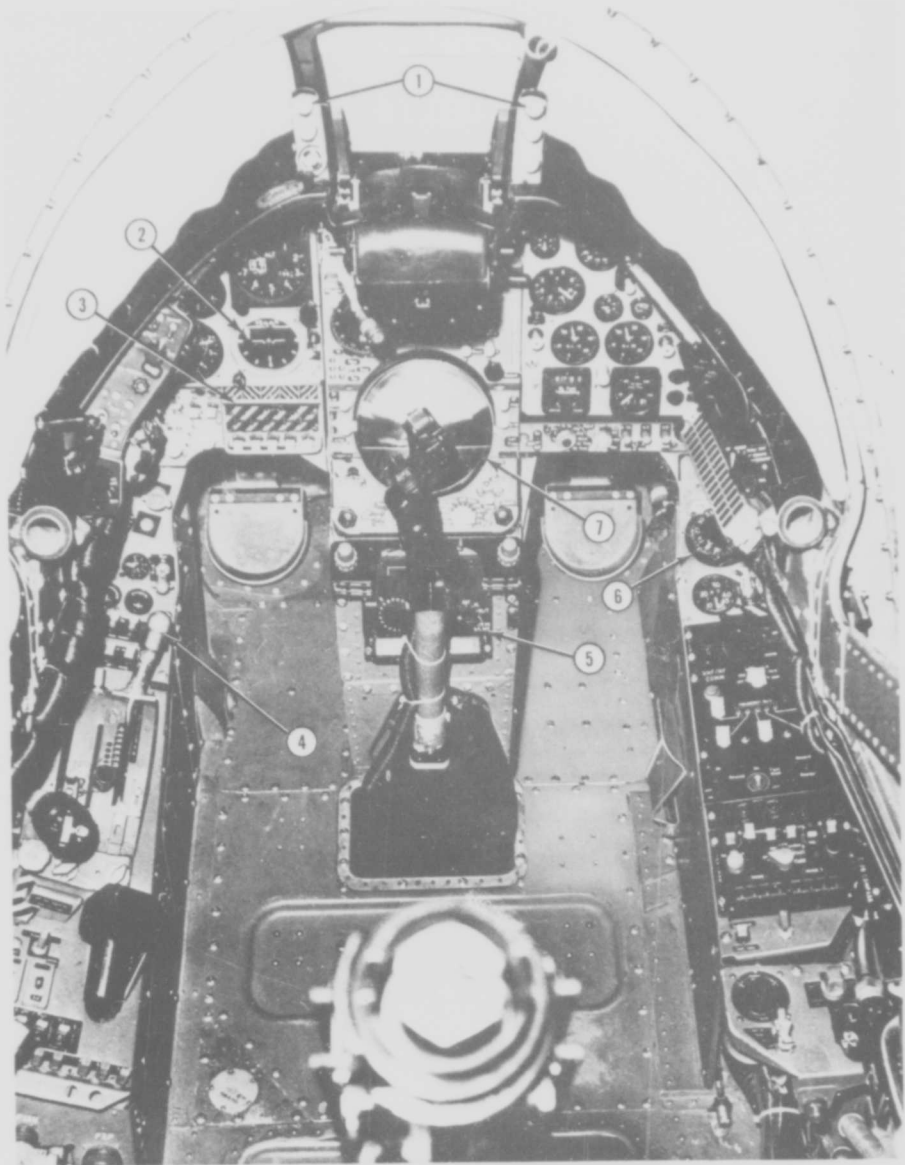
Figure 1 AIRCRAFT COCKPIT (EJECTION SEAT REMOVED)

| 1 | ATTENTION LIGHTS | 5 | UHF RADIO |
| 2 | STAND-BY ATTITUDE INDICATOR | 6 | TACAN BEARING AND DISTANCE INDICATOR |
| 3 | WEAPON CONTROL PANEL | 7 | MOVING MAP DISPLAY |
| 4 | NOZZLE CONTROL LEVER | | |

A tacan bearing and distance indicator was placed on a vertical panel just forward of the right console. In this position it was difficult to read accurately and was very difficult to adequately crosscheck during instrument flight. In addition, the compass card was not slaved to aircraft heading and did not provide relative bearing information. The length of the instrument behind the compass face and its proximity to the fuselage structure precluded the face being tilted toward the pilot. There appeared to be no better place available to relocate the instrument or to improve its readability; however, the compass card should be slaved to aircraft heading to improve its usefulness.

The standby (secondary) attitude indicator had no pitch graduation marks on its face and had a relatively large aircraft symbol which completely covered the horizon bar near the center. Small pitch changes on the instrument were difficult to see. The secondary attitude indicator should be replaced by a more functional one.

The UHF radio control box was located on the bottom of the center pedestal in front of the control stick because there appeared to be no better place to locate it. In this position, it was difficult to change channels during formation flight and it would be especially difficult during night or weather formation. A remote channel indicator on the instrument panel would eliminate the need to look down during channel changes, but it would not solve the problem completely.

A very compact and complete weapon control panel was mounted on the bottom left side of the instrument panel. The panel was approximately four inches high and six inches wide and provided control and jettison functions for a variety of stores on the seven external stations.

The very reliable and simple exhaust nozzle control lever first applied in the P-1127 series aircraft has been retained in the Harrier with no major changes. Its ease of operation and effectiveness during VSTOL flight, and especially during transitions, was outstanding. This concept is still the standard against which all similar VSTOL controls should be judged.

A central warning system was incorporated which was similar to the master caution panels found in most U.S. military aircraft. The system included two flashing attention lights mounted above the instrument panel and an accompanying audio signal in the pilot's headset. These additions greatly increased the effectiveness of the total system and should be considered for inclusion in all future aircraft.

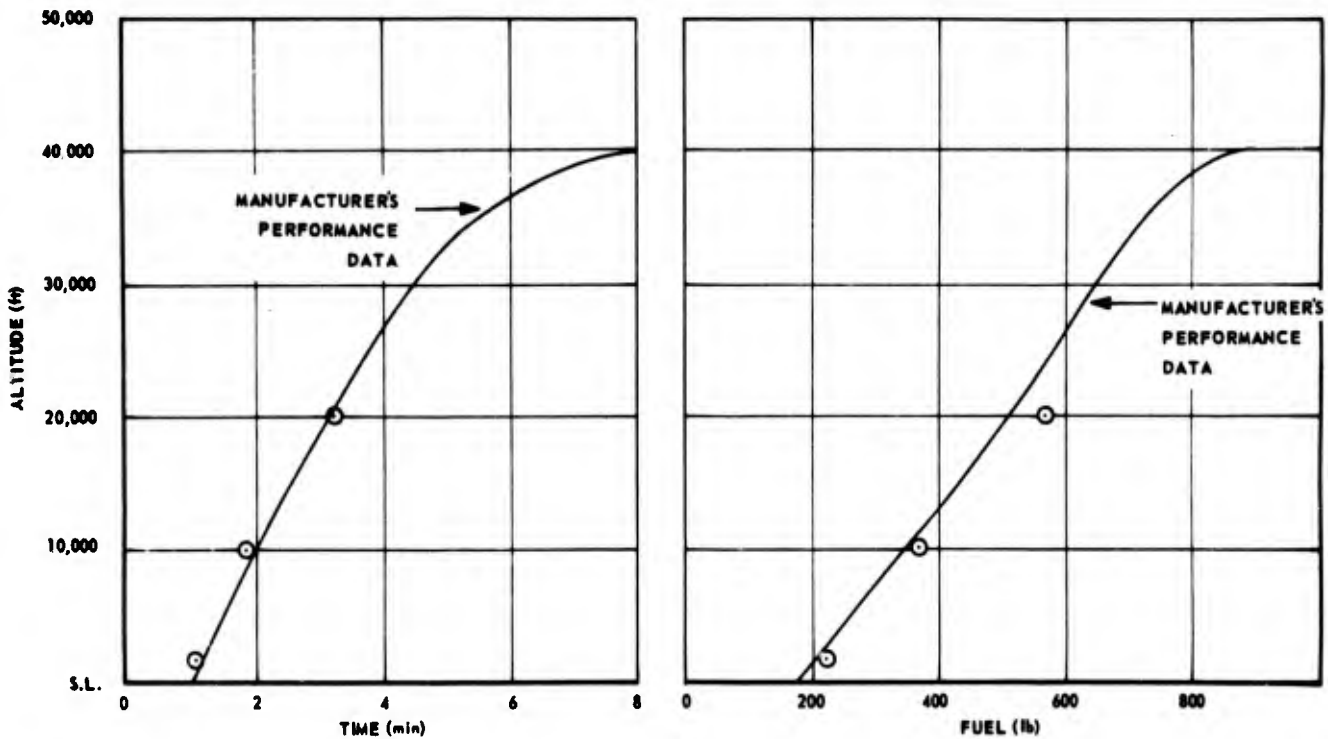
Figure 2 CLIMB PERFORMANCE

Some performance data was gathered on one of the evaluation flights using the cockpit instrumentation and the onboard tape recorder. The takeoff configuration for the flight was 2 rocket pods outboard with ballast simulating 19 rockets in each pod, 2 full one-hundred Imperial gallon drop tanks inboard, and a ballasted reconnaissance pod on the centerline. None of the instruments were calibrated and the data was not reduced to standard day conditions. The main intent of the performance check was to compare a few of the manufacturer's performance figures with evaluation flight test data. The uncorrected test data equaled or exceeded the manufacturer's performance figures in almost every instance. Figure 2 compares the test data with the manufacturer's performance charts.

HARRIER GR MK 1 S/N XV-743
 2 100-IMPERIAL GALLON DROP TANKS
 2 MATRA ROCKET PODS (BALLASTED)
 1 RECONNAISSANCE POD (BALLASTED)
 INITIAL GROSS WEIGHT 19,700 lb
 TIME AND FUEL FROM BRAKE RELEASE
 ○ UNCORRECTED TEST DATA

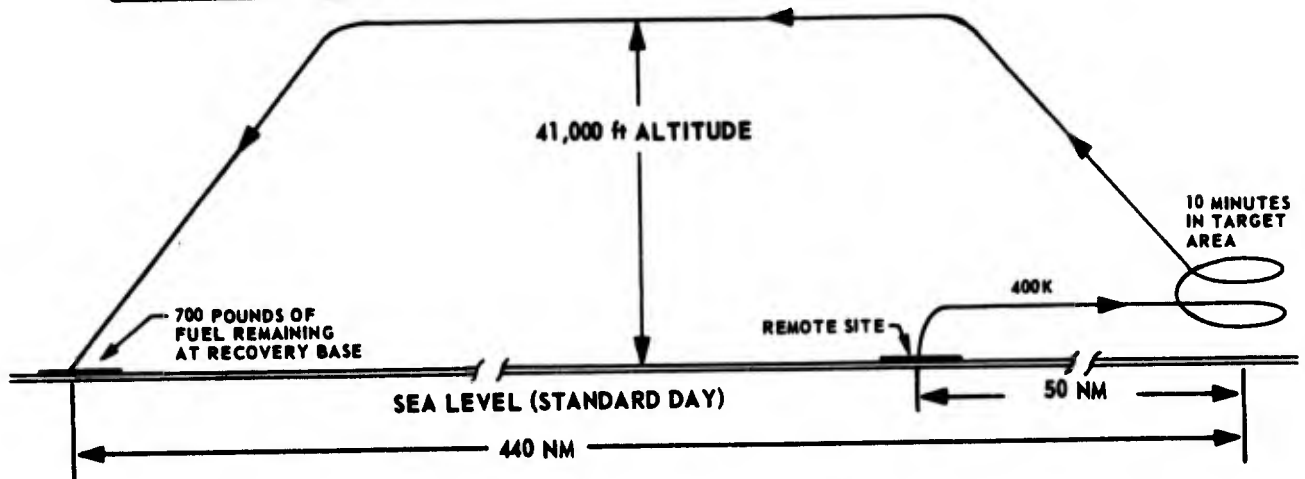
Figure 3 LO LO HIGH MISSION PROFILE

HARRIER GR MK 1
PEGASUS 101, 10 OR 11 WITH WATER INJECTION
4 MATRA 116 ROCKET PODS
2 30mm ADEN CANNONS
FULL INTERNAL FUEL (5,000 POUNDS)
INITIAL GROSS WEIGHT (19,500 POUNDS)

TAKEOFF ROLL:	
PEGASUS 101	740 ft
PEGASUS 10	550 ft
PEGASUS 11	350 ft

There were no aircraft handling problems or systems deficiencies which would preclude use of the Harrier as an effective close support fighter. Therefore, the remaining factor in determining the aircraft's possible usefulness is performance. The performance spot checks made during this evaluation closely matched the manufacturer's performance data, and it was felt that the manufacturer's data was accurate. On the basis of the manufacturer's published performance data, the Harrier had adequate performance to be a useful close support fighter with dispersal capability. Planned engine thrust increases should make the aircraft a very useful and effective VSTOL fighter. Pegasus 10 and 11 engines are expected to be available in 1970 and 1971, respectively. The Pegasus 10 has been tested to the design sea level uninstalled thrust of 20,000 pounds. Pegasus II thrust is advertised to be 21,500 pounds at sea level and 15 degrees centigrade, decreasing to 21,000 pounds at 30 degrees centigrade. Both engines are the same size as the currently installed Pegasus 101. Specific fuel flow is expected to be at least as good as that of the Pegasus 101. Figure 3 shows a mission profile computed from the manufacturer's performance data. Since fuel specifics are expected to be similar for the Pegasus 101, 10 and 11, the only change in the profile due to the different engines would be in takeoff roll. Only 80 percent of the thrust increase of the later engines has been used in the takeoff computations to compensate for duct losses and possible weight increase due to engine installation.
