Technical Note N-1032

EFFECTIVENESS OF ZINC COATING ON REINFORCING STEEL IN CONCRETE
EXPOSED TO A MARINE ENVIRONMENT

July 1969

NAVAL CIVIL ENGINEERING LABORATORY
Port Hueneme, California 93041

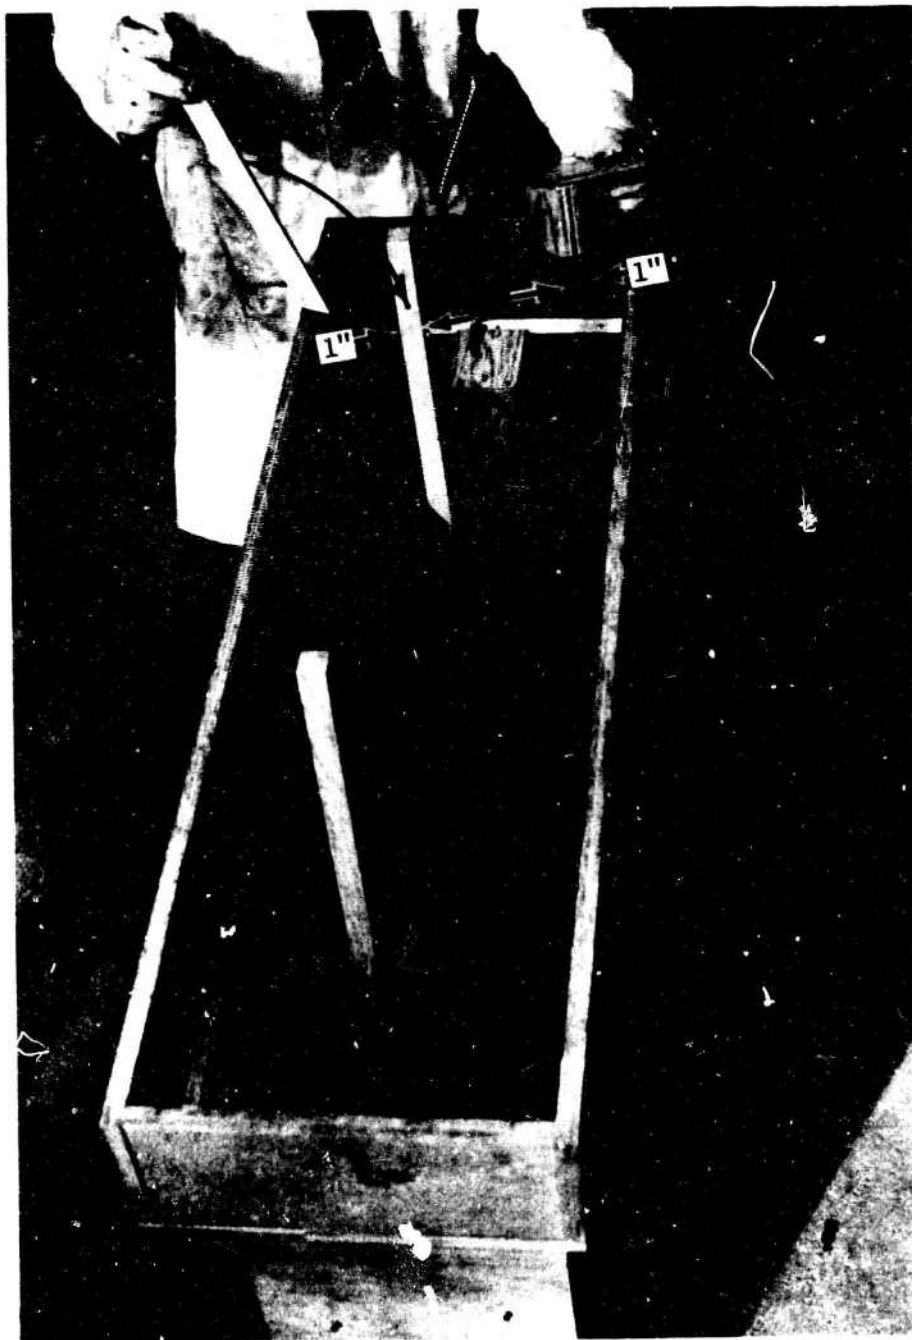
Figure 5. Wooden spacers in place for holding steel grid. Concrete disks are permanent vertical spacers.

While filling the forms with concrete, the steel grids were held securely in place with spacers as shown in Figure 5. The wooden spacers were continually withdrawn to the level of the fresh concrete; the spacers made of concrete were left in place. After a wall was half-filled with fresh concrete, the form vibrators were moved from a lower

position to an upper position on the form. The concrete disks shown in Figure 5 were of the same concrete design as the corresponding wall. The disks were etched in hydrochloric acid and rinsed in fresh water prior to use.

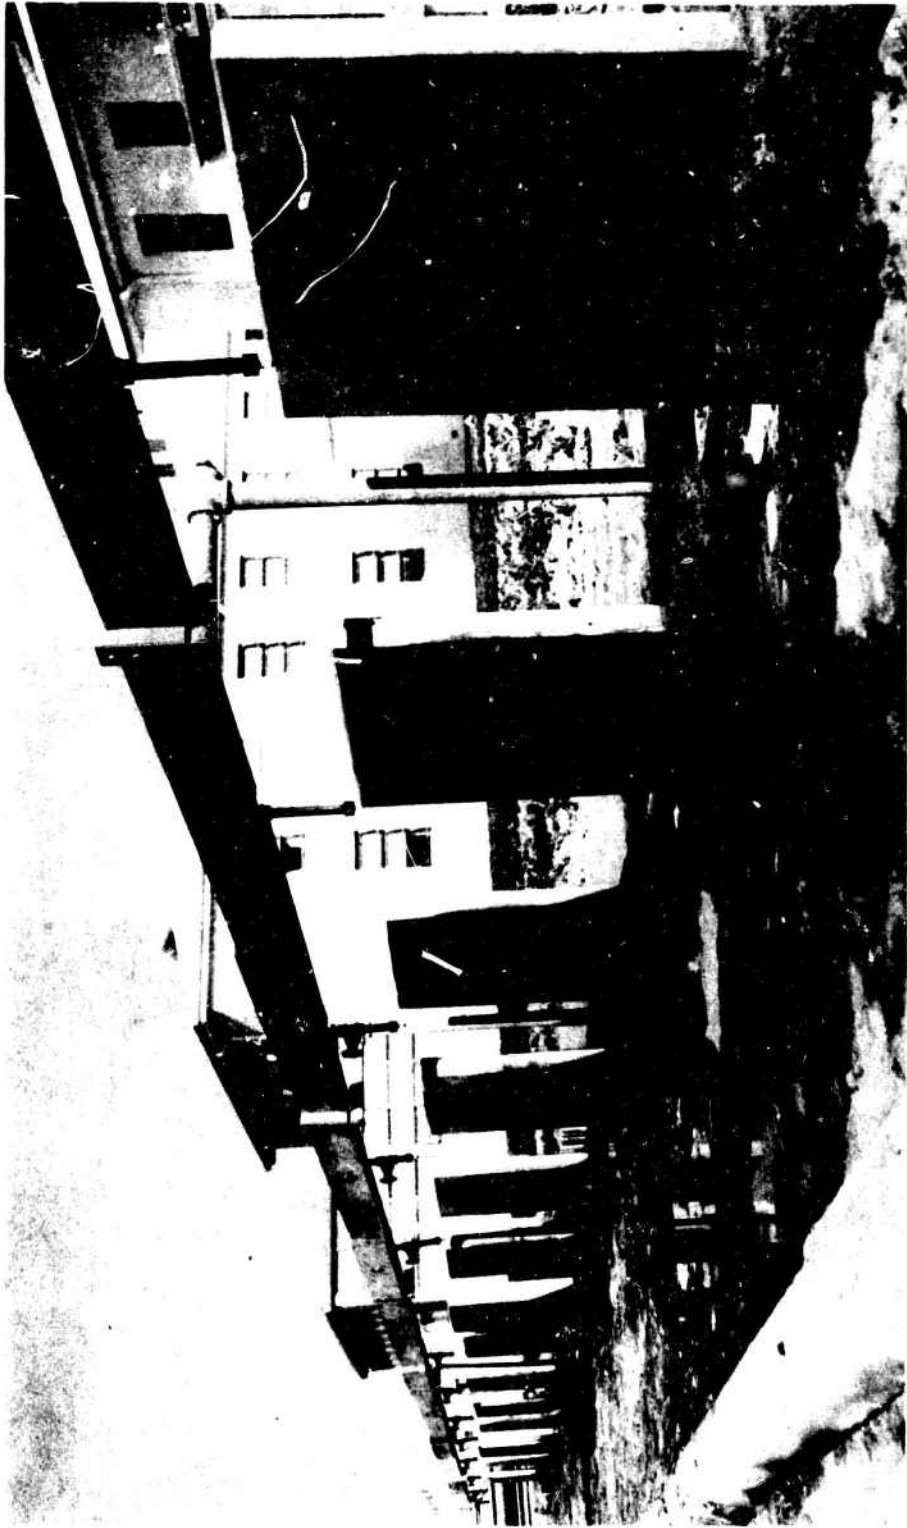
Figure 7. Overall view of walls and sea water spray system.

At 28 days age, each wall and corresponding field specimens were removed from the fog room and transferred to a field site. Each wall was carefully inverted so it was right side up. By means of rope slings, the walls were lifted as shown in Figure 6 and then lowered onto a prepared sand bed. The ropes were pulled from beneath the walls with very little disturbance of the soil and then the wood forms were removed. The walls were oriented so that the horizontal bars in the steel grids were toward the face receiving sea water spray; the vertical bars were toward the opposite face. An overall view of the walls and sea water spray system is shown in Figure 7.

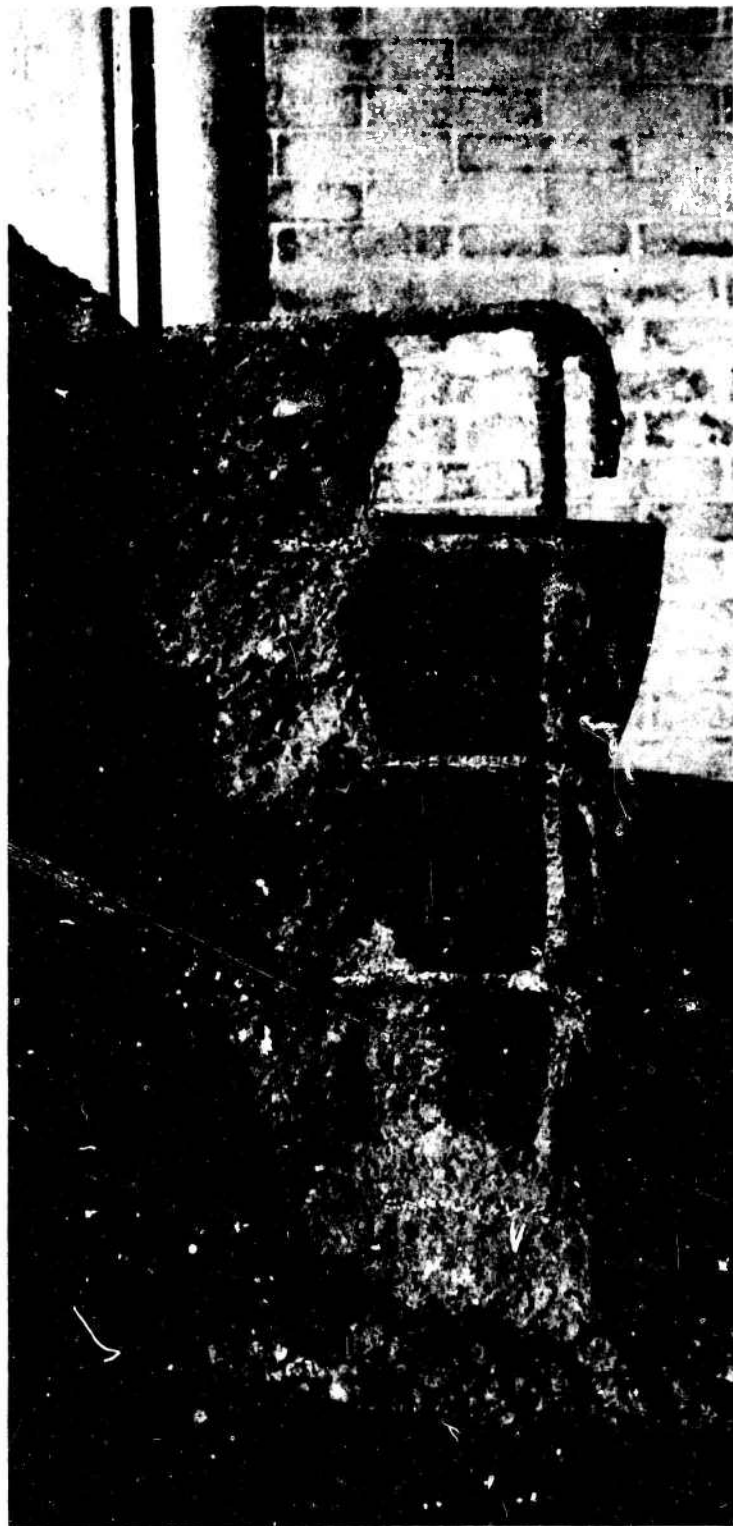
Figure 11. Ferrous oxide on zinc-coated steel bars - east end of Wall 101.

Figure 10 shows cracking typical of the kind occurring on the east and west end faces. The dark areas in Figure 10 are brown stains of ferrous oxide that had migrated from the reinforcing bars. Figure 11 shows the source of the rust.

Concrete was removed from the steel grid of wall 101 on 11 December 1968. The steel of this wall was zinc coated and the contact welds and the bends in the horizontal bars had been touched up with zinc-enriched paint. Every horizontal bar showed white corrosion products of zinc throughout the entire length. In addition each horizontal bar had positive showings of red rust scattered over the entire length. The two vertical bars, one on either side of the grid, were affected similarly to the horizontal bars. The four inner vertical bars had white corrosion products adjacent to the weld joints for a distance of about 1.5 inches on either side of the joint. There was no evidence of red rust on these four inner bars. The portions of the horizontal bars that were bent to the vertical position were the most severely corroded. On the east end of the wall, the red rust was very heavy.

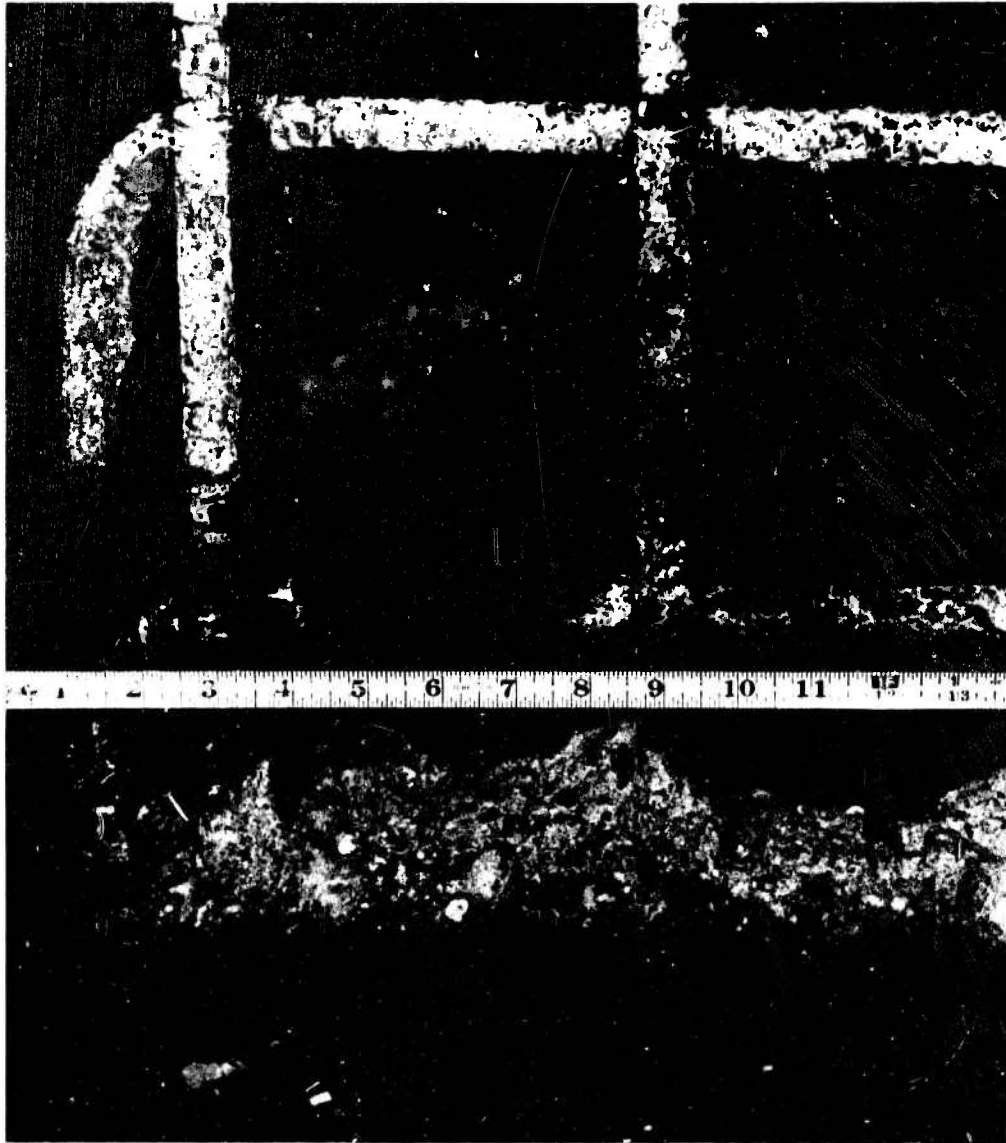
Figure 13. Steel exposed for Wall 103. Dark areas are ferrous oxide. Lower bar is opposite horizontal crack in Figure 12.

Figure 12 shows two types of cracking in the two larger faces of the walls. The crack in the upper right hand corner is typical of random cracking adjacent to east or west edges. No continuous and more or less straight vertical cracks have occurred on the north or south faces. The lower horizontal crack is not uncommon. It is directly opposite the lower horizontal steel bar of Figure 13.

On 20 January 1969 the concrete from wall 103 was removed from its steel grid. This grid was treated identical to that of wall 101 except the horizontal and vertical bars were tied and insulated one from another and were not welded. The exposed steel of wall 103 had the same general appearance as that of wall 101. All horizontal bars were coated with white corrosion products of zinc. White corrosion products on vertical bars were less extensive and more scattered than on horizontal bars; however, all vertical bars were affected. All bars (horizontal and vertical) had scattered red rust spots; however, the lower two horizontal bars contained the most red rust. Of these two bars, the lower bar had the most red rust. Where the horizontal bars were turned down vertically, there was no more red rust than for other areas of the bars, except for the lower bar on the west end; here, the red rust was heavier but not near as heavy as for wall 101.
