**WING I, LER SINGLE ISOLATOR SHOCK TESTS  
INTERIM REPORT**

**TECHNICAL REPORT NO. AFSWC-TR-69-20**

The summary data and results of tests performed on Minuteman Wing I Launcher Equipment Room (LER) Shock Isolators are presented in this report. The testing was performed by the Air Force Special Weapons Center at the request of Space and Missile Systems Organization (SAMSO). Single isolator displacement tests and single isolator shock tests were performed. The tests were conducted to determine the threshold of failure and the mode of failure for the LER isolator as a result of a shock loading condition or any other loading. The test results indicated a need for a number of improvements in the original design. Test data summary results, notation of observations made during testing, and other pertinent information are presented.

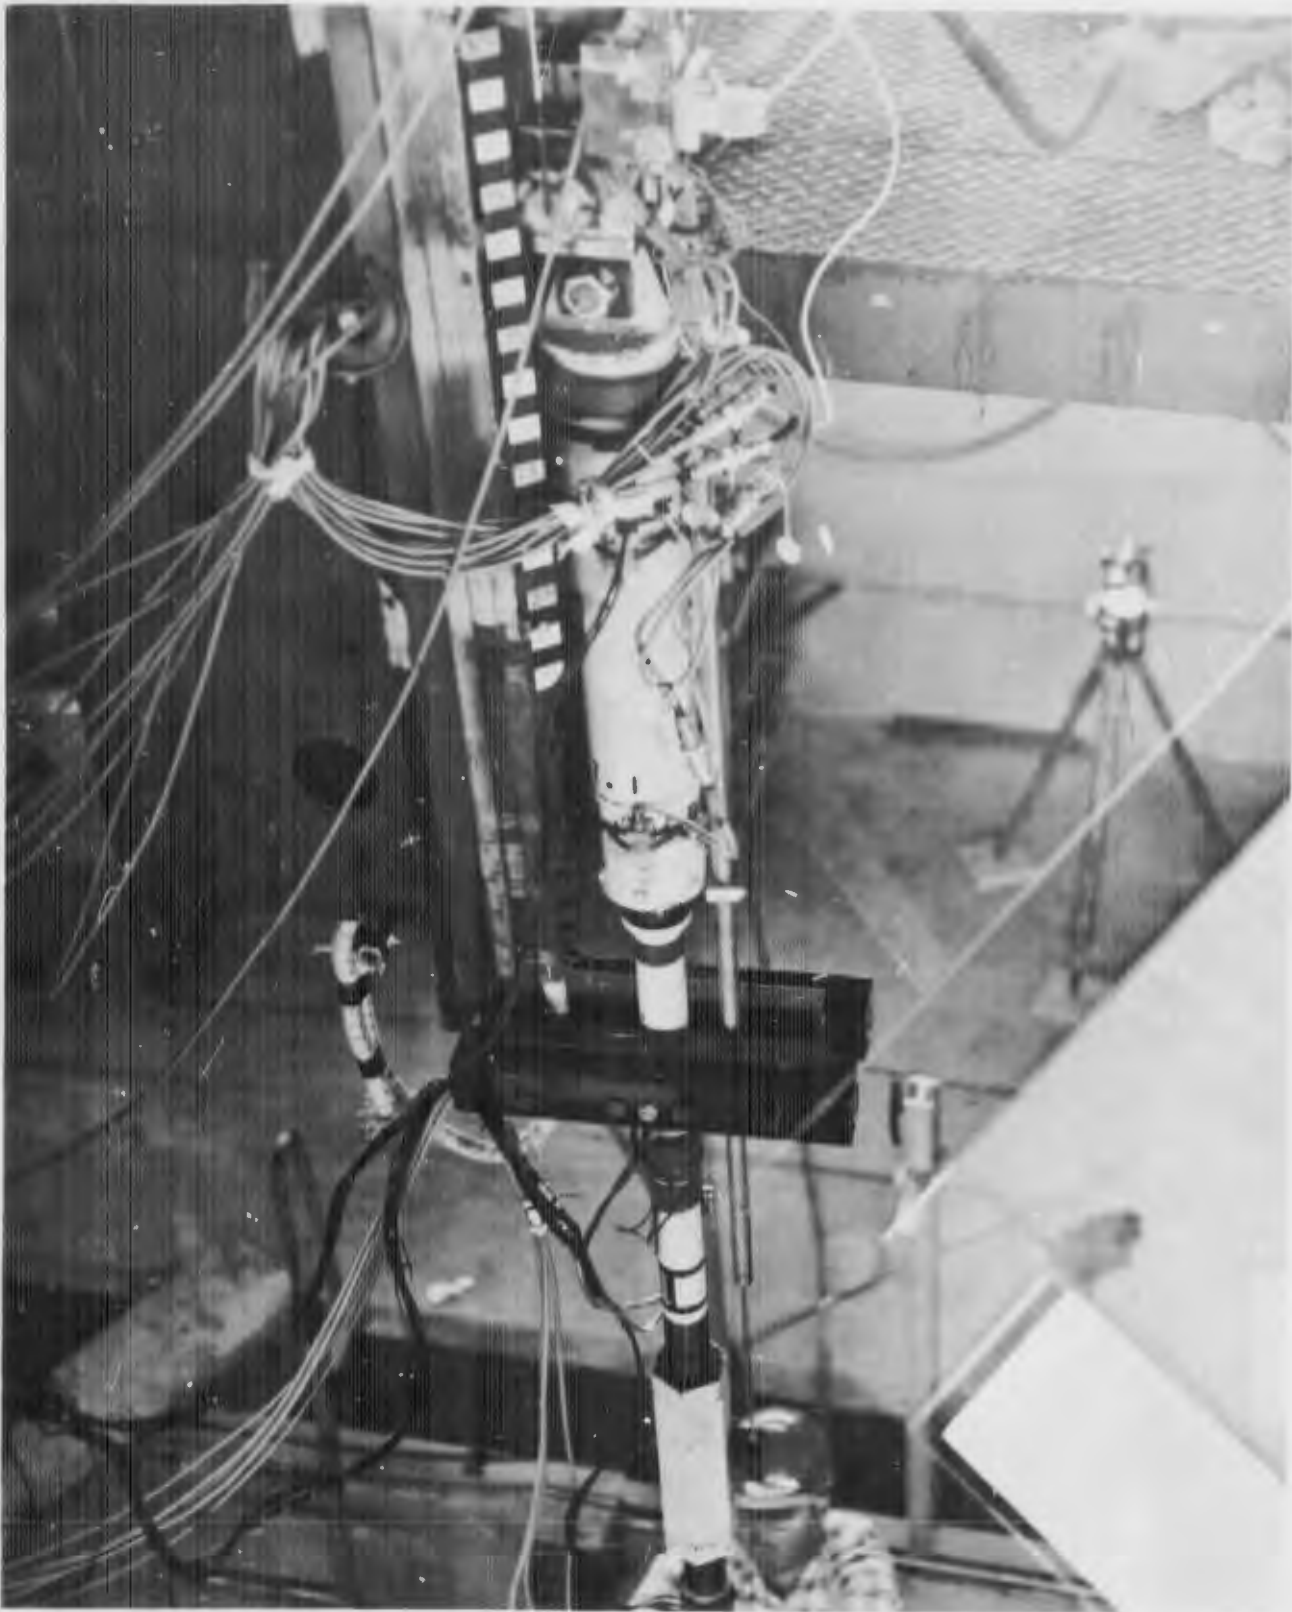
Figure 7. Instrumentation--General View Upper Portion of Isolator

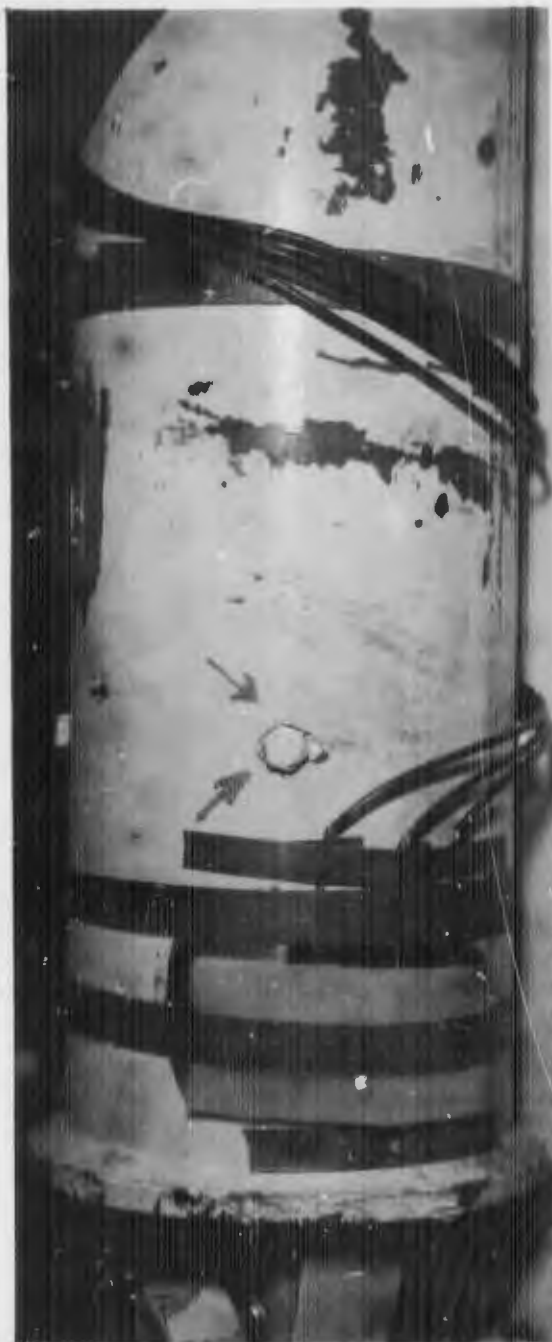
Figures 12 and 13 show the general condition of Type IV, S/N 1 isolator after incremental vertical shock testing. No failure or permanent damage was apparent. However, internal impacting at the upper can stop was noted as shown in figure 13.

Figure 13. Type IV, S/N 1, Close-Up of "Clang-Bang" Effect on Upper Can Stop

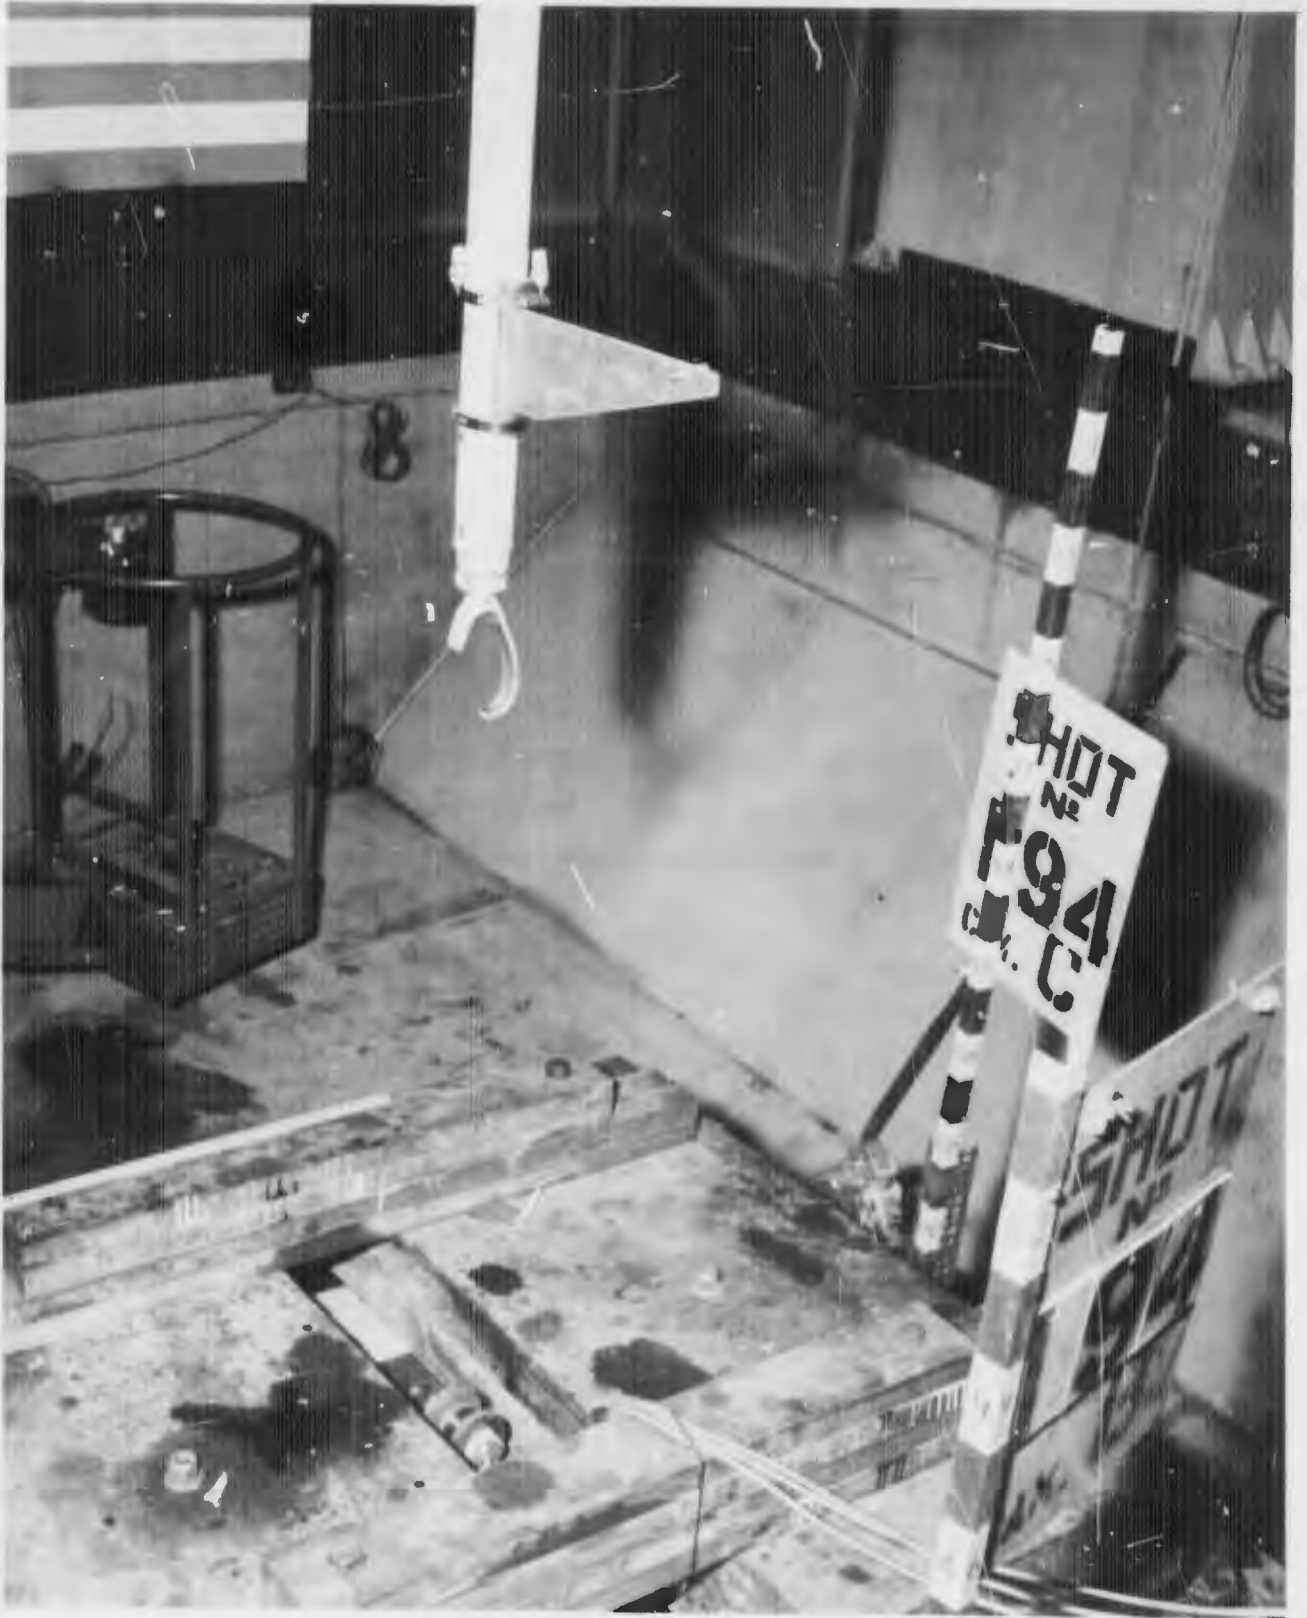
Figure 14 shows a typical Type III isolator failure. The isolator rod-end bearing proved to be the weakest "link" on all Type III isolators. Figure 15 shows the Type III rod-end bearing failure and damage to the lower can stop cap screws.

Figure 14. Typical Type III Test Failure

c. Failures occurred in two areas: (1) the lower rod-end bearing, and (2) the cap screws which attach the lower can stop to the spring can. Both of these failures had been anticipated. The cap screw shear failure occurred on the Type I and Type IV isolators, while the lower rod-end bearing failure occurred on the Type III isolators.

b. It is recommended that the lower rod-end bearing be redesigned and made stronger, structurally.

c. It is recommended that the isolators be refurbished at the two failure areas, and the higher mode shock testing be repeated to prove isolator survival.

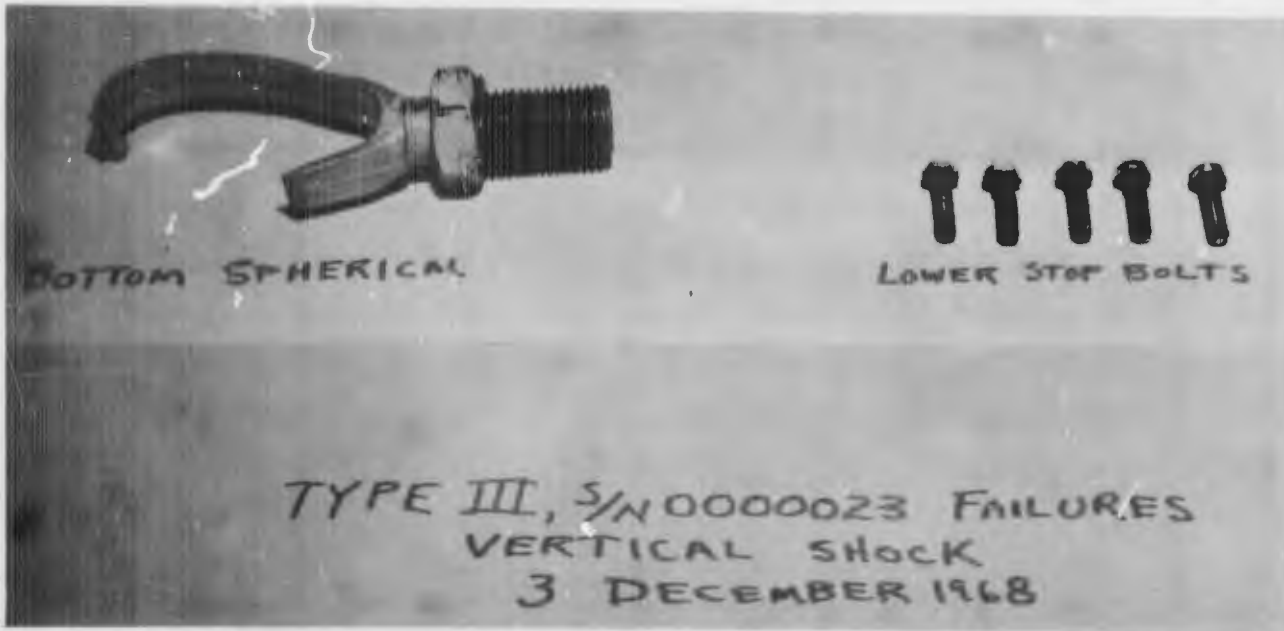
Figure 15. Type III, S/N 23, Test Failures
