## USAAVLABS TECHNICAL NOTE 1

# A METHOD FOR PREVENTING CATASTROPHIC FAILURE IN ALUMINUM STRESSED SKIN PANELS

**U. S. ARMY AVIATION MATERIEL LABORATORIES  
FORT EUSTIS, VIRGINIA**

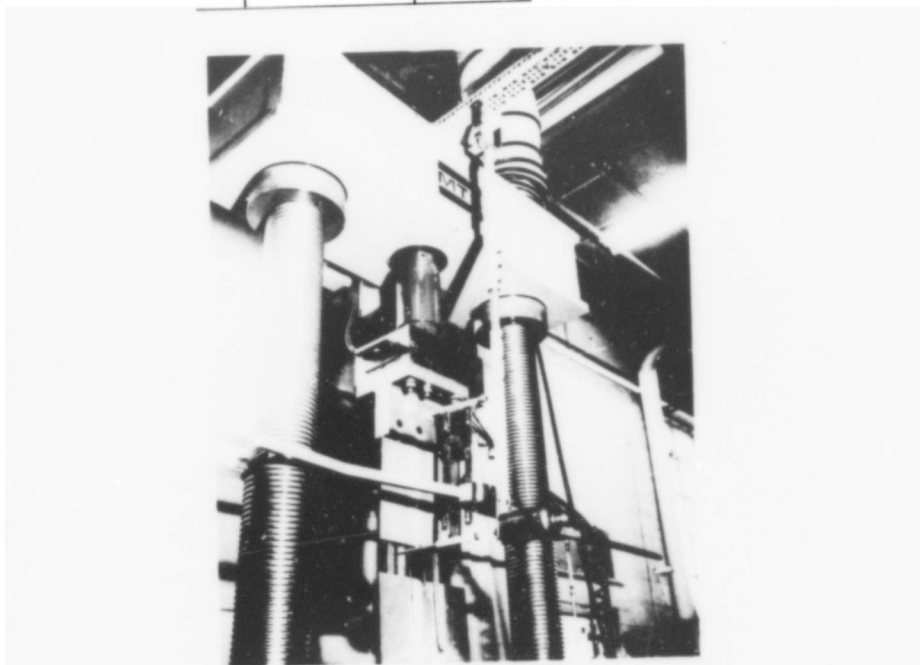
A 100,000-pound-capacity close-loop hydraulic test machine was used to perform the static tests. Loads were monitored with a Brush recorder, a recording oscilloscope, and an X-Y plotter. The specimens were loaded to predetermined values, and a pointed 0.375-inch-diameter steel rod was driven through the specimen midpoint with the pendulum device shown in Figure 2. A point was ground on the rod simulating that of a .38 caliber bullet (see Figure 3). Projectile impact velocities of 15.1 feet per second were obtained from measurements taken from motion picture film shot at 720 frames per second. The pendulum stayed in contact with the pointed rod during the time that the rod was being driven through the specimen.

Figure 2. Test Setup.

An 8mm camera operating at 10,000 frames per second was used to obtain crack growth data. In cases where failure did not occur on impact, the load was removed, the crack length was measured, and the specimen was reloaded to failure at a load rate of 1000 pounds per second.
