HIGH TEMPERATURE HYDROCARBON FUELS RESEARCH  
IN AN ADVANCED AIRCRAFT FUEL SYSTEM SIMULATOR  
ON FUEL AFFB-12-68

NORTH AMERICAN ROCKWELL CORPORATION/LOS ANGELES DIVISION

TECHNICAL REPORT AFAPL-TR-69-117

FEBRUARY 1970

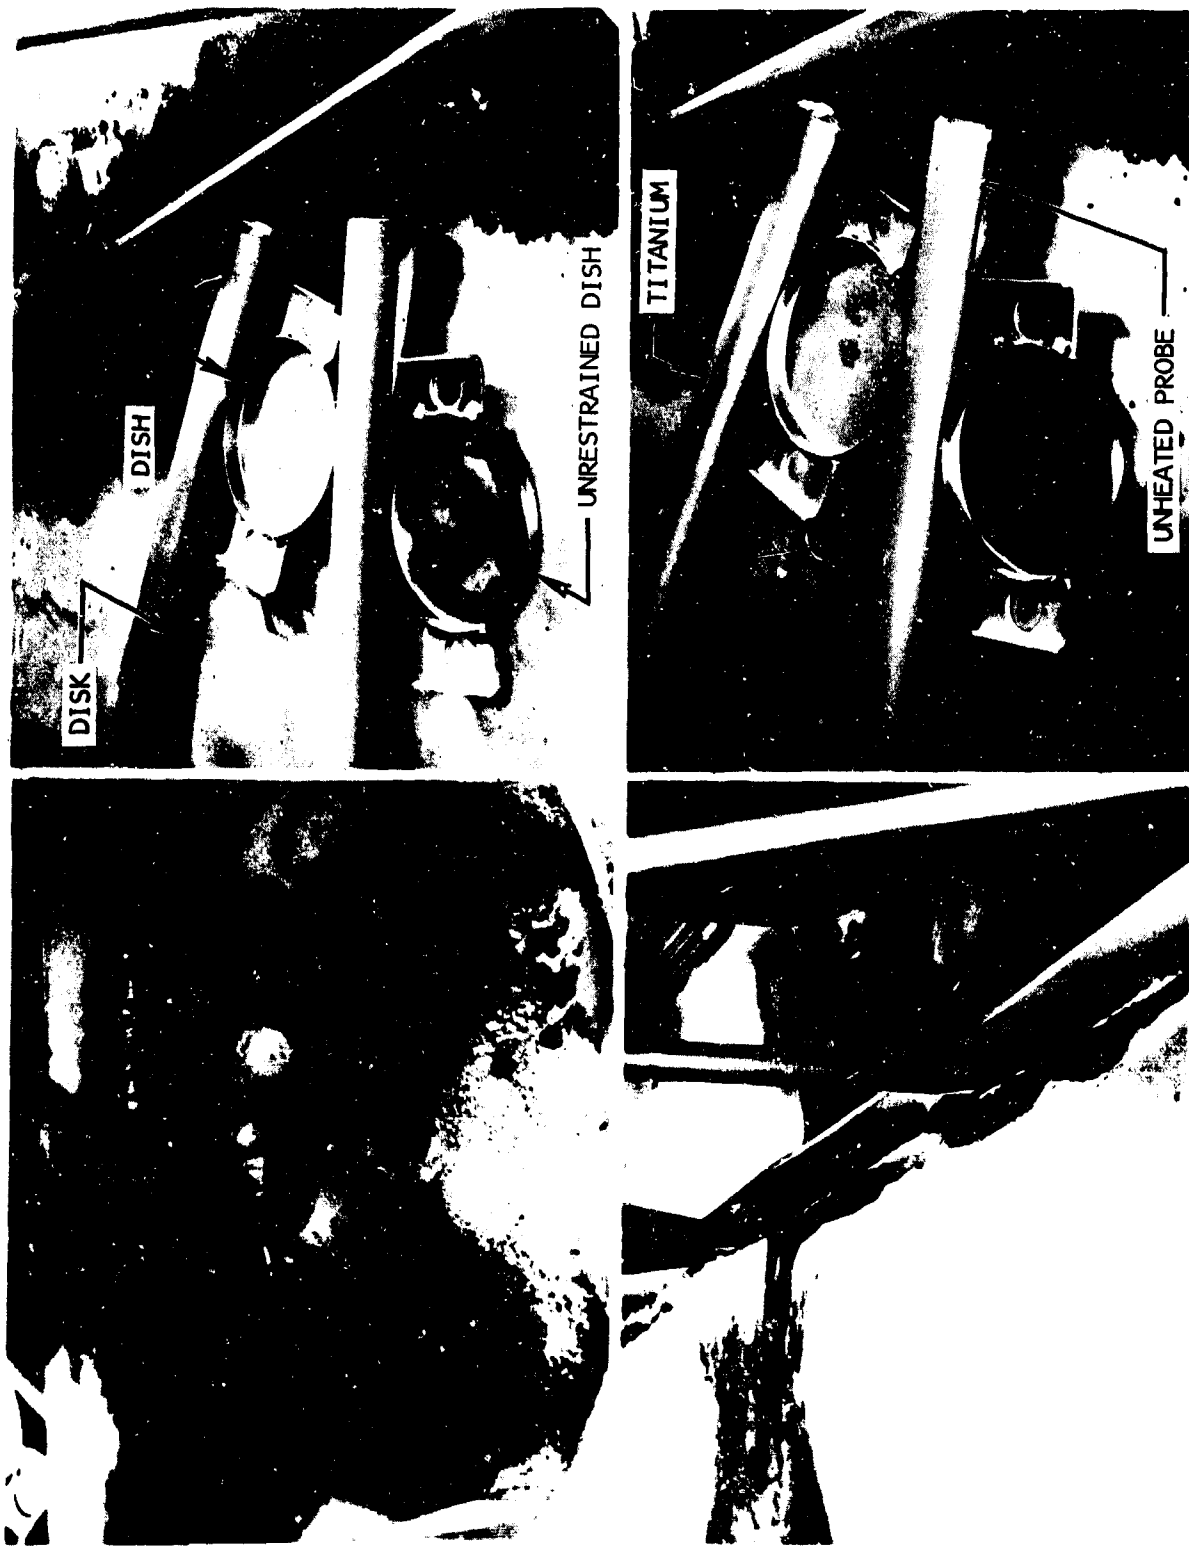
Figure 6. Wing Tank Deposits (5000° F)

It was observed that a very sharp break in deposit color existed between the bottom dry areas (5-6) and the puddle areas (8-9). The puddle areas of the tank were covered with a rough, tightly adhering, glossy-black deposit with numerous loose deposit particles evident throughout the tank and thickest beneath the boost pump. These areas are shown with the dish, disk, and probes in figure 6. Three of the four photographs show the boost pump area, and the lower left photograph shows the opposite end of the tank.

The accelerating effect of condensation on deposit formation was also observed on the bottom and sides of the tank. The pattern of the deposit beneath the main support bar indicates that fuel vapor was condensing on the bar and dripping onto the tank bottom and also running down the walls. The sidewalls adjacent to the boost pump and thermo-couple doors were streaked with a darker heavy deposit indicating that fuel was condensing and running down the walls.

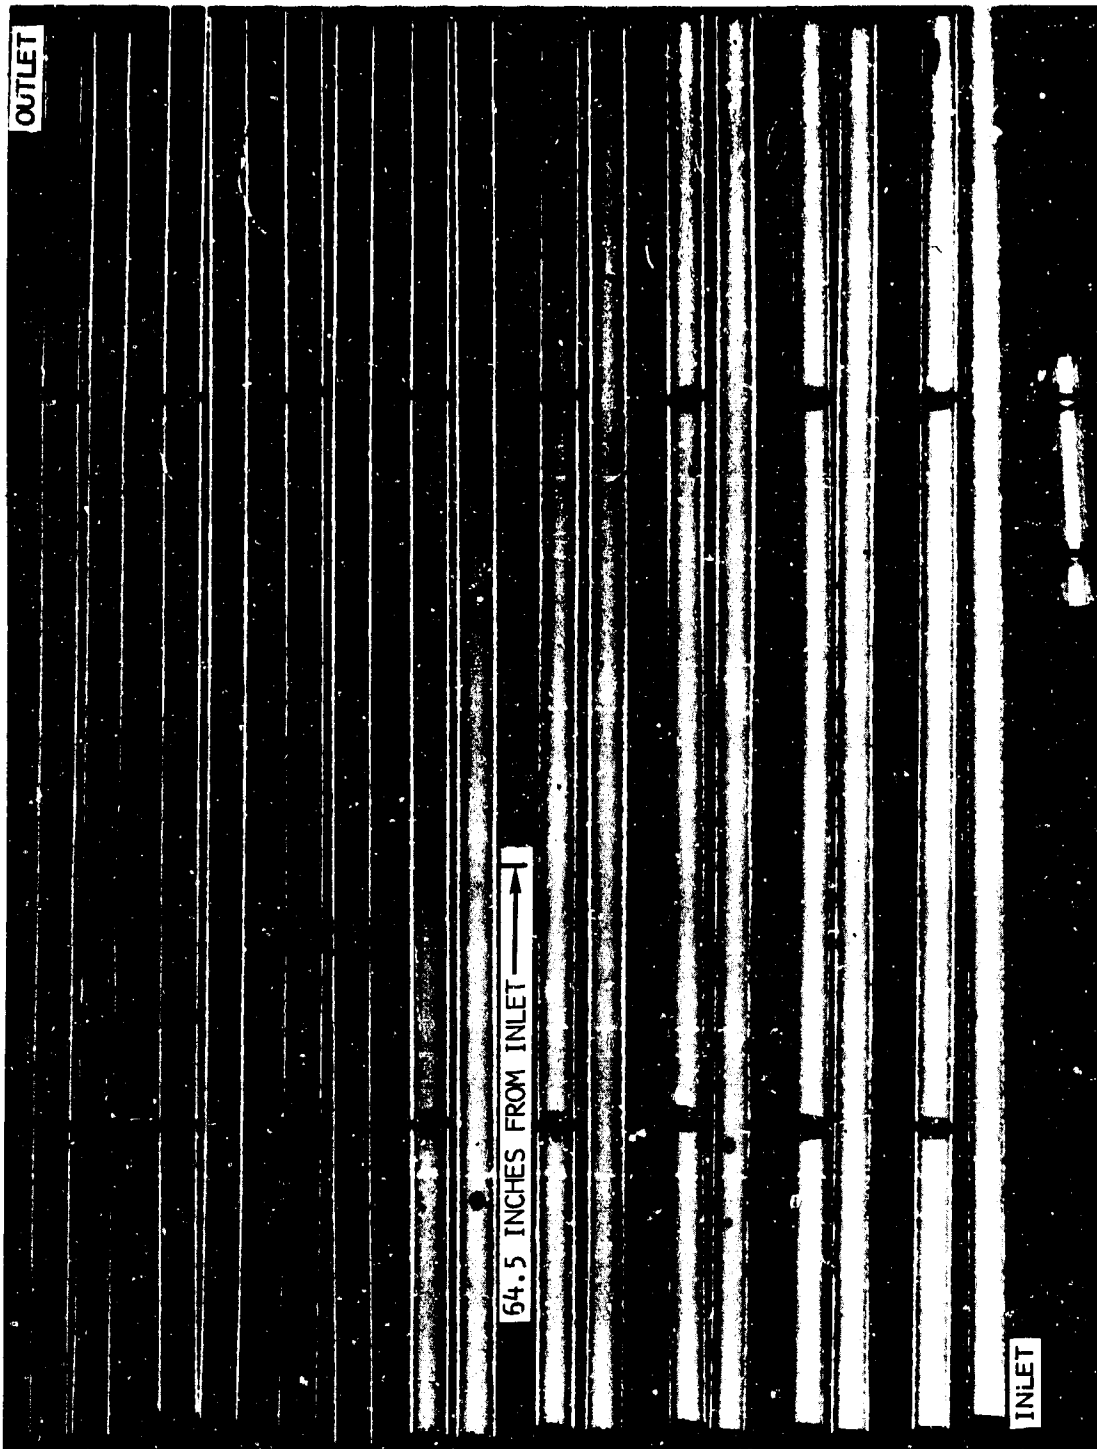
Figure 30. Manifold Used in Test 8.802

The bisected 8.802 manifold is shown in figure 30. The transition from stain to heavy deposit occurred 4.5 inches closer to the inlet on the top half than on the bottom half compared to 2.3 inches for manifold 8.801. The transition started approximately 1.5 inches further downstream (64.5 inches from the inlet) than for manifold 8.801. The portion of the manifold

prior to the transition was a weak yellow color while that portion of the 8.801 manifold was much grayer. The visual ratings of the manifold tube are shown in figure 31.
