# USAAVLABS TECHNICAL REPORT 70-55

## APPLICATION OF COMPOSITE MATERIALS TO AN AIRCRAFT WING SECTION

**CONTRACT DA 44-177-AMC-407(T)  
GOODYEAR AEROSPACE CORPORATION  
AKRON, OHIO**

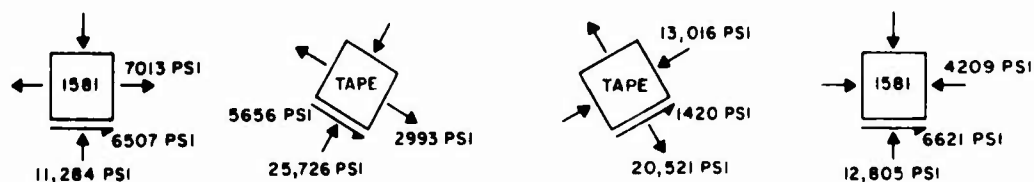
Figure 57. Calculated Stresses in Individual Plies of No. 3 Wing.
