EVALUATION OF ADVANCED GEAR MATERIALS FOR GEAR BOXES AND TRANSMISSIONS

Final Report

October 1970

The Boeing Company, Vertol Division

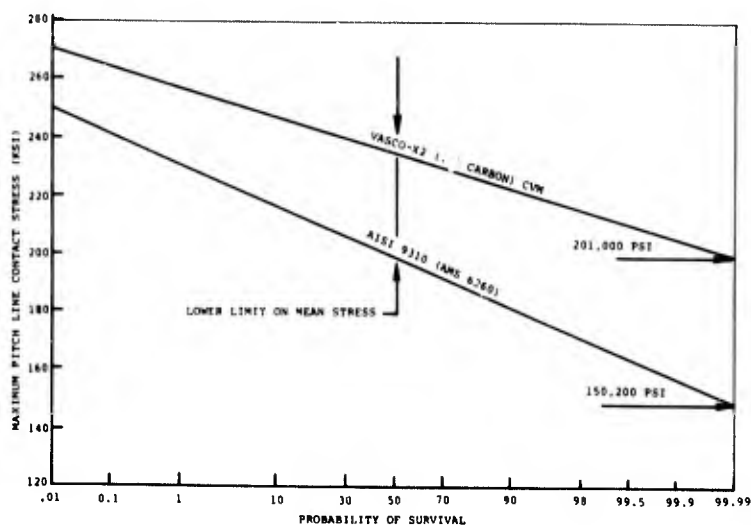
Summary of Mean Endurance Limits
Derived from Test Data Points.

A summary of the mean endurance limits derived from the test data points for both materials is shown in the figure below:

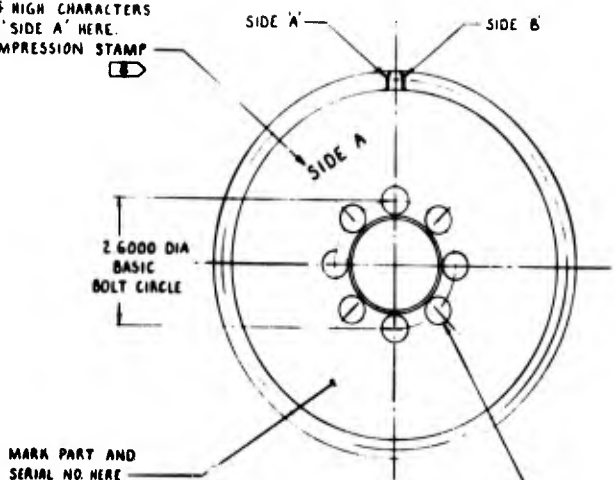
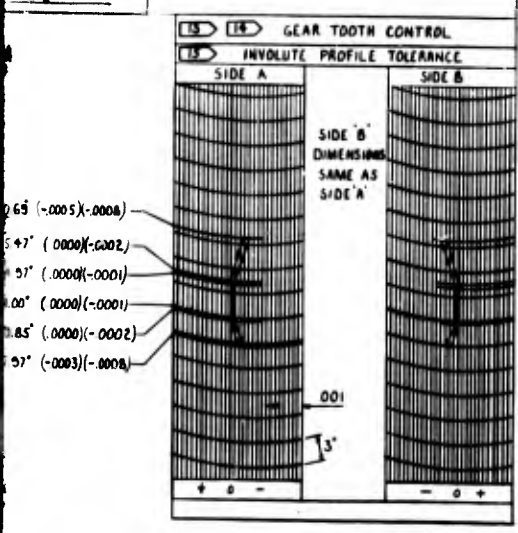
Figure 1. AISI 9310 Steel Test Gear for Rotating Fatigue Test (SK21984, 1.67 Gear Ratio, 5.33 Diametral Pitch)

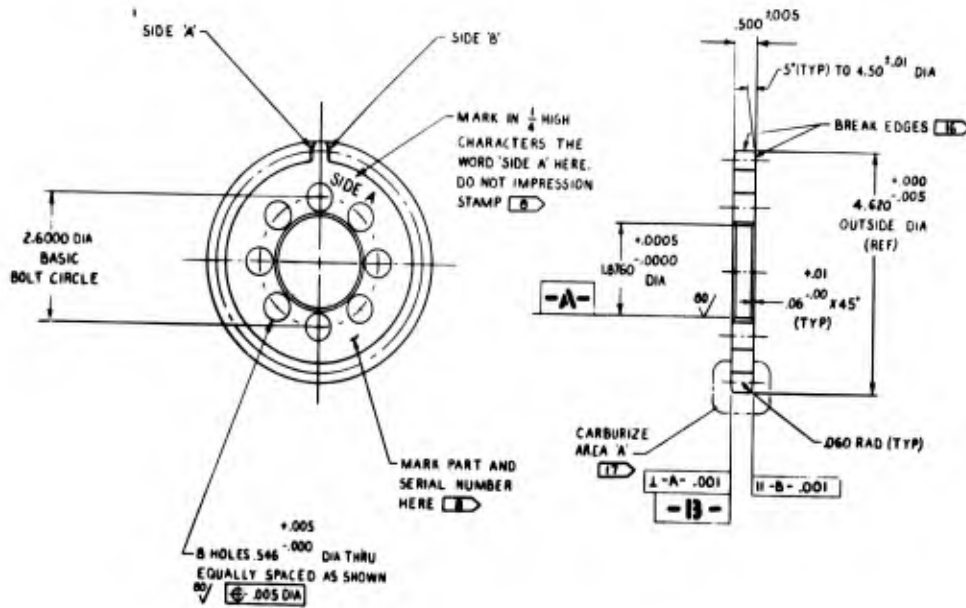
Figure 2. AISI 9310 Steel Test Pinion for Rotating Fatigue Test (SK21985, 1.67 Gear Ratio, 5.33 Diametral Pitch)

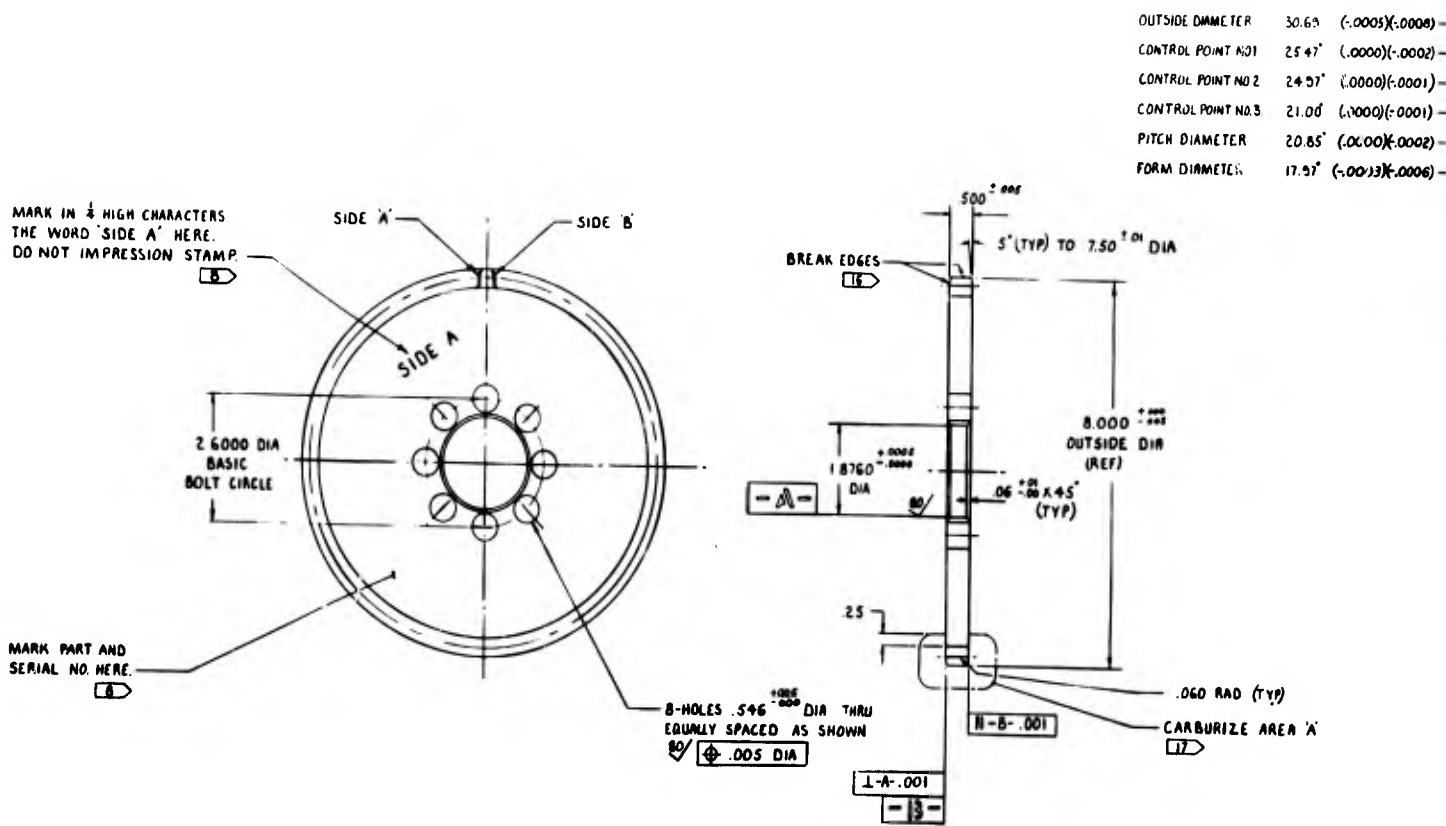
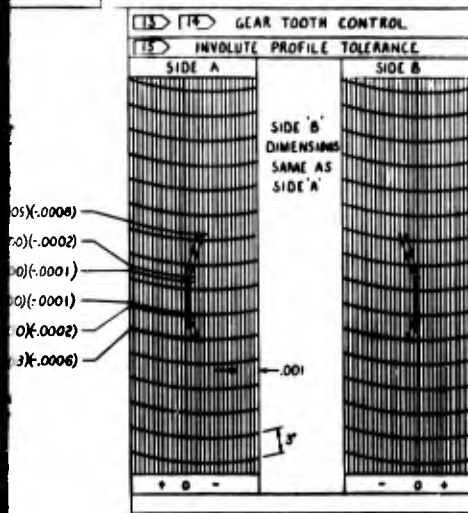
Figure 3. VASCO-X2 Test Gear for Rotating Fatigue Test (SK21988, (SK21988, 1.67 Gear Ratio, 5.33 Diametral Pitch)

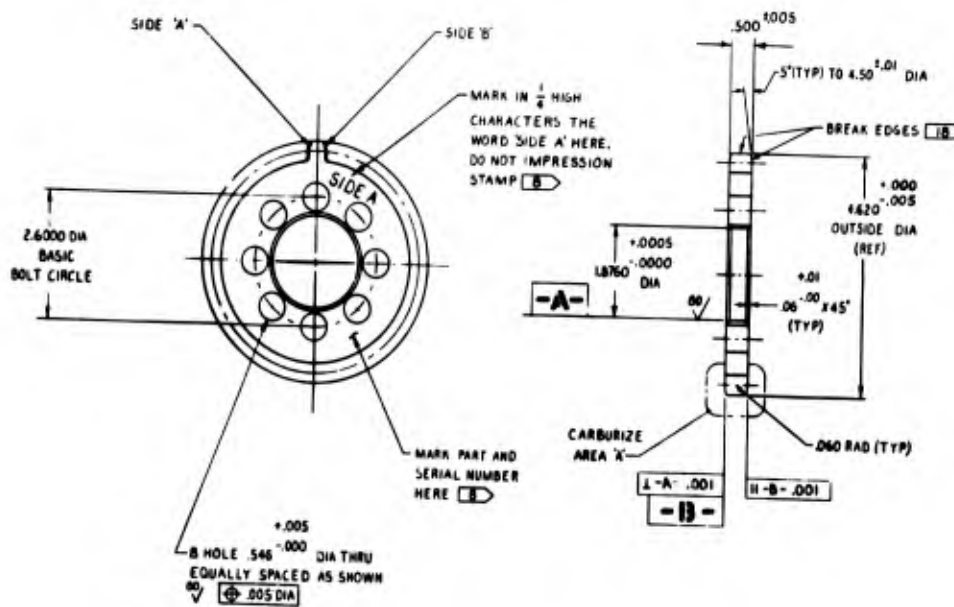
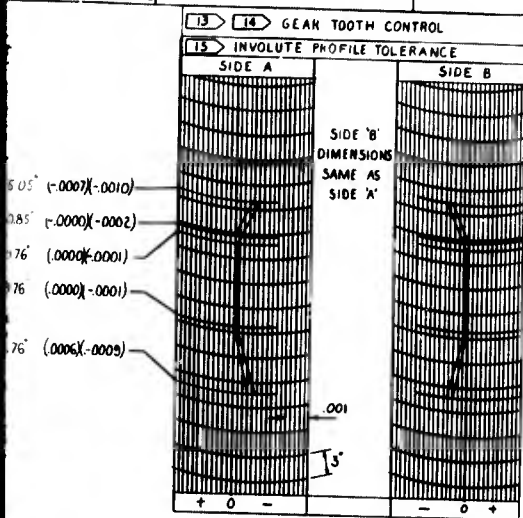
Figure 4. VASCO-X2 Test Pinion for Rotating Fatigue Test
(SK21989, 1.67 Gear Ratio, 5.33 Diametral Pitch)

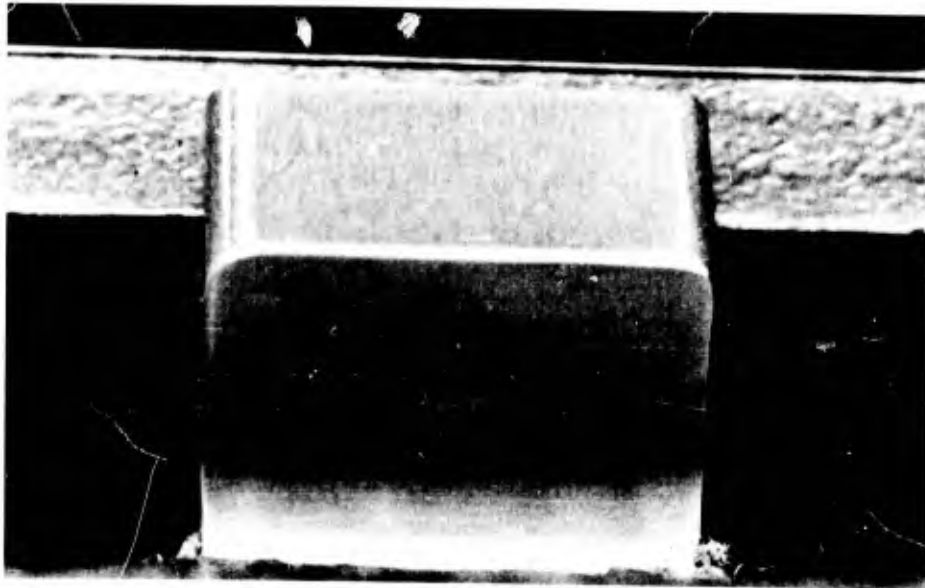
Figure 5. Tooth No. 4 of AISI 9310 Steel Test Pinion (SK21985, Serial No. 5, as received)

Figures 5 through 8 are photographs of the test gears in the as received condition.

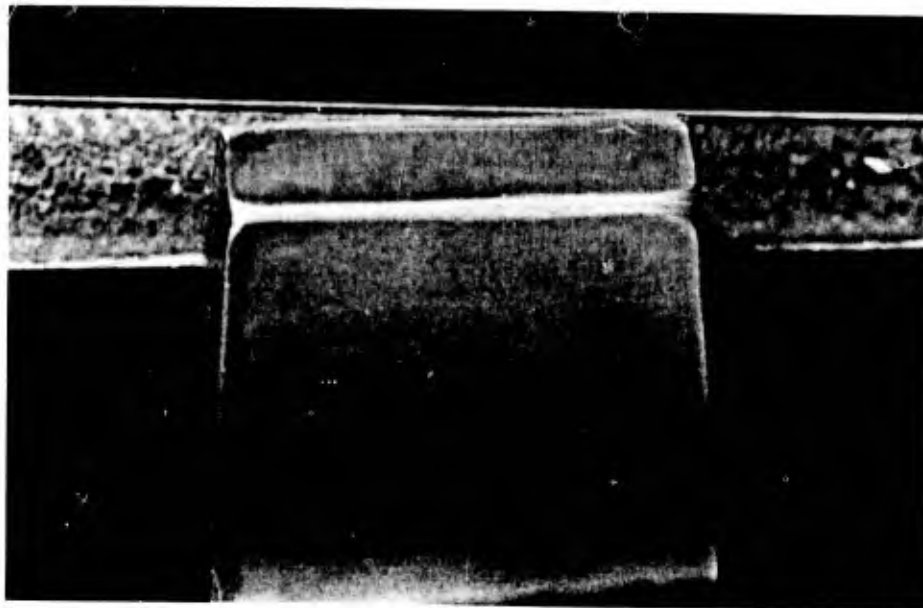
Figure 6. Tooth No. 8 of AISI 9310 Steel Test Gear (SK21984, Serial No. 1, as received)

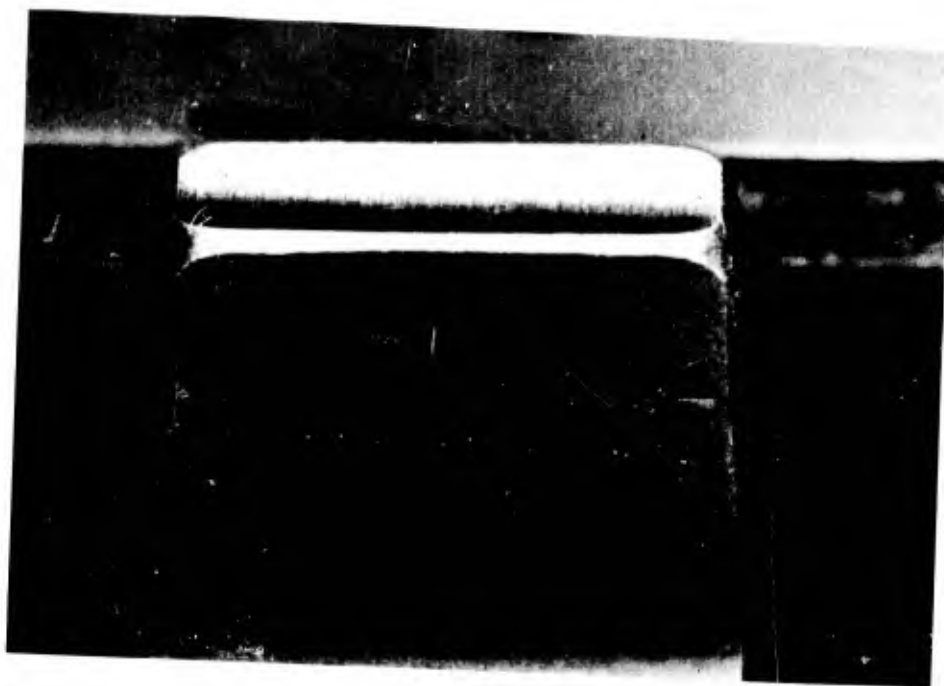
Figure 7. Tooth No. 24 of VASCO-X2 Steel Test Gear (SK21988, Serial No. 1, Side A, as received)

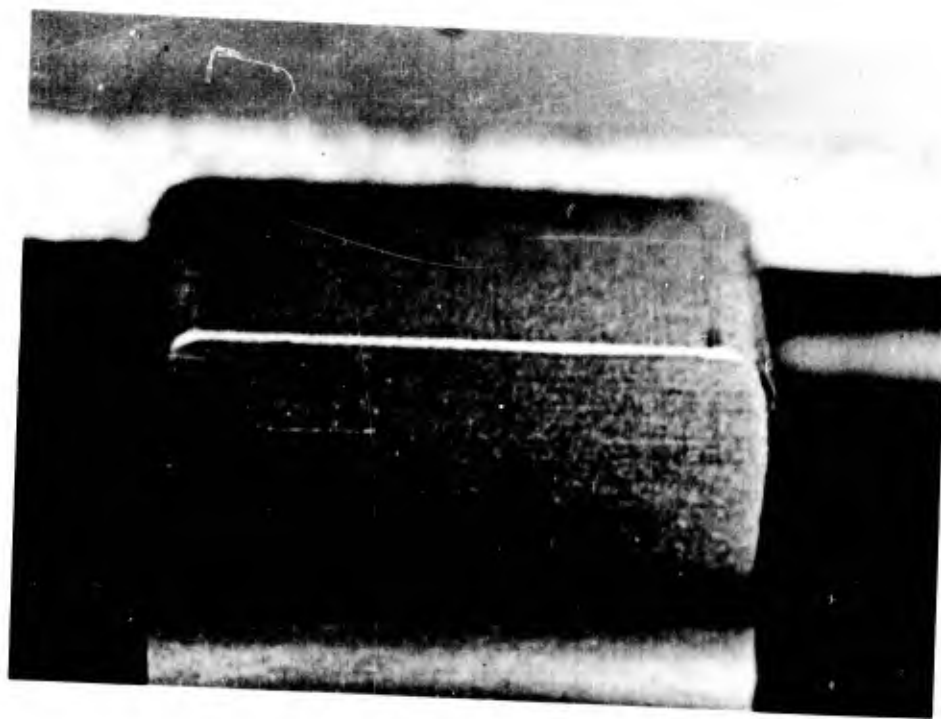
Figure 8. Tooth No. 5 of VASCO-X2 Steel Test Pinion (SK21989, Serial No. 1, Side B, as received)

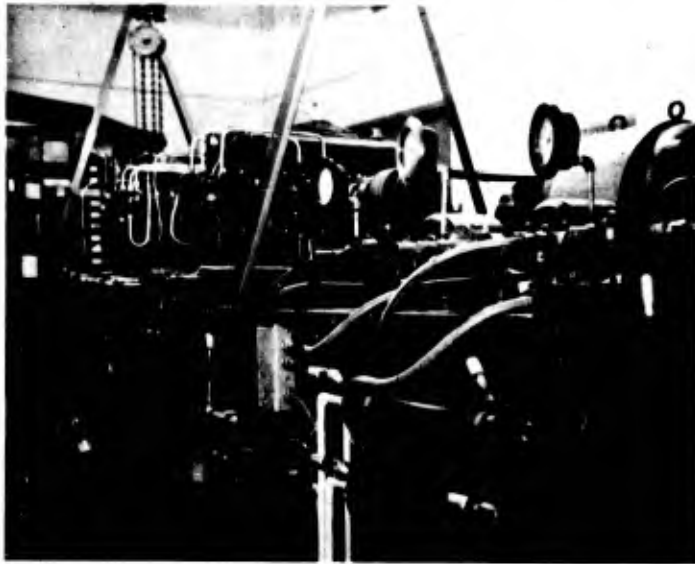
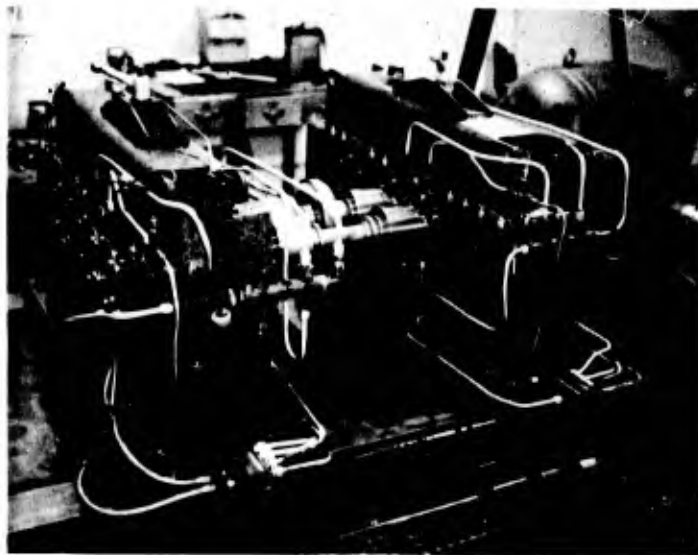
Figure 9. Gear Research Test Stand

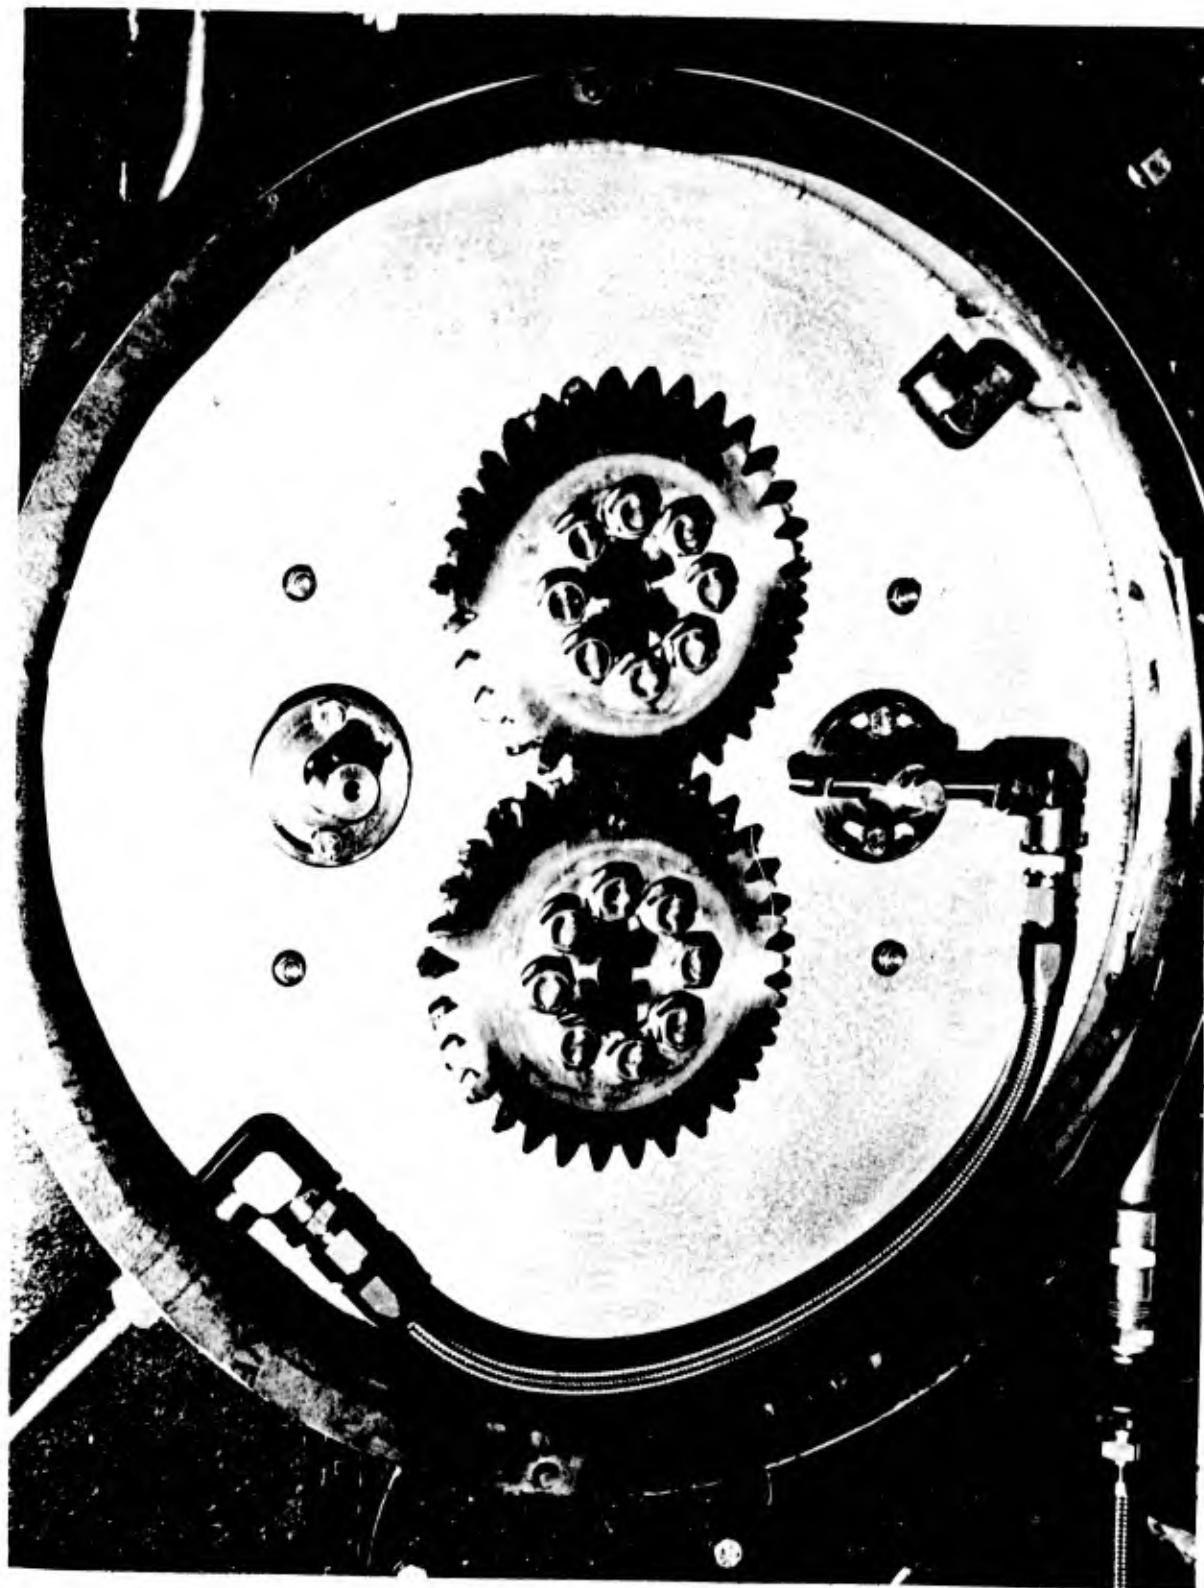
Figure 10. Research Test Stand Overhung Configuration

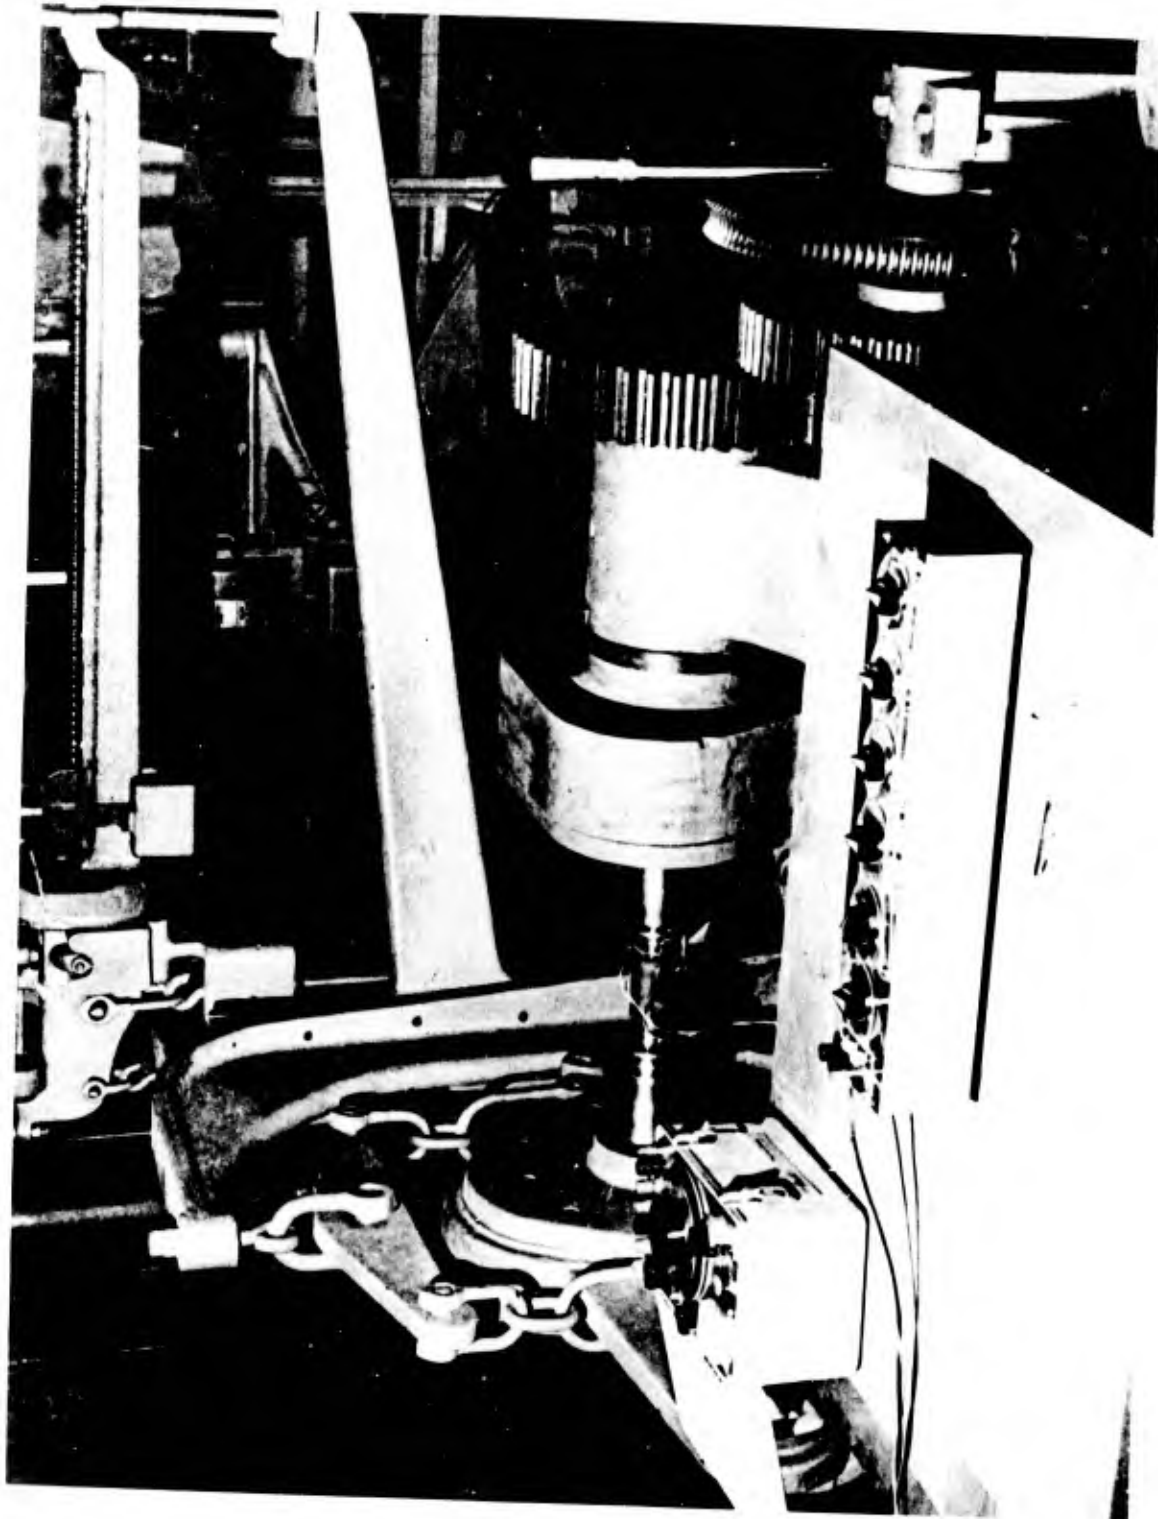
Figure 11. Deadweight Torsion Test Machine

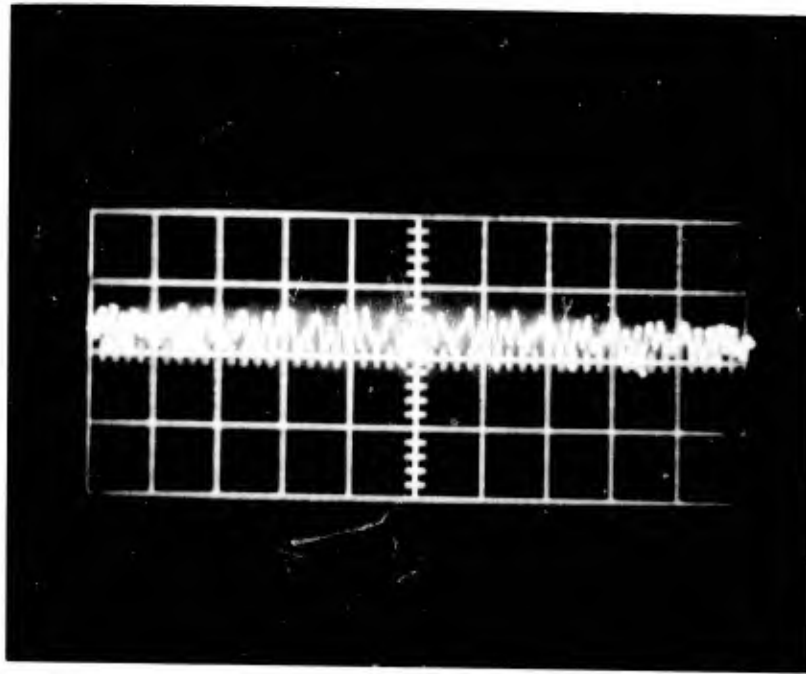
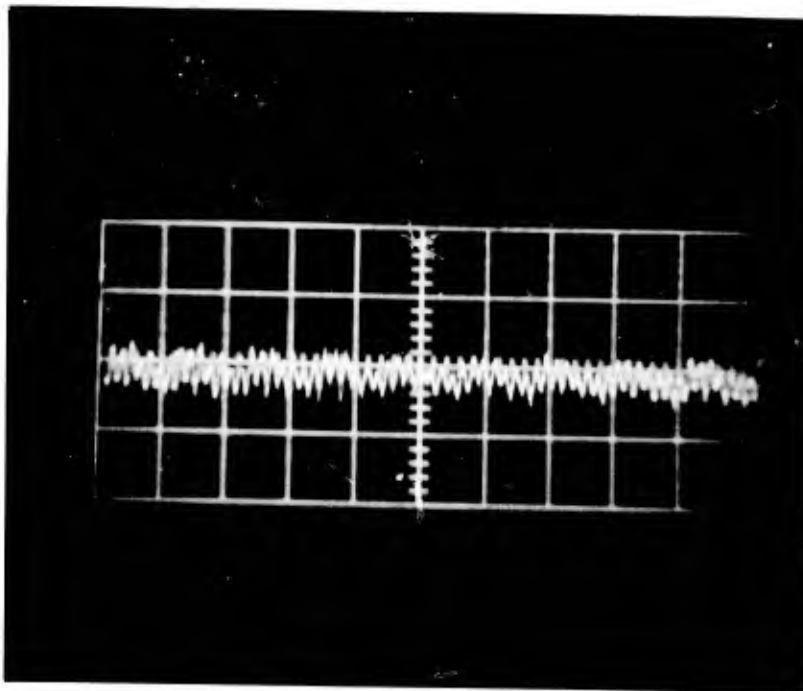
220 PERCENT LOAD, 8.46×10^5 CYCLES

100 PERCENT LOAD, 9.09×10^5 CYCLES

Figure 12. Test Box Vibration Signatures for SK21988 (Serial No. 1, Side B) and SK21989 (Serial No. 1) at Scale of 0.05 Volts per Centimeter.

In addition to the visual inspections conducted at the specified intervals, constant surveillance of the test gearbox was provided through the use of accelerometers attached to the gear case. The vibration signatures were observed with an oscilloscope and the amplitudes were recorded in the test program log. Actual vibration signatures were photographed at specified intervals; Figure 12 is a typical example.

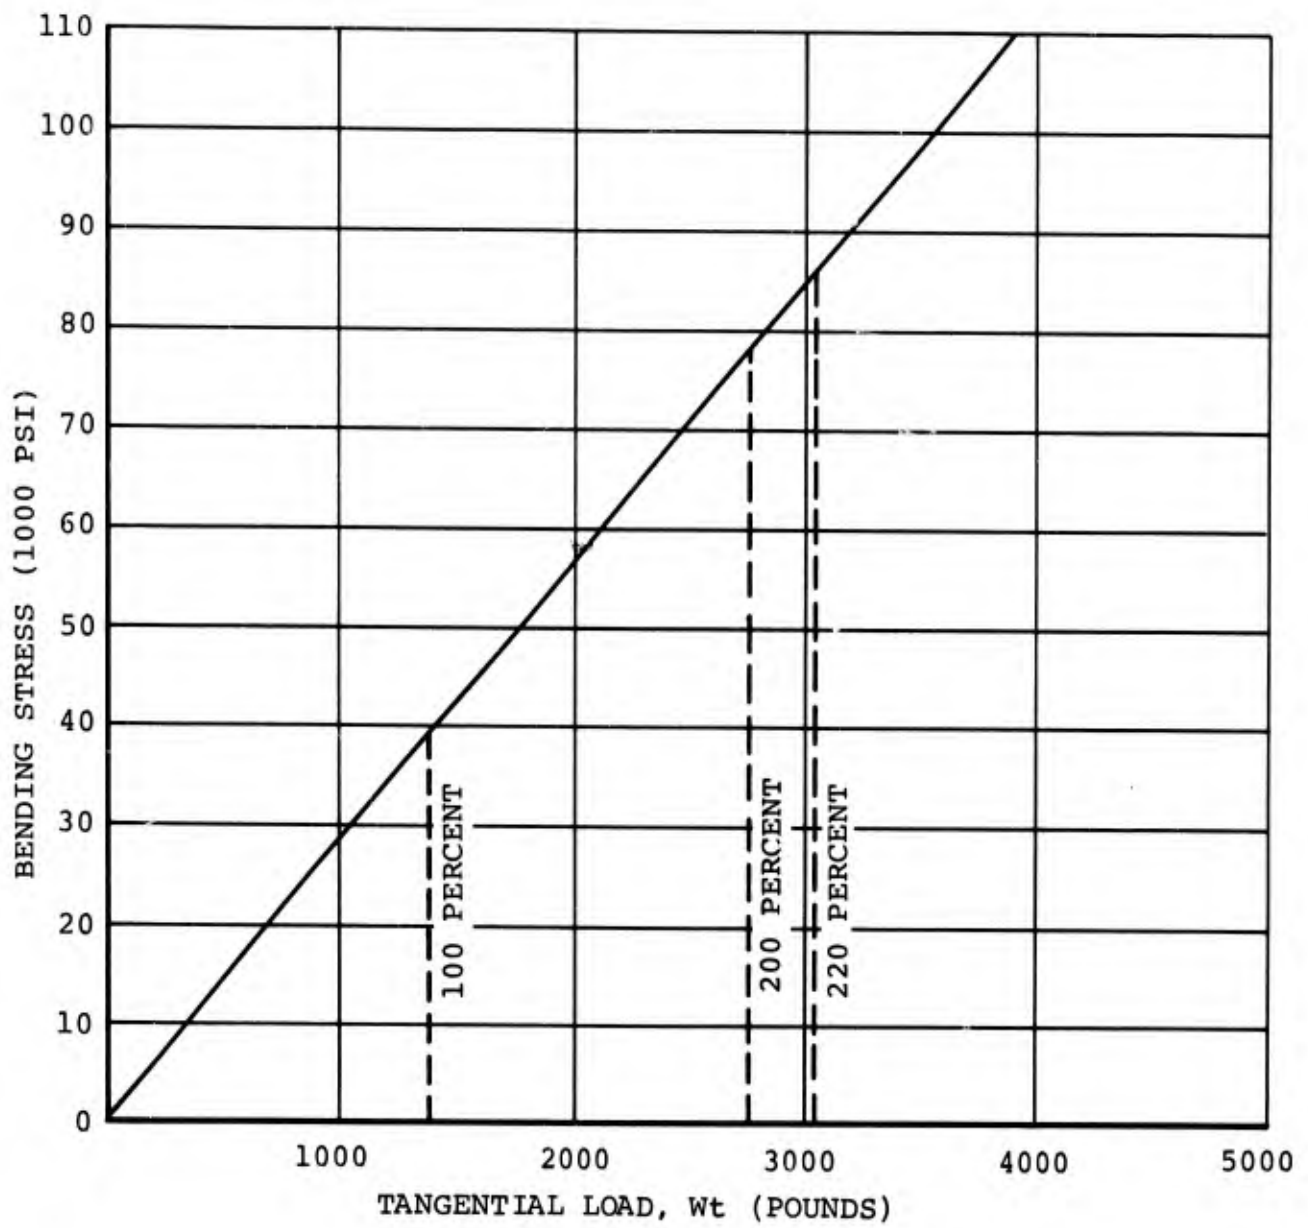
Figure 13. Test Gear Bending Stress (SK21984, SK21985, SK21988, and SK21989)

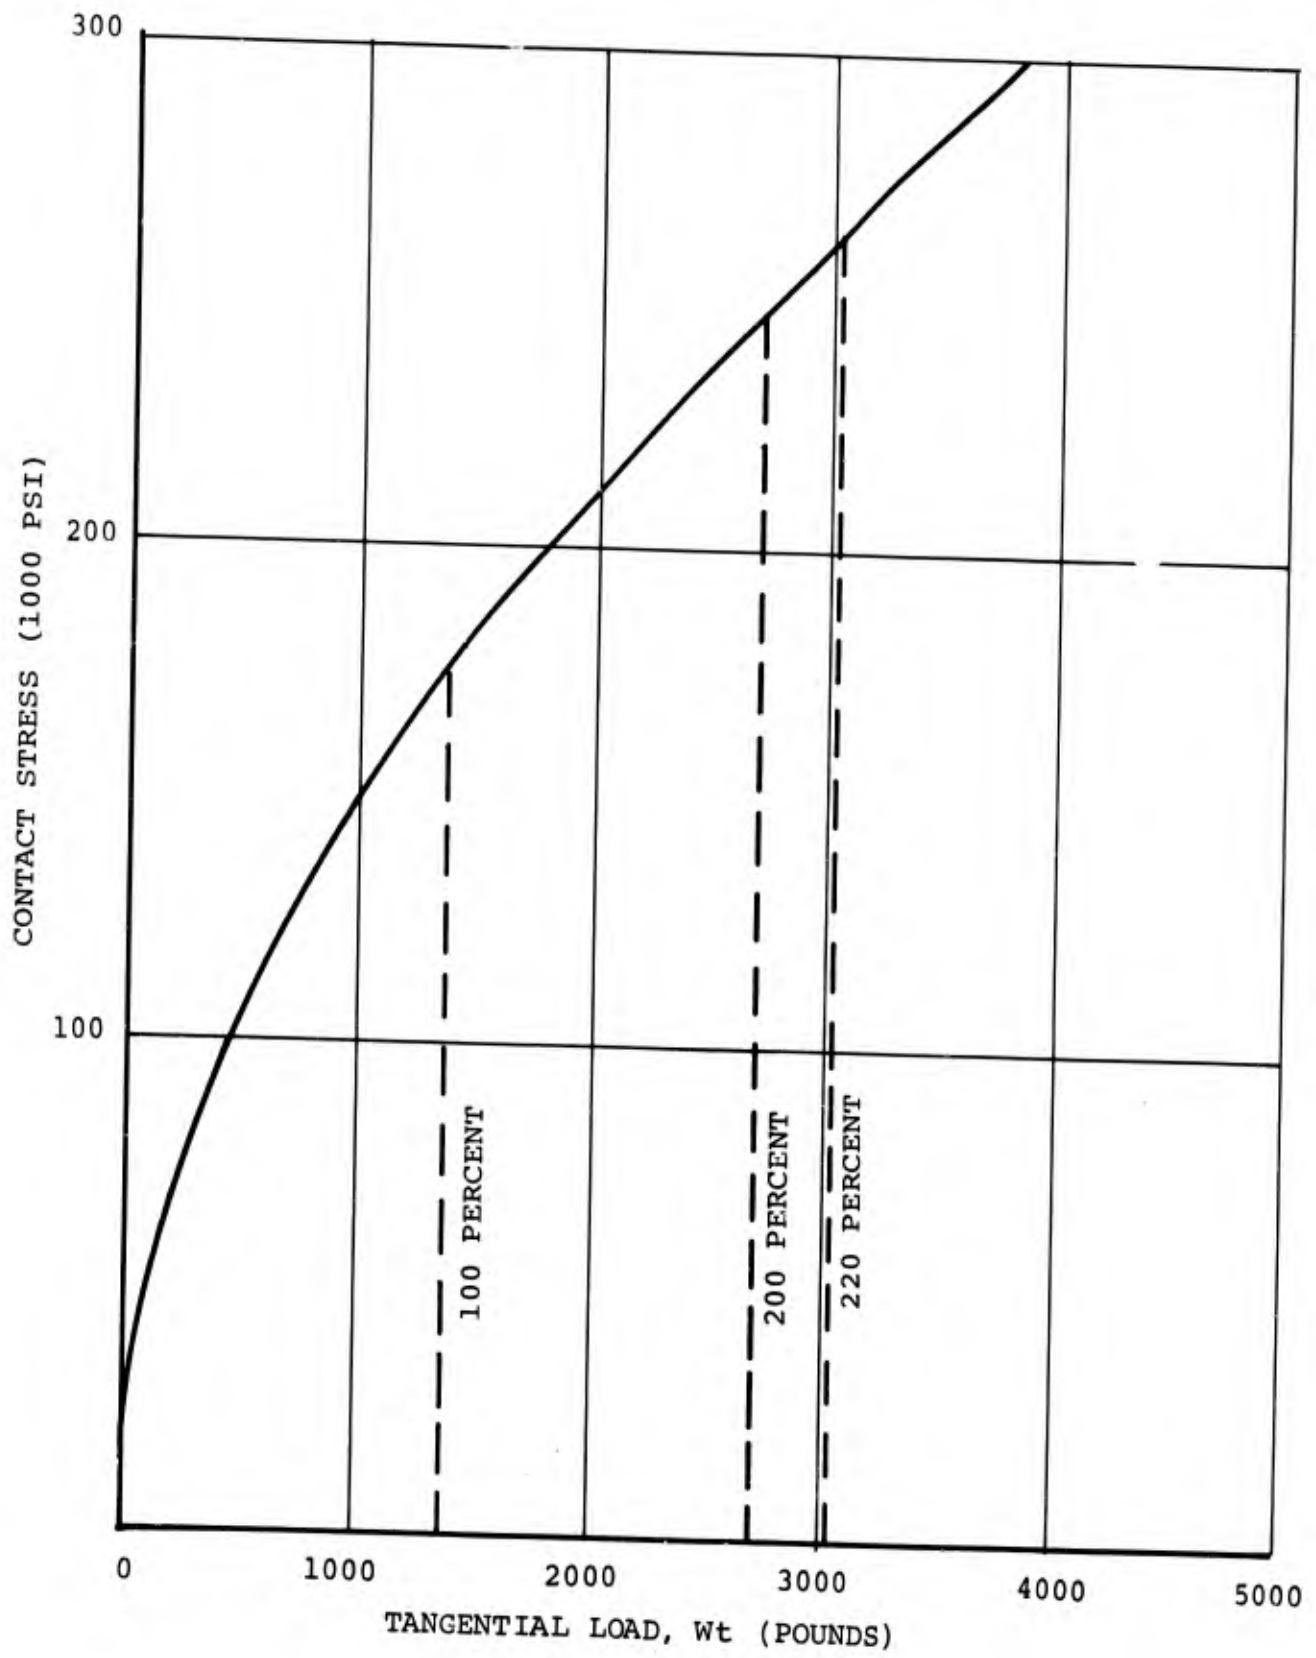
Figure 14. Test Gear Pitch Line Contact Stress (SK21984, SK21985, SI21988, and SK21989)

$$S_c = 2300 \sqrt{\frac{W_t}{.225}} \quad (\text{see Figure 14}) \quad (8)$$

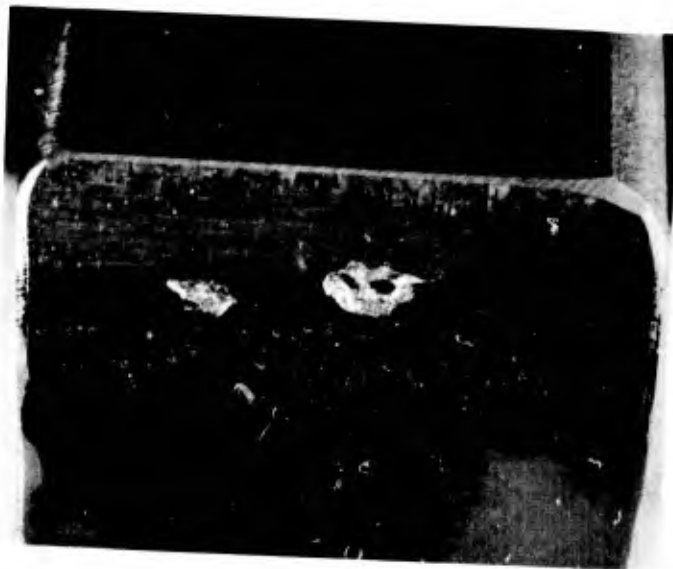
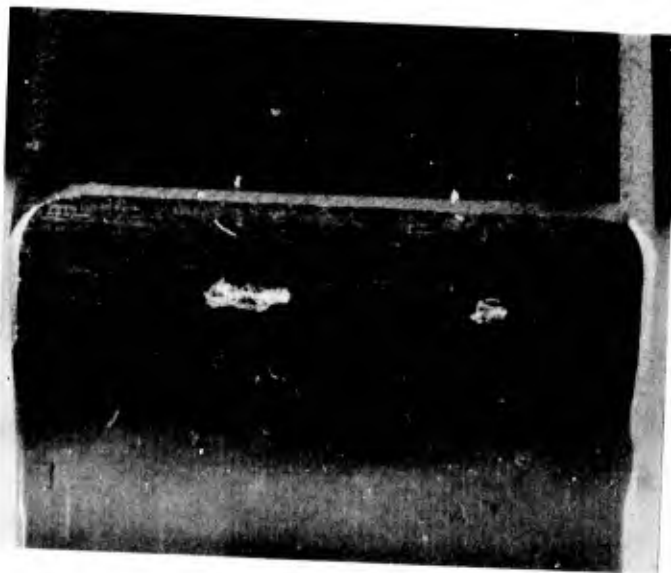
SIDE A, TOOTH 2, 190 PERCENT LOAD, 6.2×10^5 CYCLES

SIDE B, TOOTH 21, 160 PERCENT LOAD, 2.3×10^6 CYCLES

Figure 15. Final Condition of AISI 9310 Steel Test Pinion (SK21985, Serial No. 2).

The frosting condition on the pinion dedendum was usually observed at the 160 percent load level; however, the severity of this condition was not apparent to normal observation. The final condition of the AISI 9310 gear test specimens, which displayed the typical pitting and/or spalling condition is presented in Figures 15 through 19. These figures also show the typical frosting condition identified by the etch-like appearance of the surface on the pinion dedendum. Under magnification, the frosted surface appears to contain a field of micro-pits with no evidence of radial welding and/or tear marks.

The pitting condition sustained by the gear test specimens for both materials under investigation appear to be typical of destructive pitting usually found in the dedendum of the driving member in a reduction gear drive. This condition is characterized by the appearance of large pits, in excess of 1/32-inch in diameter in the dedendum region. This type of pitting failure will usually progress in size and number of pits, with repeated stress cycles, and can eventually lead to catastrophic failure. Assuming that the material integrity is sound, and that

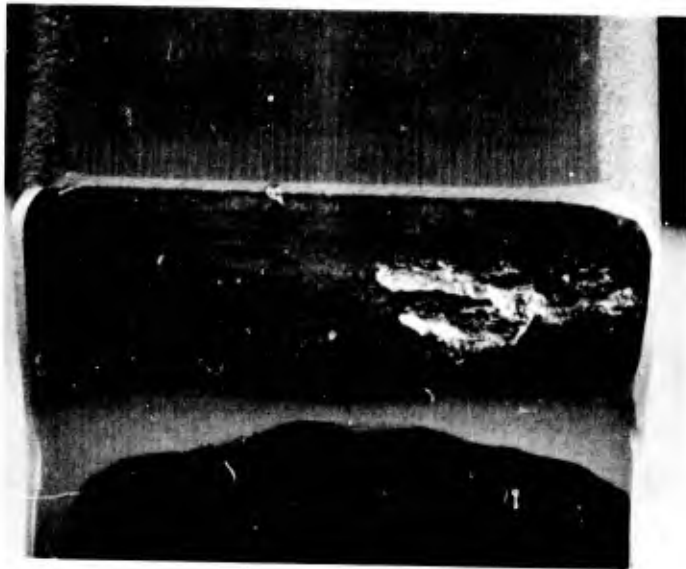
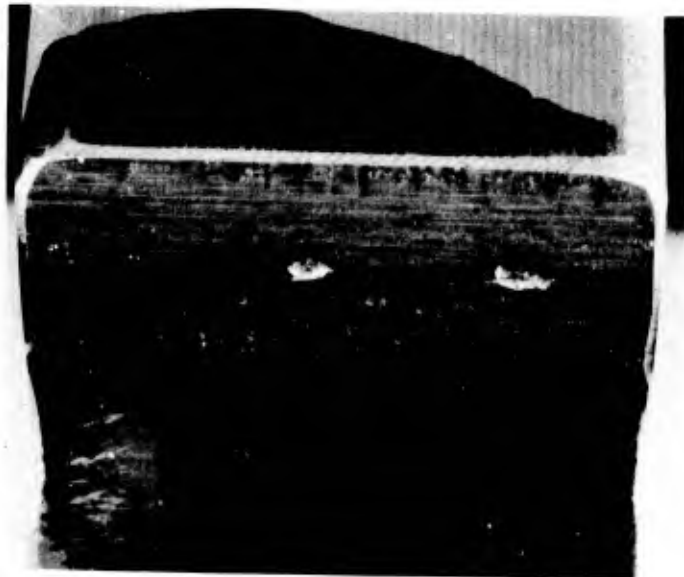
SIDE A, TOOTH 16, 190 PERCENT LOAD, 3.0×10^6 CYCLES

SIDE B, TOOTH 22, 160 PERCENT LOAD, 1.3×10^6 CYCLES

Figure 16. Final Condition of AISI 9310 Steel Test Pinion (SK21985, Serial No. 3).

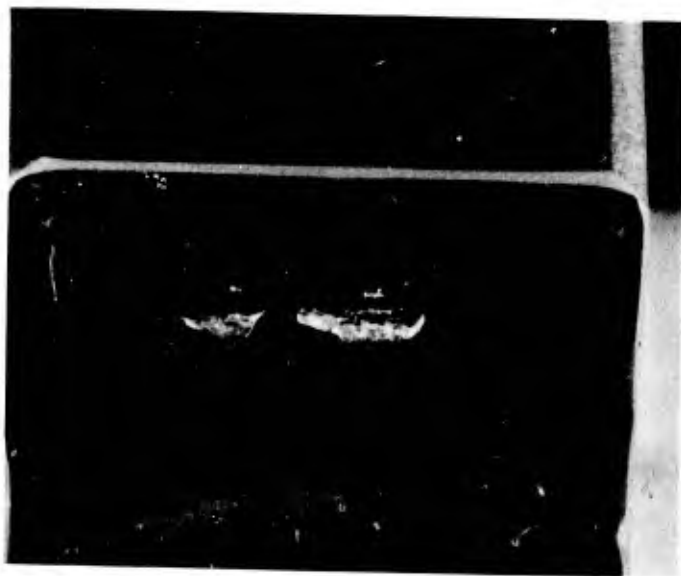
SIDE A, TOOTH 4, 190 PERCENT LOAD, 3.0×10^6 CYCLES

SIDE B, TOOTH 4, 160 PERCENT LOAD, 1.5×10^6 CYCLES

Figure 17. Final Condition of AISI 9310 Steel Test Pinion (SK21985, Serial No. 5).

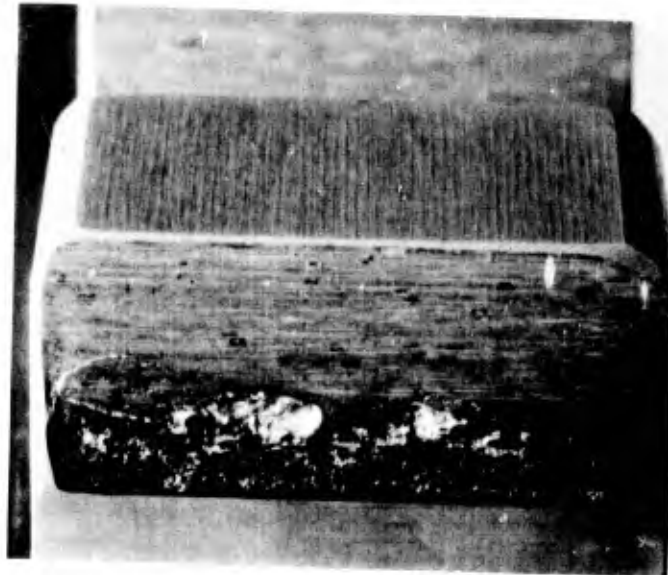
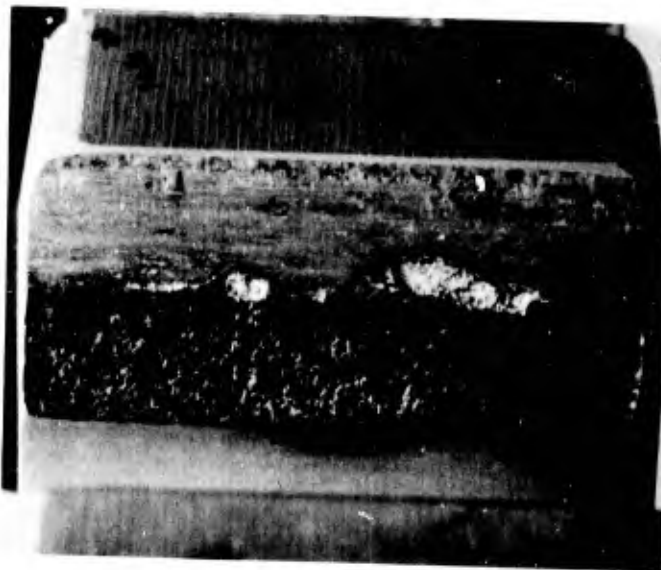
SIDE A, TOOTH 8, 160 PERCENT LOAD, 1.3×10^6 CYCLES

SIDE B, TOOTH 23, 160 PERCENT LOAD, 1.97×10^6 CYCLES

Figure 18. Final Condition of AISI 9310 Steel Test Pinion (SK21985, Serial No. 4).

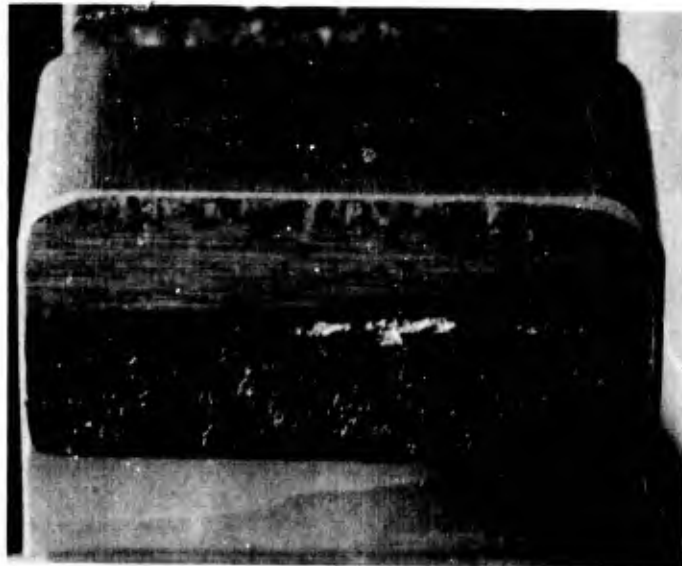
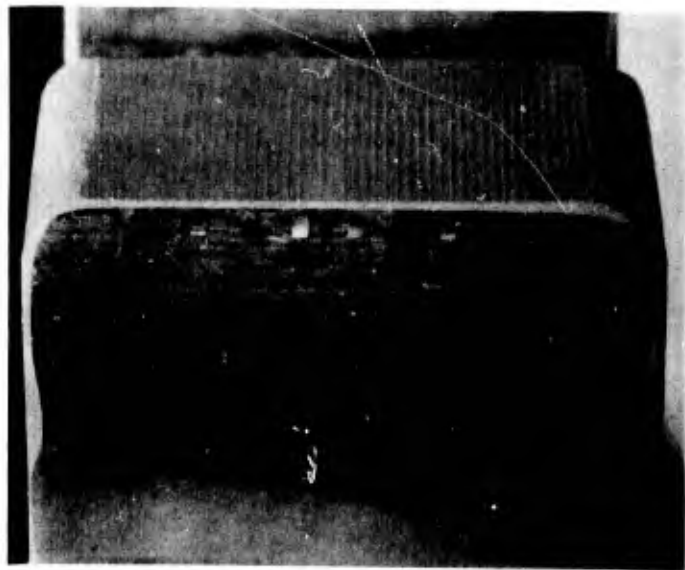
SIDE A, TOOTH 1, 160 PERCENT LOAD, 1.5×10^6 CYCLES

SIDE B, TOOTH 2, 160 PERCENT LOAD, 3.0×10^6 CYCLES

Figure 19. Final Condition of AISI 9310 Steel Test Pinion (SK21985, Serial No. 1).

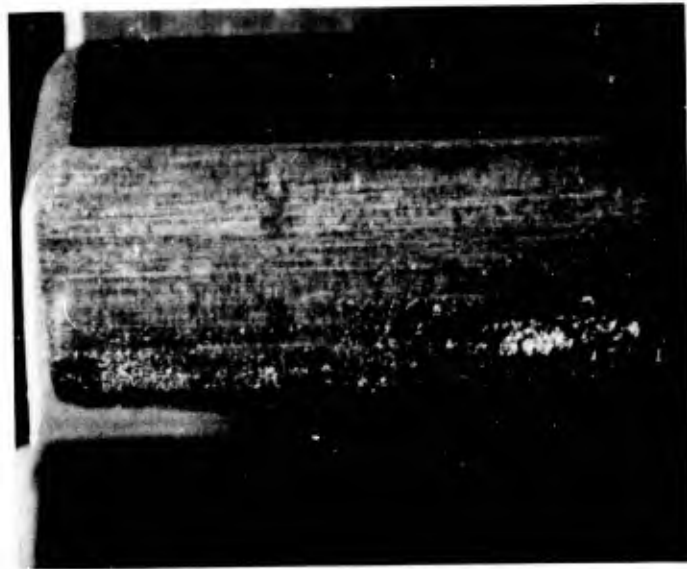
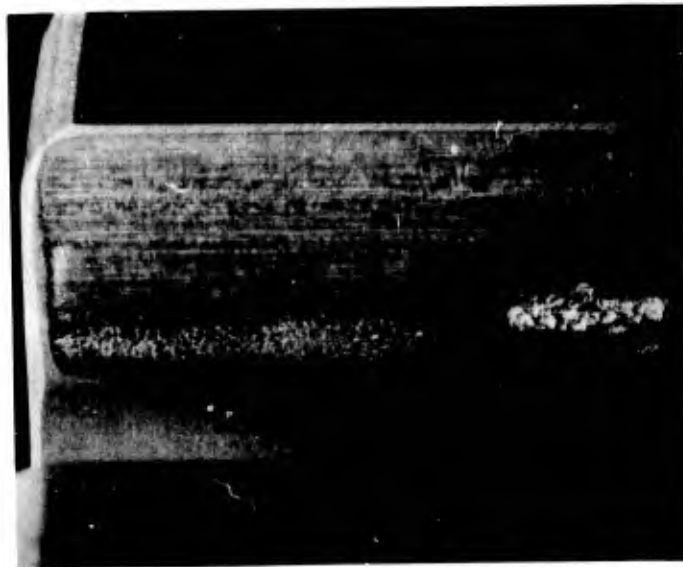
SIDE A, TOOTH 16, 250 PERCENT LOAD, 9.8×10^5 CYCLES

SIDE B, TOOTH 17, 220 PERCENT LOAD, 3×10^6 CYCLES

Figure 20. Final Condition of VASCO-X2 Steel Test Pinion (SK21985, Serial No. 4).

In most cases, a frosting condition was observed during the 190 percent load run. This condition appeared to taper across the face width with the widest portion located at the end closest to the mounting shoulder. The final condition of the VASCO-X2 gear test specimens displaying the typical pitting and/or spalling condition is presented in Figures 20 through 23. These same figures show the typical frosting condition, identified by the etch-like appearance of the surface, on the pinion dedendum. They also show the highly polished condition of the remaining tooth surface, with no evidence of scoring. Under magnification, the frosted surface appears to contain a field of micro-pits with no evidence of radial welding and/or tear marks.

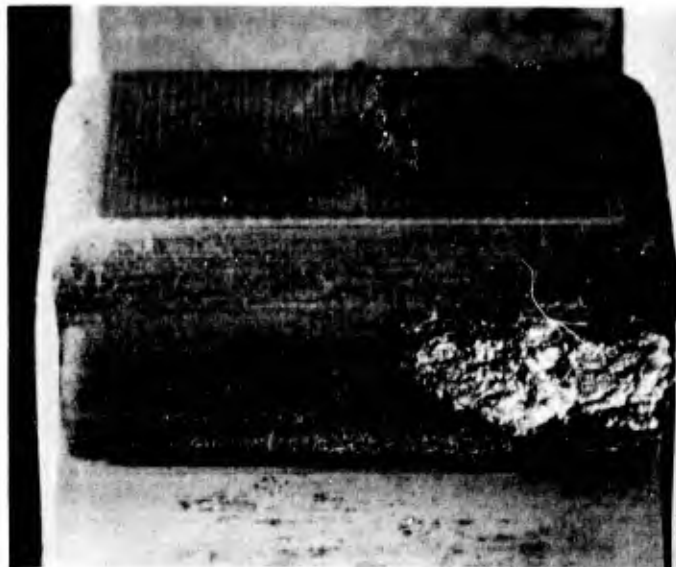
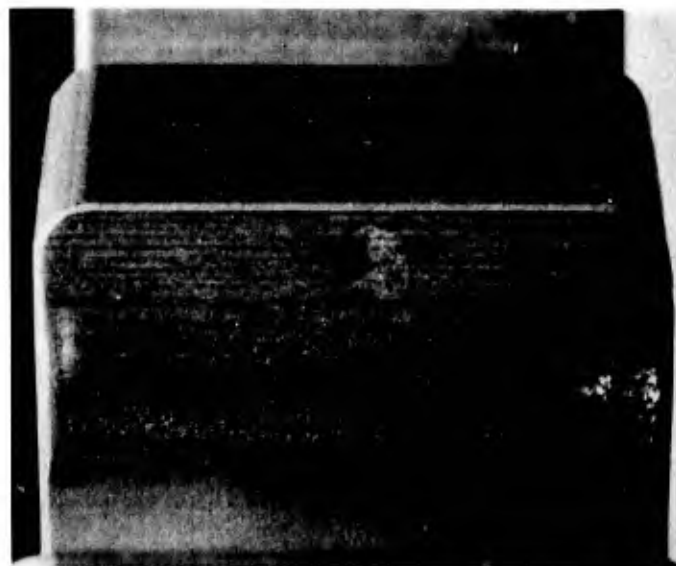
SIDE A, TOOTH 11, 220 PERCENT LOAD, 1.3×10^6 CYCLES

SIDE B, TOOTH 14, 220 PERCENT LOAD, 3×10^6 CYCLES

Figure 21. Final Condition of VASCO-X2 Steel Test Pinion (SK21989, Serial No. 3).

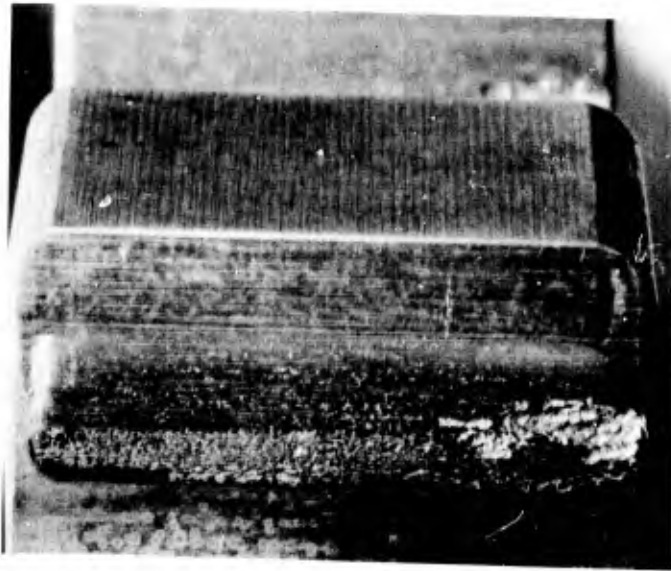
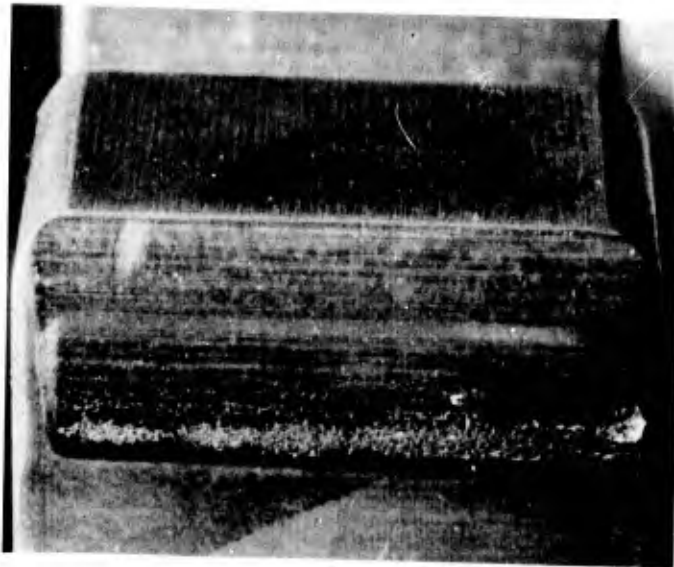
SIDE A, TOOTH 8, 250 PERCENT LOAD, 5×10^5 CYCLES

SIDE B, TOOTH 13, 250 PERCENT LOAD, 7.6×10^6 CYCLES

Figure 22. Final Condition of VASCO-X2 Steel Test Pinion (SK21989, Serial No. 2).
