EVALUATION OF ADVANCED GEAR MATERIALS FOR GEAR BOXES AND TRANSMISSIONS

Final Report

October 1970

The Boeing Company, Vertol Division

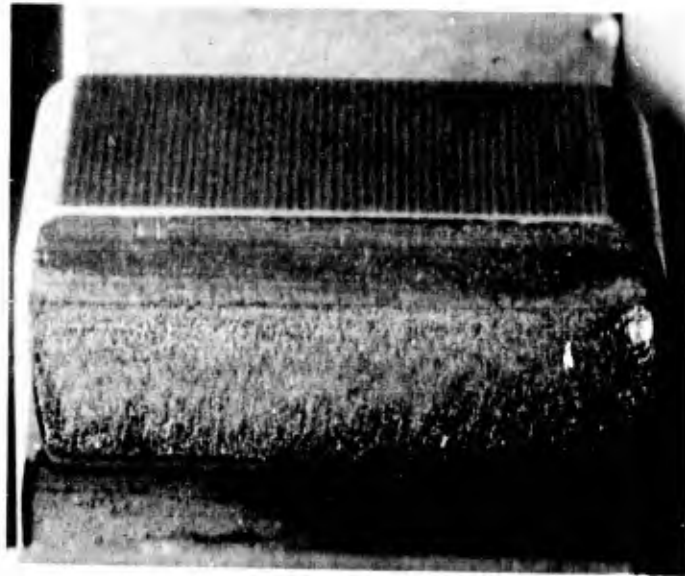
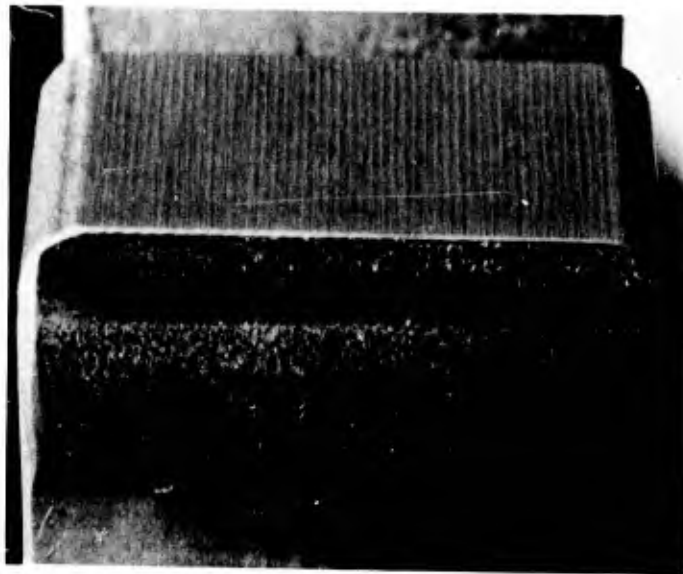
SIDE A, TOOTH 16, 250 PERCENT LOAD, 3.9×10^5 CYCLES

SIDE B, TOOTH 13, 250 PERCENT LOAD, 1.4×10^6 CYCLES

Figure 23. Final Condition of VASCO-X2 Steel Test Pinion (SK21989, Serial No. 5).

In most cases, a frosting condition was observed during the 190 percent load run. This condition appeared to taper across the face width with the widest portion located at the end closest to the mounting shoulder. The final condition of the VASCO-X2 gear test specimens displaying the typical pitting and/or spalling condition is presented in Figures 20 through 23. These same figures show the typical frosting condition, identified by the etch-like appearance of the surface, on the pinion dedendum. They also show the highly polished condition of the remaining tooth surface, with no evidence of scoring. Under magnification, the frosted surface appears to contain a field of micro-pits with no evidence of radial welding and/or tear marks.

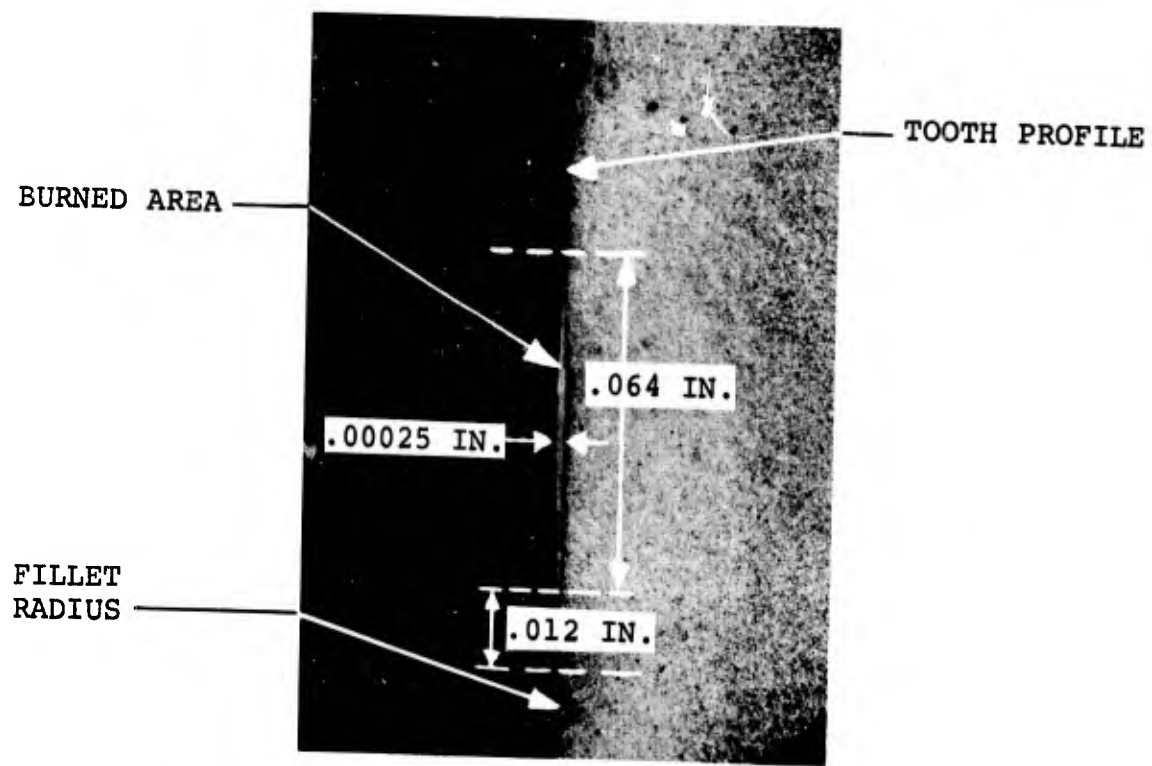
Figure 24. Contact Burn on AISI 9310 Steel Pinion (Scale 25x)

All of the gear test specimens (AISI 9310 and VASCO-X?) were inspected by the nital etch process after completion of the test program. This inspection revealed a contact burn condition in the pinion dedendum on all of the AISI 9310 steel test pinions. This condition is usually indicative of high temperature and/or concentrated pressure. A micro examination is presented in Figure 24. The photograph displays the burned area, located approximately 0.012 inch above the fillet radius juncture, 0.064-inch in length, and 0.0025-inch deep. This condition was not evident on the VASCO-X2 steel test pinions.

4. Metallurgical examination of the AISI 9310 gear specimens revealed a contact burn in the pinion dedendum, indicating that excessive temperatures were present. The VASCO-X2 test gear specimen did not exhibit this condition. Since the test gear design and operating condition were the same for the VASCO-2 gears, it is reasonable to assume that the high hot hardness VASCO-X2 steel gears can withstand higher operating temperatures and/or concentrated pressures than the AISI 9310 steel gears.

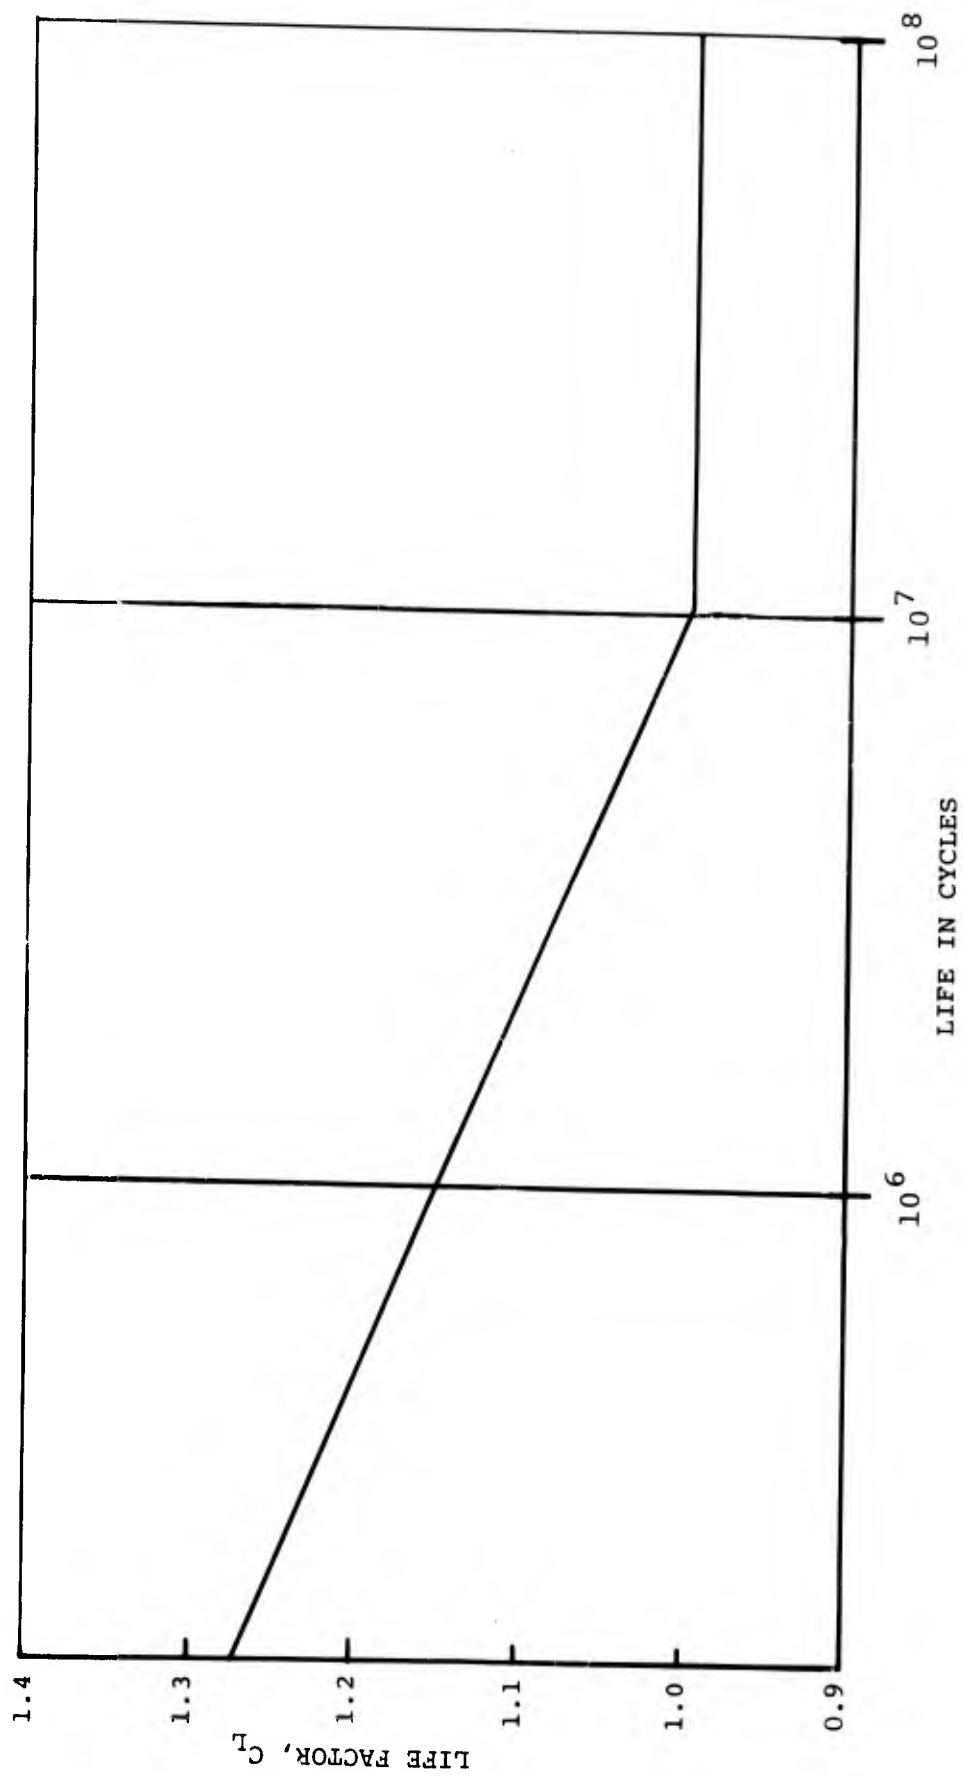
Figure 25. Surface Durability Life Factor (AGMA Standard 219.02)

All of the test data points, for both materials, listed in Tables 6 and 7 were projected for the expected endurance limit at 10 million cycles. As shown in Figure 25, the life factor C_L becomes unity at 10 million cycles, indicating that the surface fatigue endurance limit is achieved at that point. The number of test cycles to failure for each data point was used to determine the correct life factor for application to each data point. This life factor was then employed to determine the calculated endurance limit at 10 million cycles by dividing the contact stress at failure, for each data point, by the respective life factor. A listing of the specific data points, life correction factors, and calculated endurance limits is presented in Table 9.

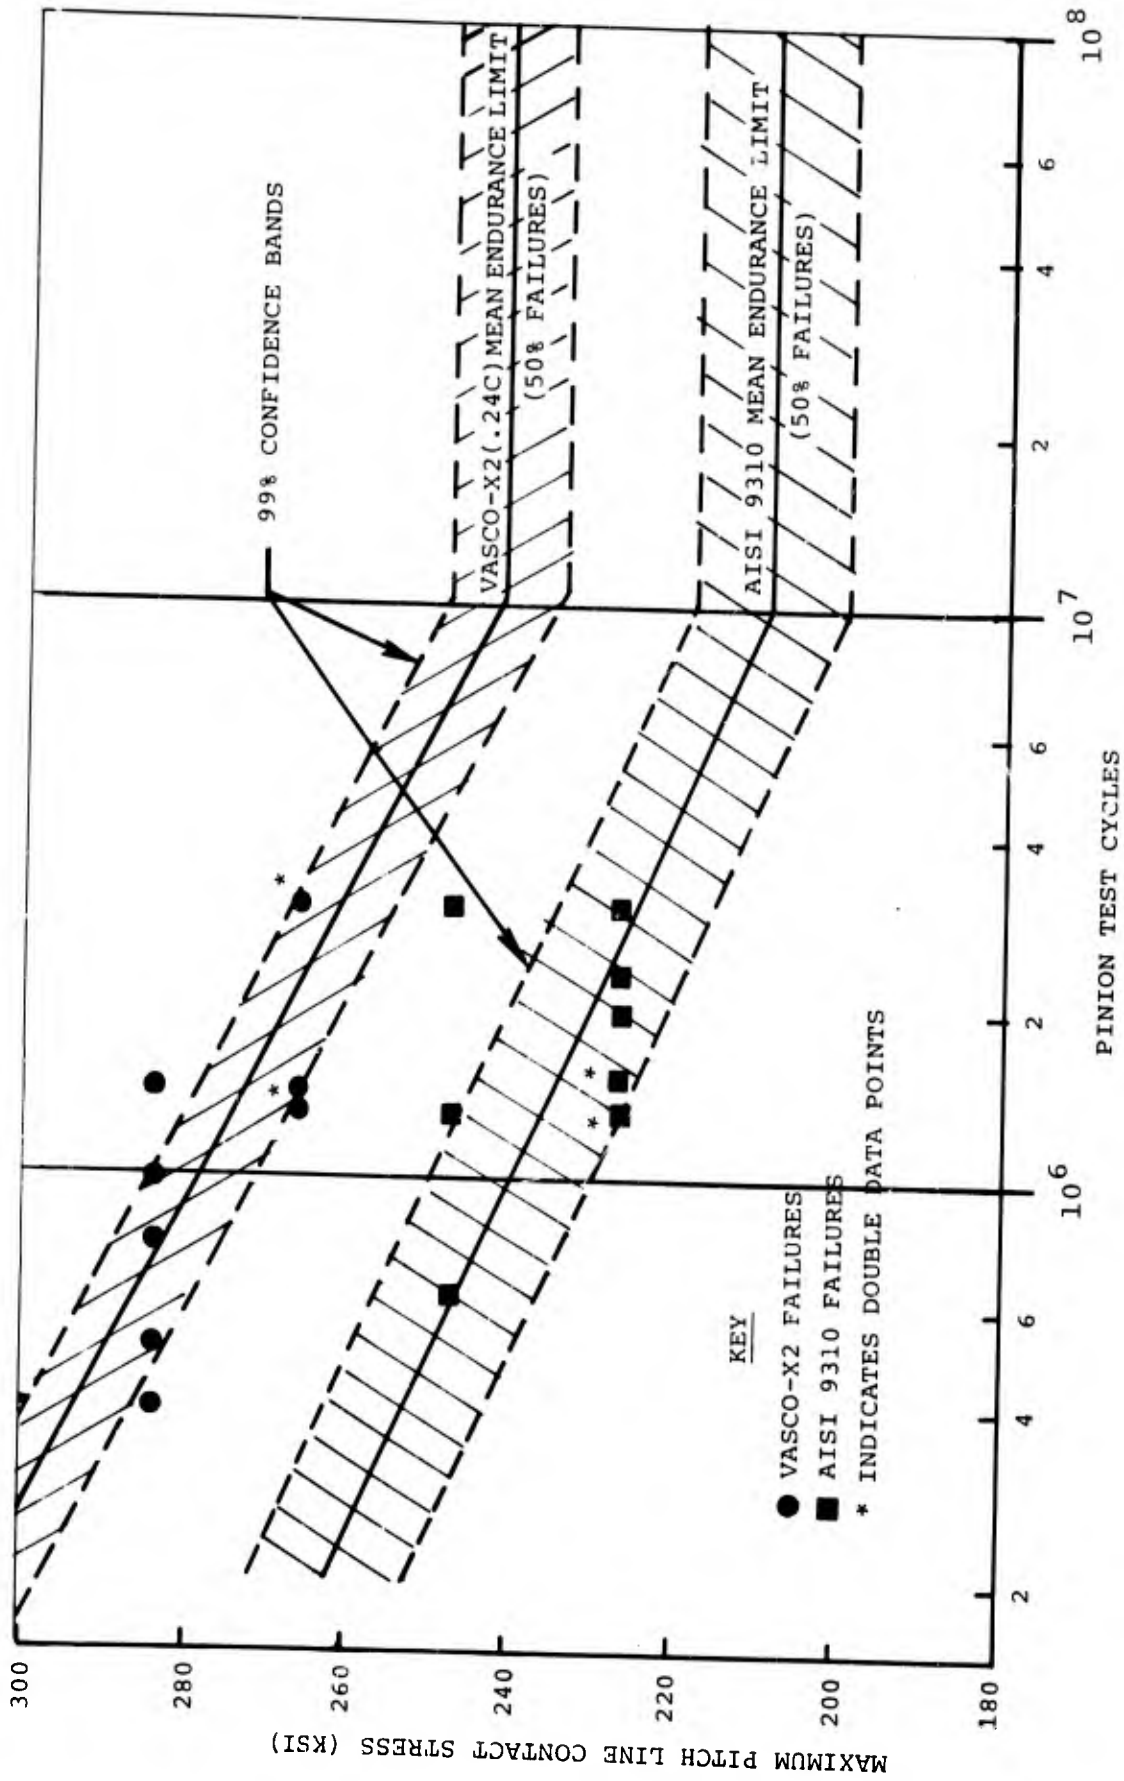
Figure 26 Mean Endurance Limits for a 99.5 Percent Probability of Survival.

An existing Boeing-Vertol computer program was used for the statistical data evaluation. This study was accomplished by employing the following method of analysis. The various calculated surface endurance stress indices were used to determine the mean (50 percent failure rate) endurance stress, the unbiased standard deviation, and the 99 percent confidence limits for the mean endurance limit. Figure 26 presents a plot of the test data points with the mean endurance limit and the associated 99 percent confidence limits. The plotted data presented in Figure 26 is also listed in tabular form in Table 8.

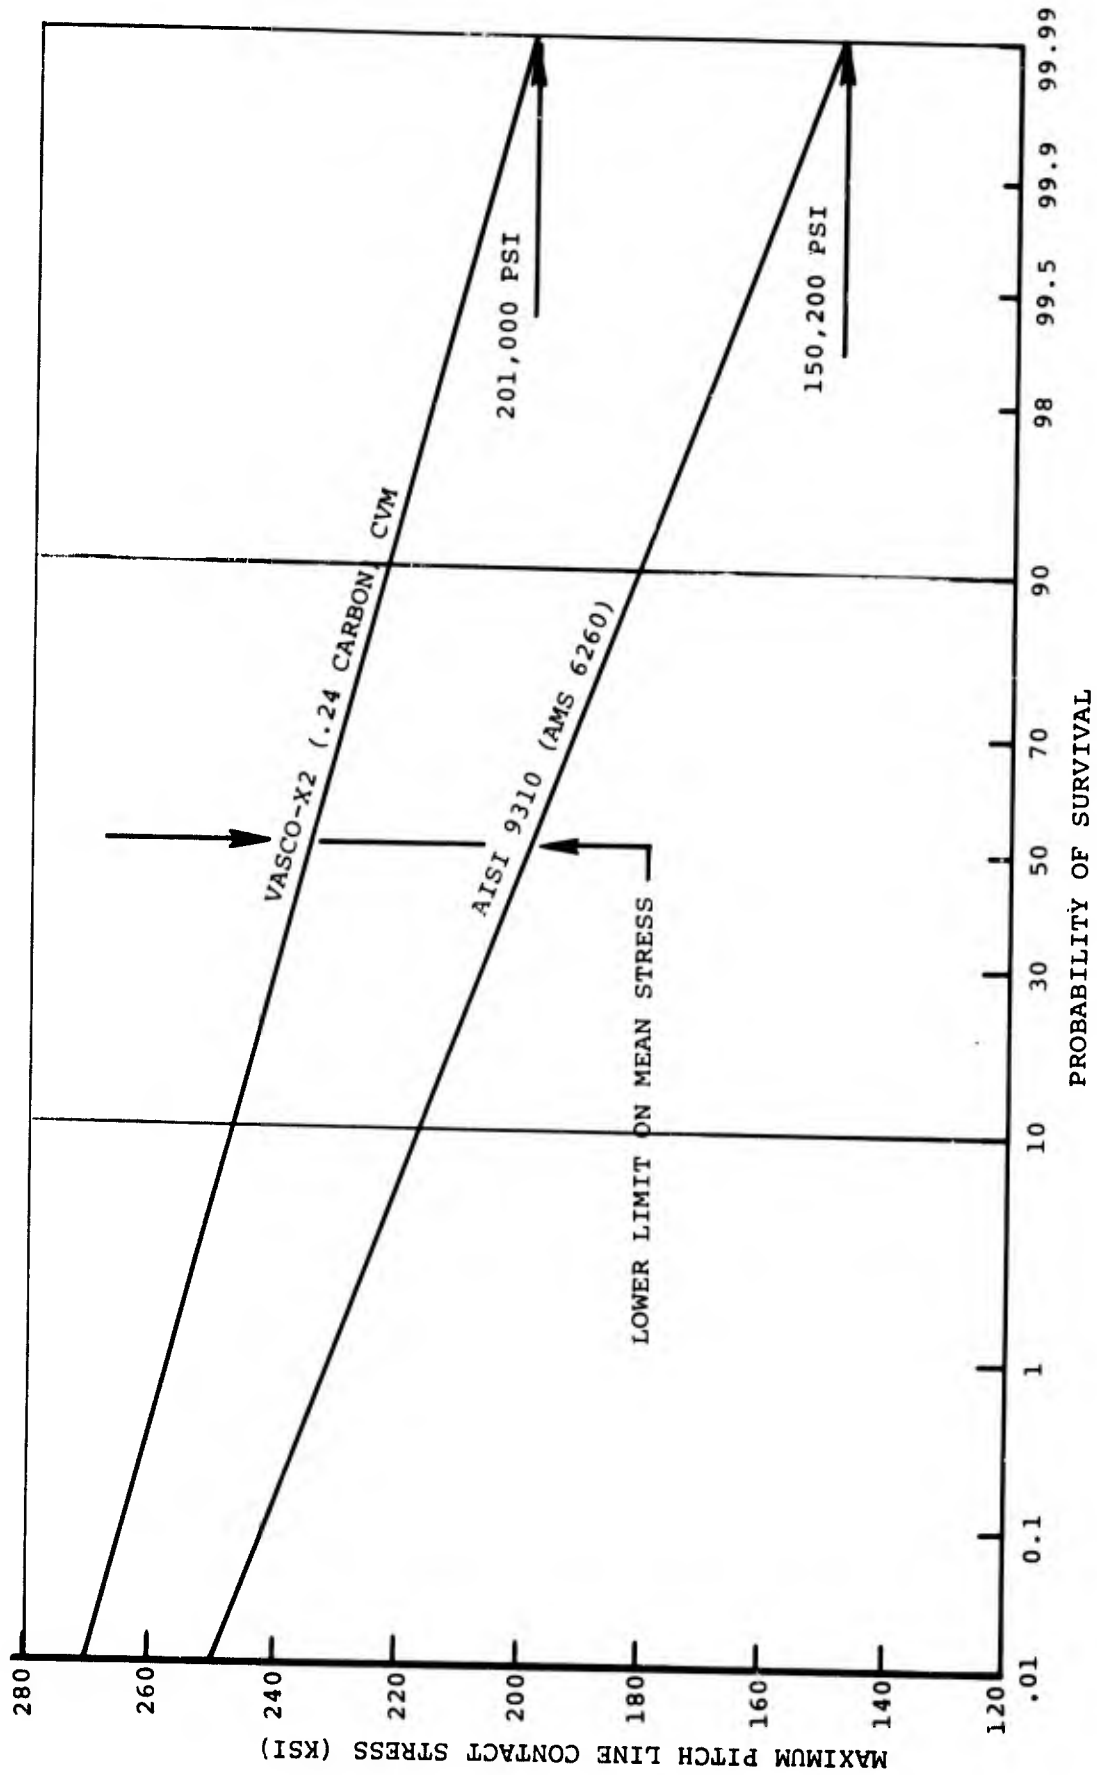
Figure 27 Test Data Points with Mean Endurance Limits at 99 Percent Confidence Level

The data was further evaluated by assuming the lower limit of the mean as the actual mean, which results in an endurance limit with a 99 percent confidence and a 50 percent probability of survival. The mean endurance limit for a 99.5 percent probability of survival was then calculated using student's t distribution factors, which resulted in the data presented in Figure 27. With these results, a comparison of the two materials can be accomplished at a 99.99 percent probability of survival (standard aircraft gear design practice) with a confidence level of 99 percent.
