EXPERIMENTAL INVESTIGATION OF SMALL SCALE LINED AND UNLINED CYLINDRICAL CAVITIES IN ROCK

IIT RESEARCH INSTITUTE

TECHNICAL REPORT NO. AFWL-TR-70-55

November 1970

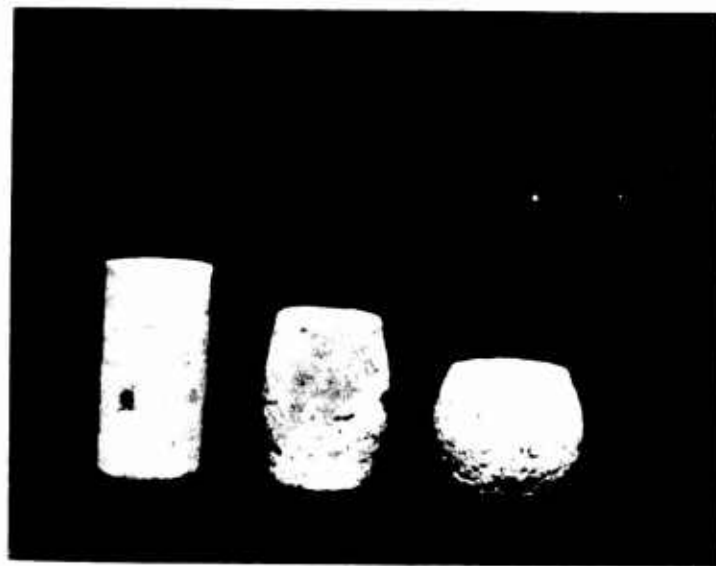
Fig. 26 VERMONT MARBLE SPECIMENS SUBJECTED TO TRIAXIAL COMPRESSION.

Mohr's envelopes developed for Indiana limestone are given in Figs. 21 and 22, and those for Vermont marble are depicted in Figs. 23 and 24. Photographs of Indiana limestone cores retrieved from the triaxial tests are shown in Fig. 25, and those for Vermont marble in Fig. 26. Shear planes of failure and barreling of the cores at high confining pressures are evident in these figures, although the former are more readily observed in Fig. 25 and the latter is more pronounced in Fig. 26.

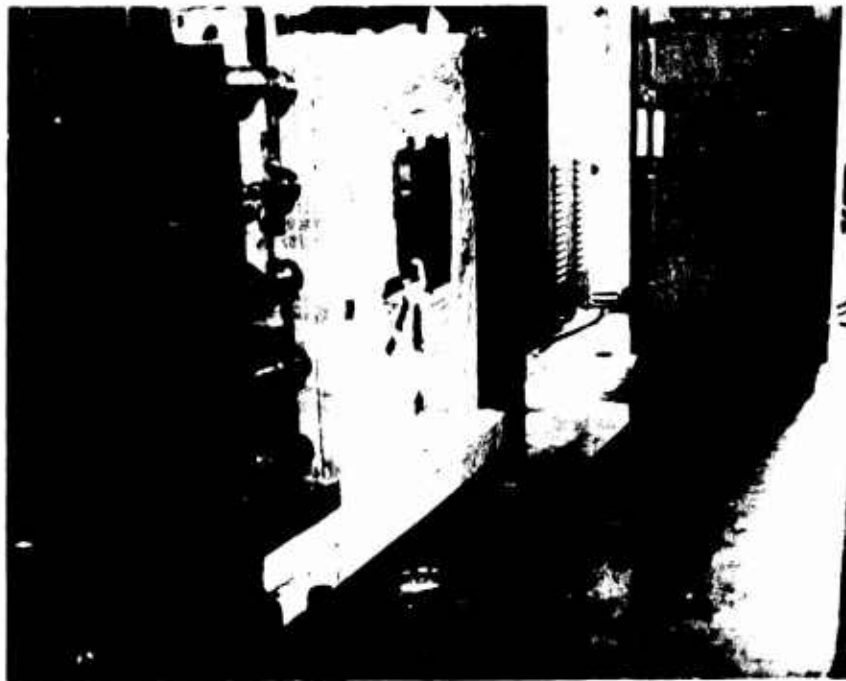
Fig. 168 TWO VIEWS OF SPECIMEN NO. 13 AFTER FAILURE
(LIMESTONE UNLINED UNDER BIAXIAL LOADING)

Isochromatic fringe patterns for specimen No. 13 are shown in Fig. 167 for various levels of loading. The applied vertical and horizontal stresses are shown in each frame. The fringe patterns show a high compressive strain increasing with load up to a vertical stress of $p = 3,220$ psi and a horizontal stress of $q = 1,100$ psi. Failure occurred at a vertical stress of 3,550 psi and a horizontal stress of 1,190 psi. Failure occurred by splitting of the specimen along vertical planes parallel to the faces (Figs. 168 and 169). This failure is considered typical for materials like rock and

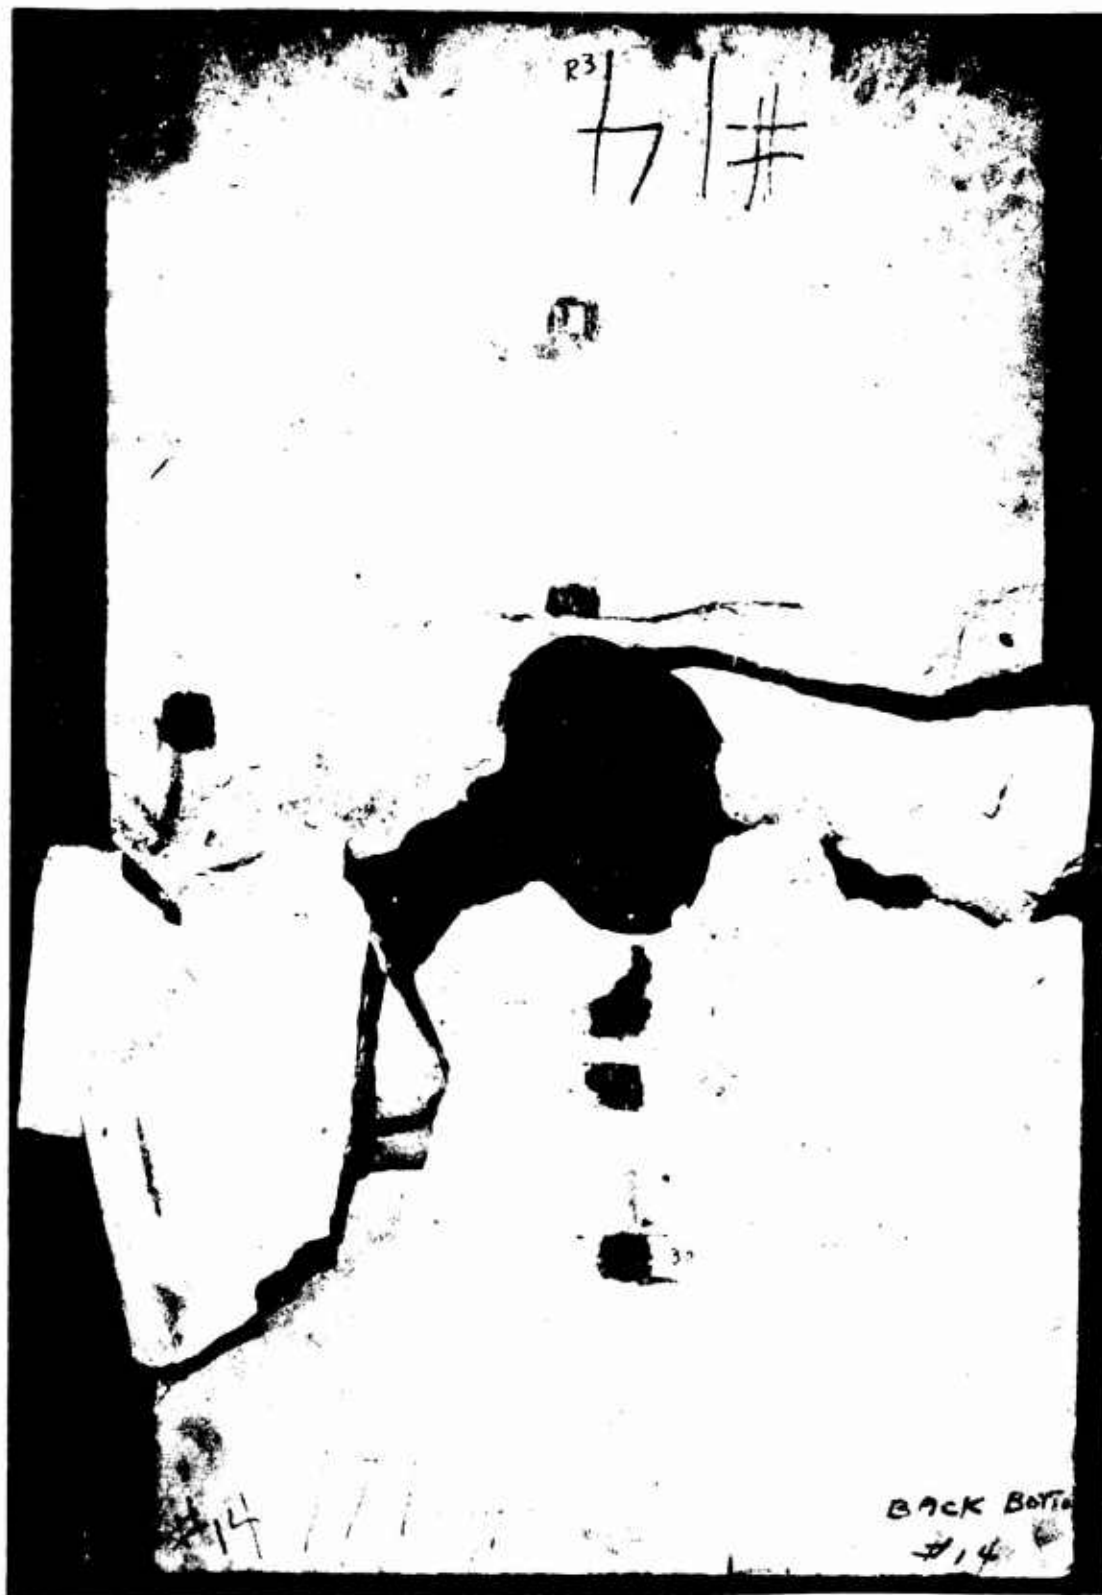
Fig. 172 FAILURE PATTERN IN SPECIMEN NO. 14 (LIMESTONE UNLINED UNDER BIAXIAL LOADING)
