AD _____
RDTE PROJECT NO.
USAAVSCOM PROJECT NO. 70-29
USAASTA PROJECT NO. 70-29

**VIBRATION AND ELEVATOR LOADS SURVEY TESTS
OF THE
UH-1M HELICOPTER WITH THE FORWARD-LOOKING
INFRARED (FLIR) SYSTEM INSTALLED**

FINAL REPORT

**US ARMY AVIATION SYSTEMS TEST ACTIVITY
EDWARDS AIR FORCE BASE, CALIFORNIA 93523**

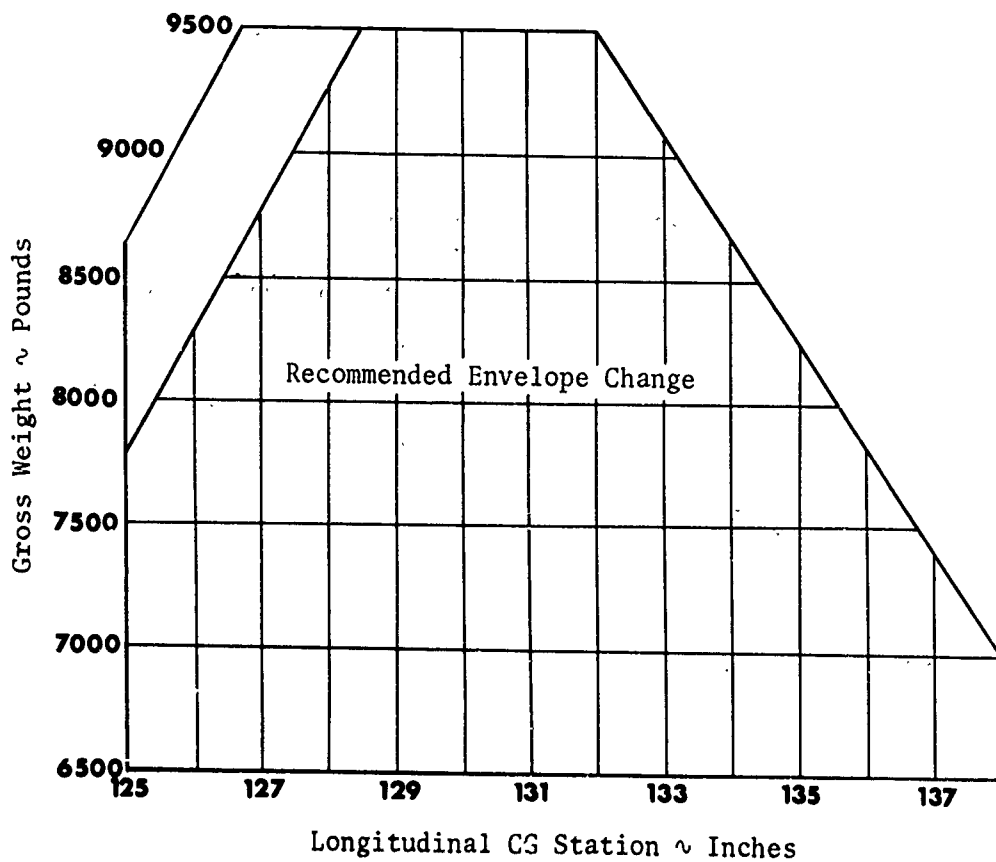
Figure A. Recommended Gross Weight Versus Longitudinal CG Station Envelope.
