Technical Note N-1162

ELECTROMAGNETIC INTERFERENCE (EMI) STUDY OF SIX TYPICAL ARMY  
PORTABLE 3 KW ENGINE-GENERATOR SETS

May 1971

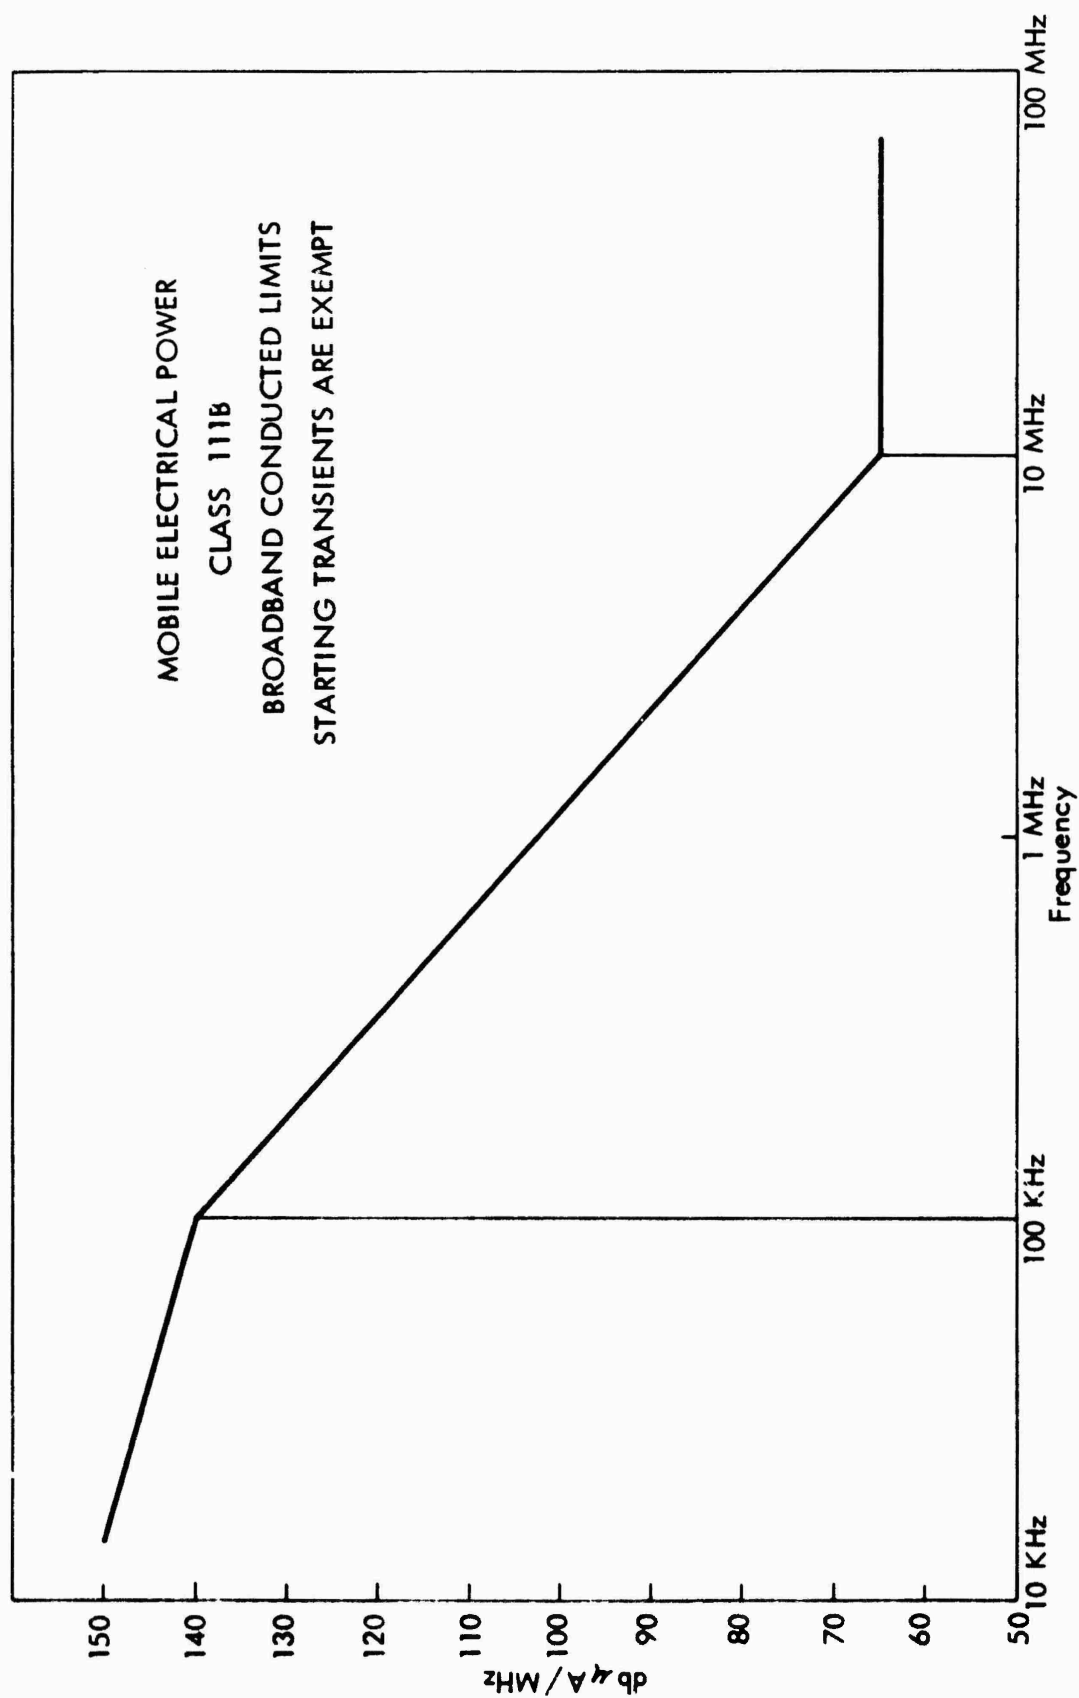
Figure 1. Broadband conducted EMI limits.

- a. Eliminate narrowband EMI tests completely.
- b. Perform broadband EMI tests both conducted and radiated using automated techniques to the relaxed limits as shown in Figures 1 and 2.
- c. Determine suppression measures and retrofit the E-G sets to ascertain compliance.

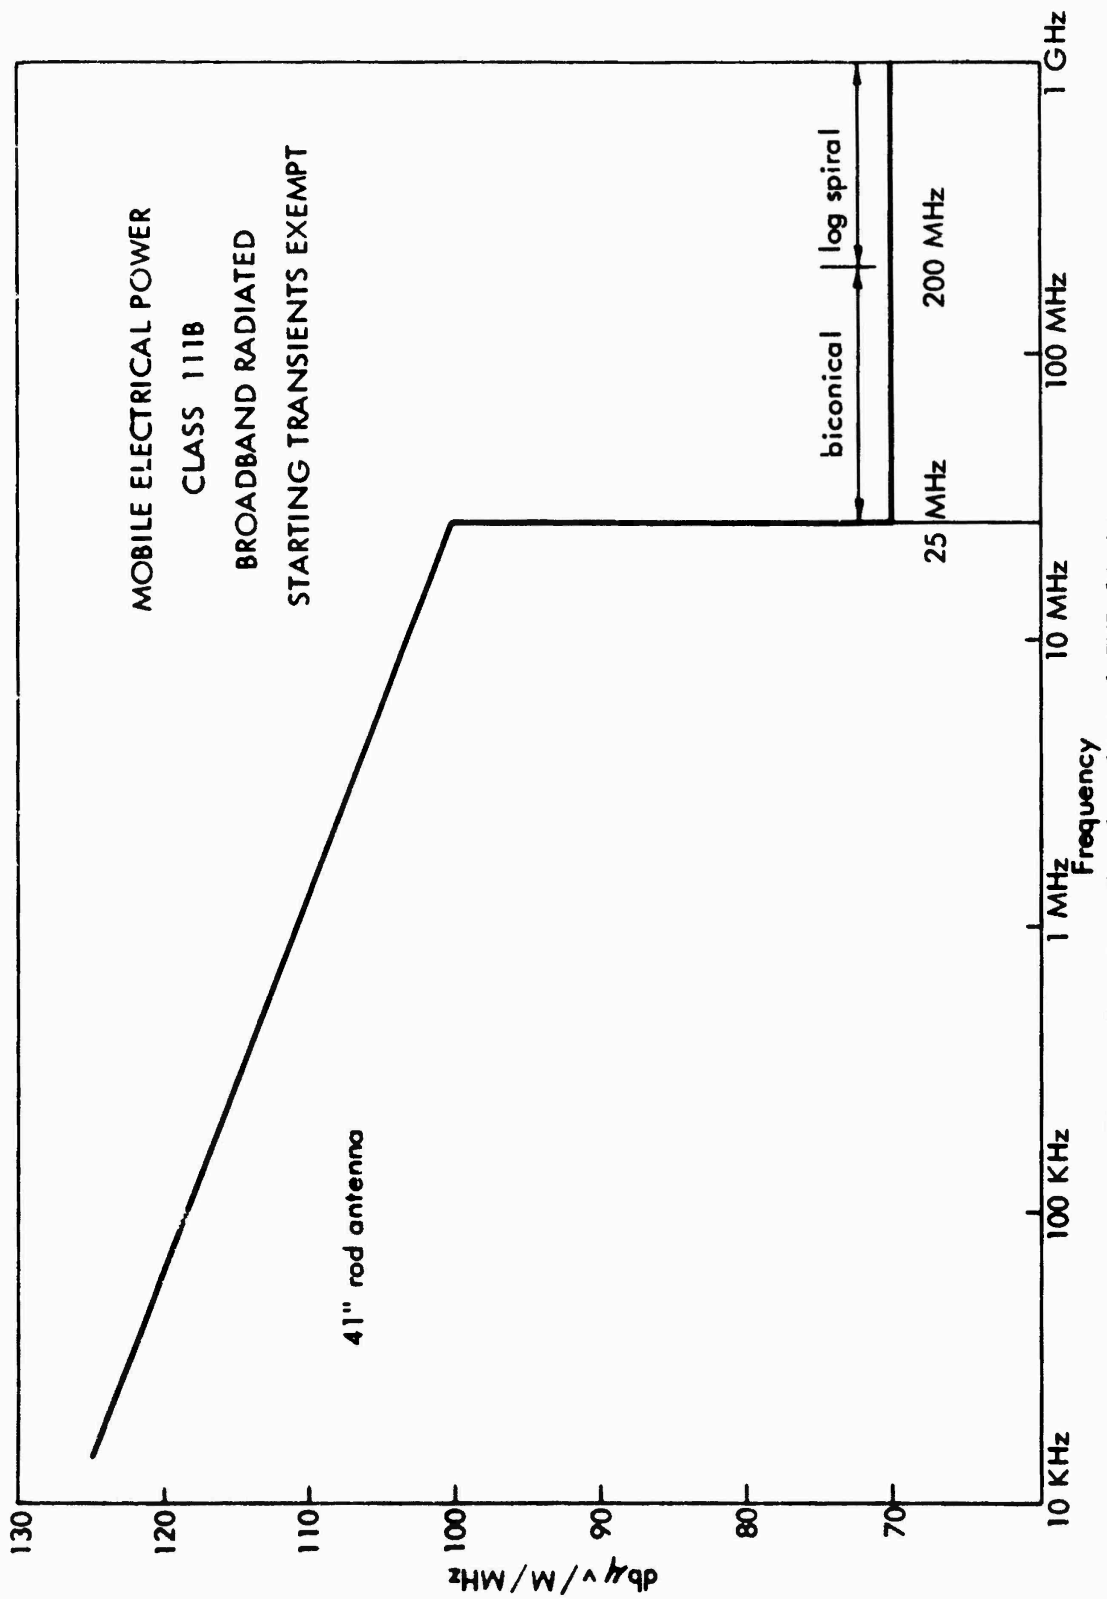
Figure 2. Broadband radiated EMI limits.

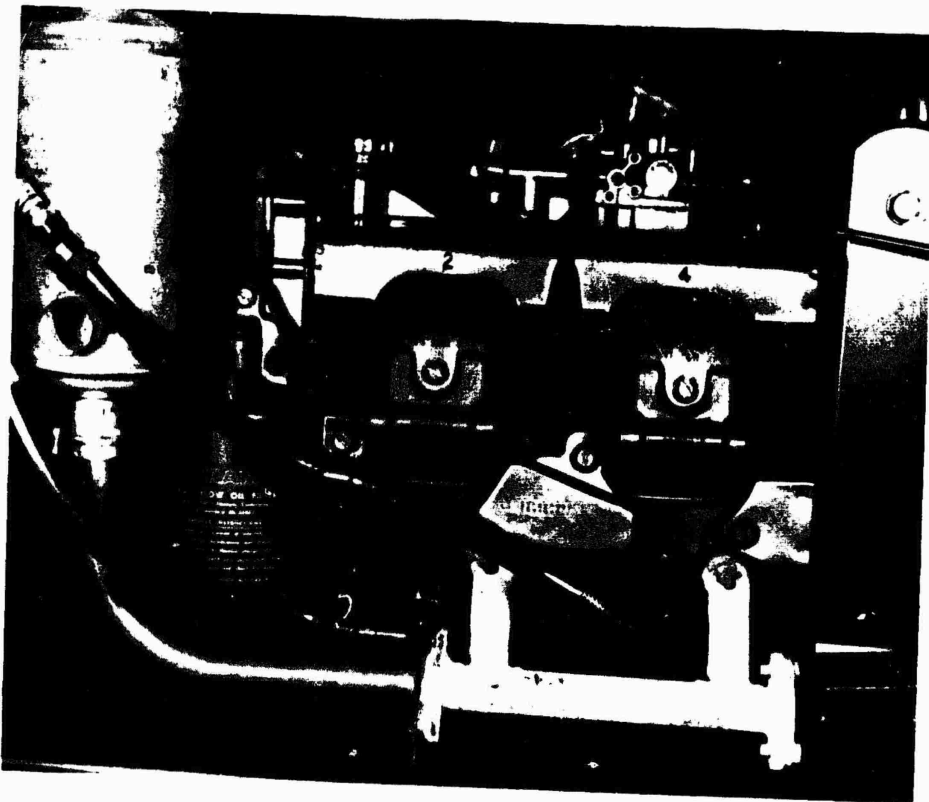
A casual observation of the test sample E-G sets revealed that they all had the same type of gasoline engine equipped with EMI suppression harnesses and shielded ignition wiring. Figure 3 shows a close-up photo of the harness installation.

Figure 3. Close up photograph of the EMI shielding harness.

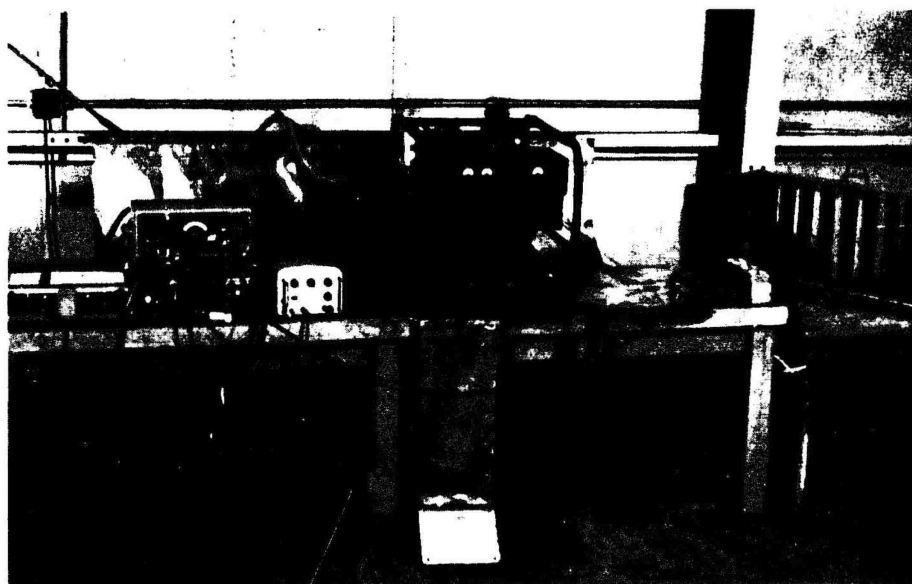
Conducted EMI. The conducted EMI tests were performed on this unit while it was operating at full load in the 3-phase Y configuration. Therefore, there are 4 traces per band on the X-Y plots. Where possible, the individual traces are identified as N,  $\phi 1$ ,  $\phi 2$  or  $\phi 3$  corresponding to the L0, L1, L2 and L3 markings on the generator output. The X-Y plots shown in Figures A-1, A-2, A-3 and A-4 are the data taken during this test. Note that the highest trace represents the neutral lead, however, none exceed the specification limit. The data has been summarized in Figure 11. The existing filtering utilized by the manufacturer is sufficient and amounts to a 0.1  $\mu$ f bypass capacitor from each phase lead and the neutral lead to the generator case. Figure 12 shows a photograph of these bypass capacitors in place. Figure 13 shows a typical conducted EMI test set-up.

Figure 13. Photograph of conducted EMI test setup.

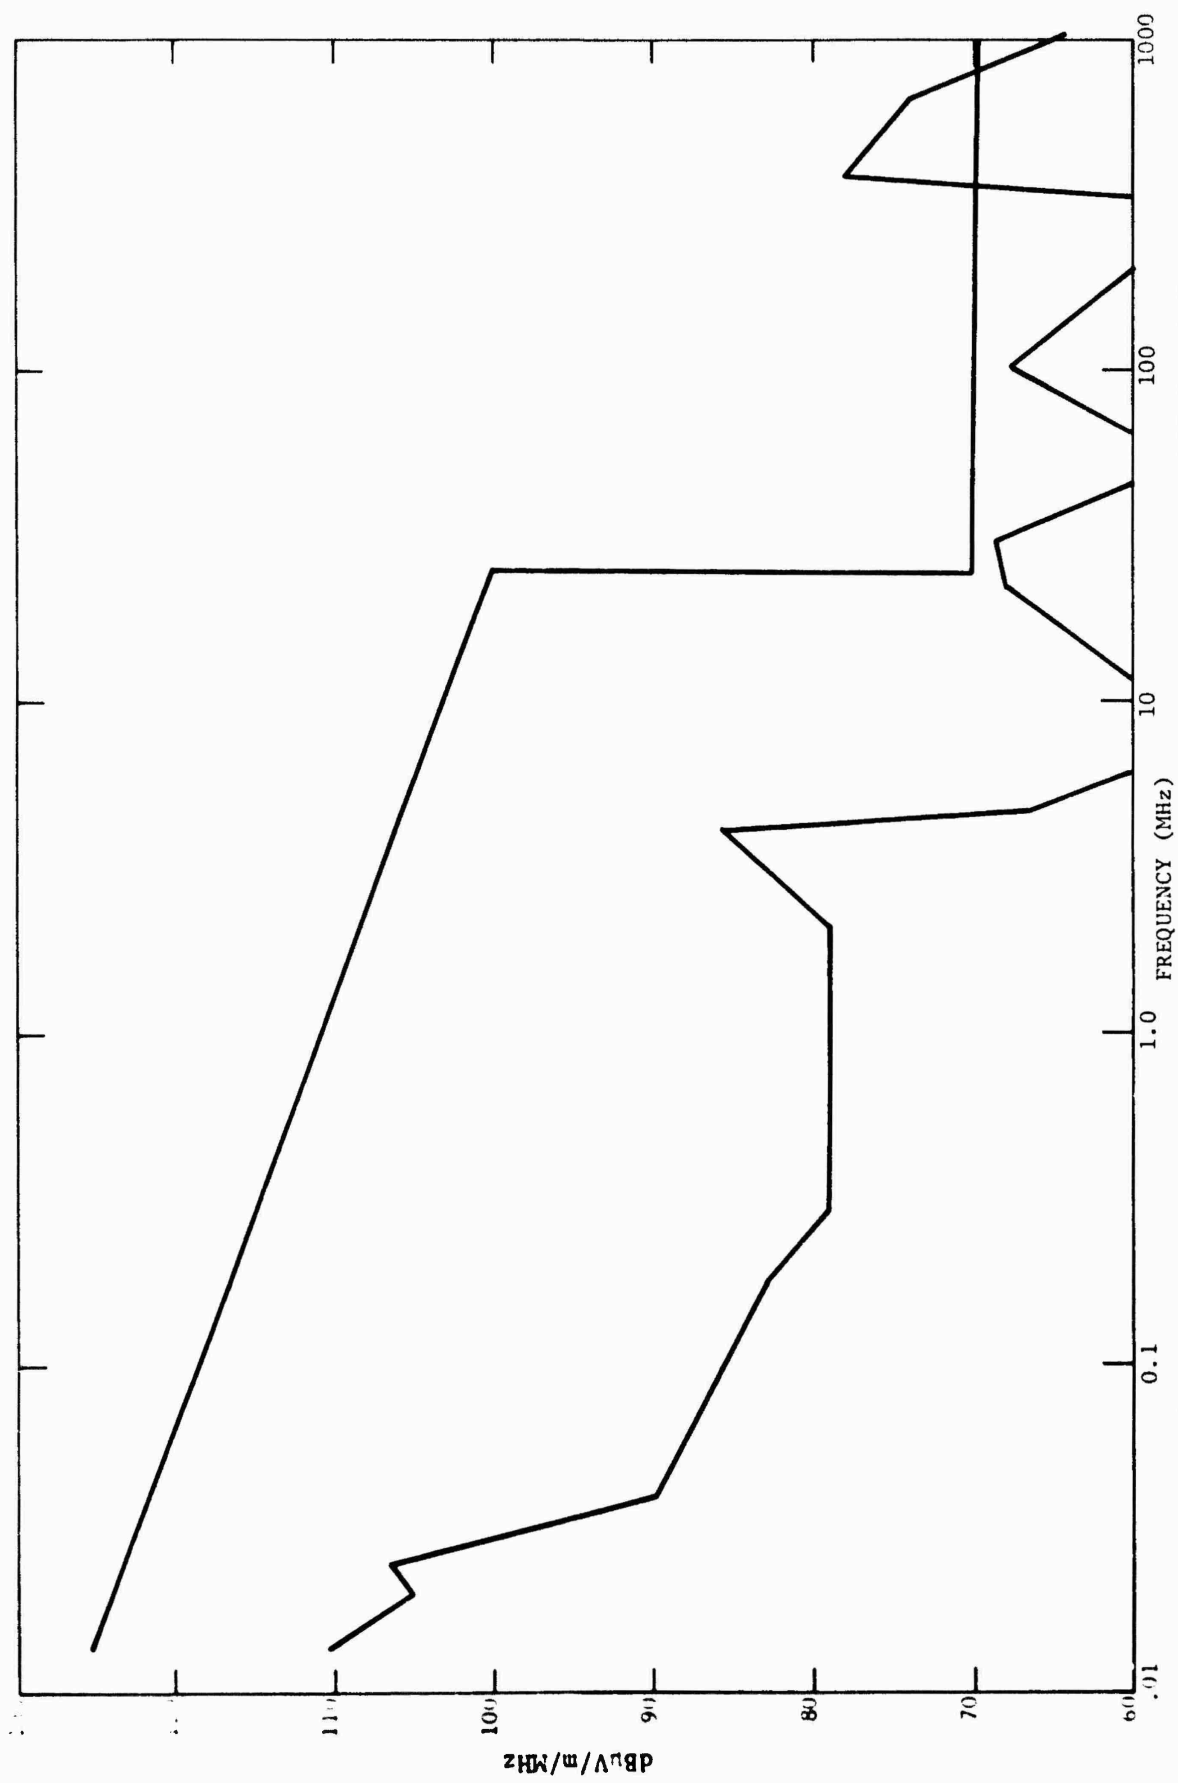
The results of this test are shown in Figures A-5, A-6, A-7, A-8 and A-9 and are summarized in Figure 14. It is interesting to note that the first out-of-specification condition occurred at 300 MHz and above. The most serious out-of-specification condition occurred between 300 and 600 MHz. A search loop was connected to the input of the EMI meter and the entire E-G set was searched at very close quarters for the source of the offending EMI. The front of the engine section demonstrated the highest level of EMI concentrating in the vicinity of the contact points housing. As a result, the shielding effectiveness of the ignition

system was determined to be deficient. This result was a little unexpected since the engine was equipped with an ignition shielding harness.

Figure 14. Broadband radiated EMI before suppression. GEN Set A, 400 Hz, 3 KW.

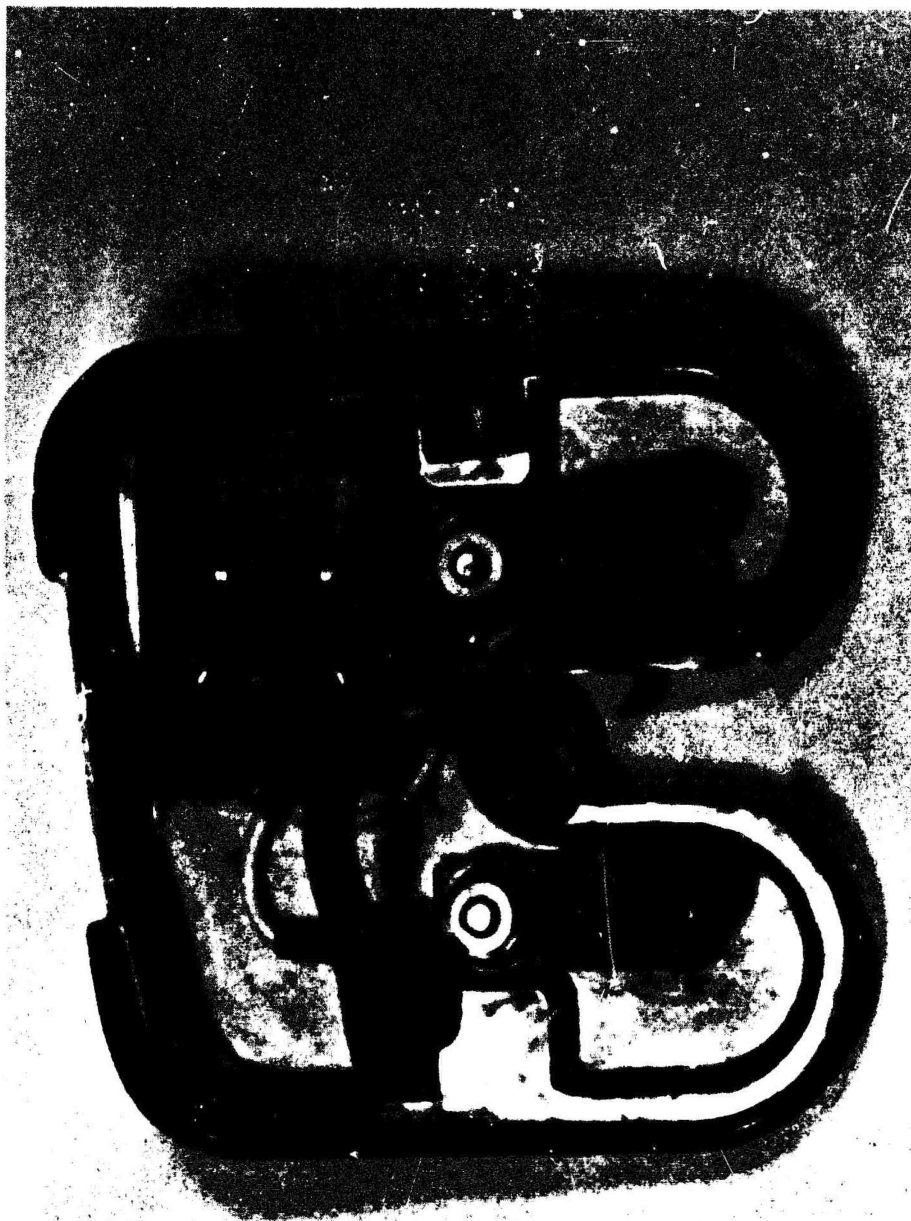
Suppression Required. The snap cover of the contact points housing, mounted on the front of the engine, was removed and examined for possible leakage holes. A close examination revealed that the existing gasketing, a soft metal gasket intended for EMI shielding, had been glued in place, presumably to aid in maintenance work. The result of the gluing was to violate the metal to metal contact around the periphery of the cover thereby reducing the shielding effectiveness. Figure 15 is a photograph of the points housing cover showing the gasketing partially peeled back.

Figure 15. Photograph of the contact points housing cover with the original gasket partially peeled back.

The gasket was removed, both it and the cover plate were cleaned and then reassembled on the E-G set. The 300 MHz to 600 MHz band was retested for radiated EMI and still demonstrated an out-of-specification condition. However, a slight improvement was noticed. Since the points housing cover is held on by two spring snaps, the two spring snaps were suspected of not providing sufficient peripheral force to effectively shield the points circuitry. Consequently, a new gasket was made from a piece of 1/8 inch thick commercial wire mesh shielding material with a rubber support (adhesive) edge which should provide a better peripheral metal to metal contact resulting from the increased spring snap pressure. Figure 16 is a photograph of the points housing cover with the new gasket attached.

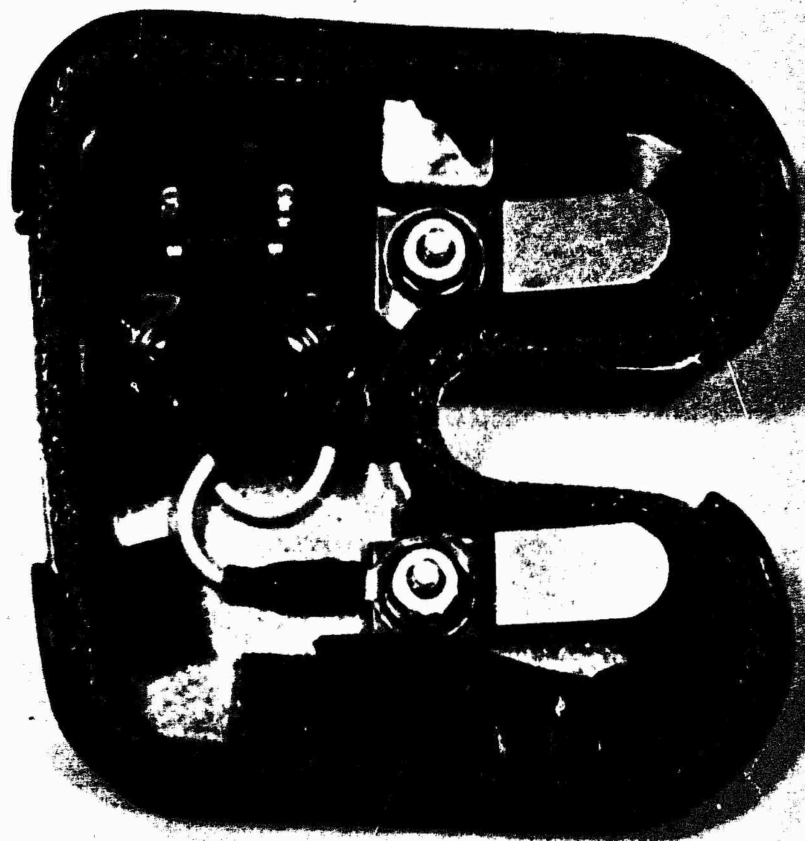
Figure 16. Photograph of the contact points housing cover showing the new EMI shielding gasket installed and a sample strip of the shielding material below.

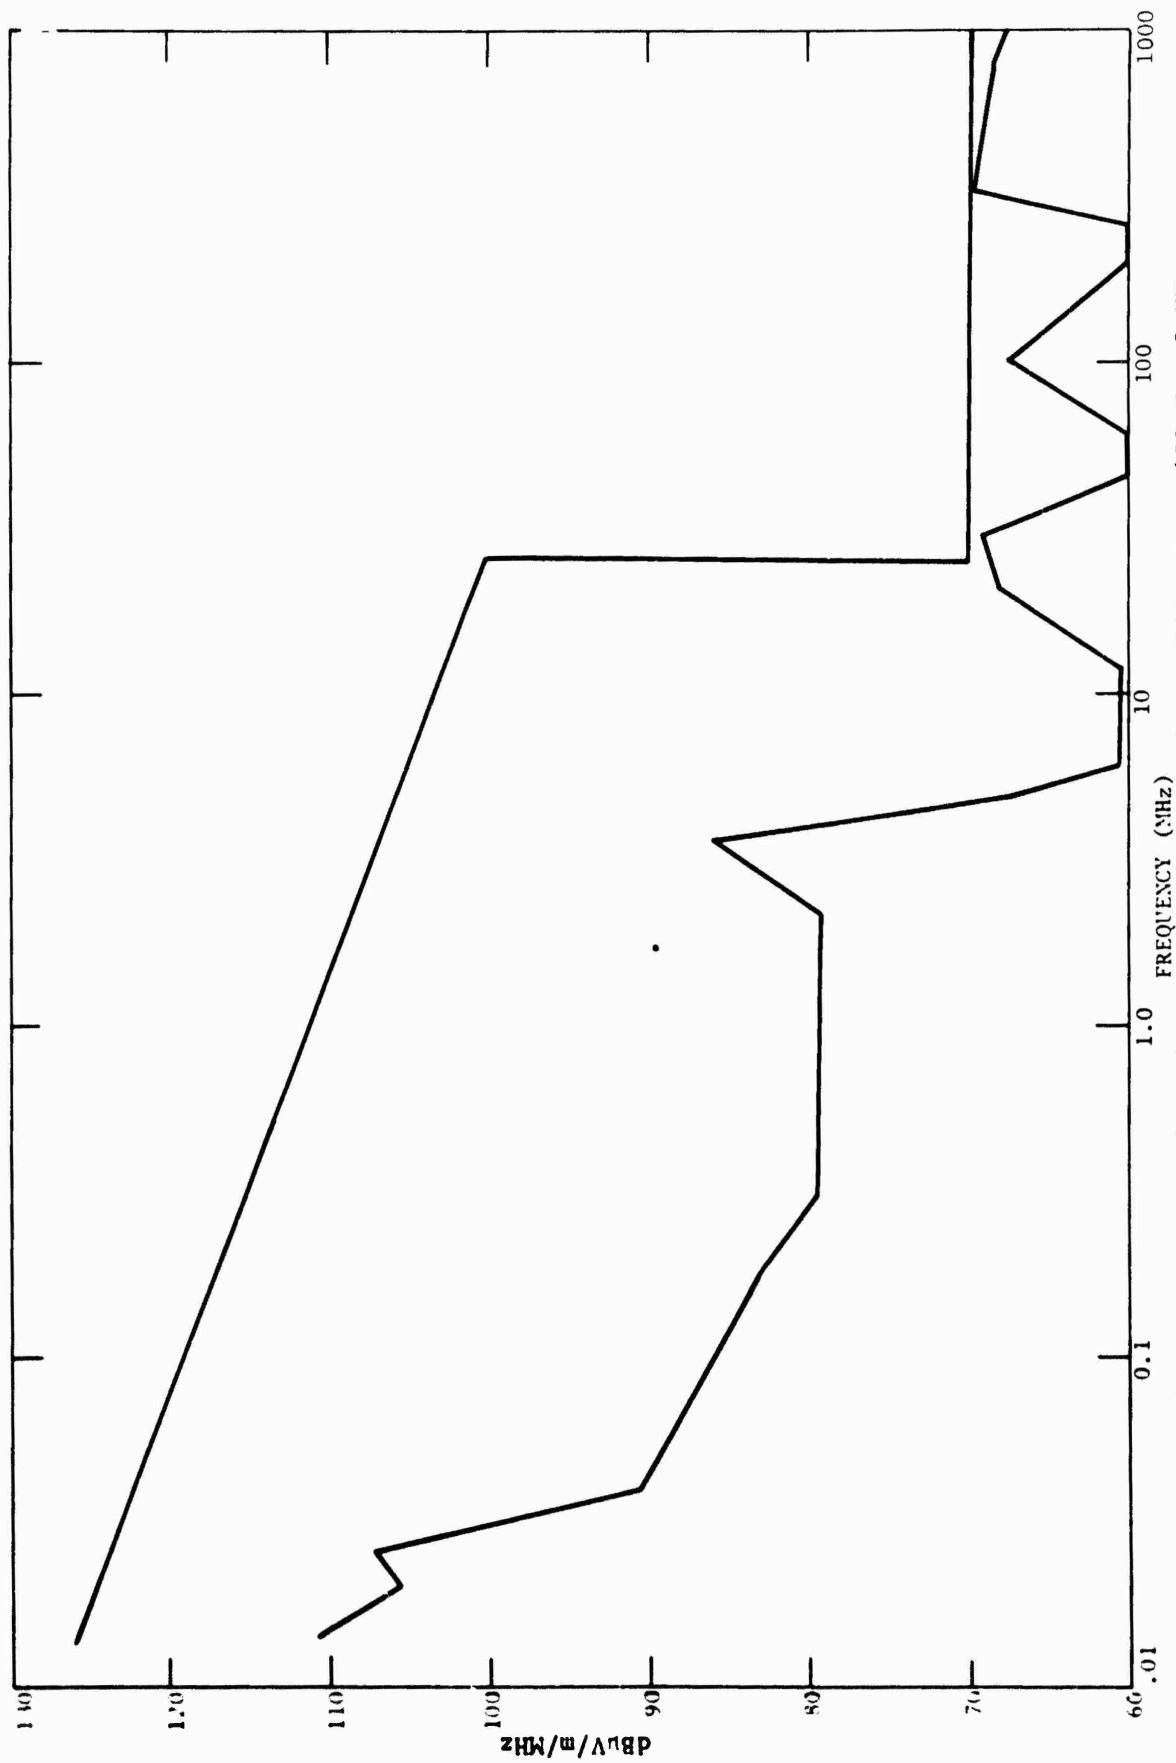
Retesting. Test Sample A was retested with the new gasket in place and this time demonstrated an in-specification condition as shown in Figure A-10 and again summarized in Figure 17. As a matter of interest, the area around the front of the E-G set was again searched with the test loop and again demonstrated a high concentration of radiated EMI, however, the E-G set had been suppressed to within the limits of accuracy to the specification desired, so it was set aside so that the test program could continue.

Figure 17. Broadband radiated EMI after suppression. GEN Set A, 400 Hz, 3 KW.

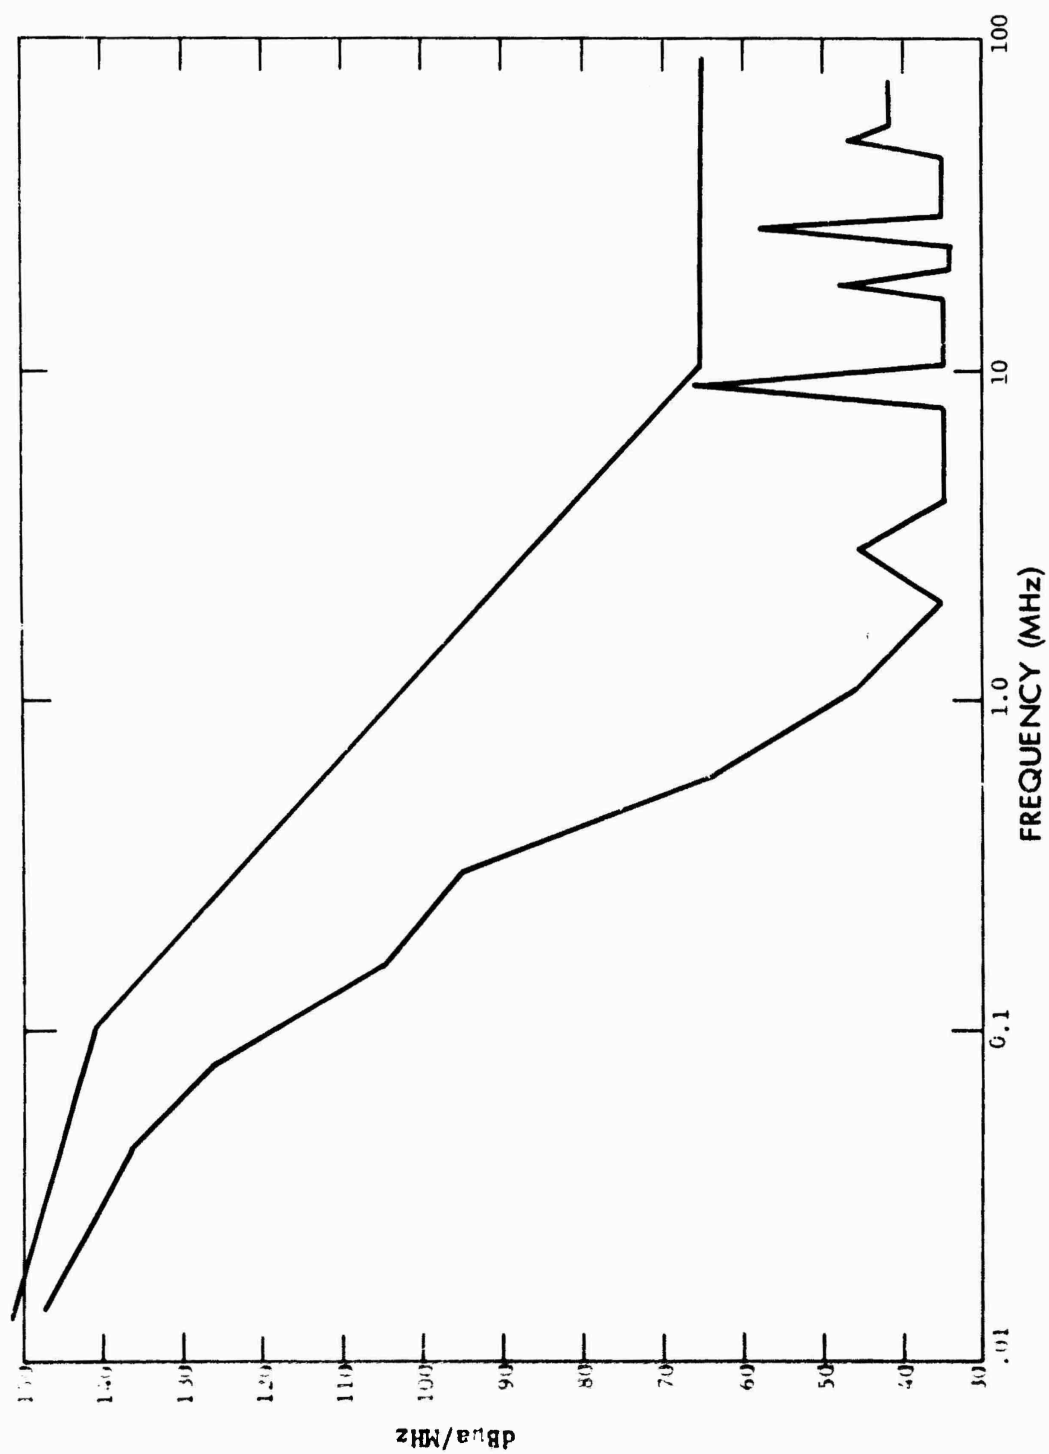
Mode 1: 120V, 4 wire, 3 $\phi$ Y. The test results are summarized in Figure 18. The conducted EMI did not exceed the specification level for any of the four wires.

Figure 18. Broadband conducted EMI. No suppression required. GEN Set B, 400 Hz, 3 kW, 120V, 3φY.

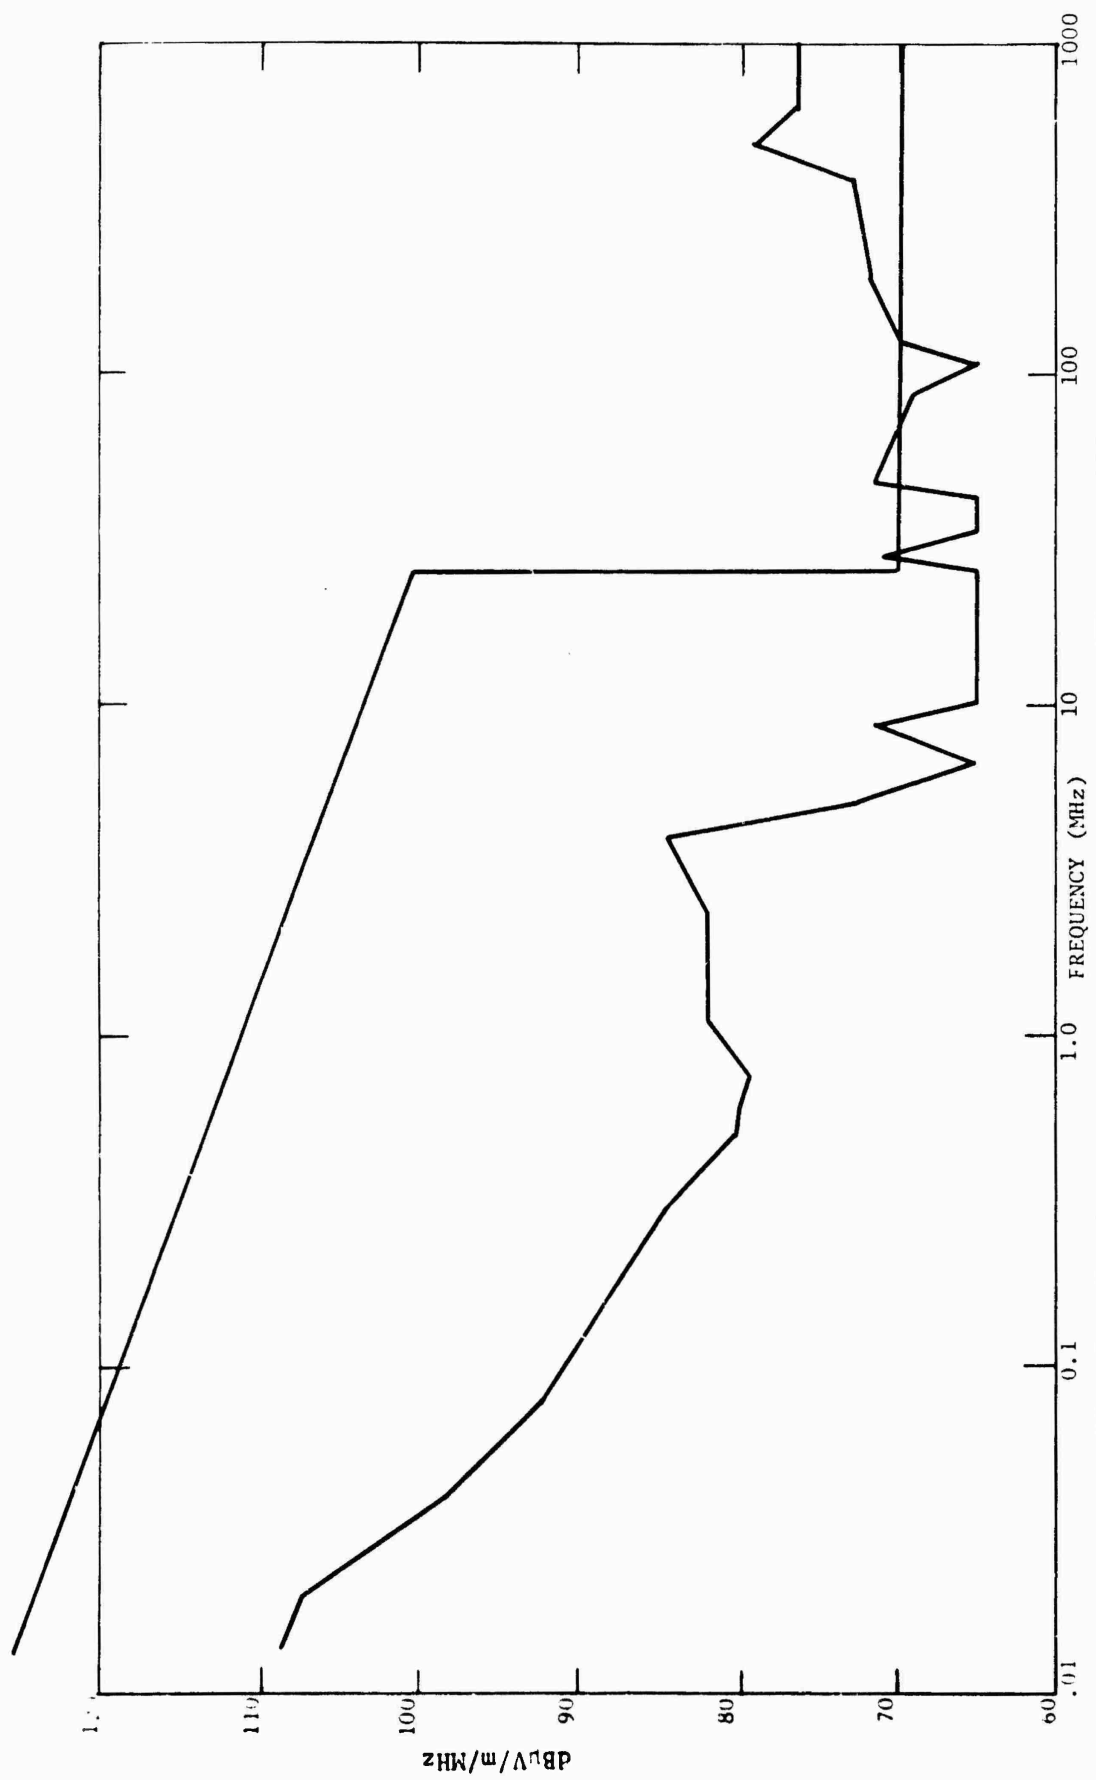
Radiated EMI. The radiated tests were performed on Test Sample B in exactly the same manner as Test Sample A, with very similar results. The results of this test have been summarized in Figure 22. Again the out-of-specification condition occurred at the high frequencies, due to ignition interference (see Figure 14). The source of the offending interference was again traced with the small loop as described for Generator A, with exactly the same results.

Figure 22. Broadband radiated EMI before suppression. GEN Set B, 400 Hz, 3 KW.

Required Suppression. The first attempt at suppressing the ignition interference was identical to that performed on Generator A. The points housing cover was removed and cleaned, the gasket was replaced and the unit was retested. It was discovered, however, that this suppression was not enough. The front of the engine still demonstrated considerable radiated interference when searched with the test loop.

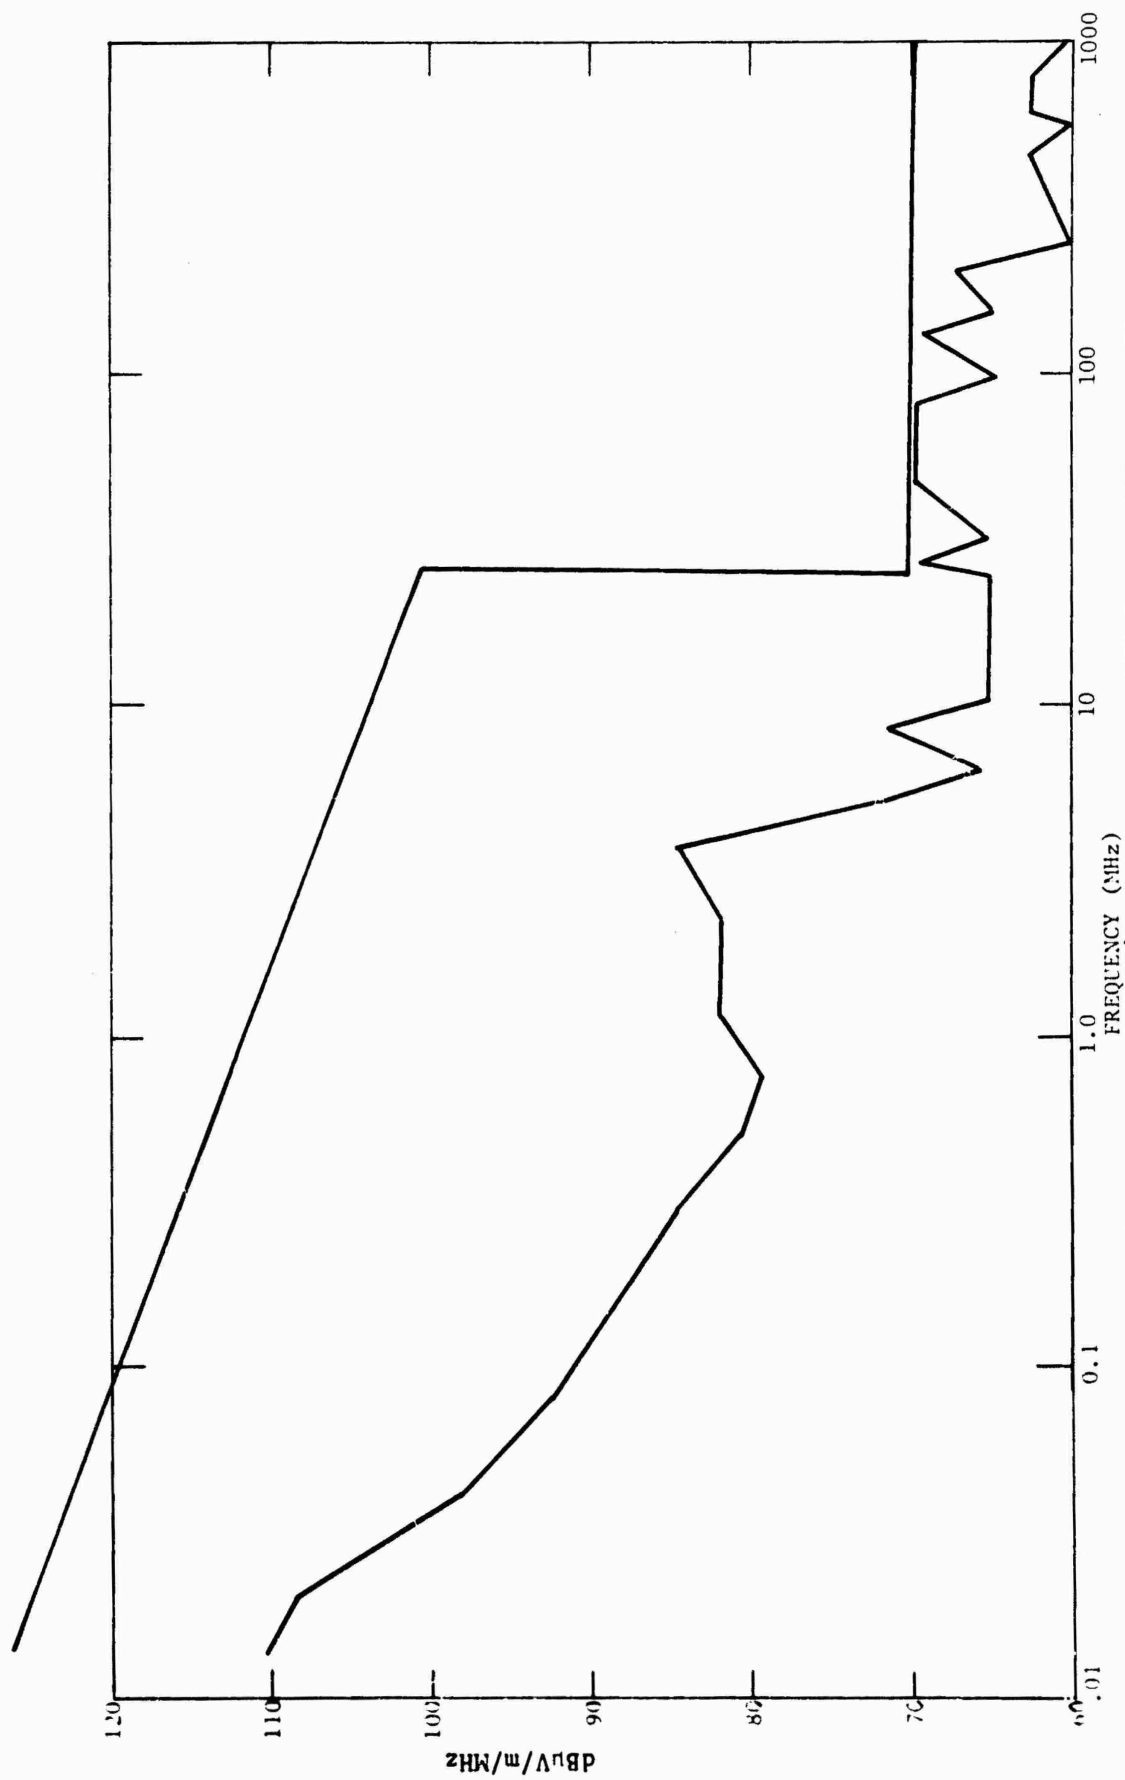
Retesting. Test Sample B was then retested completely for radiated EMI with the results summarized in Figure 25. Conformance with the limits of MIL-STD-461 was then assured. As a precaution, Generator A was retrofitted with a pulley hole gasket in the same manner although it had passed the specification limit.

Figure 25. Broadband radiated EMI after suppression. GEN Set B, 400 Hz, 3 KW.

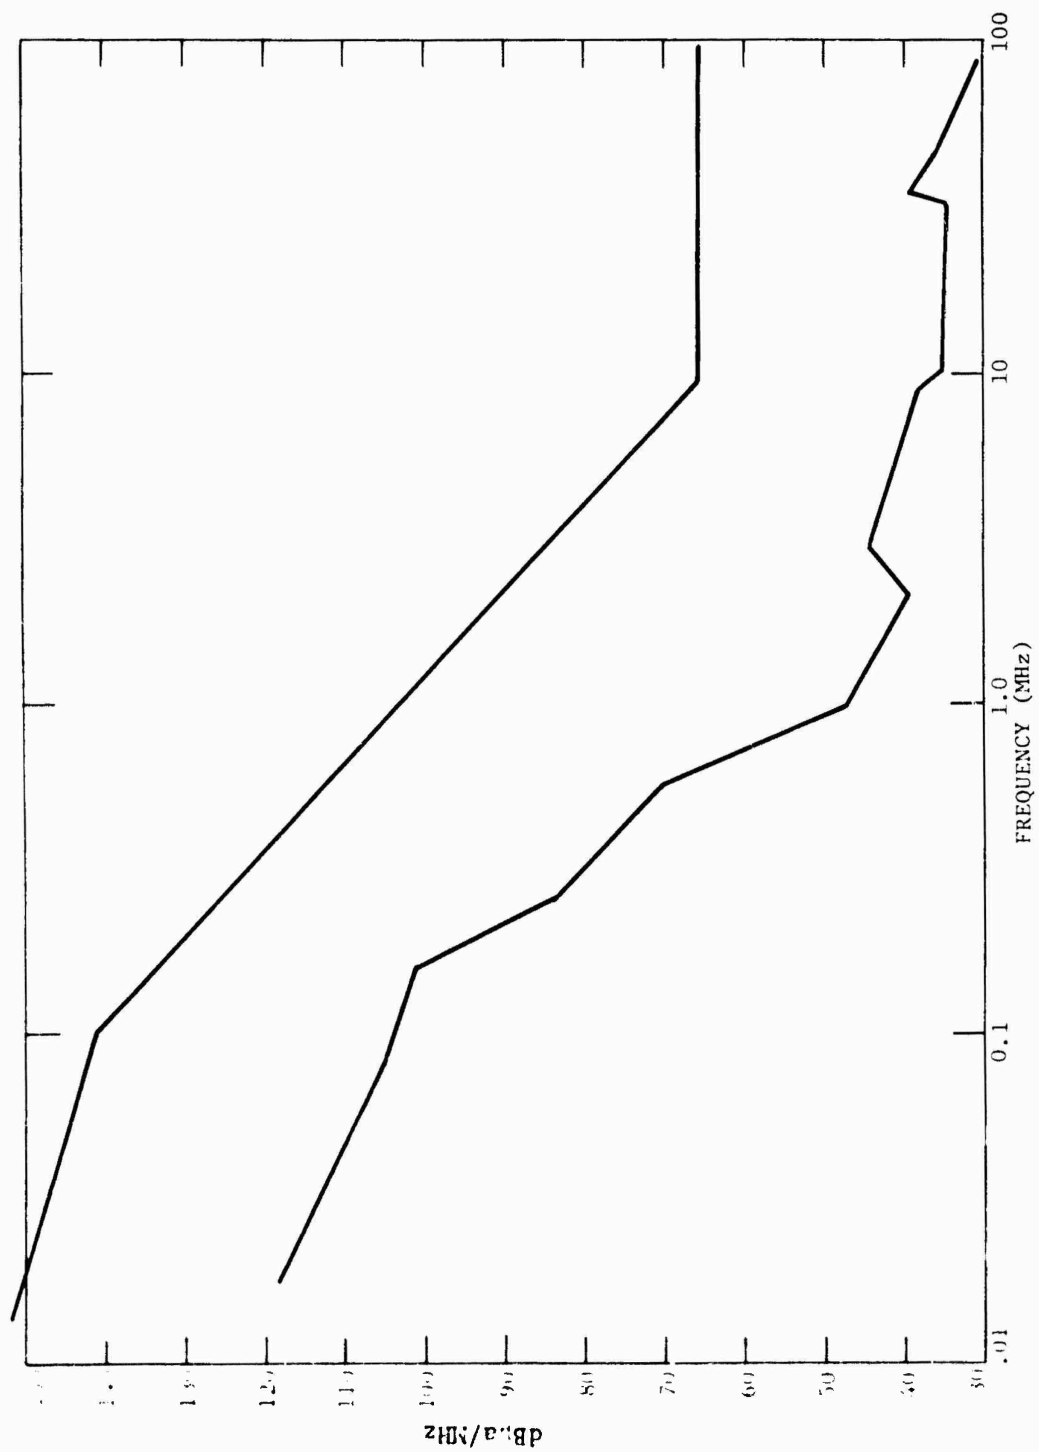
Conducted EMI. The conducted EMI test on Test Sample C was performed while the unit was operating in the 120V, 3 $\phi$ Y mode. The results are summarized in Figure 26. Again, the neutral lead demonstrated the highest EMI level. The conducted interference was within the specification limits. The generator output lugs were marked the same as the 400 Hz units had been, however, the 60 Hz units were equipped with additional parallel outputs in the form of a standard 3 prong plug. See Figure 27. The existing filtering which consists of a .1 $\mu$ f capacitor from each phase including neutral to chassis proved adequate in meeting the suppression required.

Figure 26. Broadband conducted EMI. No suppression required. GEN Set C, 60 Hz, 3 KW, 120V, 3 $\phi$ Y.

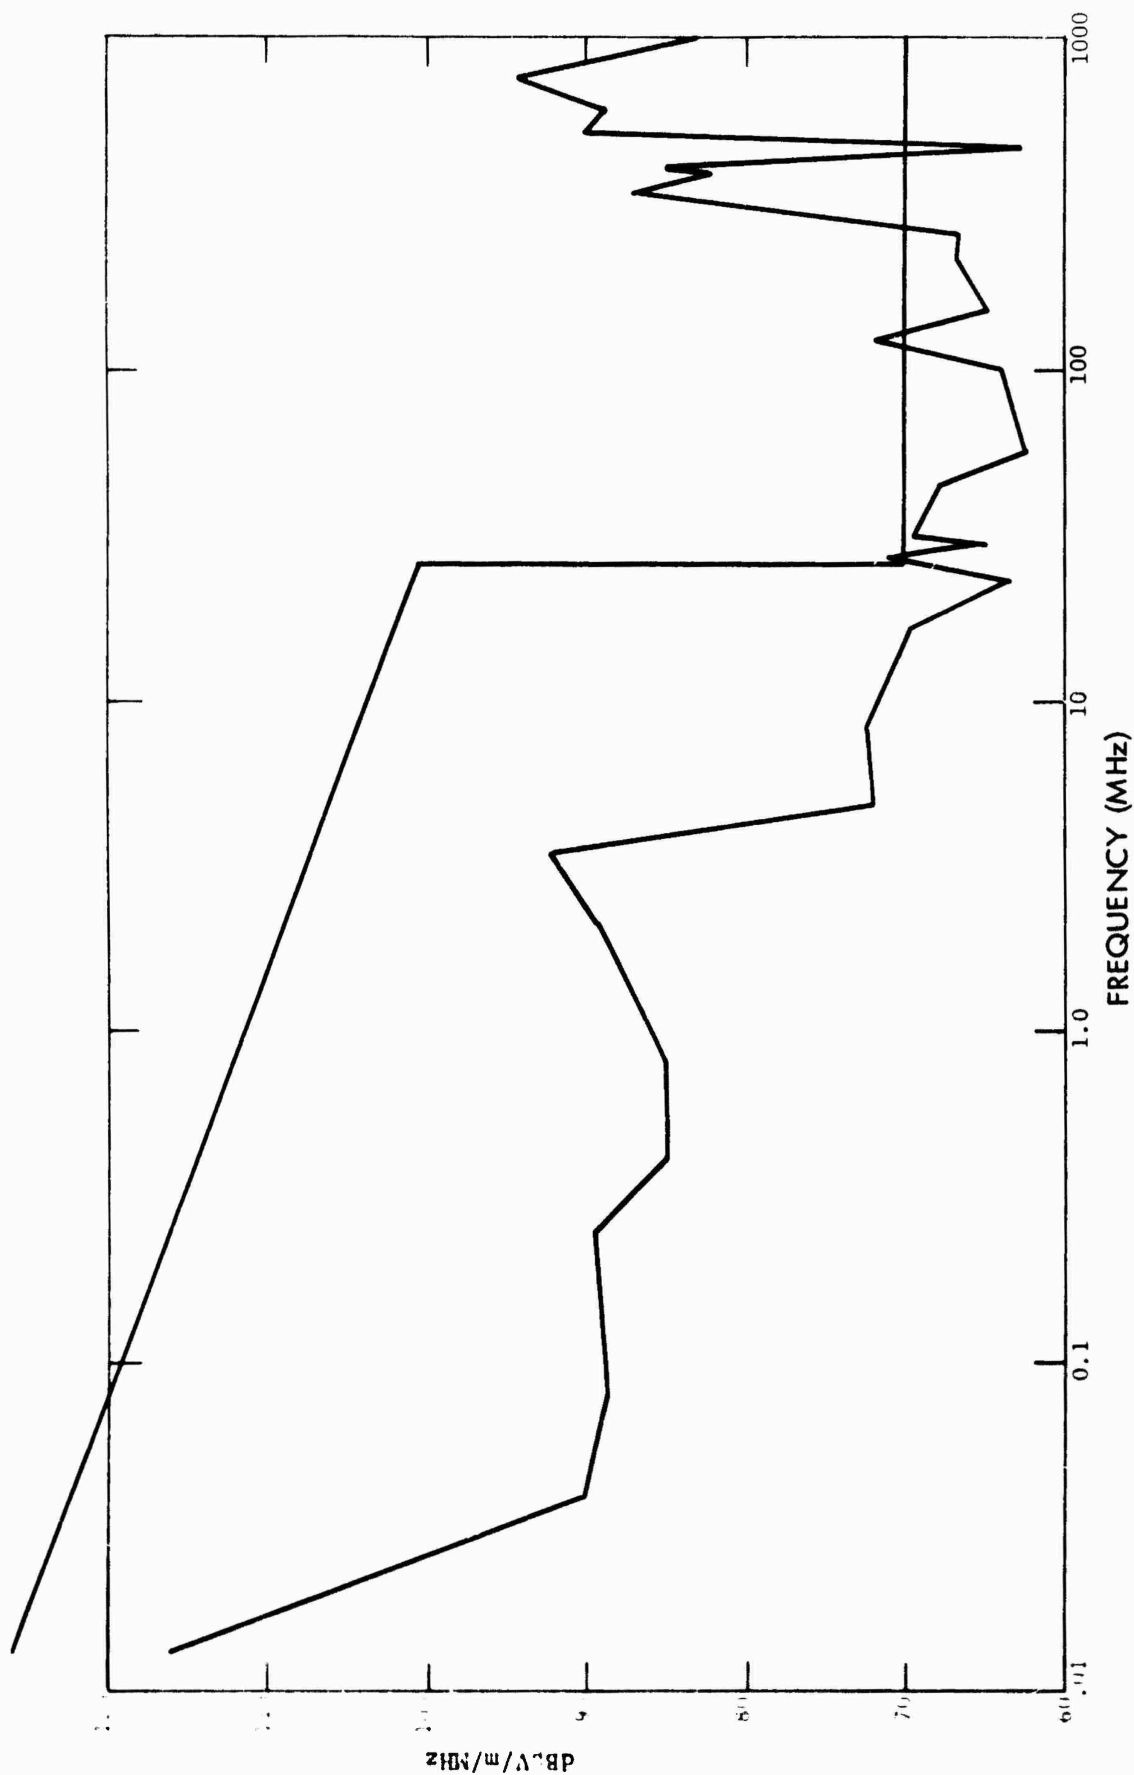
Radiated EMI. The radiated EMI test proceeded in the same manner as described for the previous generators. Again, the engine demonstrated the out-of-specification condition at the higher frequencies, as summarized in Figure 28.

Figure 28. Broadband radiated EMI before suppression. GEN Set C, 60 Hz, 3 KW.

Required Suppression. Both the points housing cover and the coil housing cover were removed and cleaned. A new RFI gasket was installed on the points housing cover and filler gasket was installed in the shaft hole of the coil housing. Both covers were then replaced for verification testing.
