Technical Note N-1162

ELECTROMAGNETIC INTERFERENCE (EMI) STUDY OF SIX TYPICAL ARMY  
PORTABLE 3 KW ENGINE-GENERATOR SETS

May 1971

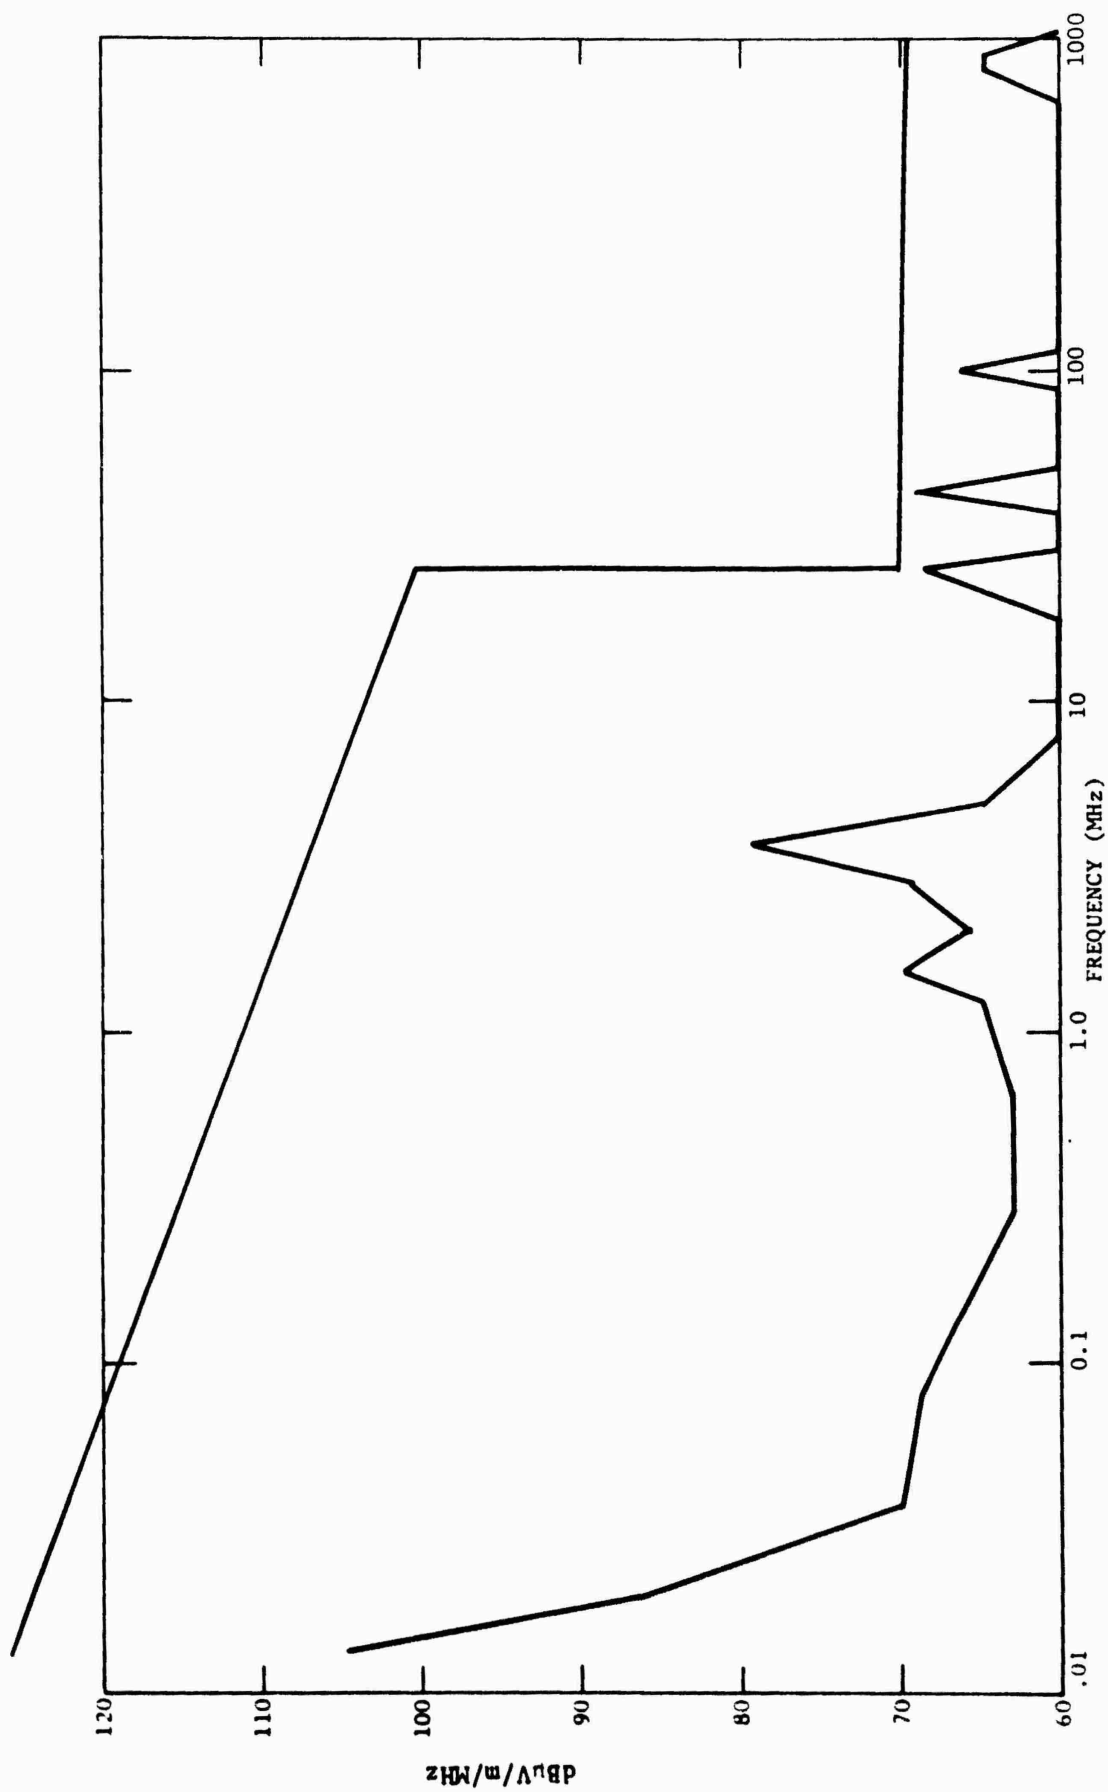
Retesting. The radiated EMI was remeasured on the suppressed Test Sample C with the results summarized in Figure 29. The suppression proved to be adequate.

Figure 29. Broadband radiated EMI after suppression. GEN Set C, 60 Hz, 3 KW.

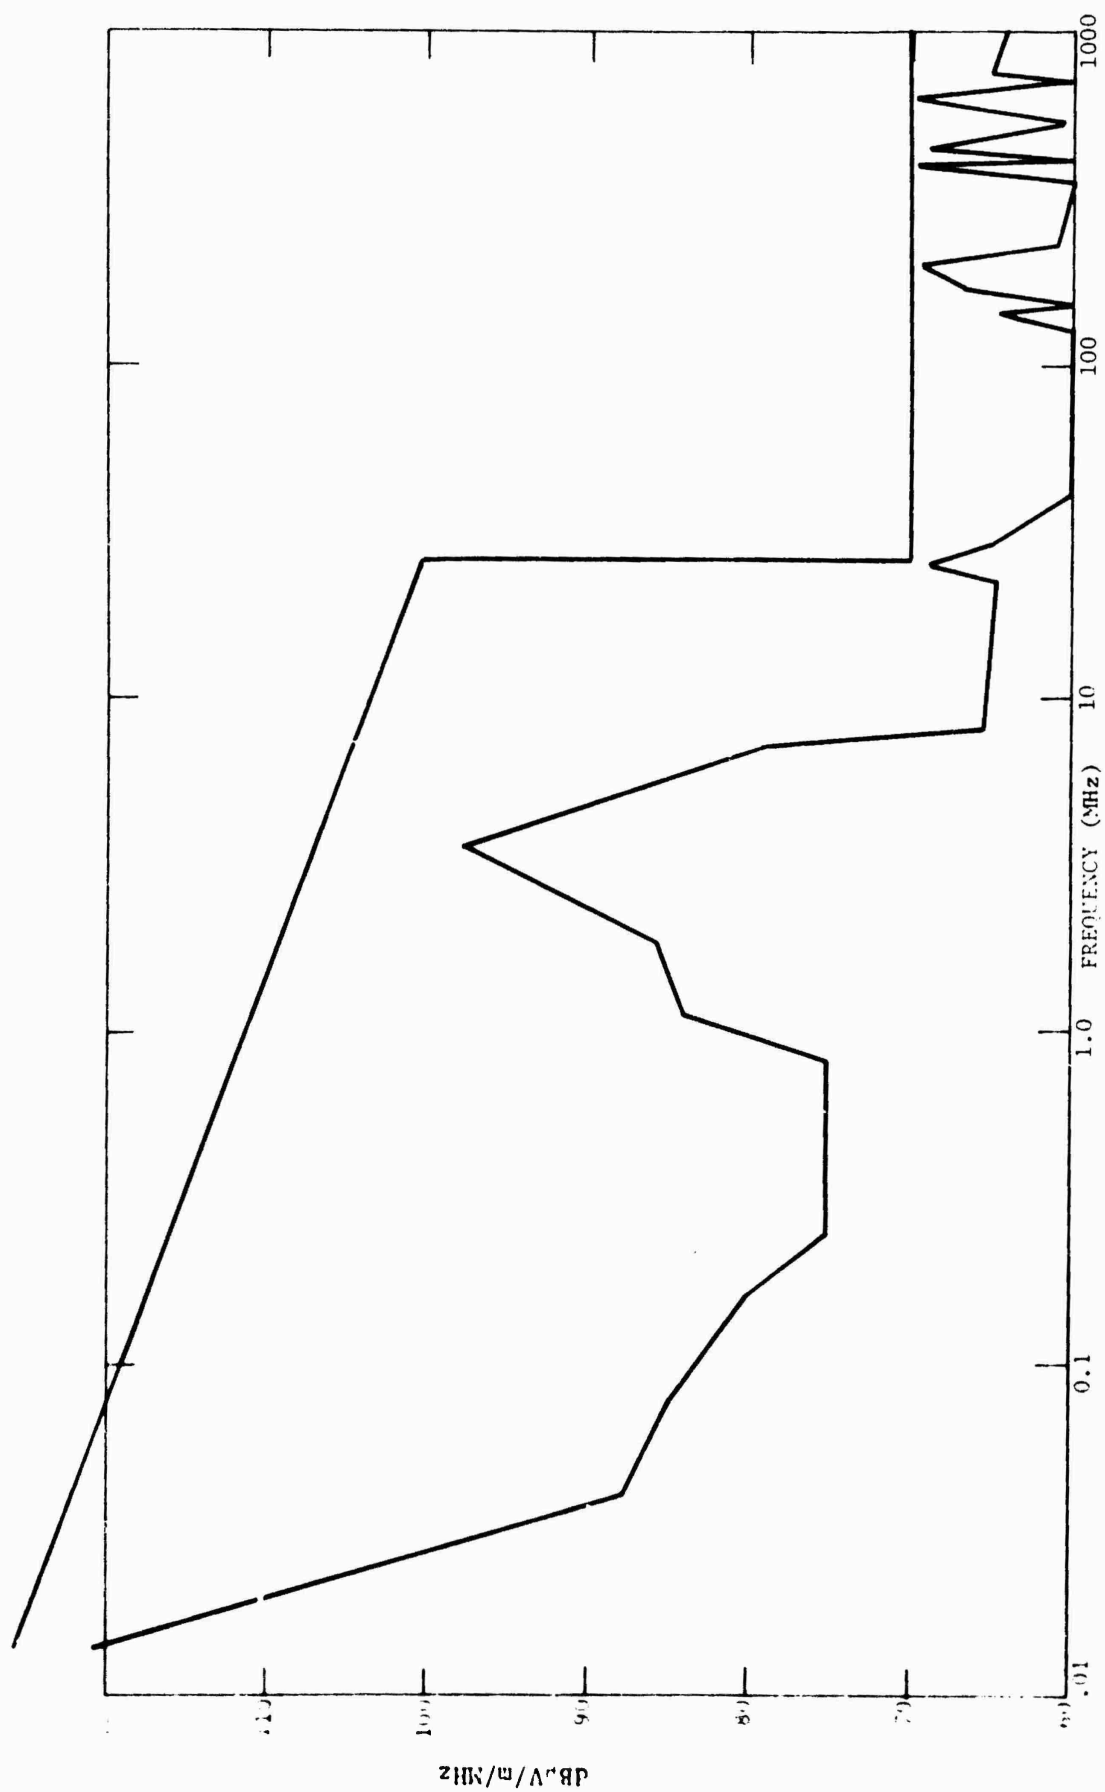
Retesting. The results of retesting Test Sample E are summarized in Figure 38. The suppression technique was effective.

Figure 38. Broadband radiated EMI after suppression. GEN Set E, 28V DC, 3 KW.

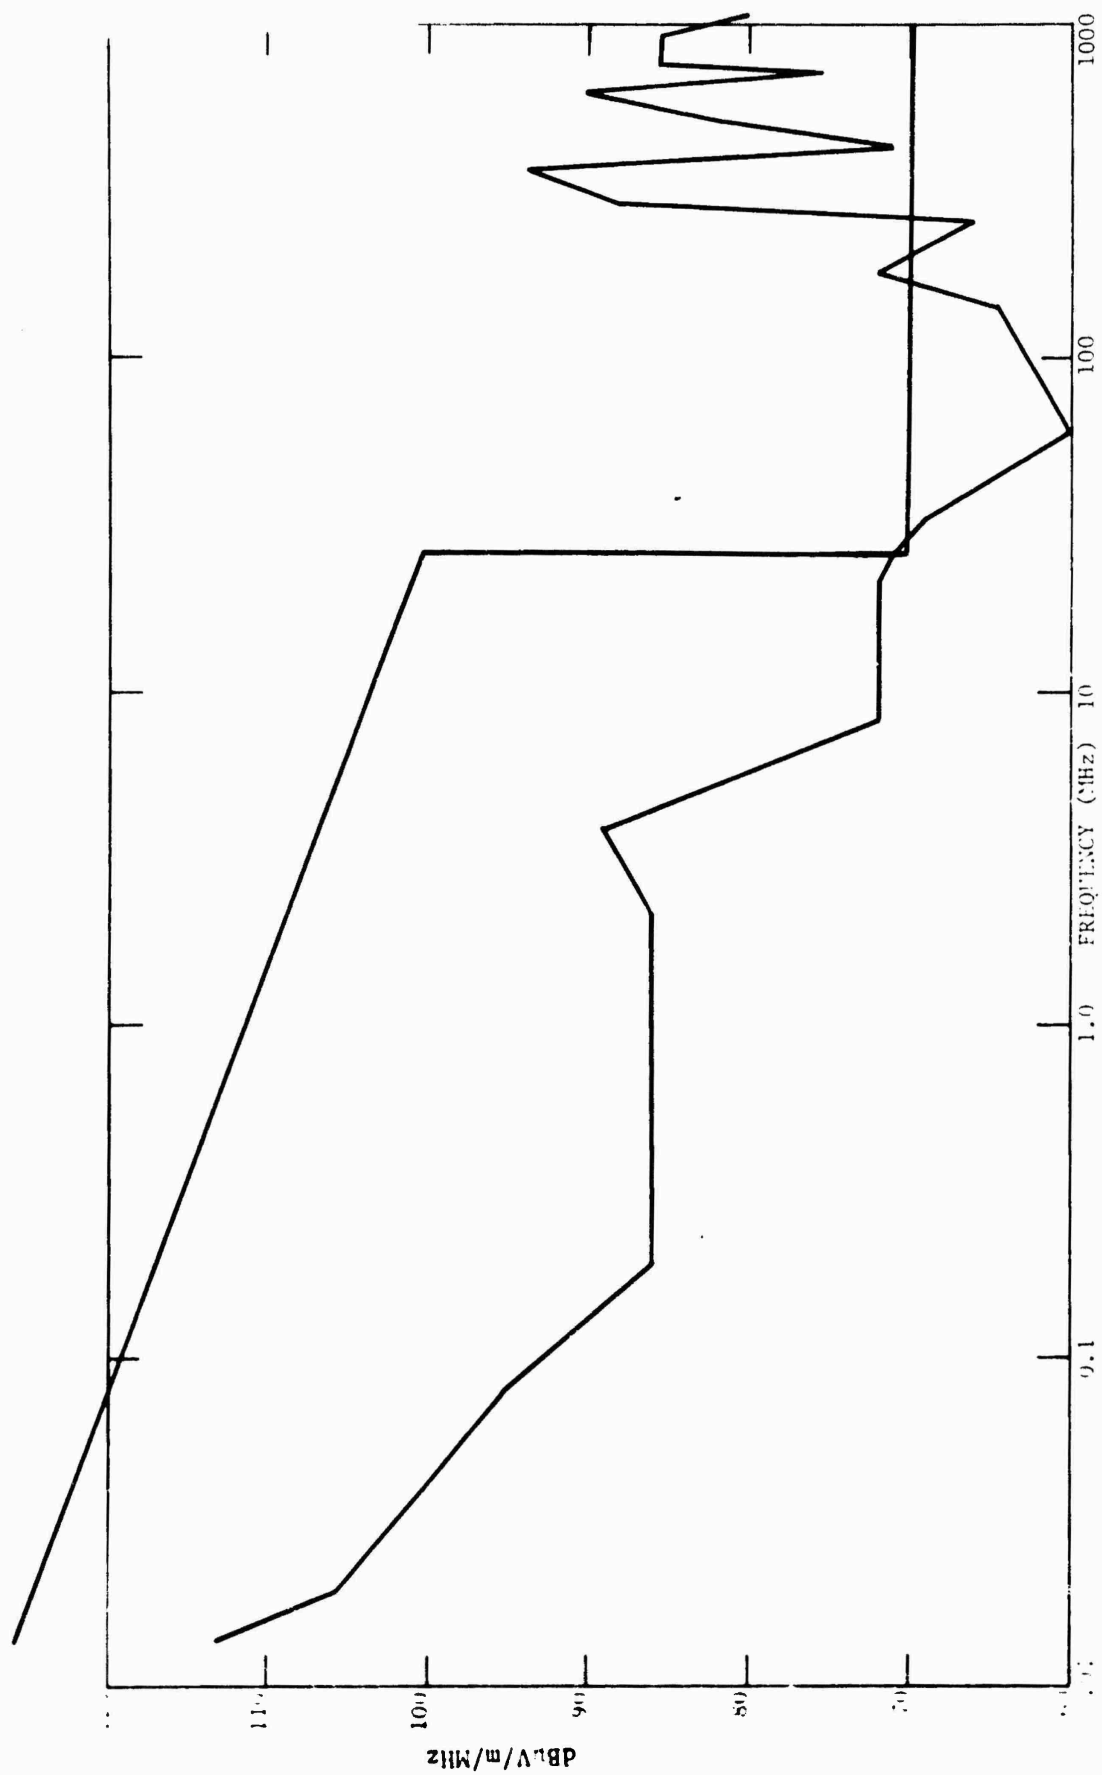
Radiated EMI. The radiated EMI test followed the same procedure as before with about the same results. The engine demonstrated an out-of-specification condition at the very high frequencies. The results are summarized in Figure 40.

Figure 40. Broadband radiated EMI before suppression. GEN Set F, 28V DC, 3 KW.

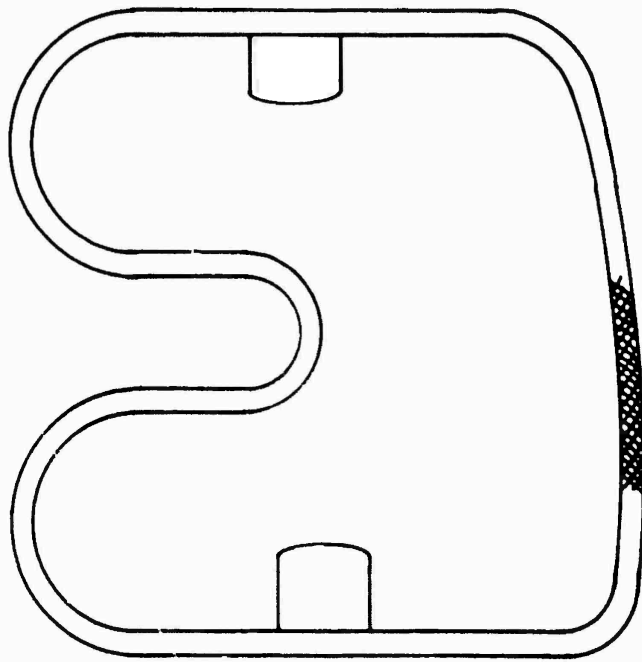
Material: Wire mesh with adhesive covered rubber tabs. 1/8" square cross-section.

Figure 42. Recommended EMI gasket for contact points housing cover.

- a. Replace the existing gasket. (Identified in TM-5-2805-203-24P<sup>2</sup> as item 1 in Figure 14) U.S. Army Technical Manual with a new gasket made of 1/8-inch cross section wire mesh material.<sup>1</sup> Glue should not be applied to the mating surfaces. The new gasket can be procured with an adhesive tab attached to the edge so that the gasket may be attached to the cover plate. A sketch of this new gasket is shown in Figure 42.

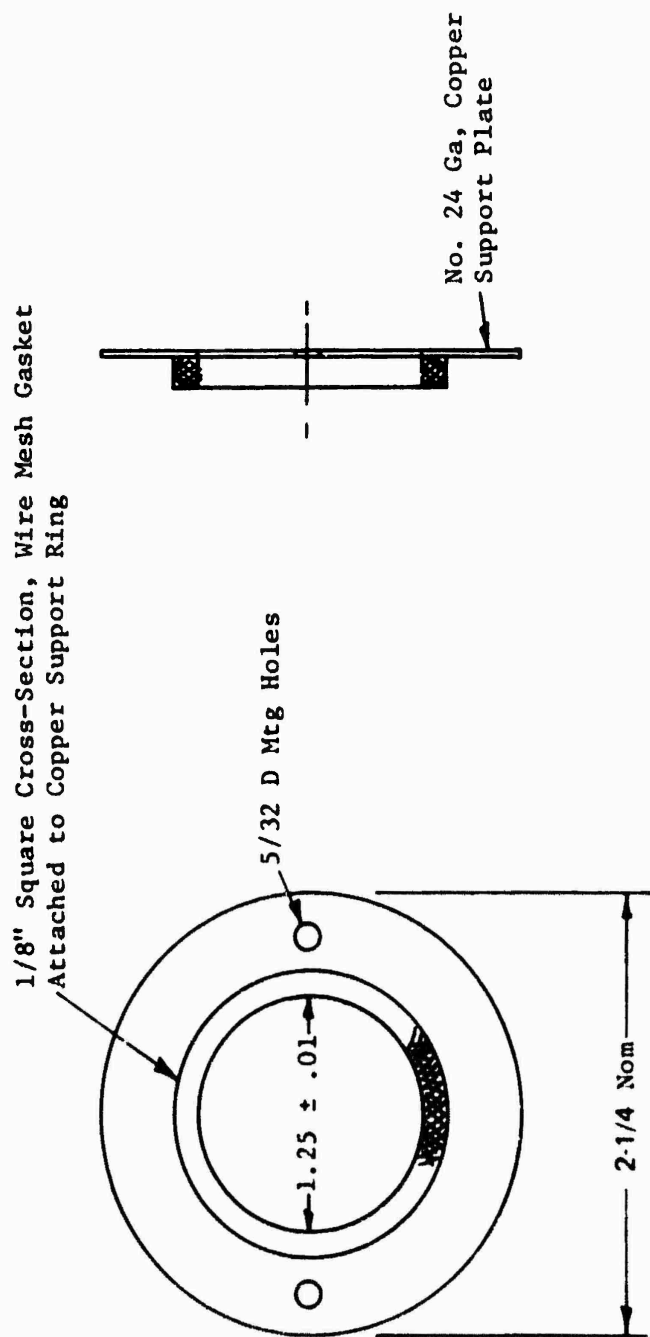
Figure 43. Recommended EMI gasket for coil housing cover, pulley shaft hole.
