Report NATF-EN-1114

EVALUATION OF LOW-MODULUS NYLON AND ENERGY-ABSORBING
STAINLESS-STEEL DECK PENDANTS USED WITH
THE E-28 ARRESTING-GEAR SYSTEM
(24 August 1970 through 24 June 1971)

Final Report
30 September 1971

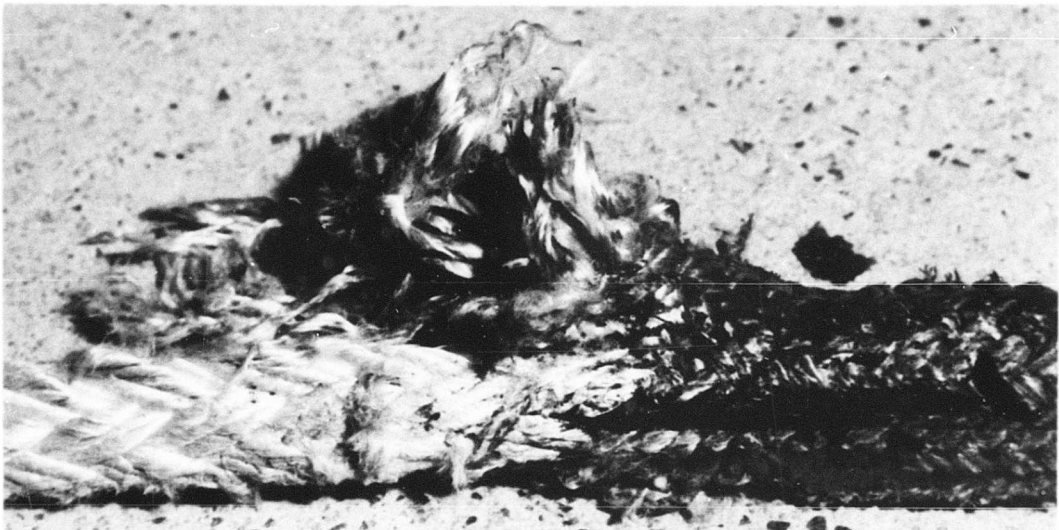
AAE PENDANT NO. 1 FOLLOWING 11 ARRESTMENTS AT 129 TO 171 KNOTS

AAE PENDANT NO. 3 FOLLOWING 7 ARRESTMENTS AT 171 TO 206 KNOTS

AAE PENDANT NO. 5 FOLLOWING 3 ARRESTMENTS AT 214, 219, AND 223 KNOTS
(ALSO SEE FIGURE 7)

Figure 5 - All American Engineering Company Low-Modulus Nylon Deck Pendant
(25,000-Pound Deadload, E-28 Arresting-Gear System)

<u>Pendant No.</u>	<u>Number of Arrests</u>	<u>Engaging-Speed Range (Kn)</u>	<u>Reason for Removal</u>	<u>Refer to Figure</u>
AAE NYLON PENDANTS				
1	11	129 - 171	Abrasion	5
2	3	181 - 182	Spliced eye damaged by steel pendant connector	6
3	7	171 - 206	Nylon frayed in hook impact area	5
4	4	201 - 214	Abrasion	*
5	3	214 - 223	Outer weave of pendant separated; inner weave held for arrestment	5 & 7
6	2	223 - 226	Abrasion	*
7	2	230 - 232	Abrasion	*
8†	6	135 - 160	Pendant still usable: program complete	*
BLISS NYLON PENDANTS				
1	11	131 - 181	Abrasion	8
2	6	189 - 204	Outer weave damaged in hook impact area	8
3	4	207 - 219	Abrasion	*
4	1	233	Spliced eye damaged when port tape failed	*
5	3	226 - 231	Abrasion	*
6†	6	114 - 162	Pendant still usable: program complete	*
Poured Terminals‡	6	149 - 170	Pendant still usable: program complete	*

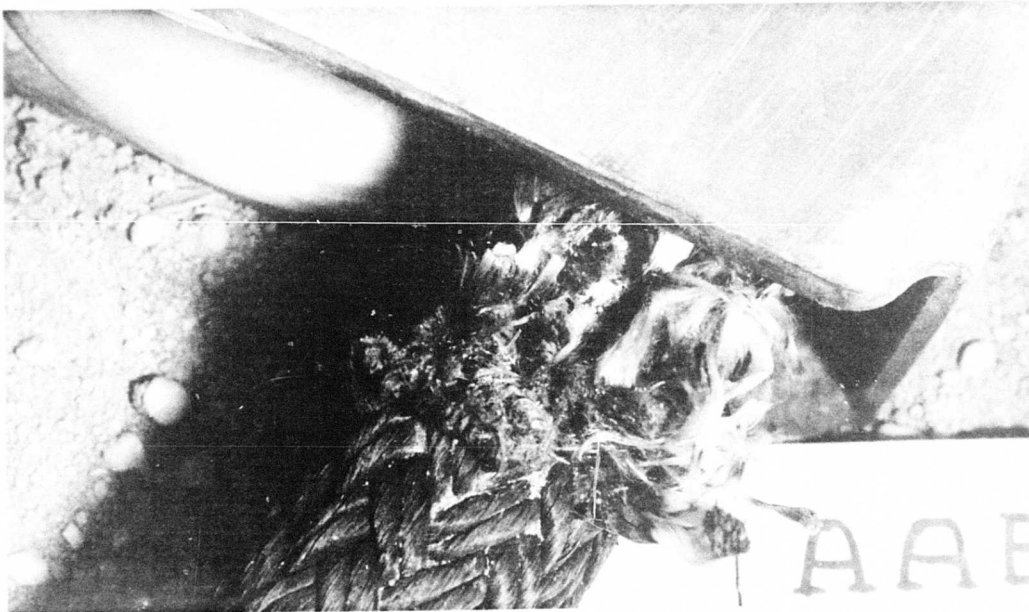
Figure 6 - All American Engineering Company Low-Modulus Nylon Deck Pendant No. 2 Following 3 Arrestments at 181, 182, and 182 Knots (25,000-Pound Deadload, E-28 Arresting-Gear System)

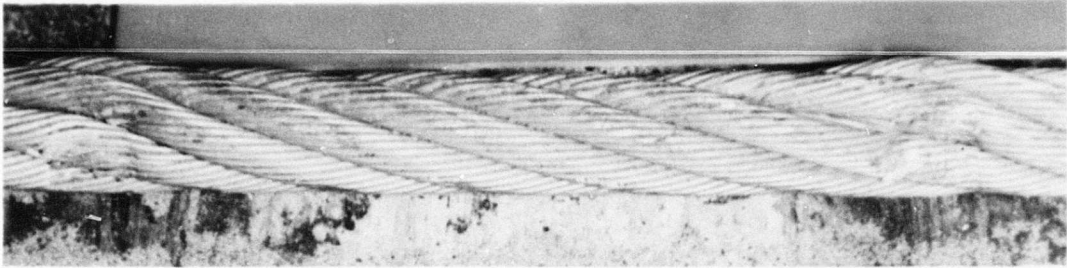
Figure 14 - Results of Simulated Aircraft Main-Wheel-Rim Rollovers of American Chain and Cable Company Energy-Absorbing Stainless-Steel Deck Pendants No. 3, 7, and 11 at Speeds of 99, 102, and 102 Knots Respectively

Manufac- turer	Pendant		Main- Wheel-Rim Rollover Speed (Kn)	Apparent Damage	Refer to Figure
	Type	No.			
	Standard Steel	1*	107	Strands flattened where contacted by rim	11
	"	1*	103	" " " "	"
	"	1*	98	" " " "	"
AAE	Nylon	3	101	Outer weave partially cut	12
"	"	4	101	" " " "	"
"	"	7	101	Outer weave completely cut	"
Bliss	"	2	100	Outer weave completely cut	13
"	"	5	102	Outer weave partially cut	"
"	"	6	98	Outer weave completely cut	"
ACCO	Stainless Steel	3	99	Strands flattened where contacted by rim	14
"	"	7	102	" " " "	"
"	"	11	102	" " " "	"

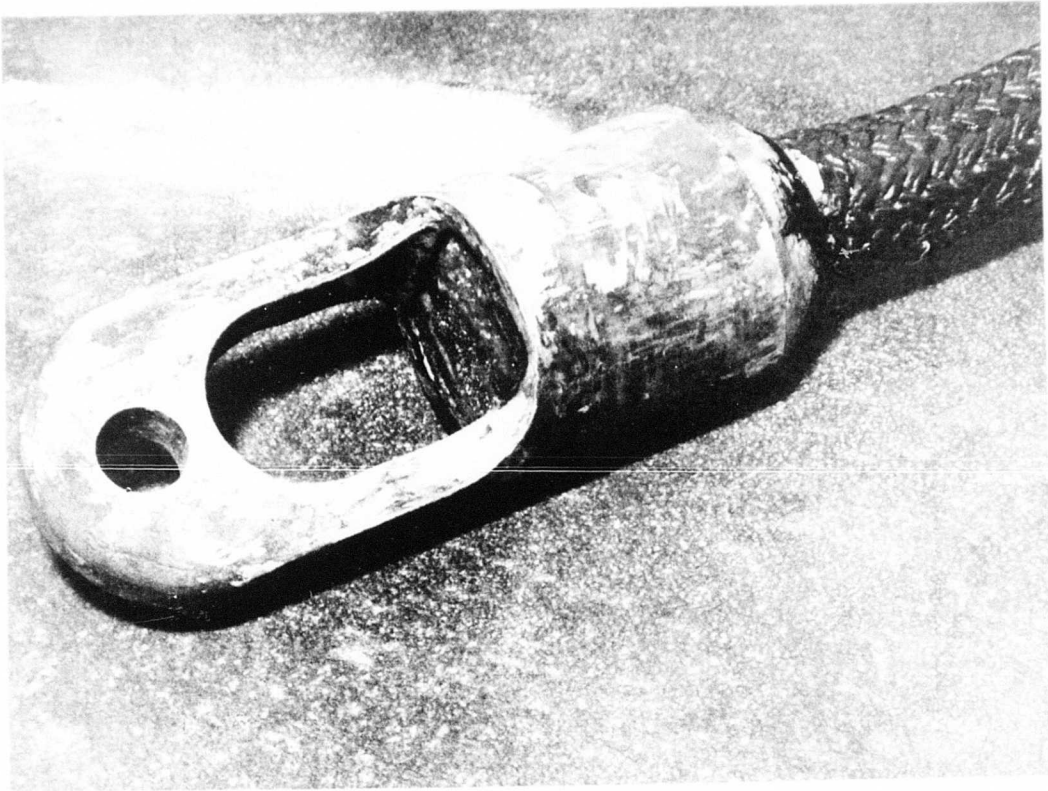
**Figure 15 - E. W. Bliss Company Low-Modulus Nylon Deck Pendant
With Poured Plastic Terminal for Use With Standard
E-28 Tape Connectors**

b. After the sixth arrestment, inspection of the terminals revealed that they were in excellent condition with no apparent signs of cracking of the plastic.
