Technical Note N-1258

OSDOC II ENGINEERING TESTS - CORONADO

NAVAL CIVIL ENGINEERING LABORATORY  
Port Hueneme, California 93043

ABSTRACT

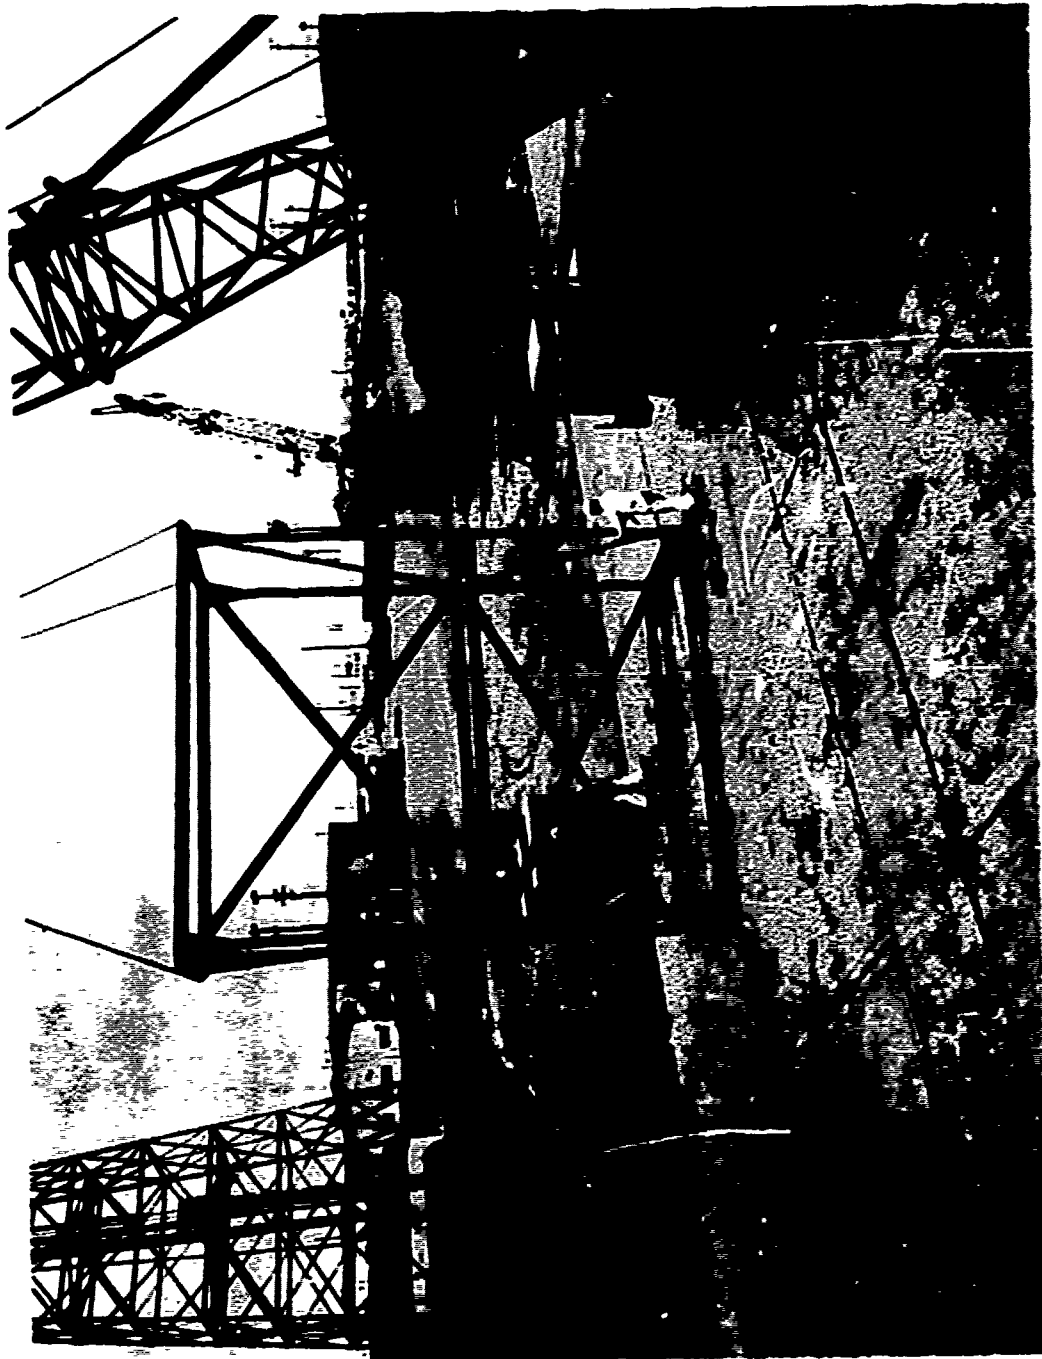
Figure D.1. Container cell frame ready for installation on IST.

The container cell served its intended function of simulating cell operations on a containership. The cell extensions apparently assisted the insertion of the spreader into the cell based on the shorter in and out time when the extensions were used; however, the crane operator had gained considerable experience by this time. A good comparison of the performance of the extensions would have been to remove the containers from the cell without the extensions and under similar conditions; however, existing circumstances at sea did not permit such a test. The crane operator commented that the cell extensions were a significant aid in placement of the spreader. The tilting of the spreader bar while lowering it in the cell indicated that the longitudinal clearance of  $1\frac{1}{2}$  inches may have been excessive. Possibly, one inch all around would be better.

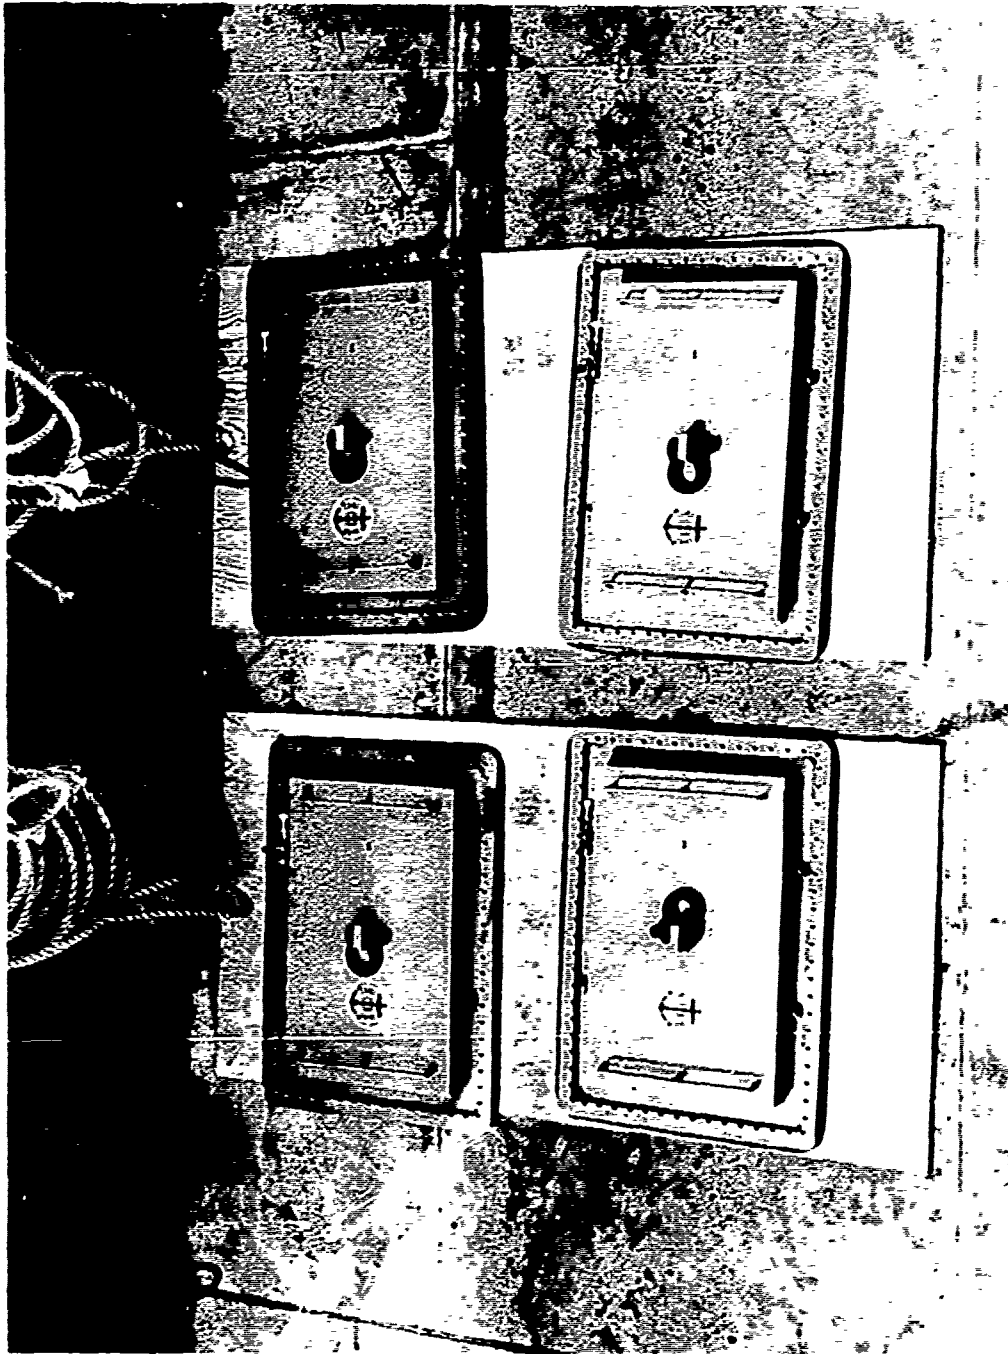
Figure D.6. 3'x4' vacuum pads intended for tying barge to LST.

The pads, 20,000-pound capacity, were obtained from the Thompson Vacuum Company, Sarasota, Florida. Each pad was composed of a steel plate, 32 inches by 46 inches, with a heavy neoprene seal bolted around the perimeter. Each pad weighed 110 pounds. The vacuum supply was provided by a 1½ horsepower, 115 volt, single phase motor driving a vacuum pump connected to a 21 cubic foot tank. A manifold connected to the tank held five control valves which provided individual vacuum control to each pad.

The plan was to use five of the 20,000-pound capacity units to hold the 6x15 barge. But on-site changes in operational procedures coupled with electrical problems associated with the ship's power supply precluded testing the vacuum pad concept. The units are pictured in Figures D.5 and D.6.
