WADC-TR-72-314  
FINAL REPORT  
DECEMBER 1972

RELIABILITY OF LINEAR INTEGRATED CIRCUITS  
IN CERAMIC AND PLASTIC PACKAGES

General Electric Company

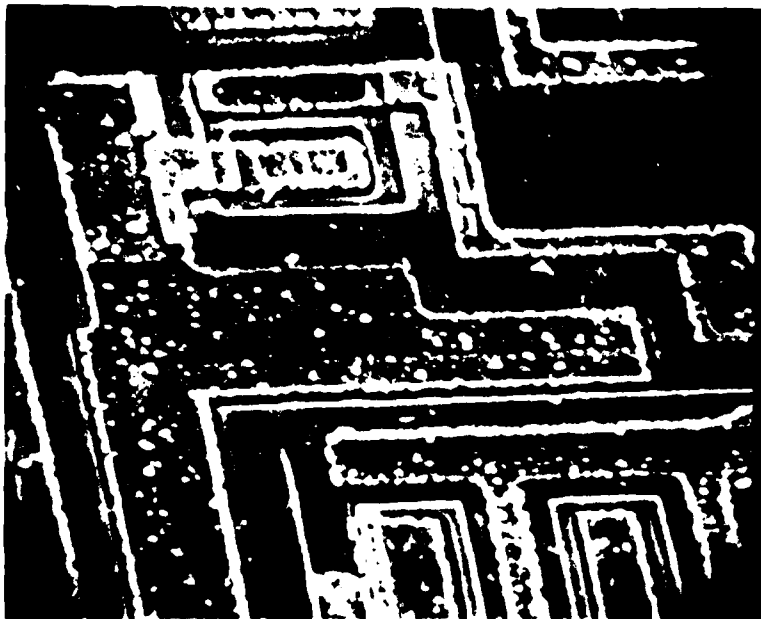
Figure 66 Device 4173 500X  
Crack in Collector Metalization, Q20

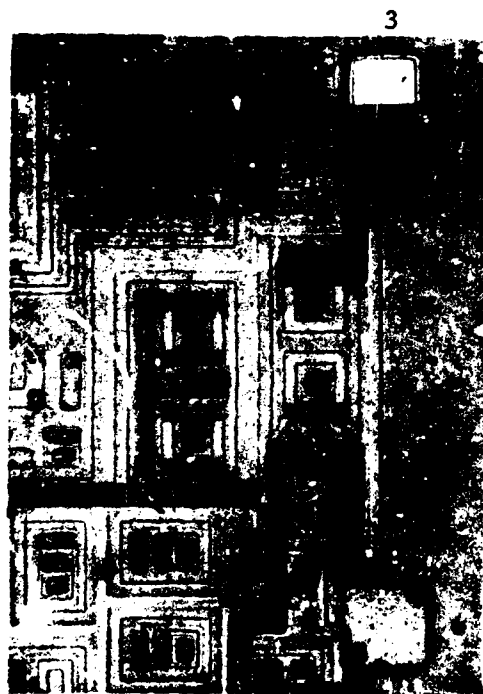
Figure 86

Gangbonds Etched off in Aqua Regia  
Note Defects in Pad 3 in D

Transistor with Base & Emitter  
Gangbonds in Place

Pad 3  
With all Metal Removed by Prolonged  
Oxidizing & Aqua Regia Etching  
Note Passivation Cracks Appearing  
in Areas Previously Covered by Metal

Pad 3  
With Cracks to Silicon  
Enlarged by Selective  
Silicon Etch
