UNCLASSIFIED

THIS PAGE IS UNCLASSIFIED

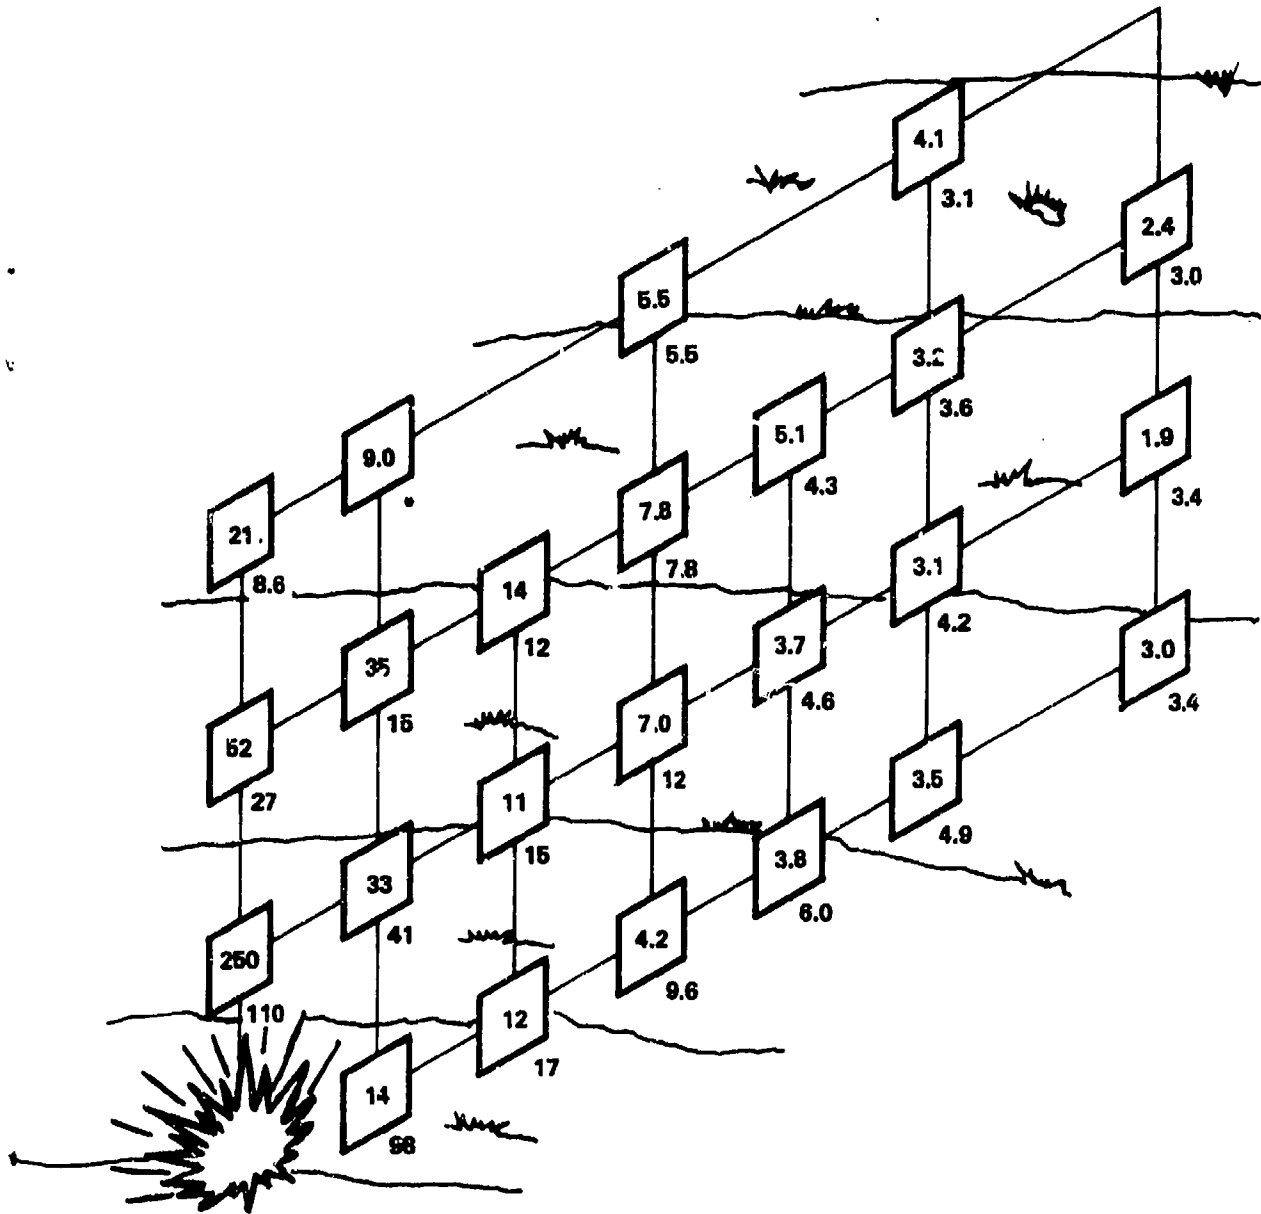
Figure 2. Peak dynamic overpressures (psig) for 1-pound TNT charges as measured in test Shots 4 through 9. Values represent the in-basket pressures (boxed figures) and the free air pressures.

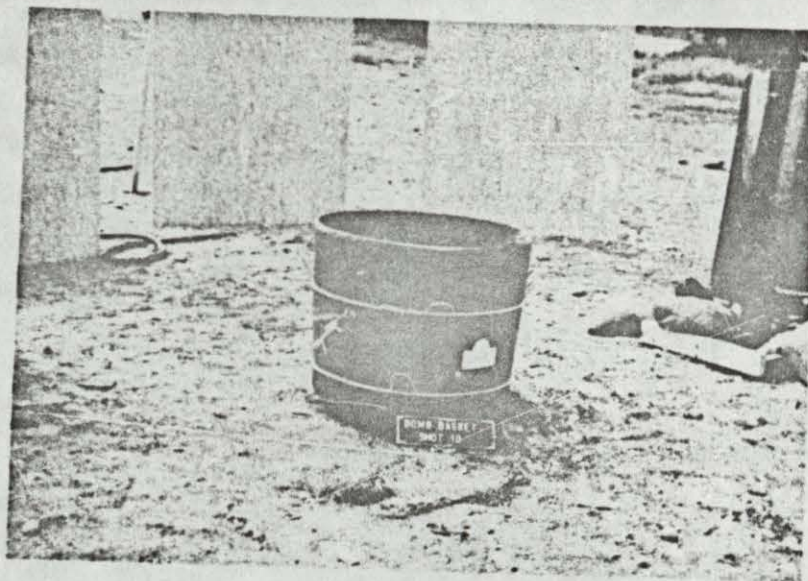
Figure C-12. Results from black powder-filled pipe bomb. Very little damage was done to the basket and no fragments penetrated the walls. Note the rubber rim in the background.

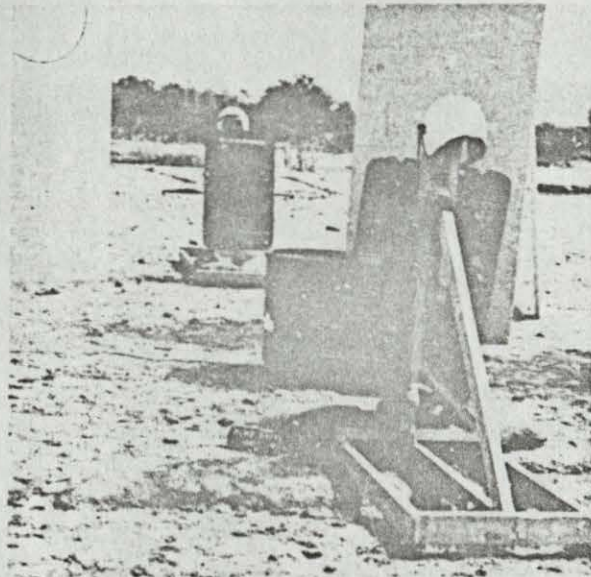
*Figure C-14. When testing fragmenting explosive devices, personnel helmets, body armor, and shields were placed on stands at distances of 6 and 12 feet from the basket.*

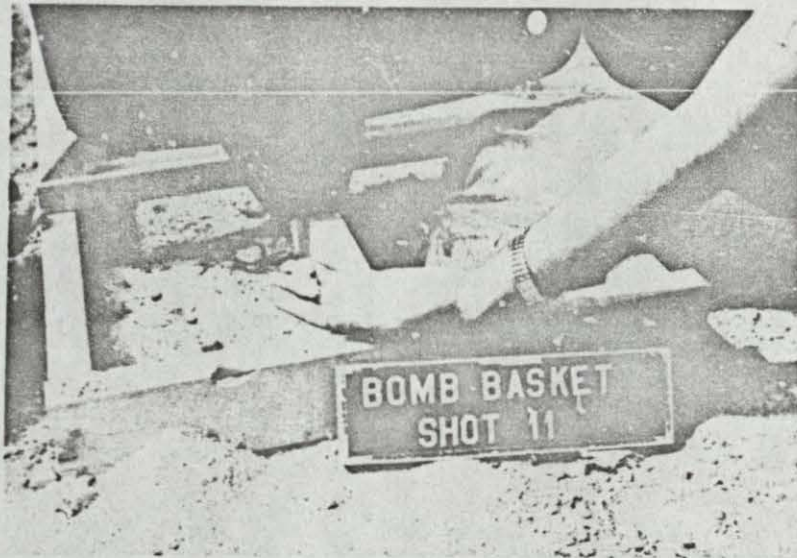
*Figure C-17. A portion of the metal end cap perforated the basket wall with sufficient velocity remaining to damage a sandbag and the wooden stand.*

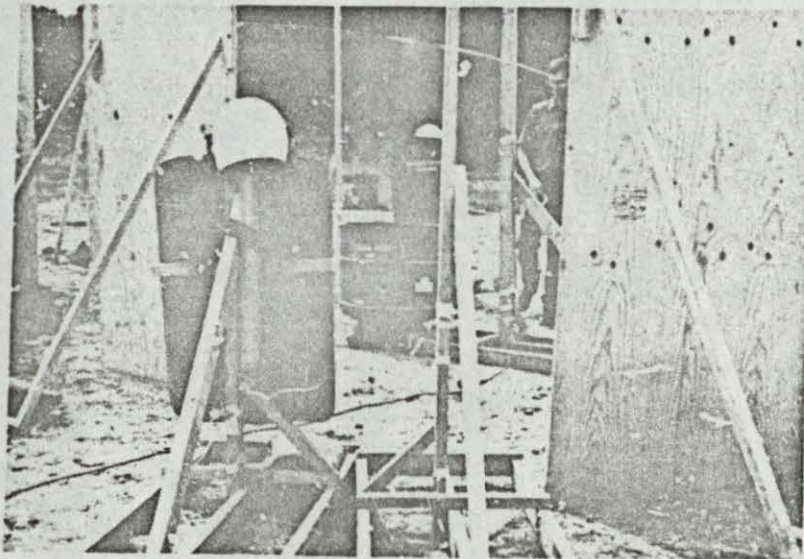
*Figure C-18. A dynamite-filled pipe bomb was used for Shot 12. Pressure gages were placed behind and near body armor at 6 and 12 feet.*

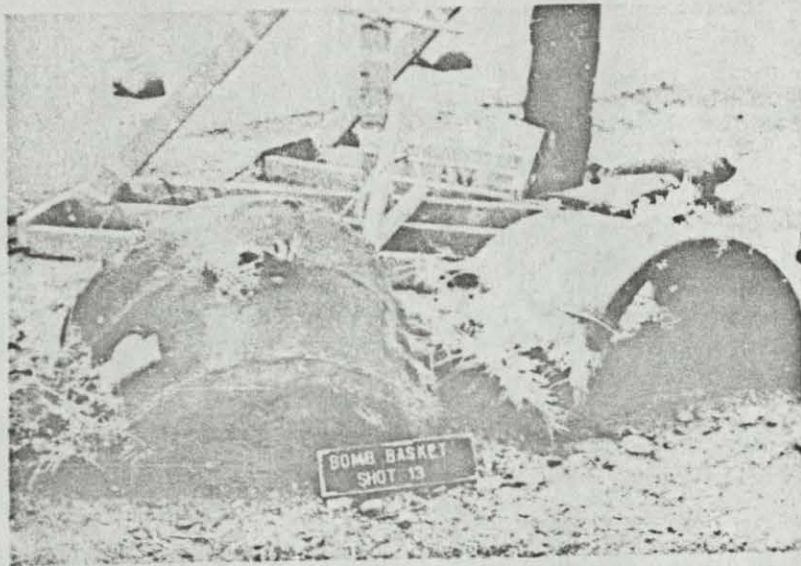
*Figure C-25. The exterior of the basket shows the exit holes made by the end caps. The wall condition indicates relatively little blast pressure damage, but extensive destruction from high velocity fragments.*

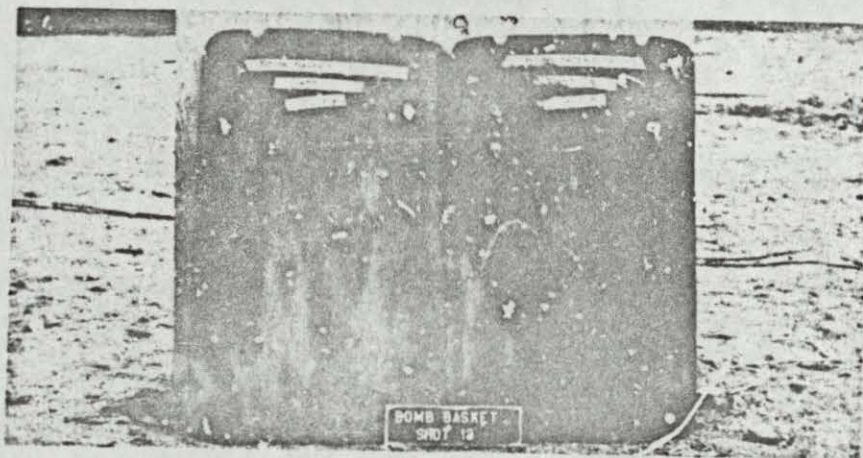
*Figure C-28. A side by side comparison of personnel shields from 12- and 6-foot distances shows that the fragmentation hazard decreases with distance.*

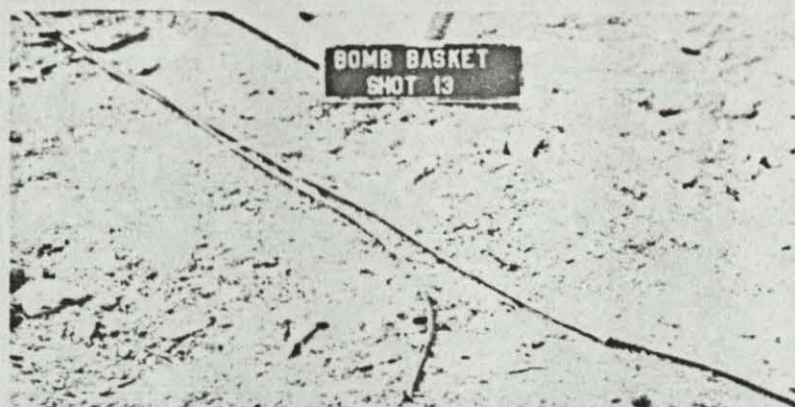
*Figure C-31. A single metal fragment from the composition C-4 pipe bomb cut two pressure gage cables.*

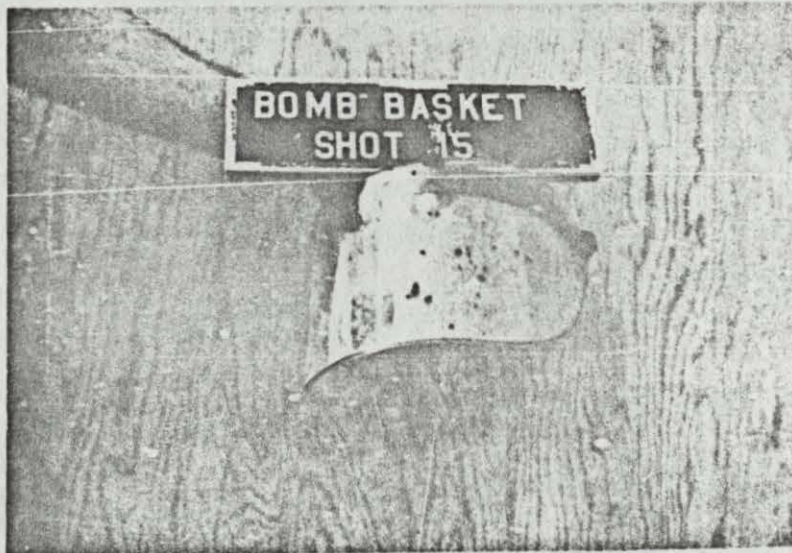
*Figure C-40. The face protector from 6 feet shows a splattering of carbon material from the dry cell battery. The perforation was caused by Shot 13.*

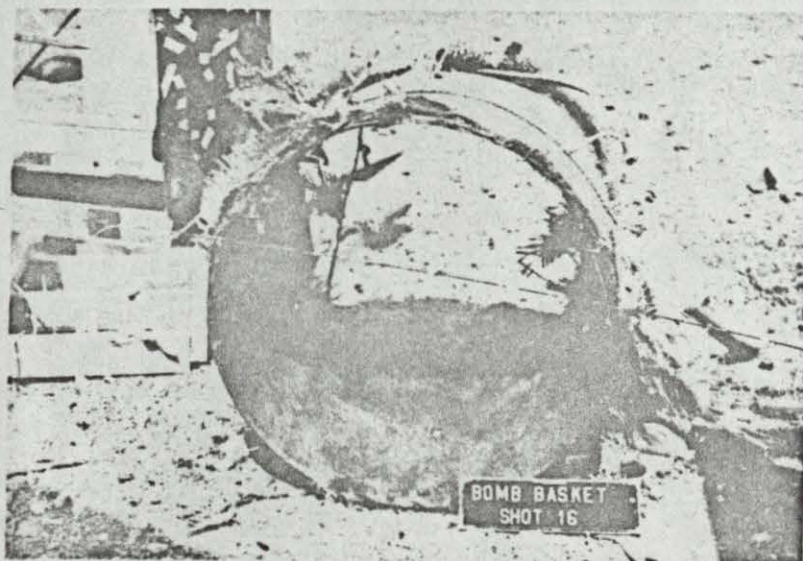
*Figure C-42. A view from the top of the basket after the detonation of the 10-stick IED shows little fragment damage.*

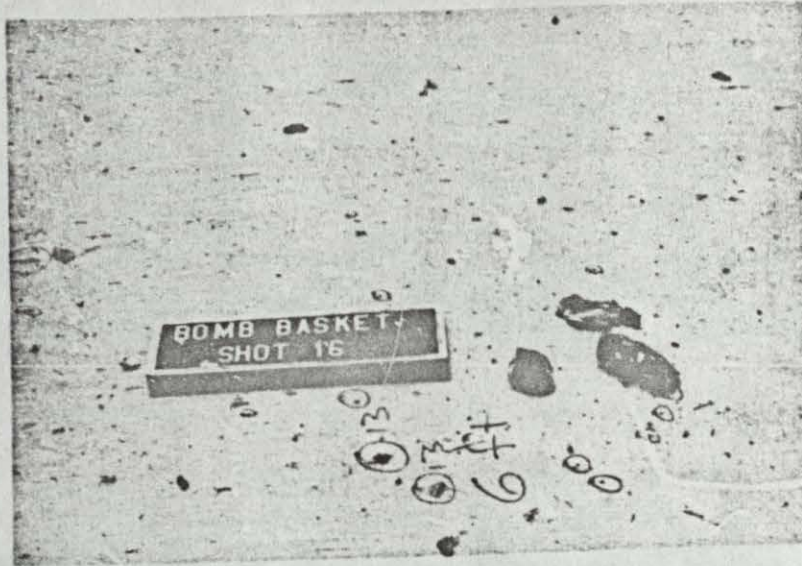
Figure C-45. Metal components from the alarm clock presented a fragmentation hazard.

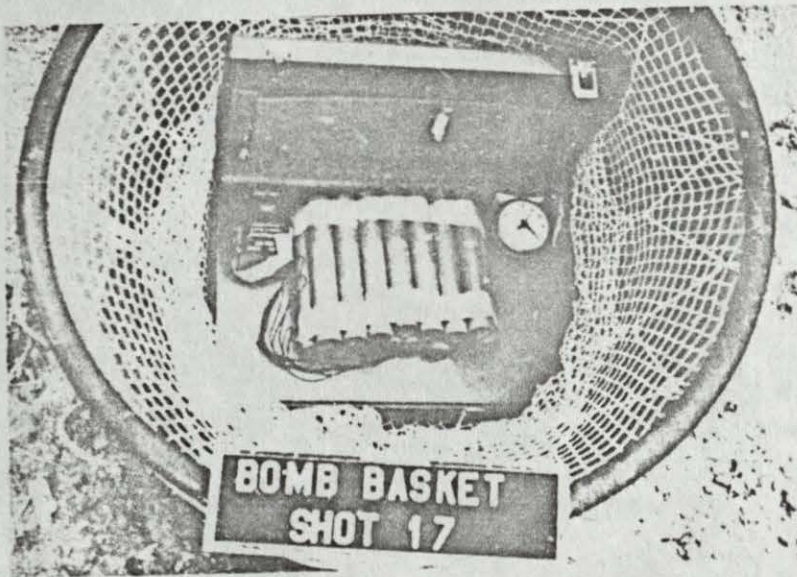
Figure C-46. A 15-stick IED was prepared for Shot 17.

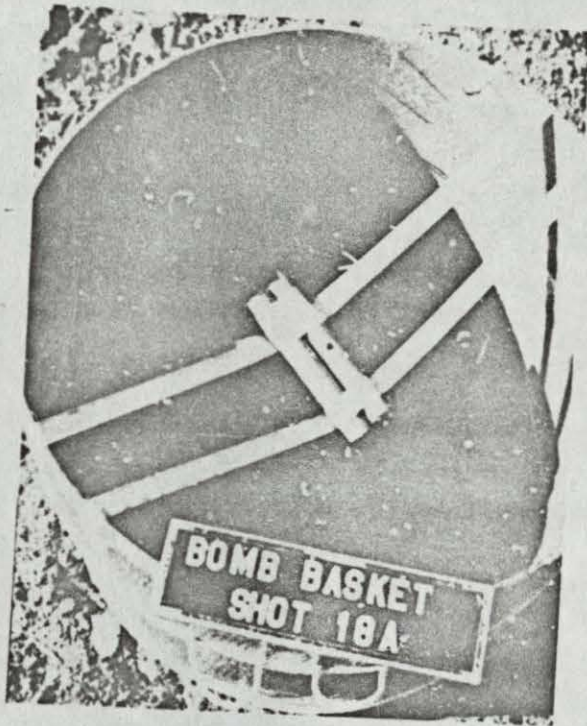
*Figure C-51. Subsequent charges were placed in the basket by suspending them with paper masking tape.*
