**USING 25% / 75% ATJ/JP-8 BLEND ROTARY FUEL
INJECTION PUMP WEAR TESTING AT ELEVATED
TEMPERATURE**

**INTERIM REPORT
TFLRF No. 468**

**U.S. Army TARDEC Fuels and Lubricants Research Facility
Southwest Research Institute[®] (SwRI[®])
San Antonio, TX**

**Contract No. W56HZV-09-C-0100 (WD24 Task 2.5)
SwRI[®] Project No. 08.19452**

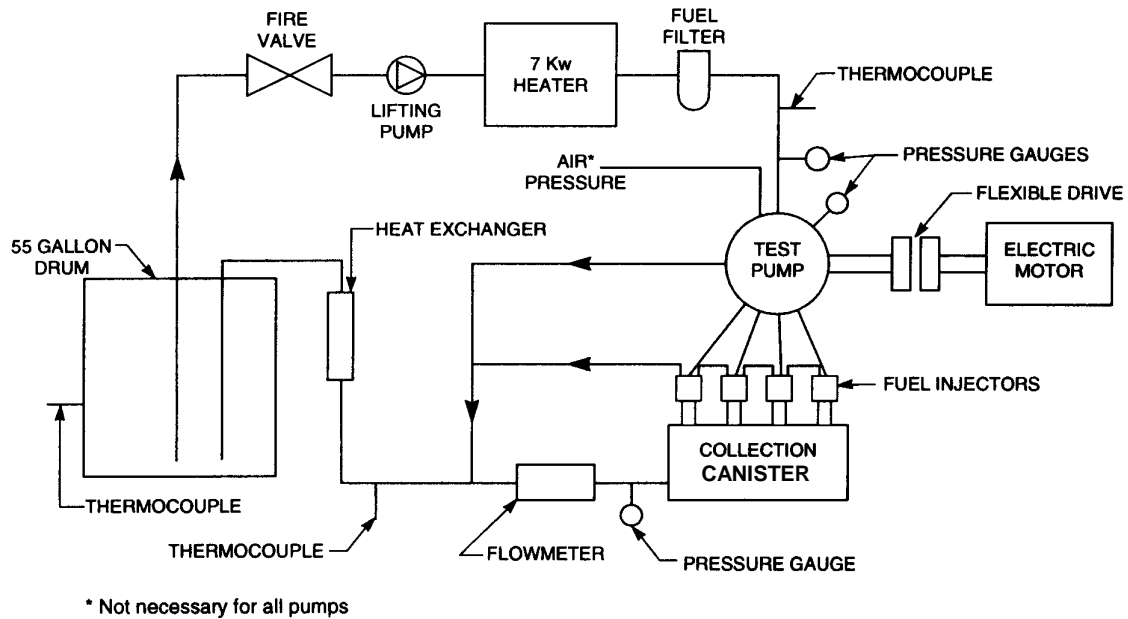
Figure 1. Schematic Diagram of Fuel Delivery System

The test stand included injection flow and pump return pipes, lift pumps, filters, flow meters, a fuel pre-heater and a heat exchanger to reduce the temperature of the fuel before returning to the storage tank. A schematic diagram of the fuel supply system proposed for the pump stand is shown in Figure 1. The temperature of the incoming fuel to each fuel injection pump was controlled to 77 °C. The high-pressure outlets from the pumps were connected to fuel injectors assembled in a collection canister.

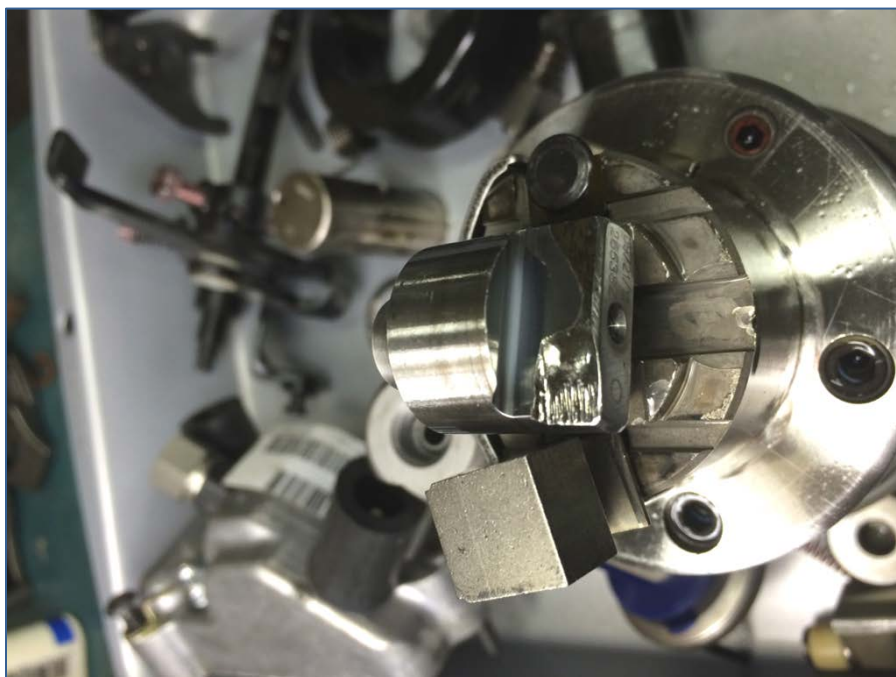
The first pump test was initiated with the minimum level CI/LI additive blend at a 77 °C fuel inlet temperature. At 251 hours, after the first fuel drum change, pump SN:16756534 seized and fractured the drive shaft. Examination of the driveshaft pieces revealed substantial wear on the drive tang that contributed to internal pump backlash and caused a fracture of the governor weight cage. Internal pump debris eventually contributed to the head and rotor seizure. The fractured drive shaft, drive tang wear and rotor distress for pump SN:16756534 is evident in Figure 3.

Figure 4. Pump SN:16756534 Showing Fractured Drive Shaft, Drive Tang Wear, and Rotor Distress at 251-hours with 25/75 ATJ/JP-8 Fuel with 9-ppm CI/LI at 77 °C Inlet Temperature

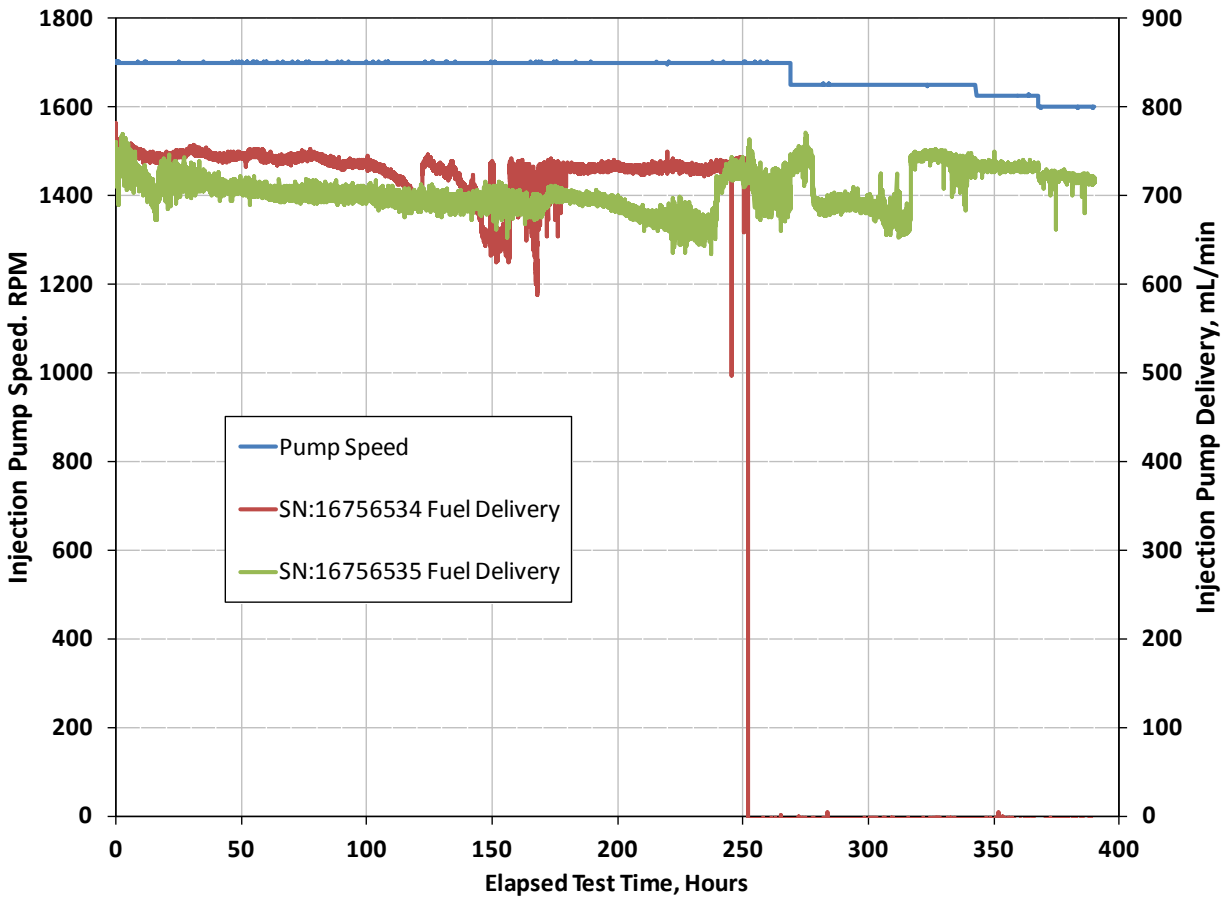
The fuel injection pump delivery histories are shown in Figure 6 for both fuel injection pumps for operation on the ATJ/JP-8 fuel with 9-ppm CI/LI at 77 °C fuel inlet temperature. Both injection pumps revealed slightly erratic delivery characteristics. Erratic delivery in these pumps could be due to metering valve wear, governor linkage wear, or excessive backlash due to drive tang wear. The reductions of the pump drive speed, and the effect of pump speed on fuel delivery for the respective pump times are shown in Figure 6.

Figure 6. Fuel Flow Rate Histories for 25/75 ATJ/JP-8 Fuel with 9-ppm CI/LI at Elevated Temperature

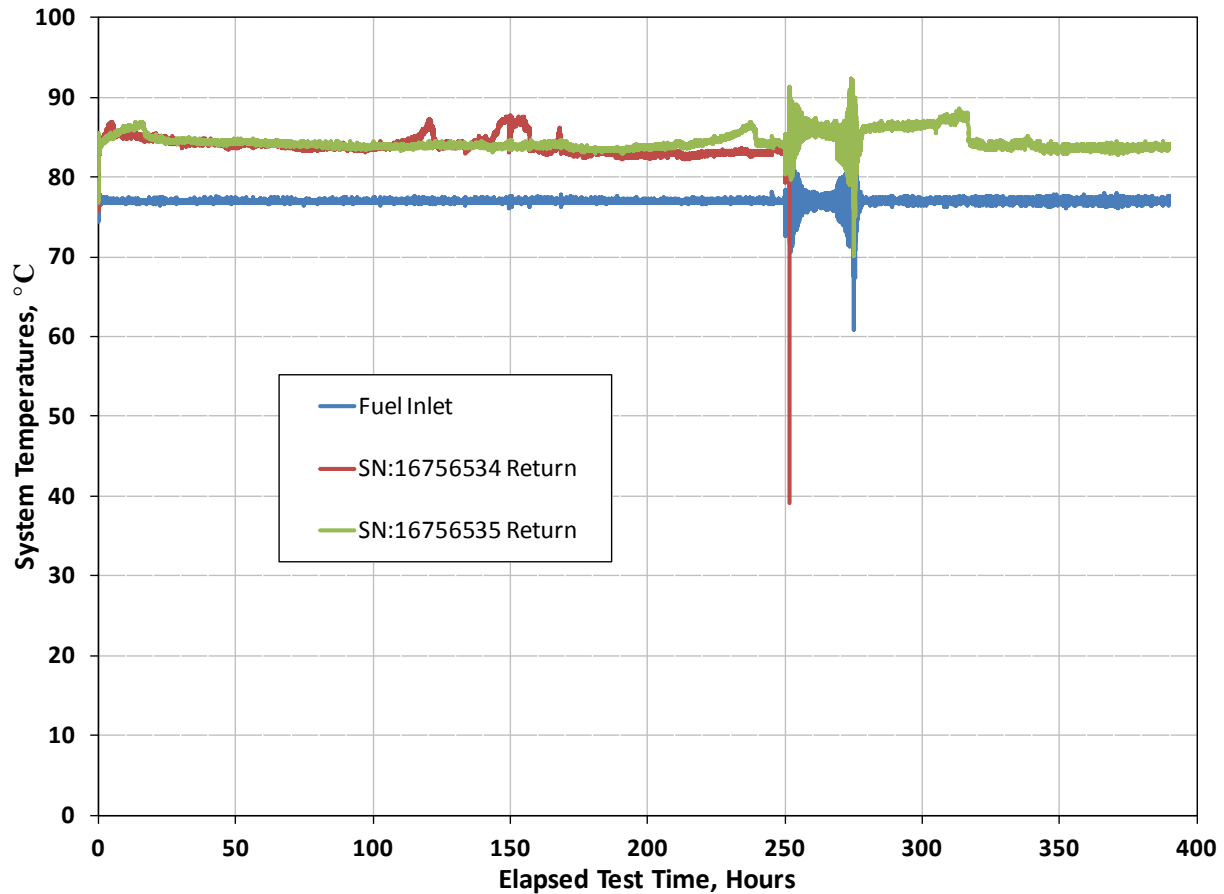
The fuel injection pump temperature histories are shown in Figure 7 for both fuel injection pumps for operation on ATJ/JP-8 fuel with 9-ppm CI/LI at 77 °C fuel inlet temperature. The test stand was converted to single pump operation with the removal of pump SN:16756534. The fuel inlet temperature controller had a difficult time maintaining the fuel inlet temperature. The controller was re-tuned, after which a consistent fuel inlet temperature was maintained. It is possible the swings in fuel inlet temperature may have hastened the wear with pump SN:16756535 after the 251-hour re-start, as the housing fuel return temperature settled at an elevated value after re-tuning the temperature controller. Prior to the test termination with either fuel injection pump, the housing fuel return temperatures are seen to increase at various times, due to increased internal friction in the fuel injection pumps.

Figure 7. Fuel Inlet and Fuel Return Temperatures for 25/75 ATJ/JP-8 Fuel with 9-ppm CI/LI at Elevated Temperature

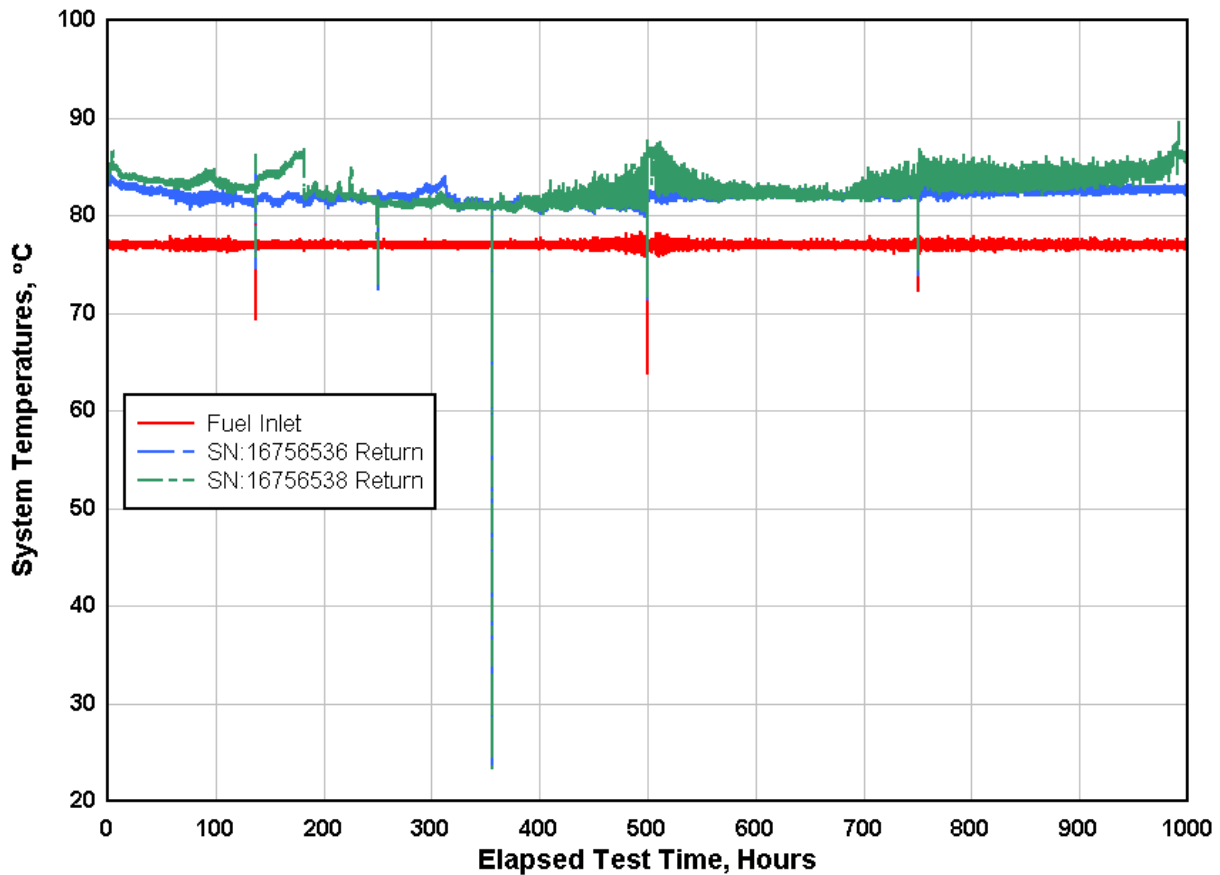
The temperature histories of the fuel injection pumps are shown in Figure 10. From the onset of testing both fuel injection pumps exhibited some form of erratic fuel return temperature behavior. For pump SN:16756538 the return fuel temperature increased, usually a sign of increased internal friction, then decreased and increased again towards end of test. Pump SN:16756536 exhibited steady initial fuel return temperature that decreased until about mid-test, then gradually increased towards test conclusion, indicating increasing internal friction. Unusual wear in the pumps usually result in increases and variability of the fuel return temperatures. The fuel inlet temperature to both pumps was very consistent throughout testing.

Figure 10. Injection Pump Temperature Histories for 25/75 ATJ/JP-8 Fuel with 24-ppm CI/LI Evaluation

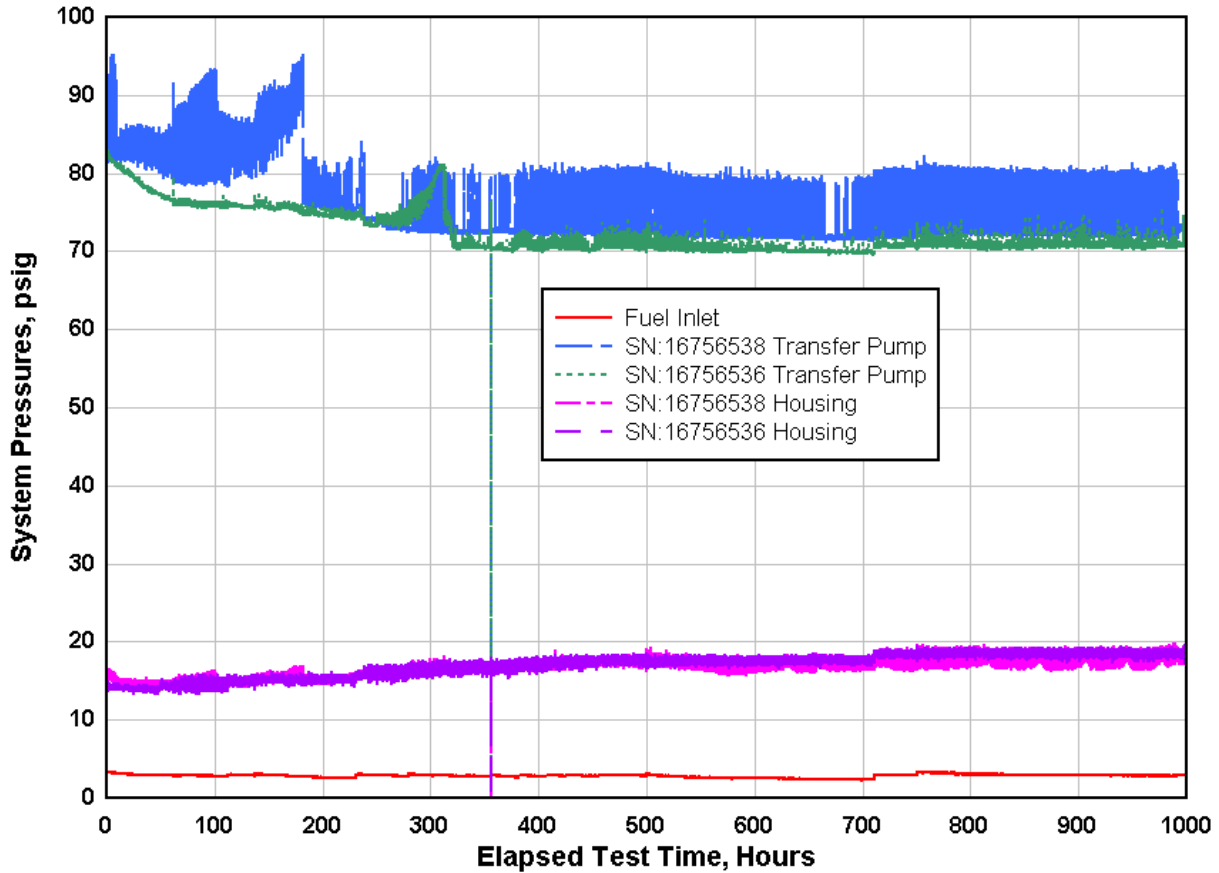
Figure 11. Injection Pump Pressure Histories for 25/75 ATJ/JP-8 Fuel with 24-ppm CI/LI Evaluation

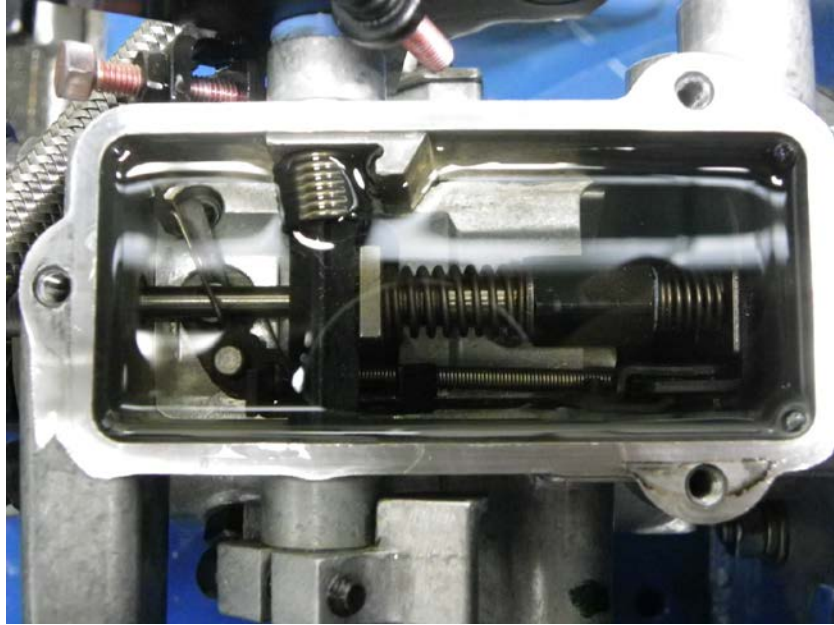
At 1000-hours of testing the tops of both fuel injection pumps were removed for inspection of wear debris. The housing for pump SN:16756536 is shown in Figure 12 and there is not any wear debris or housing staining evident. The housing for pump SN:16756538 is shown in Figure 13, for which wear debris is evident along with light amber staining of the housing. Pump SN:16756538 displayed more erratic behavior and rattling throughout testing.

Figure 12. Pump SN:16756536 Governor Assembly with 1000-Hours Testing with ATJ/JP-8 Fuel

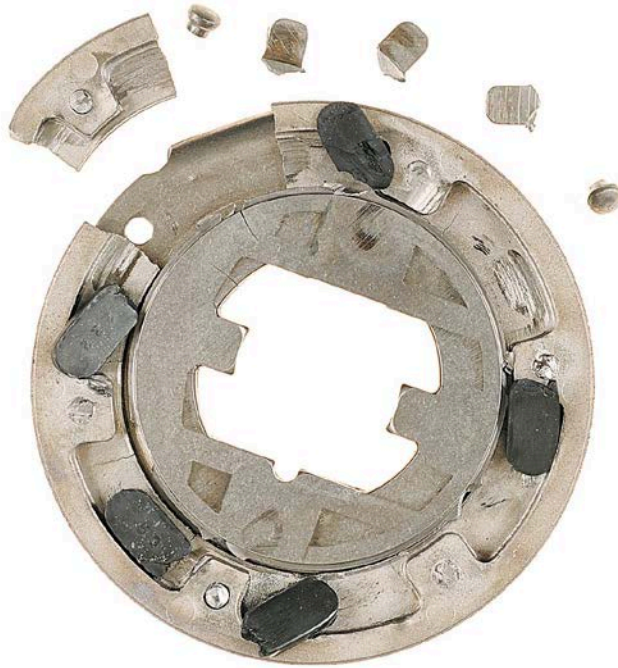
Figure 16. Pump SN:16756534 Governor Weight Cage Breakage with 251-hours Testing with 25/75 ATJ/JP-8 Fuel with 9-ppm CI/LI

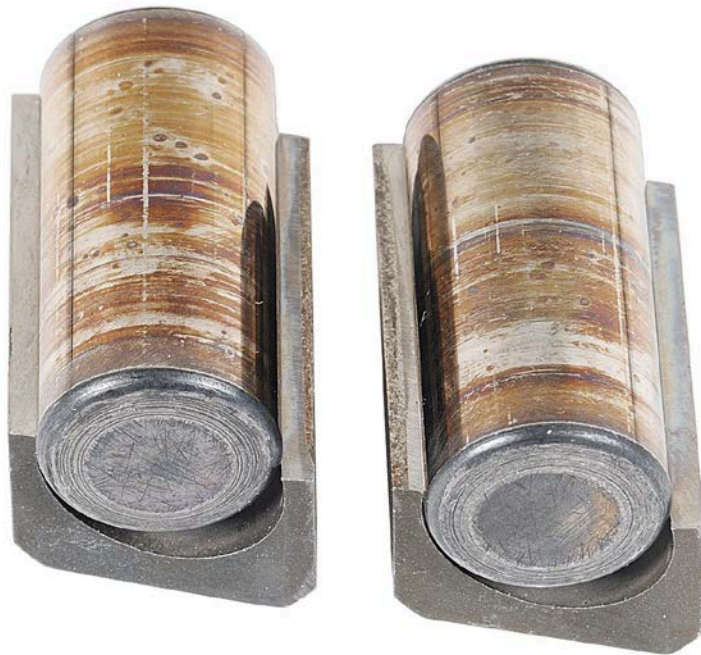
Figure 18. Pump SN:16756534 Rollers and Shoe with 251-hours Testing with 25/75 ATJ/JP-8 Fuel with 9-ppm CI/LI

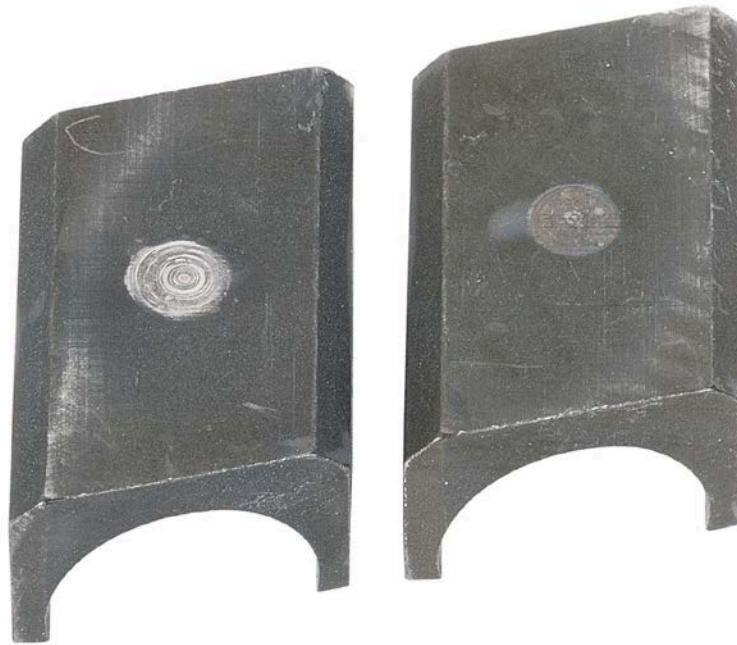
Figure 20. Pump SN:16756534 Roller Shoe with 251-hours Testing with 25/75 ATJ/JP-8 Fuel with 9-ppm CI/LI

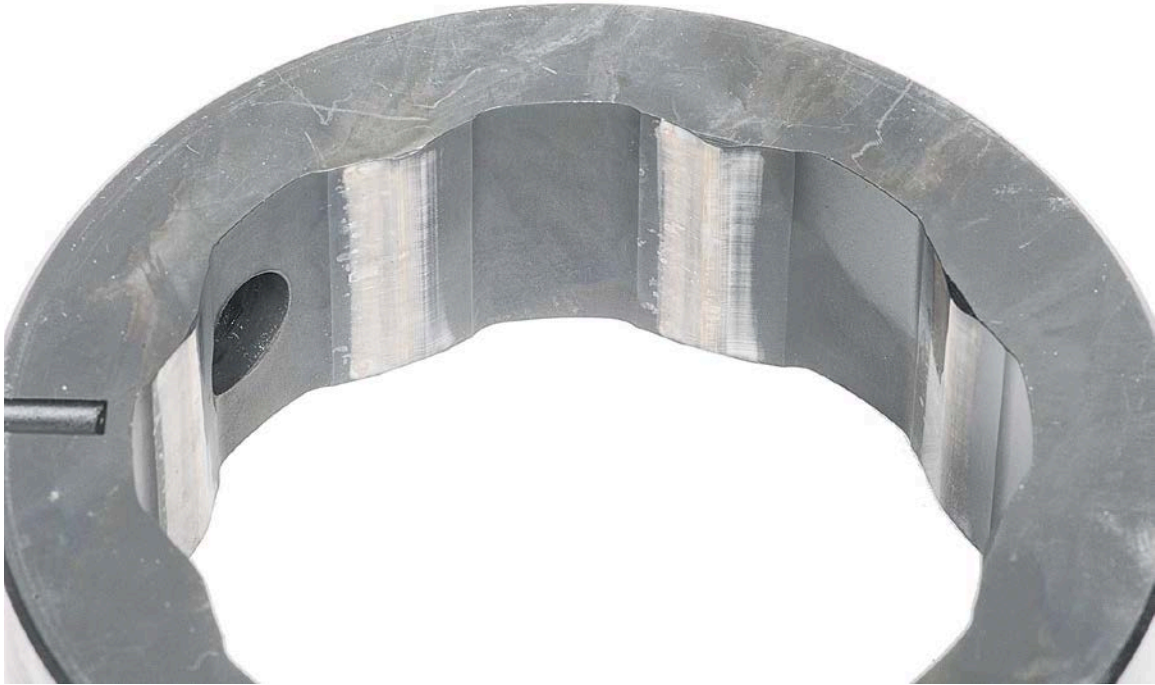
Figure 22. Pump SN:16756534 Cam Ring with 251-hours Testing with 25/75 ATJ/JP-8 Fuel with 9-ppm CI/LI

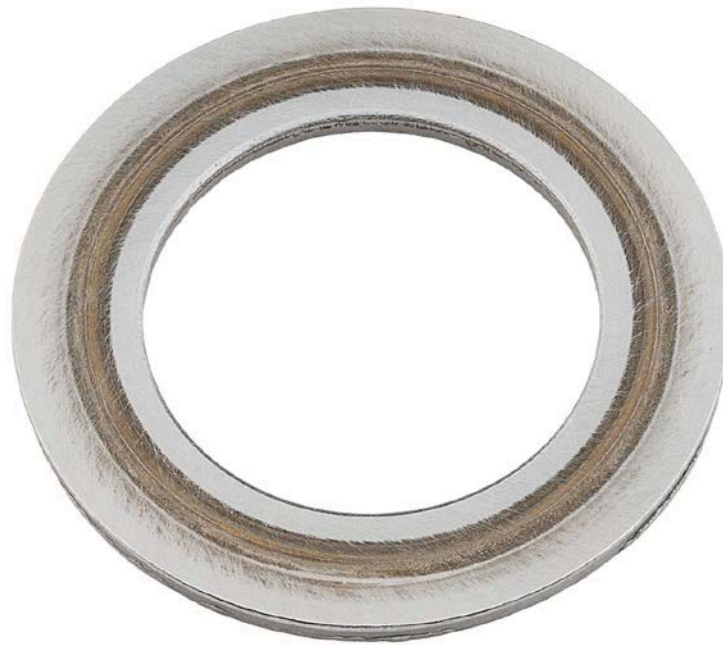
Figure 24. Pump SN:16756534 Thrust Washer with 251-hours Testing with 25/75 ATJ/JP-8 Fuel with 9-ppm CI/LI

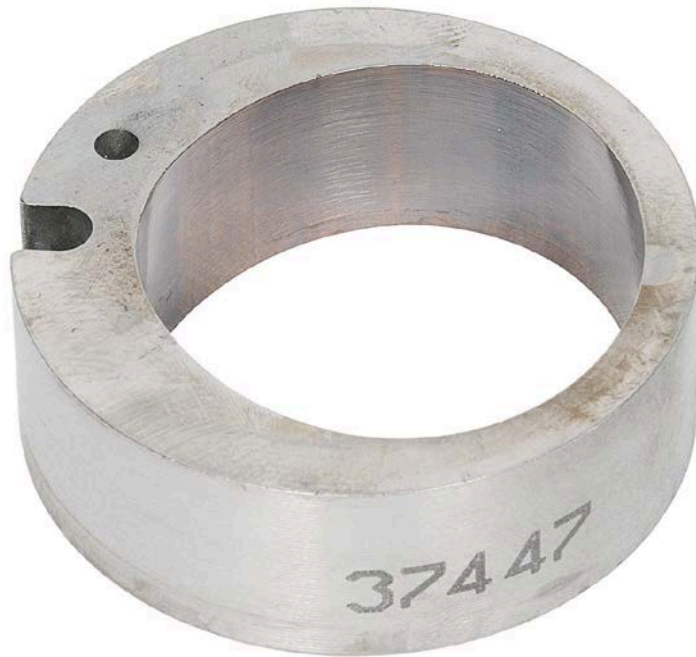
Figure 26. Pump SN:16756534 Transfer Pump Liner with 251-hours Testing with 25/75 ATJ/JP-8 Fuel with 9-ppm CI/LI

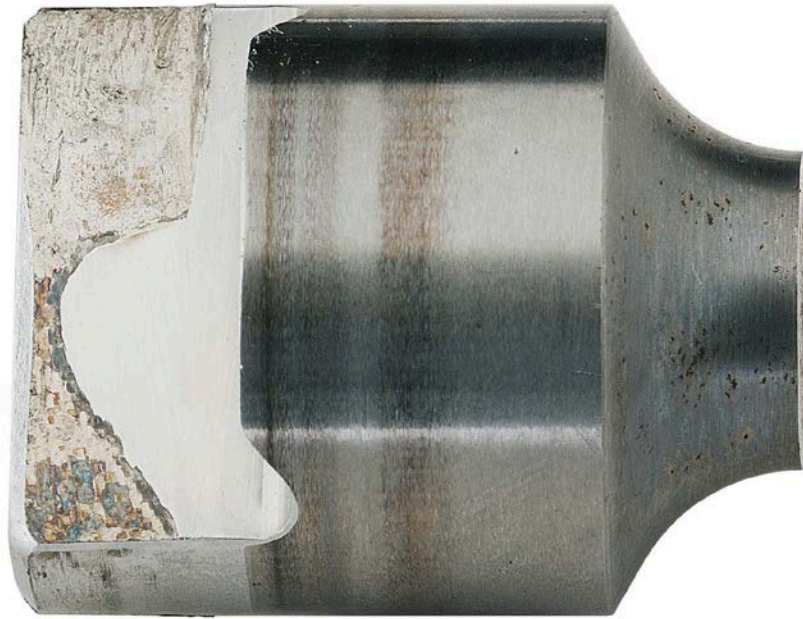
Figure 31 and Figure 32 show the condition of the injection pump drive shaft drive tang that transmits torque to the hydraulic section of the pump from the engine. Figure 31 and Figure 32 reveal a severe wear scar that indicates backlash and timing were altered with the ATJ/JP-8 fuel with 9-ppm CI/LI at elevated temperature after 251-hours. Also evident in Figure 32 is the sheared drive shaft due to the head and rotor seizure

Figure 32. Pump SN:16756534 Driveshaft Drive Tang with 251-hours Testing with 25/75 ATJ/JP-8 Fuel with 9-ppm CI/LI

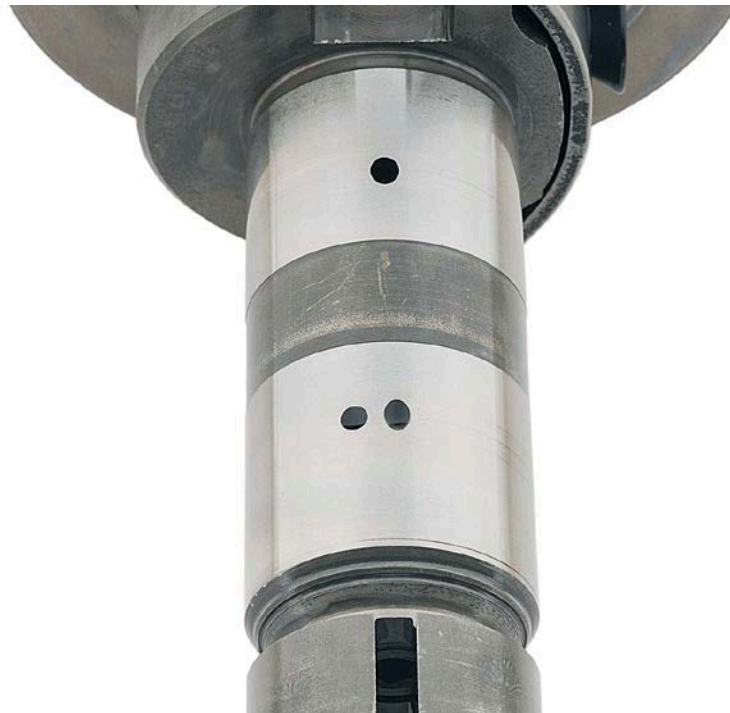
Figure 34. Pump SN:16756535 Distributor Rotor with 389-hours Testing with 25/75 ATJ/JP-8 Fuel with 9-ppm CI/LI

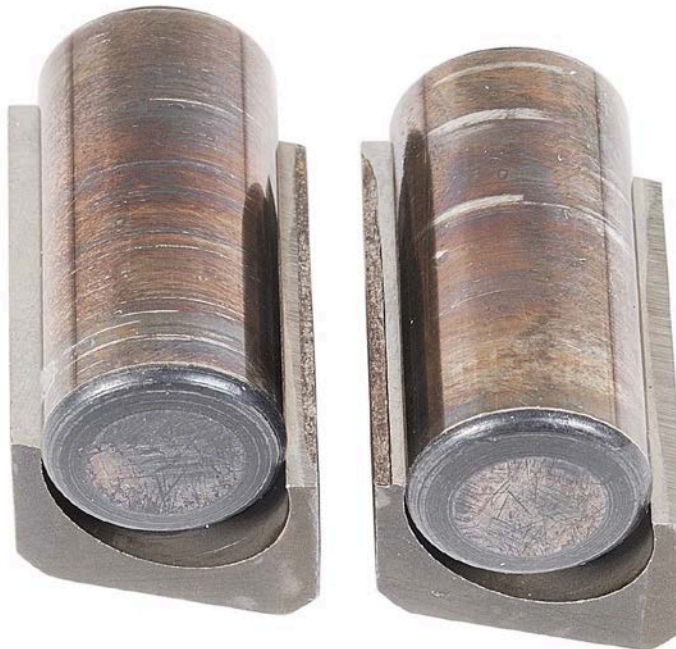
Figure 36. Pump SN:16756535 Rollers and Shoe with 389-hours Testing with 25/75 ATJ/JP-8 Fuel with 9-ppm CI/LI

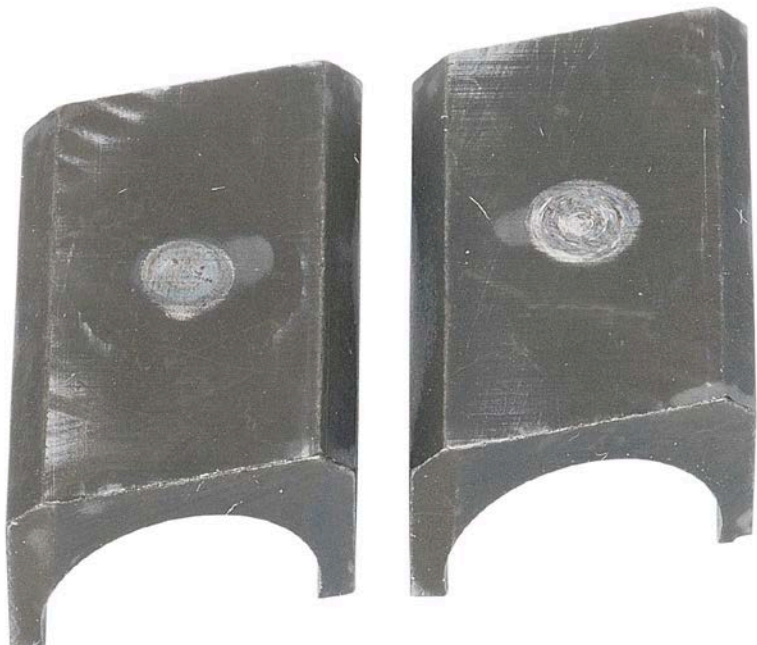
Figure 38. Pump SN:16756535 Roller Shoe with 389-hours Testing with 25/75 ATJ/JP-8 Fuel with 9-ppm CI/LI

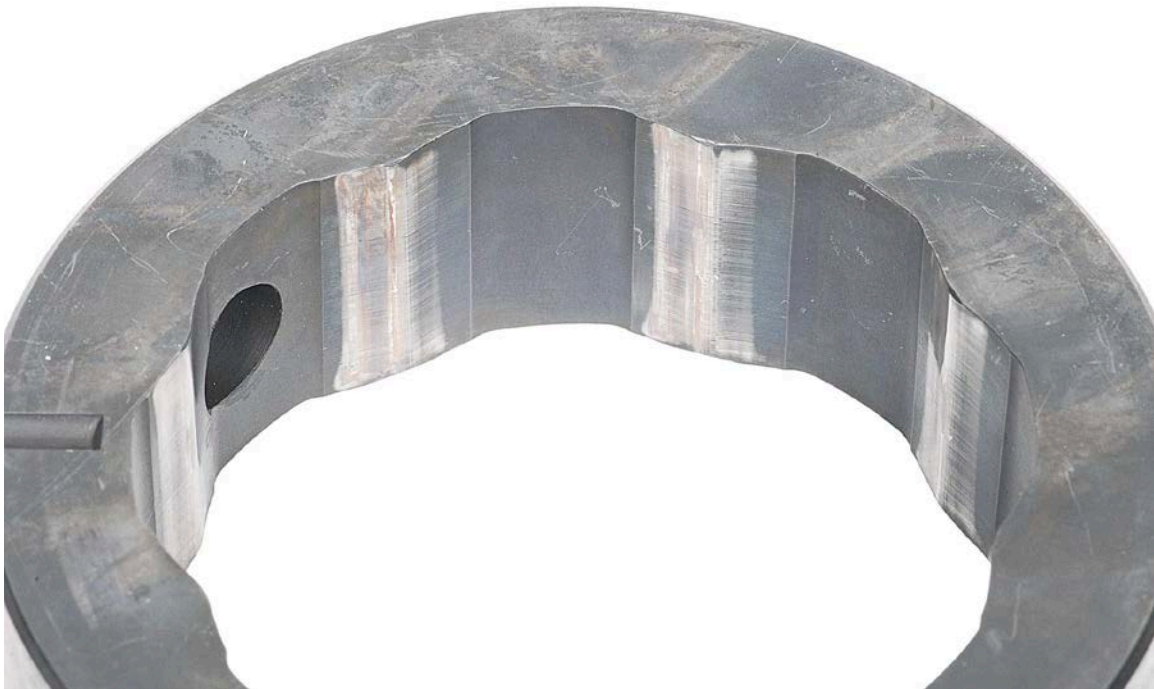
Figure 40. Pump SN:16756535 Cam Ring with 389-hours Testing with 25/75 ATJ/JP-8 Fuel with 9-ppm CI/LI

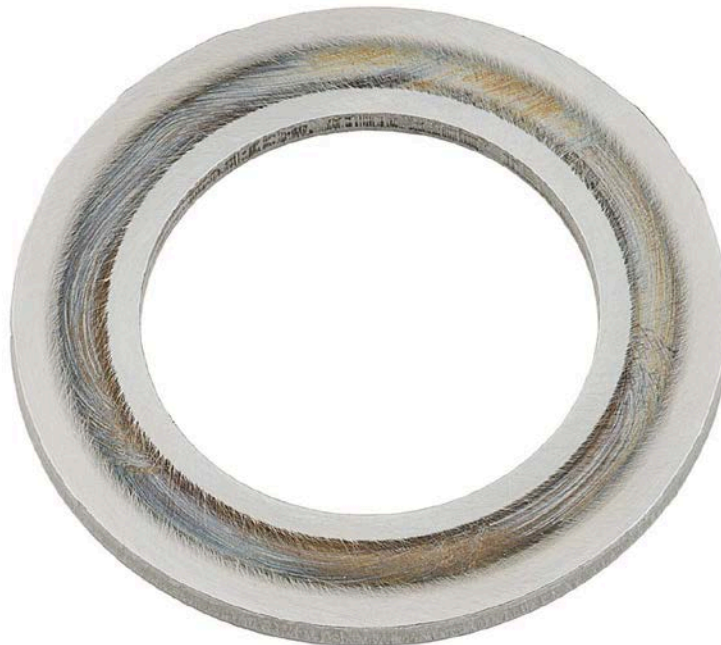
Figure 42. Pump SN:16756535 Thrust Washer with 389-hours Testing with 25/75 ATJ/JP-8 Fuel with 9-ppm CI/LI

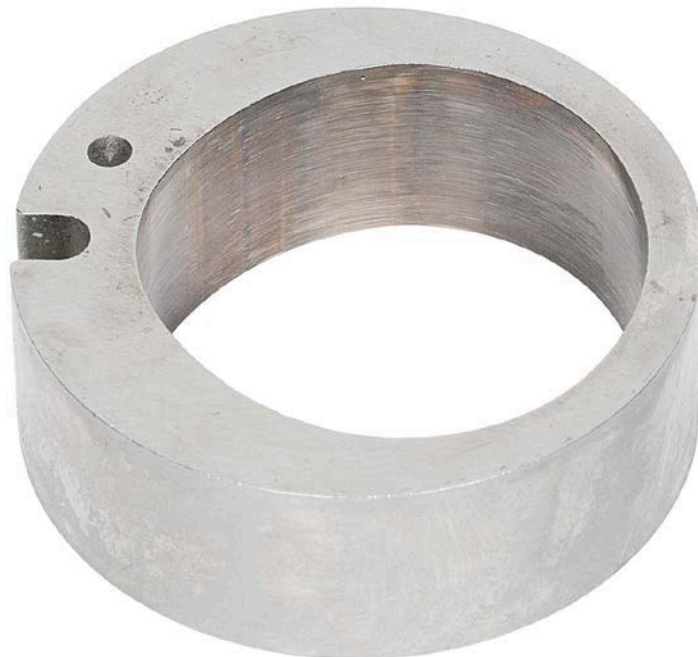
Figure 44. Pump SN:16756535 Transfer Pump Liner with 389-hours Testing with 25/75 ATJ/JP-8 Fuel with 9-ppm CI/LI

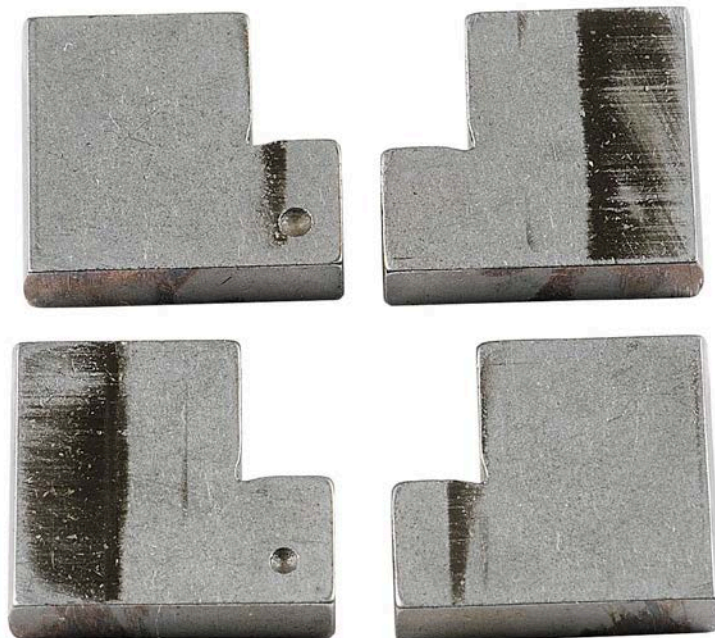
Figure 48. Pump SN:16756535 Transfer Pump Blade Sides with 389-hours Testing with 25/75 ATJ/JP-8 Fuel with 9-ppm CI/LI

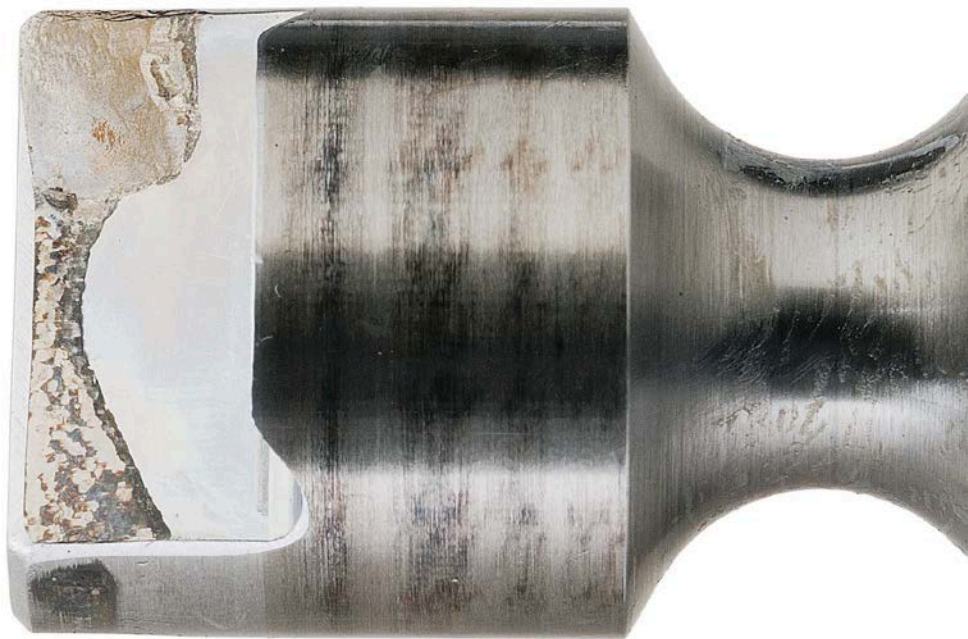
Figure 49 and Figure 50 show the condition of the injection pump drive shaft drive tang that transmits torque to the hydraulic section of the pump from the engine. Figure 50 reveals a mild wear scar that indicates backlash was occurring. For both pumps the cumulative effect of all the worn components contributed to the performance degradation with the ATJ/JP-8 fuel with 9-ppm CI/LI at 77°C fuel inlet temperature.

Figure 50. Pump SN:16756535 Driveshaft Drive Tang with 389-Hours Testing with 25/75 ATJ/JP-8 Fuel with 9-ppm CI/LI

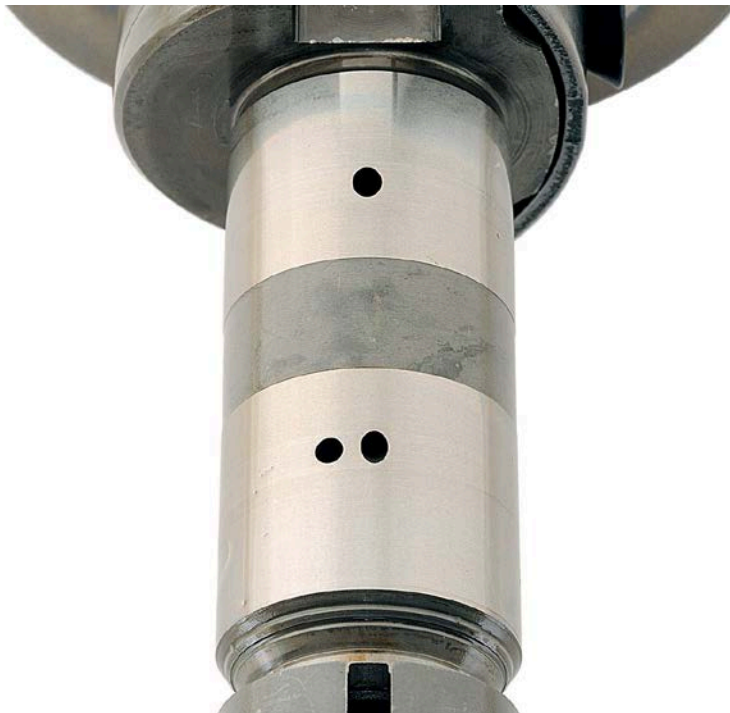
Figure 52. Pump SN:16756536 Distributor Rotor with 1000-Hours Testing with 25/75 ATJ/JP-8 Fuel with 24-ppm CI/LI

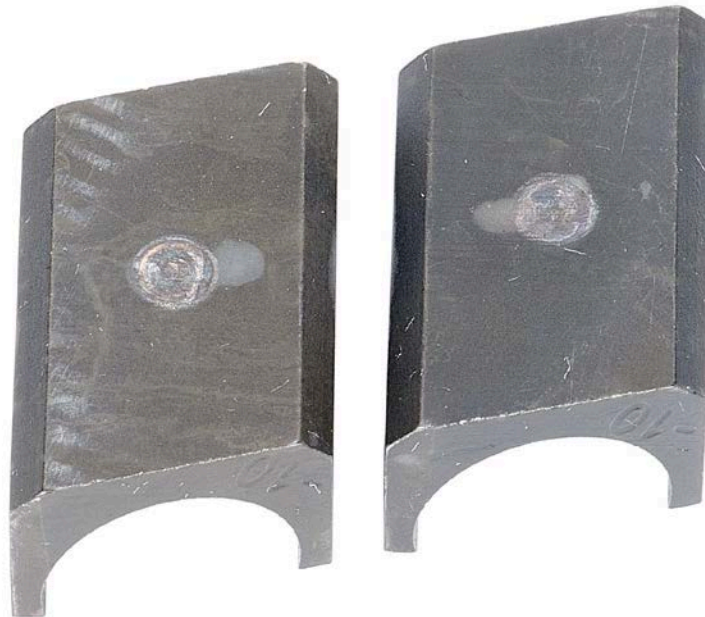
Figure 56. Pump SN:16756536 Roller Shoe with 1000-Hours Testing with 25/75 ATJ/JP-8 Fuel with 24-ppm CI/LI

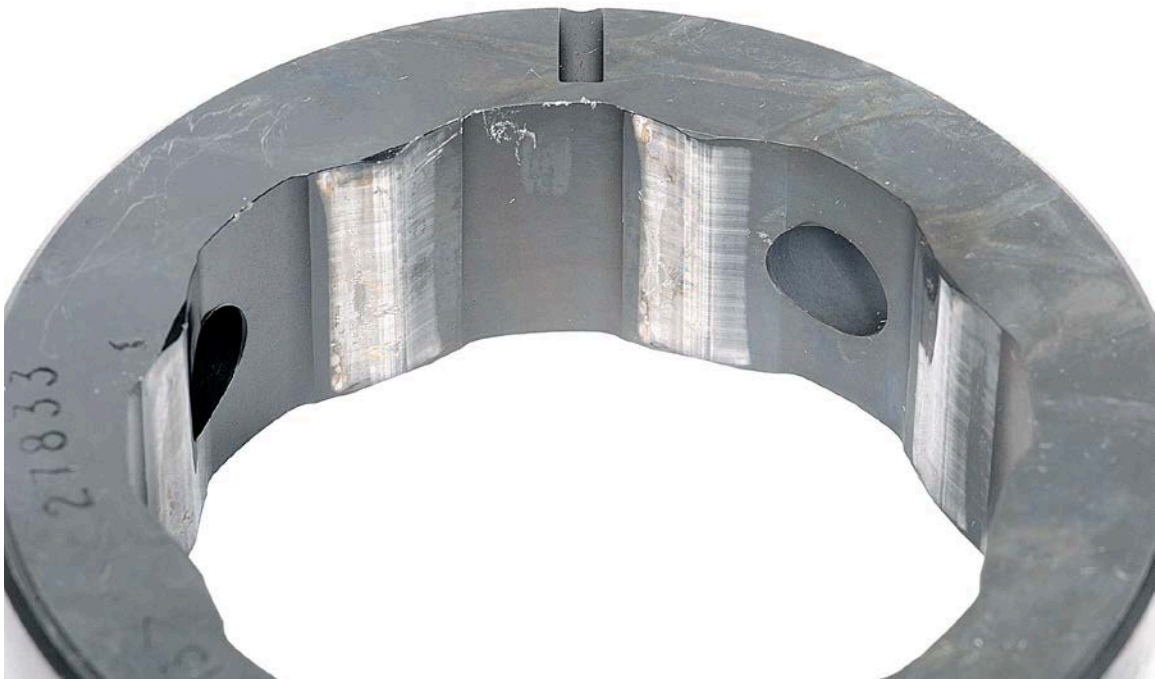
Figure 58. Pump SN:16756536 Cam Ring with 1000-Hours Testing with 25/75 ATJ/JP-8 Fuel with 24-ppm CI/LI

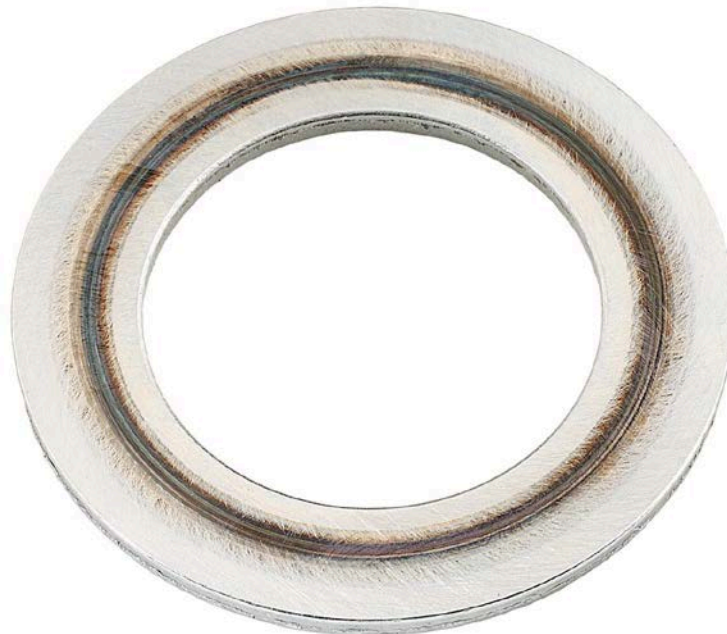
Figure 60. Pump SN:16756536 Thrust Washer with 1000-Hours Testing with 25/75 ATJ/JP-8 Fuel with 24-ppm CI/LI

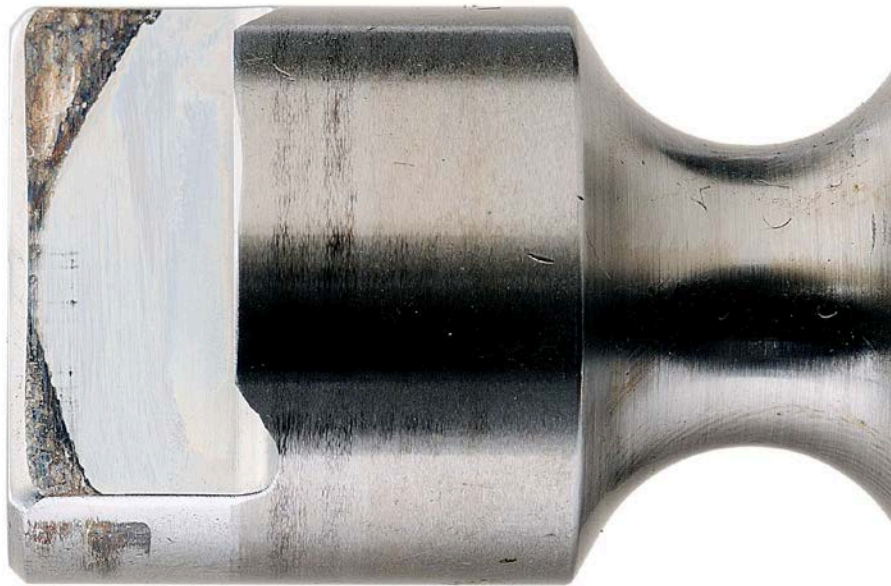
Figure 68. Pump SN:16756536 Driveshaft Drive Tang with 1000-Hours Testing with 25/75 ATJ/JP-8 Fuel with 24-ppm CI/LI

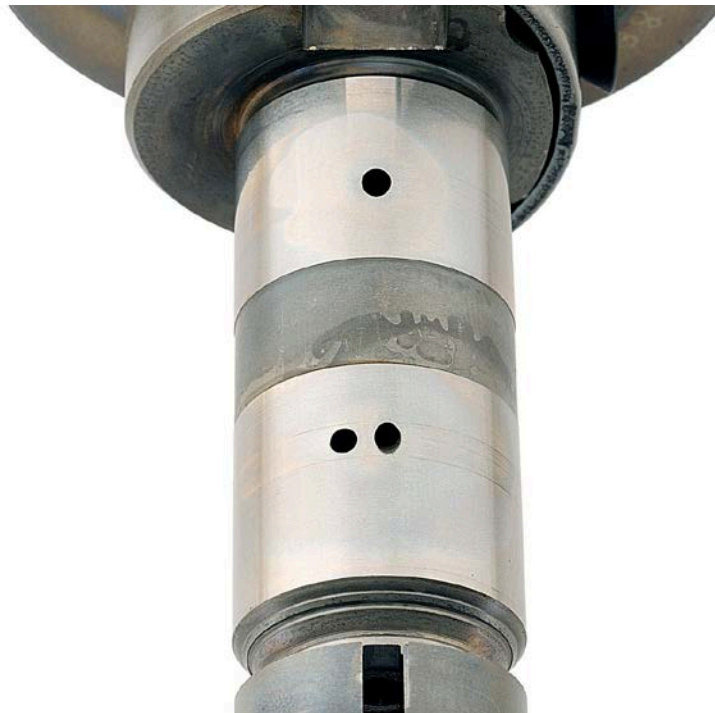
Figure 70. Pump SN:16756538 Distributor Rotor with 1000-Hours Testing with 25/75 ATJ/JP-8 Fuel with 24-ppm CI/LI

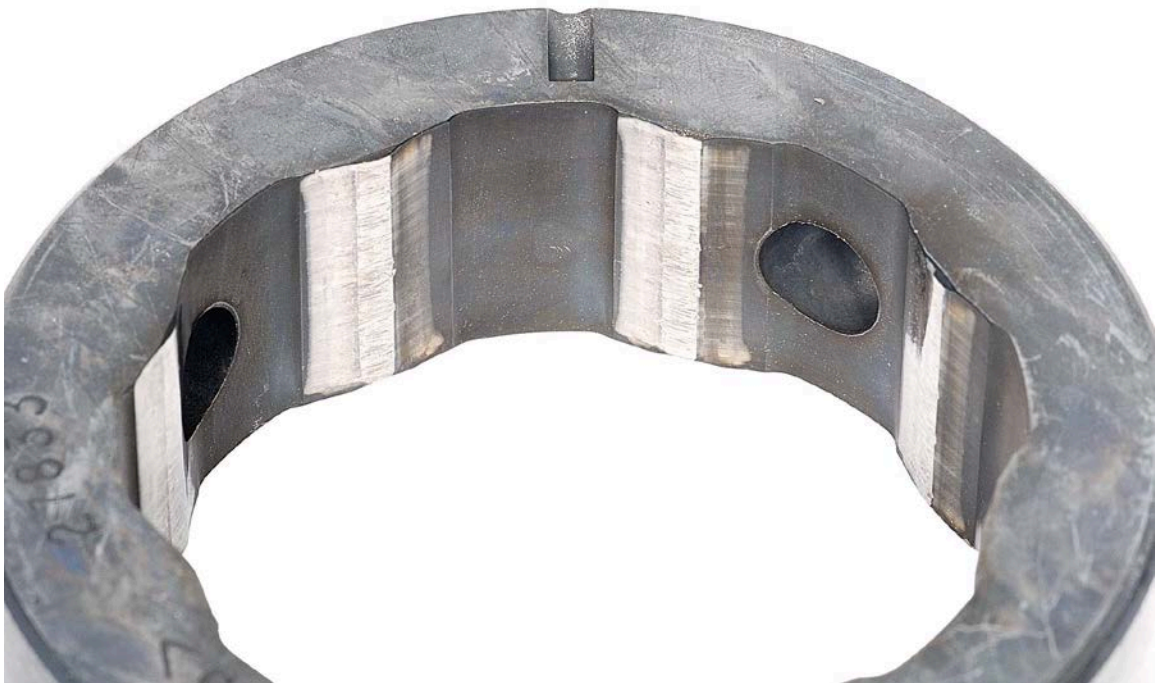
Figure 76. Pump SN:16756538 Cam Ring with 1000-Hours Testing with 25/75 ATJ/JP-8 Fuel with 24-ppm CI/LI

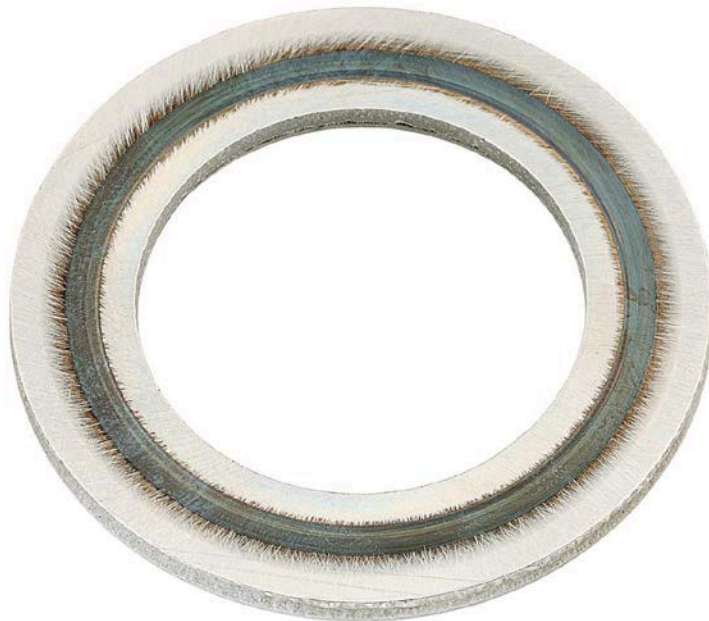
Figure 78. Pump SN:16756538 Thrust Washer with 1000-Hours Testing with 25/75 ATJ/JP-8 Fuel with 24-ppm CI/LI

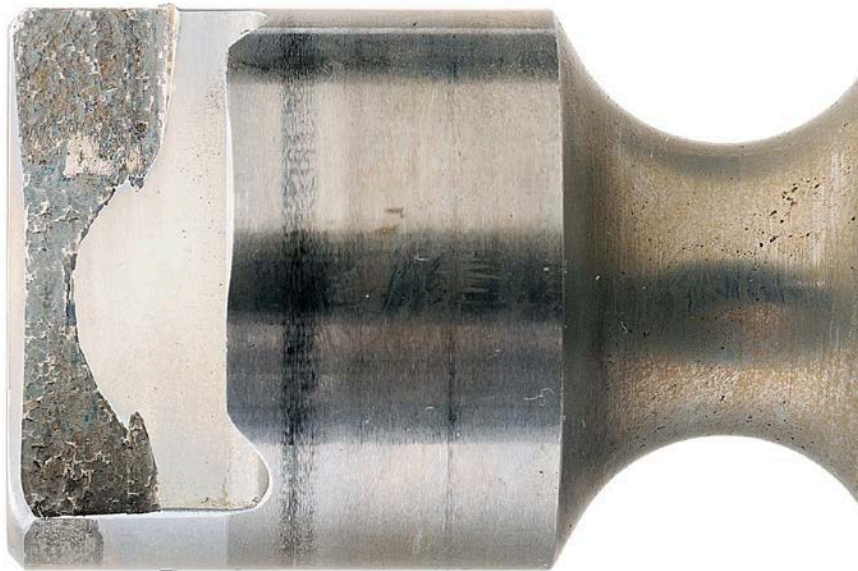
Figure 86. Pump SN:16756538 Driveshaft Drive Tang with 1000-Hours Testing with 25/75 ATJ/JP-8 Fuel with 24-ppm CI/LI
