The PC9A Filter Screening Tool

DST-Group-TR-3210

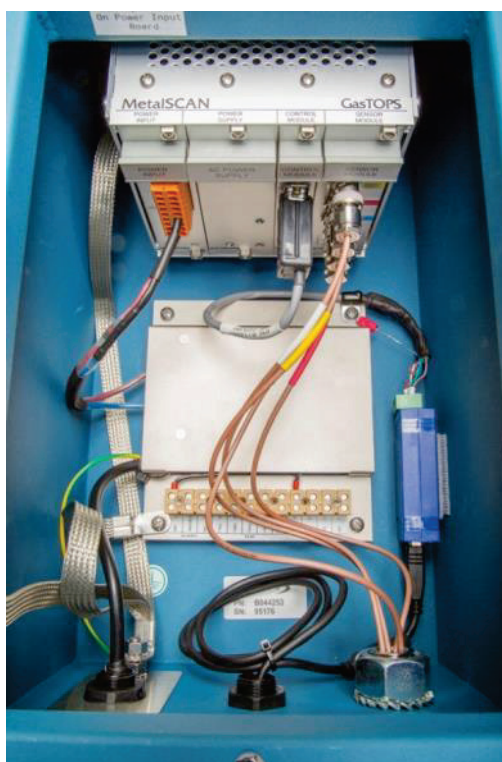
Figure 5: Interior of MetalSCAN control box showing hard-wired modifications

The MetalSCAN Control Box contains various electronic and power supply modules that enable the sensor to function, record data and communicate with the computer. In this instance a 240V version of the Control Box was used. The Control Boxes as supplied by the manufacturer do not come wired for use, therefore the DST Group engineering services contractor (Qinetiq) were engaged to wire the power cable and RS485 communication cable for both boxes. The power cable was wired in accordance with Australian Standard 3000 wiring rules [5] resulting in the exposed terminal board (provided by the manufacturer) being bypassed to reduce the number of connections and enable the power wires to be double insulated. The access fasteners provided on the Control Box are not lockable and therefore would not have met the wiring rules if the terminal block had been retained; double insulating the power cables enabled the wiring rules to be met. Figure 5 shows the internal configuration of the Control Boxes. Users of the FST are not required to access any components inside the Control Box at any time.

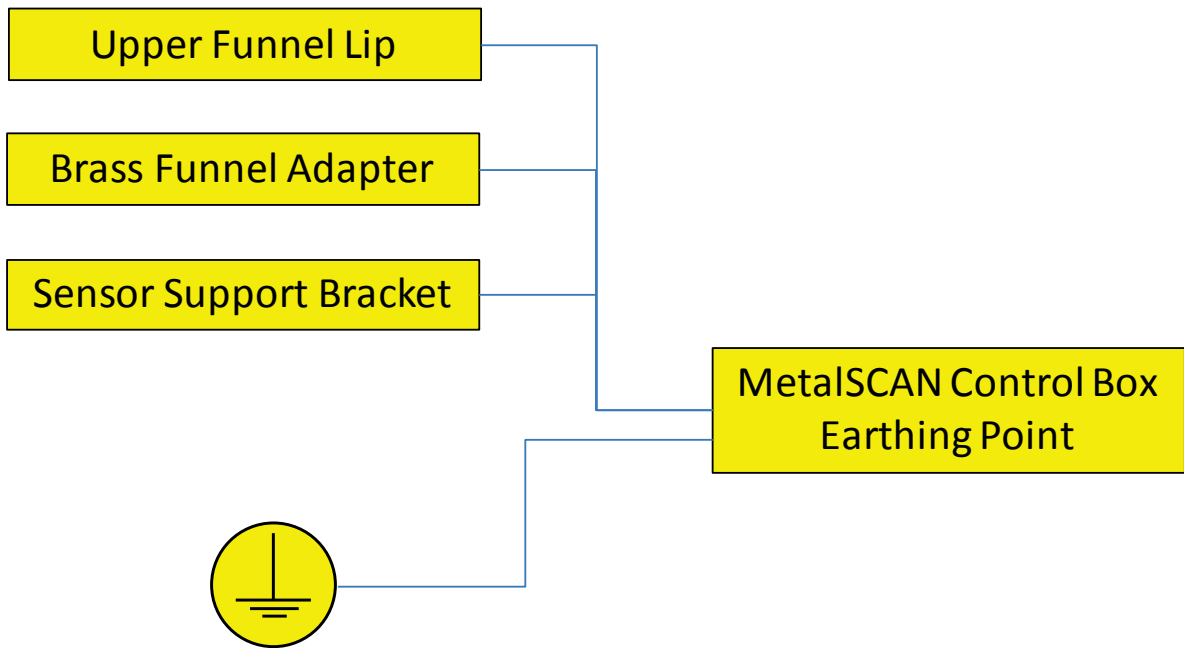
Figure 8: FST Earthing Schematic

It is essential that the FST is earthed correctly to prevent static or other electric potential differences interfering with the sensor or causing a static ignition hazard. Figure 8 shows a schematic of the system earthing configuration and Figure 9 shows the earthing leads attached to the various sub-components of the funnel assembly. Figure 10 shows the earthing connection on the MetalSCAN Control Box and shows that all funnel items are earthed to the Control Box which is in turn earthed to the power supply outlet earth. Users are instructed to visually check the earthing leads prior to each use and an annual continuity check is mandated (Section 6.2). The FST must not be used if the earthing leads are damaged or disconnected.

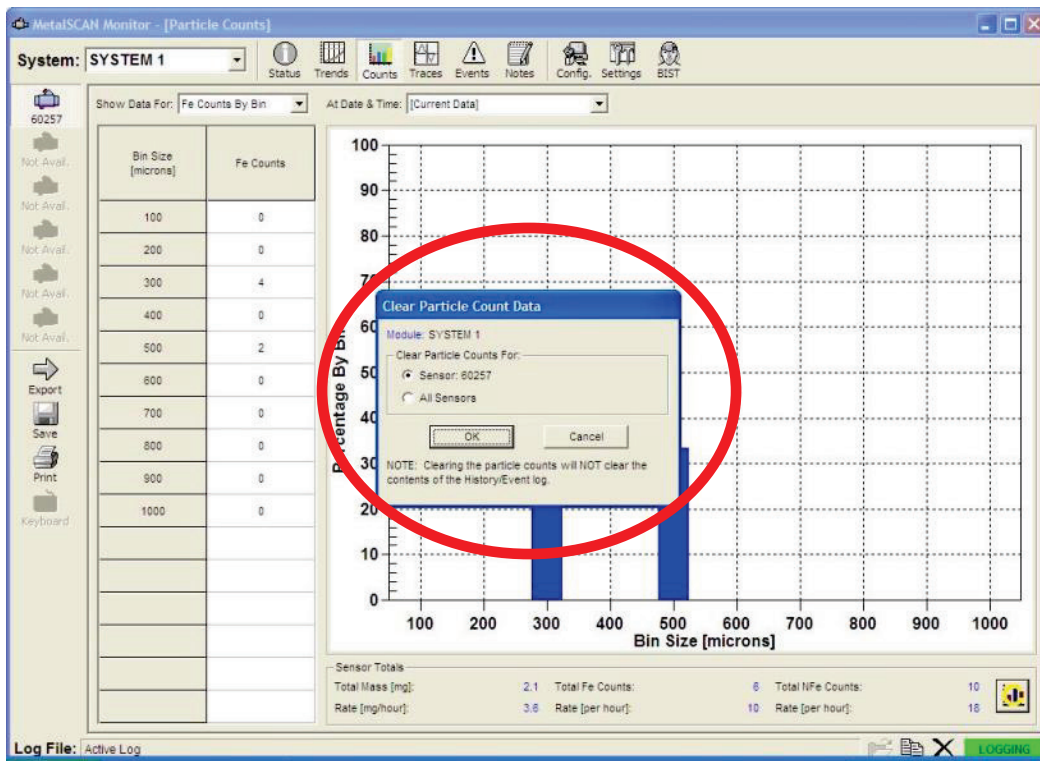
Figure 13: Counts screen showing prompt after clicking clear counts button

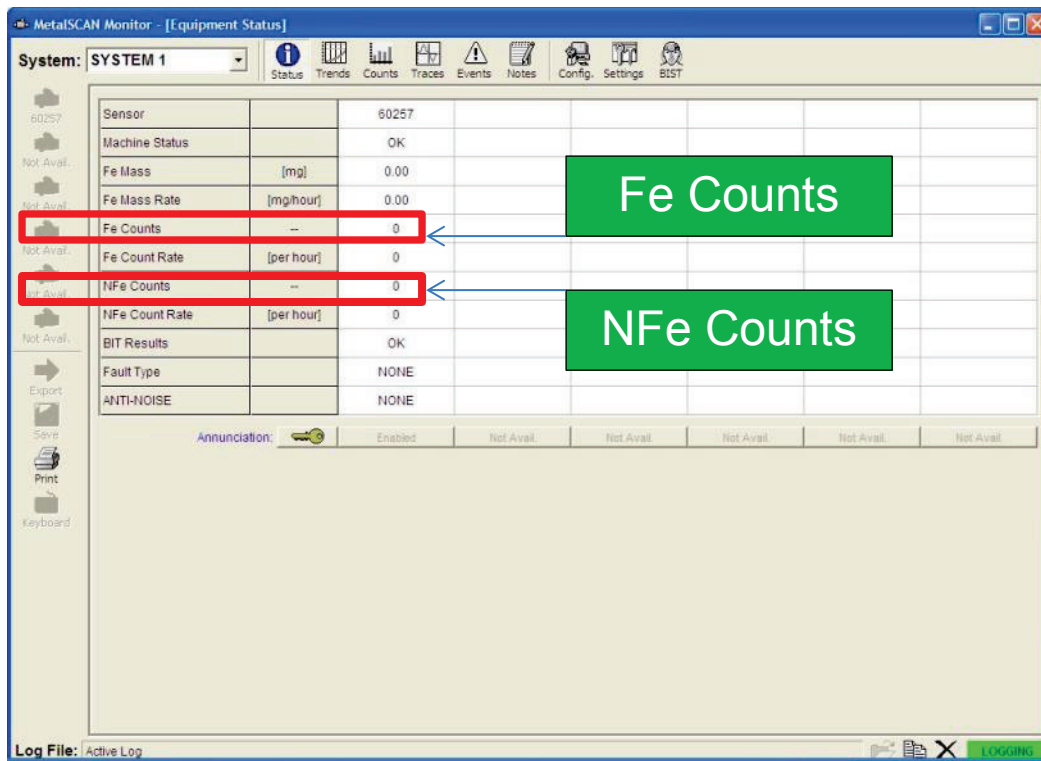
Figure 18: Status screen showing where Fe and NFe Counts are recorded

Results for the ferromagnetic (Fe) count and non-ferromagnetic (NFe) count are obtained from the *Status* screen of the MetalSCAN software (Figure 18). The Fe *rate* and NFe *rate* values are meaningless in this application and should be ignored; they are intended to be used where the sensor is installed in a machine lubrication system and measuring continuously. It is recommended that a form like that shown in Appendix F be used to record each screening.

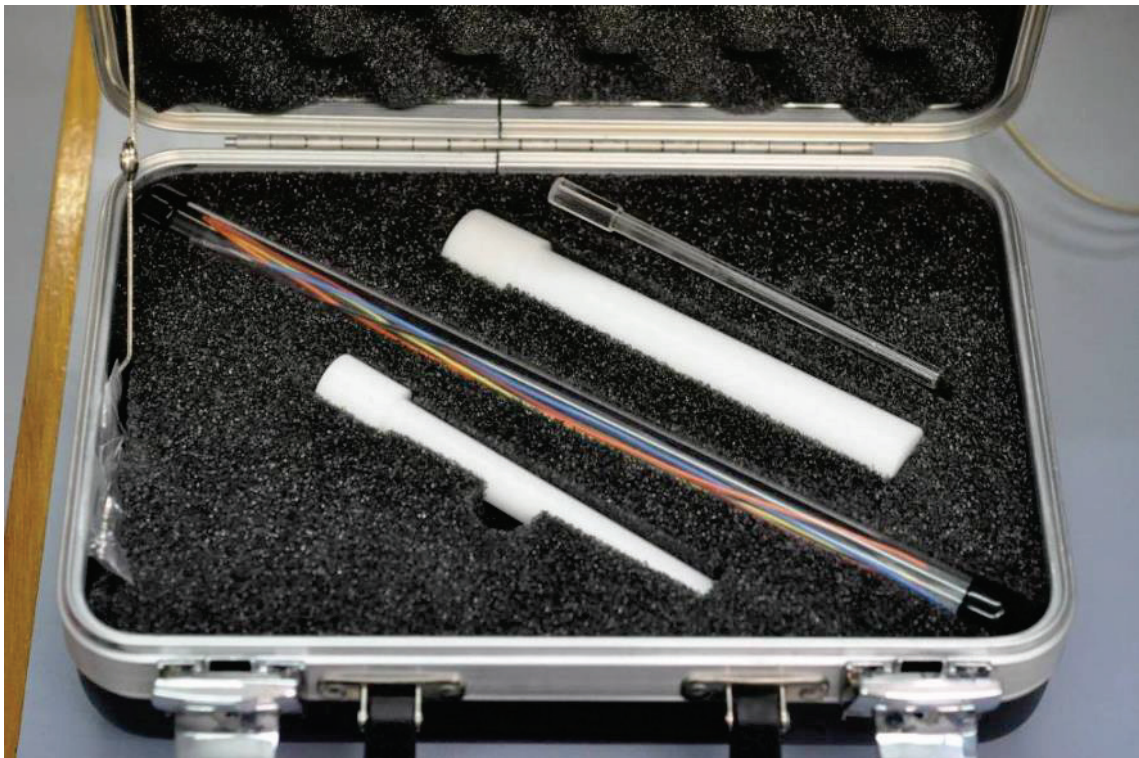
Figure 26: MetalSCAN performance test kit

No routine calibration is recommended by the sensor manufacturer. Instead, a performance test kit (Figure 26) is provided containing particles of known size encased in thin plastic straws that can be easily passed through the sensor. The test kit consists of 5 test straws each containing a single particle of known size (Figure 27). Table 13 contains the particle size and type for each coloured test straw. Whilst the kit contains a mix of Fe

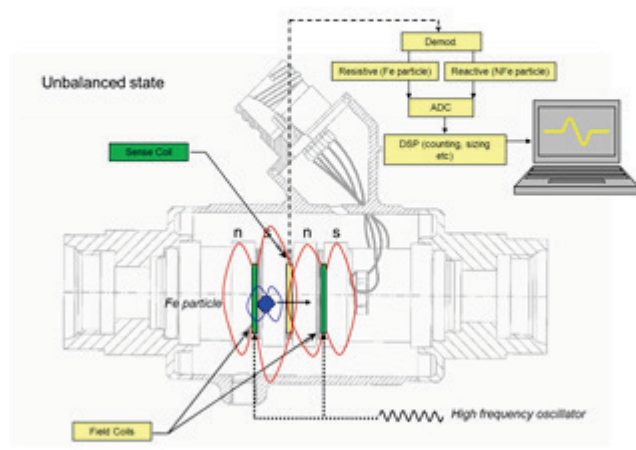
At the heart of the FST is an inductive sensor. Here's how it works:
