# **BRAKE FLUID COMPATIBILITY WITH HARDWARE**

**INTERIM REPORT  
TFLRF No. 445**

**U.S. Army TARDEC Fuels and Lubricants Research Facility  
Southwest Research Institute<sup>®</sup> (SwRI<sup>®</sup>)  
San Antonio, TX**

**May 2014**

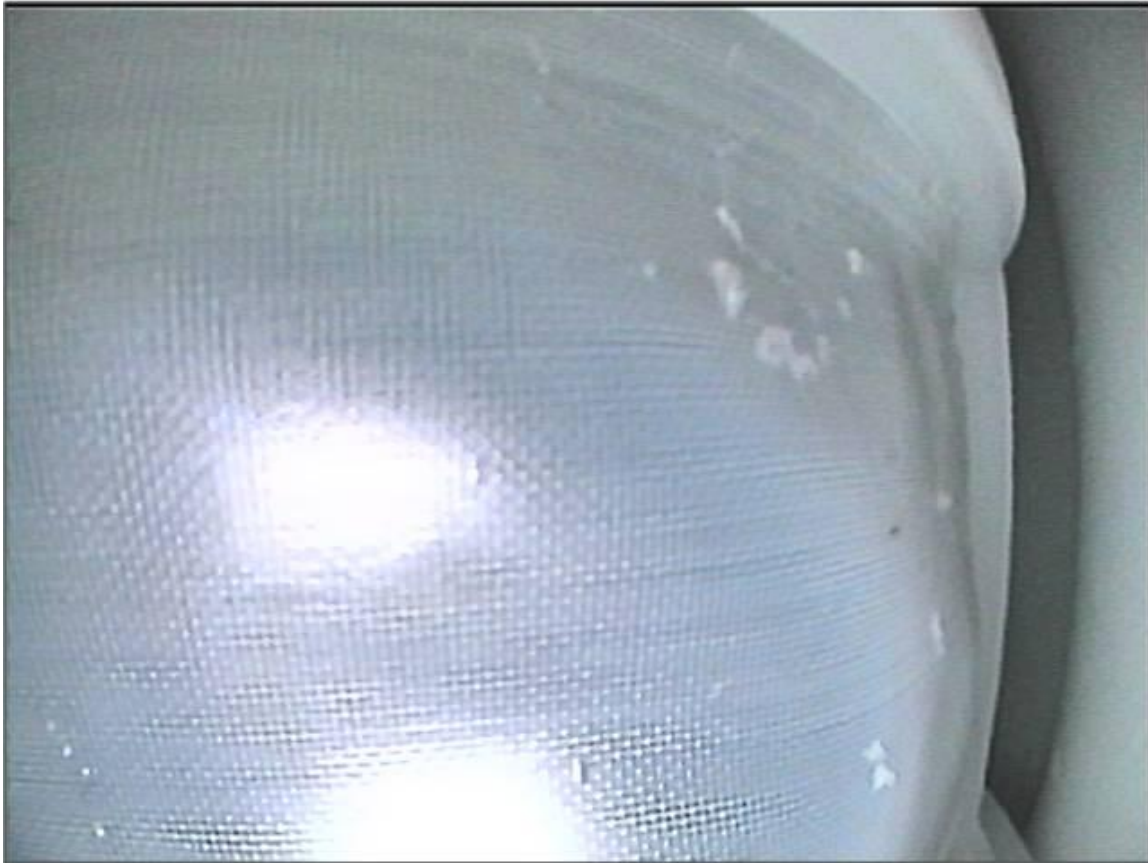
which is a fluid certified for the system. Figure 5 shows one of the HPB filter meshes for the DOT III fluid that appears clean. The image was obtained using a video bore scope to inspect the filter meshes. Any flaky debris on the mesh is either plastic from the window cut out or residual epoxy from the initial attempts to glue the window to the reservoir. There is evidence of adhesive (Figure 5, lower left) on the mesh from the filter assembly manufacturing process.

**Figure 5. Clean DOT III Filter Mesh After 1500-cycles**

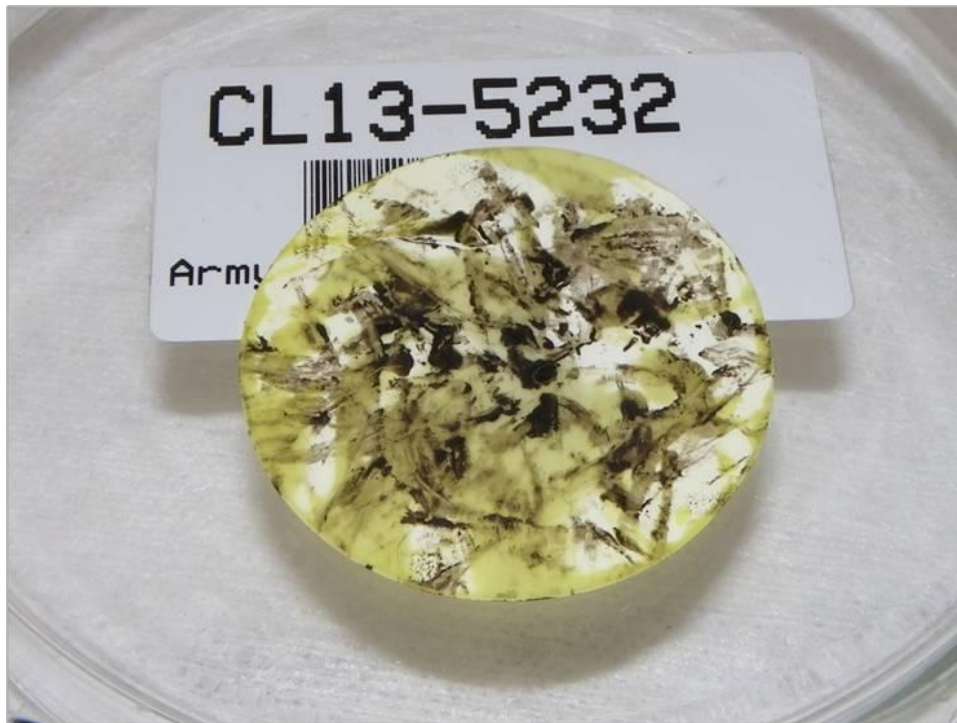
After 7,000 pump and dump cycles were accumulated with the DOT V fluid it was noted a dark viscous fluid appeared to cover the filter mesh, but particulate did not appear evident. There was not any evidence of particulate formation plugging the filter screens. There did appear to be an “ink-like” viscous fluid on the screens that was believed to be the dye for the fluid. A sample of the “ink-like” fluid was scraped off a section of the HPB filter media and onto a glass fiber filter paper as shown in Figure 6. Examination under a microscope revealed dark and metallic particles were suspended in the thickened liquid, Figure 7.

**Figure 6. Scraping from HPB Media of Thickened DOT V Fluid after 7,000 Cycles**

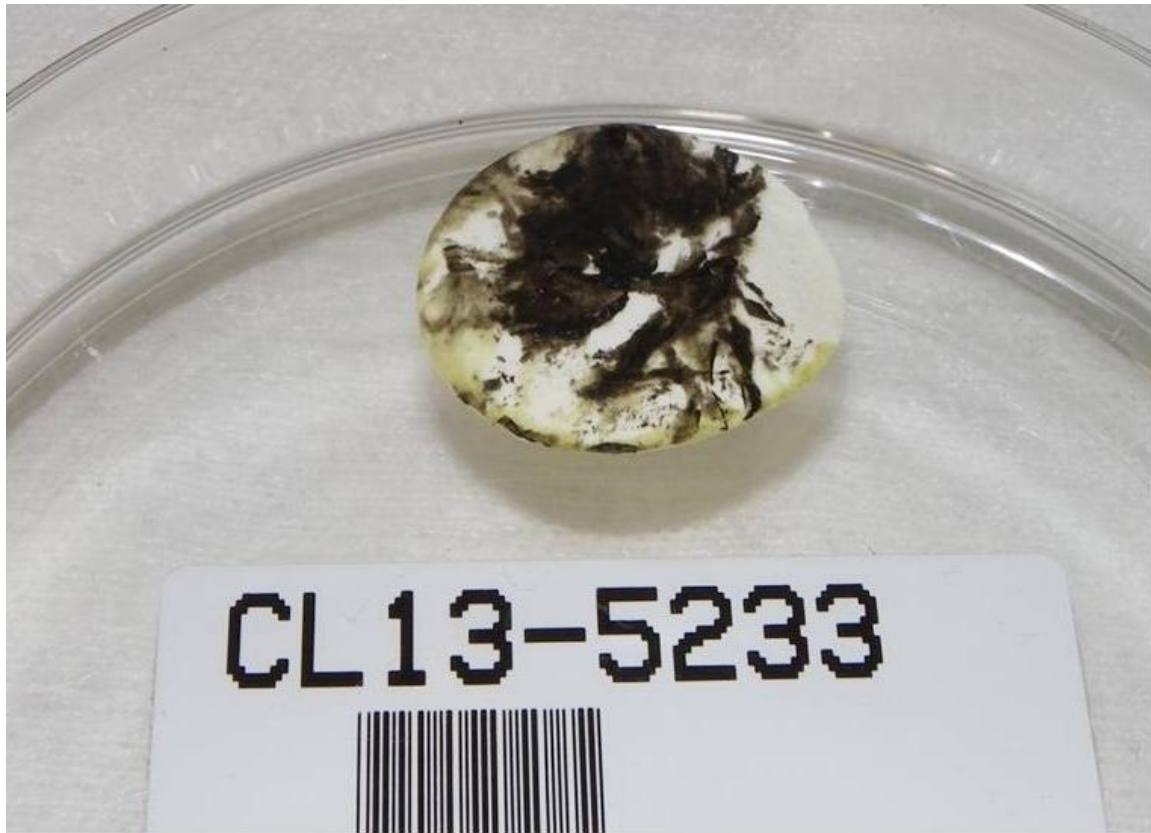
thickened fluid evident at 7,000 cycles was also present, and appeared to be heavier, but did not appear to compromise the filter media. Another scraping was made of the thick fluid, and transferred to glass fiber filter media. The thickened fluid at 11,000 cycles is shown in Figure 11.

**Figure 11. Scraping from HPB Media of Thickened DOT V Fluid after 11,000 Cycles**

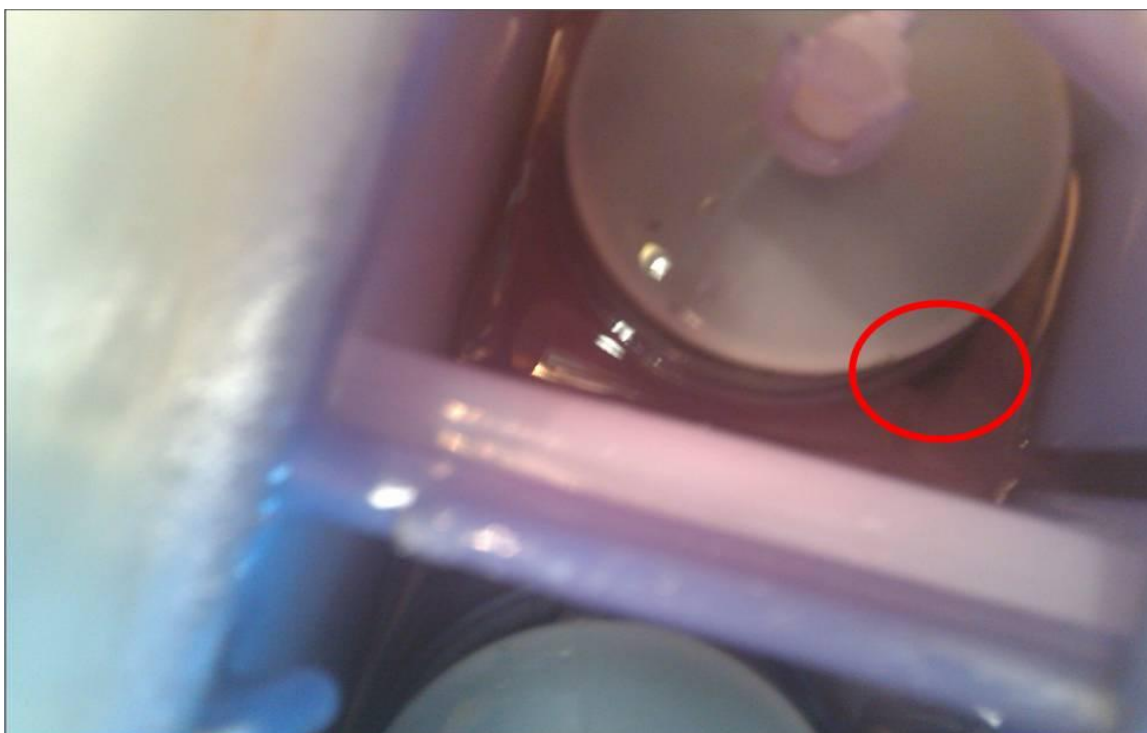
formation in the HPB reservoir. The particulates formed are shown in Figure 14, indicated by the ellipse, as seen in the emptied reservoir. There was not sufficient particulate formed to cause a compromise of the filter media as noted by the manufacturer in prior testing. A pipette was used to withdraw the particulate and the remaining 50-ml of fluid from the HPB reservoir. The 50-ml of fluid was filtered through a 0.7-micron glass fiber filter to capture any particles as shown in Figure 15. The large flake like particle is likely some of the thickened fluid from the HPB filter that was transferred by the pipette. The fluid prior to filtering did appear to have a grayish tint, which usually indicates black particulate is present. The filter media was examined under magnification and black particulate was present along with evidence of metallic particles as shown in Figure 16.

**Figure 14. HPB Reservoir with Particle Accumulation Evident after 15,000 Cycles**

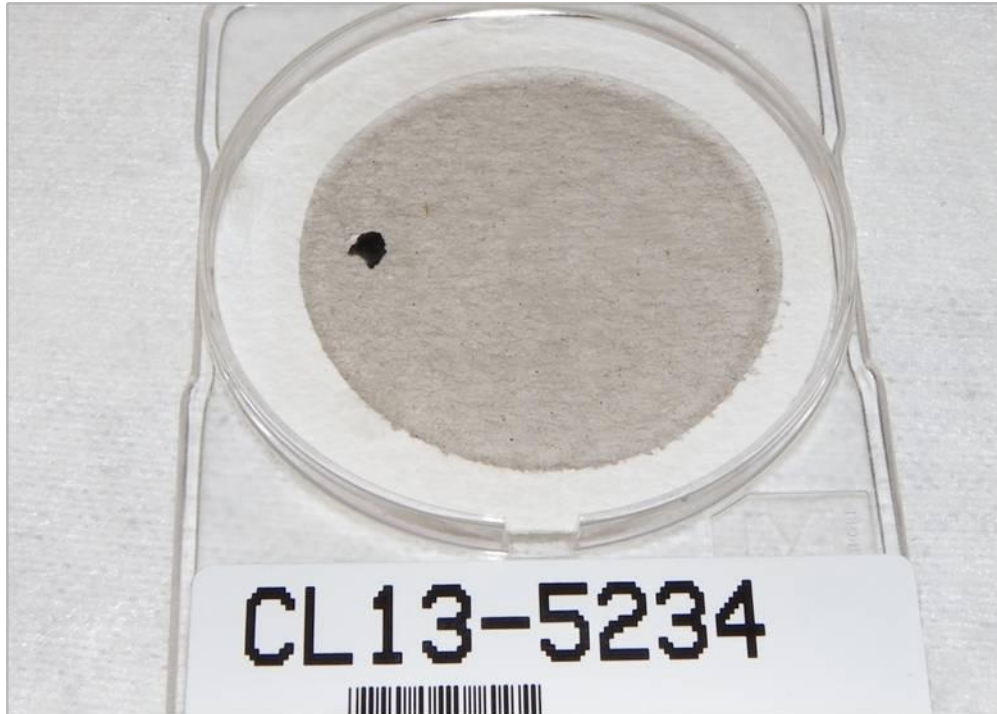
**Figure 15. Filtered DOT V Fluid from Reservoir after 15,000 Cycles.**

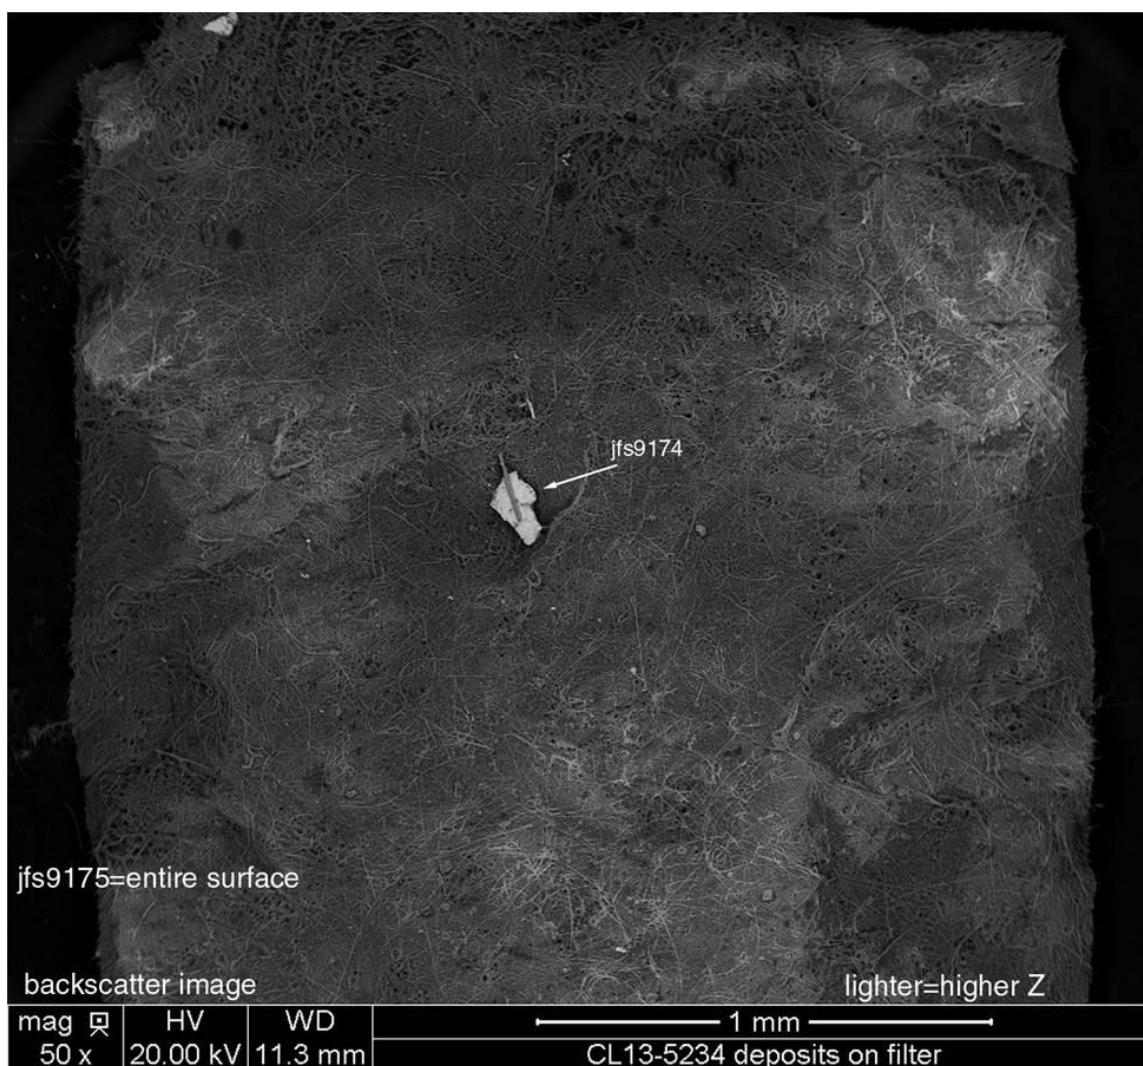
In Figure 16, large and small black particles and large and small metallic particles can be seen. A backscatter SEM image of the large metallic particle is noted jsf9174 in Figure 17, with the elemental analysis of the particle shown in Figure 18. The elemental analysis of particle shows high levels of silicon and zinc. An elemental analysis scan of the filter surface, noted as jsf9175, reveals primarily silicon, as shown in Figure 19. Testing was continued because the filter media did not appear compromised.

**Figure 17. Backscatter SEM Image showing Elemental Analysis Scan Locations of Glass Fiber Filter**

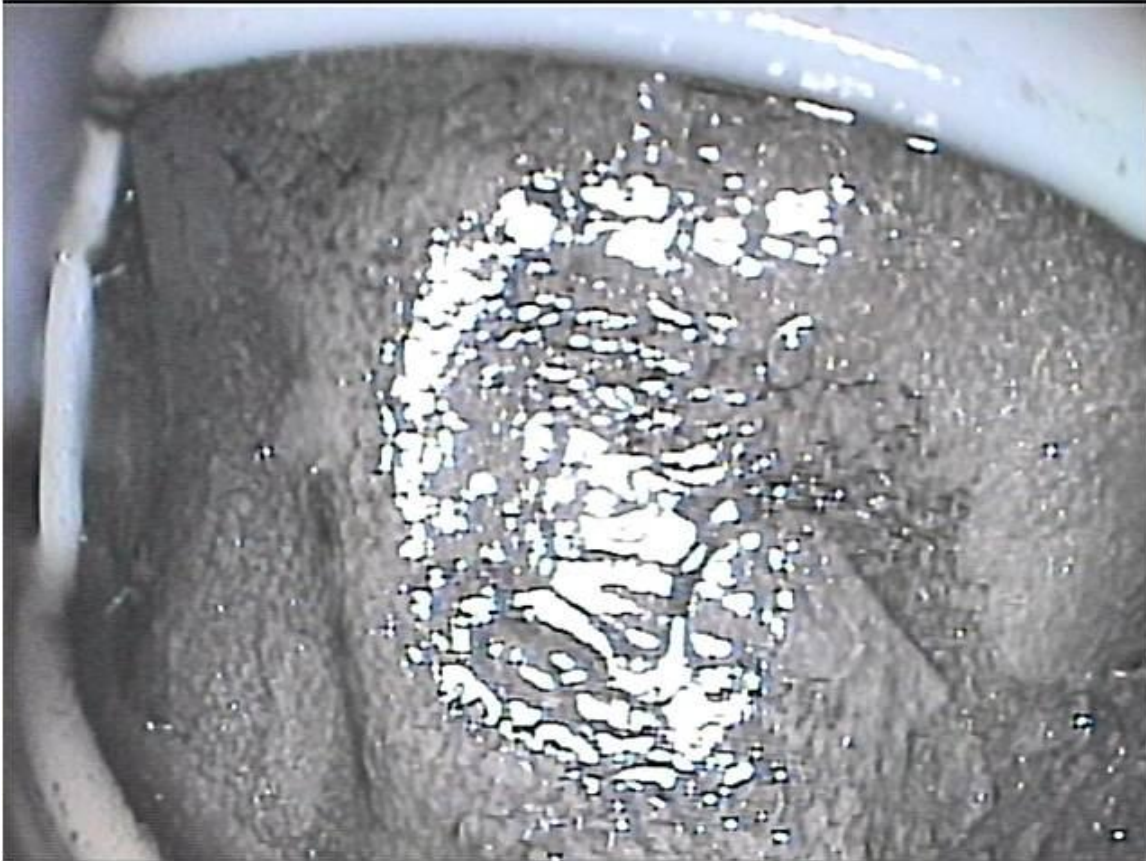
Testing continued till 20,000 cycles when it was noted the filter media appeared to be collapsing. A video bore scope was used to inspect the filter media and filter integrity. Figure 20 shows one of the filter windows covered with a particulate laden viscous fluid, with wrinkling of the filter media suggesting an elevated differential pressure due to the deposition.

**Figure 20. Filter Media after 20,000 Cycles with DOT V Brake Fluid.**

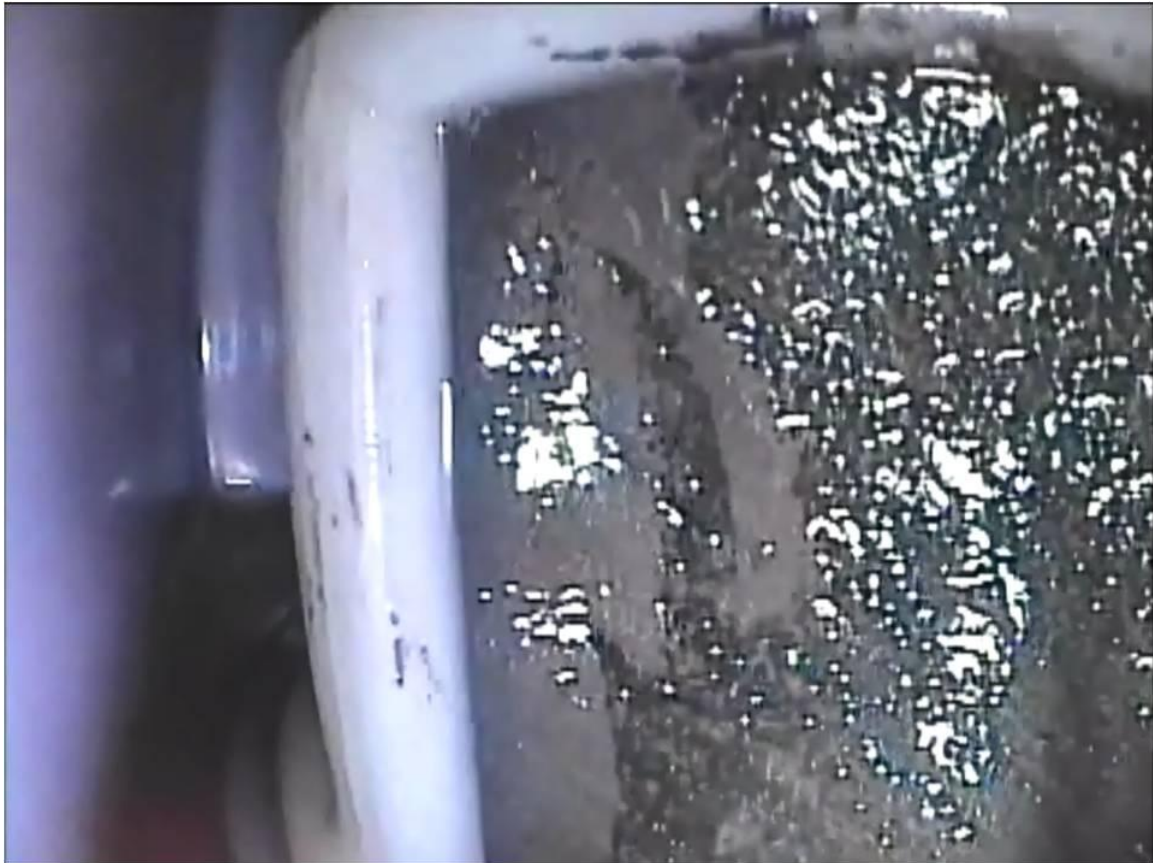
The image shown in Figure 21 is a frame capture from the inspection video of a window of one of the two HPB filters, revealing the accumulation of deposits and viscous fluid. The heaviest accumulation of viscous fluid and deposits are shown in Figure 22 from the second HPB filter. Those shown in Figure 22 are the heaviest of the deposits noted from either of the inspection videos. Although the deposits appeared heavy, and the filter media was wrinkled due to elevated differential pressure, the filter integrity had not been compromised.

**Figure 21. Image Capture From Filter Inspection Video, Revealing Deposits and Viscous Fluid Buildup**

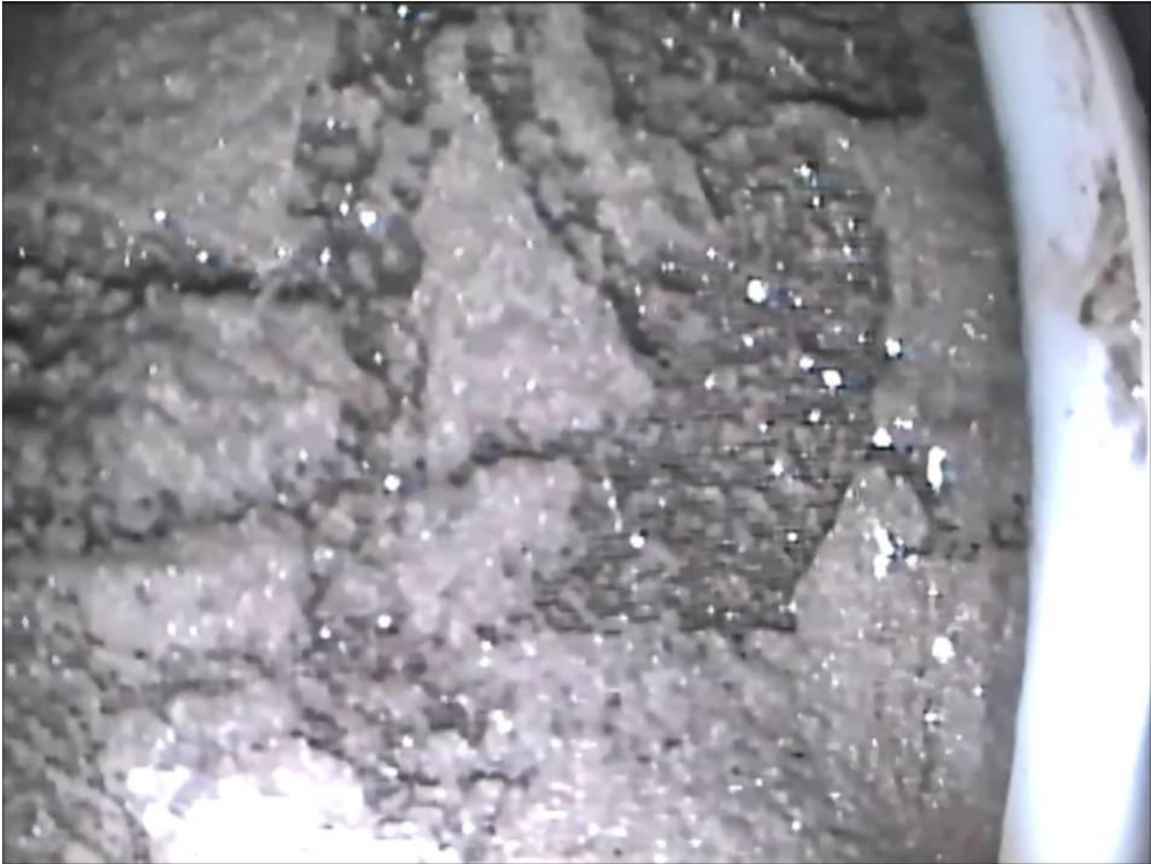
**Figure 22. Heavy Deposition Noted on HPB Filter Media After 20,000 Cycles**

The testing indicated deposits can form with the DOT V brake fluid, however they had not yet compromised the filter integrity, nor had the deposition triggered any malfunction codes in the service control software. Deposit analysis from the earlier cycles indicated that metal particles are present within the viscous fluid, silicon particle matrix, suggesting wear is occurring somewhere in the HPB system.

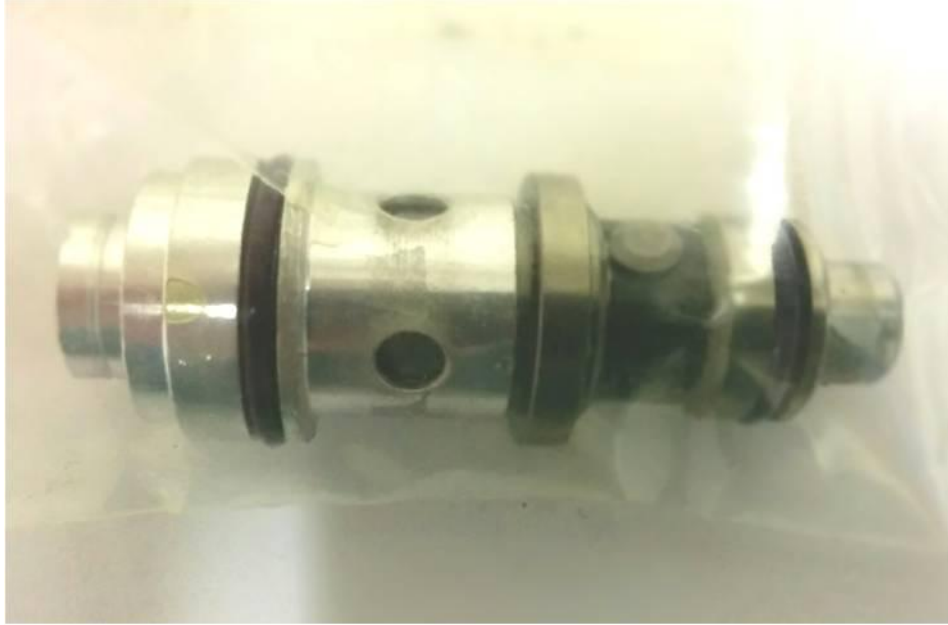
Discussions were held with TARDEC on how to proceed with future testing and analysis. The HPB was disassembled and the pumping elements, filters, and internal components reserved for future inspections for wear and deposits. A pumping element assembly from the DOT V fluid testing is shown in Figure 23. There are new pumping elements available for condition comparison. Samples of new fluid and 20,000-cycle fluids and a filter element with accumulated residue, Figure 24, were shipped to a chemical manufacturer for analysis.

**Figure 23. One of Two HPB Pump Elements From DOT V Fluid Testing**

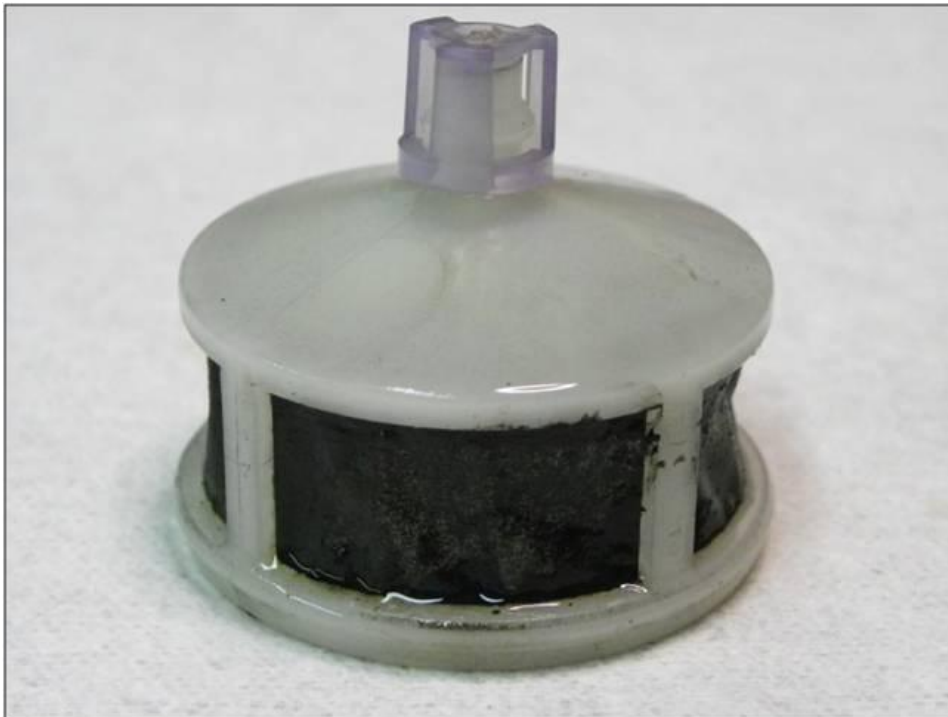
**Figure 24. One of Two HPB Filter Elements with Accumulated Particulate Residue From DOT V Fluid Testing**
