**INSPECTION OF STRYKER TRANSMISSIONS  
EVALUATED USING SCPL IN A 20K MILE RAM-D  
TEST**

**INTERIM REPORT  
TFLRF No. 457**

**U.S. Army TARDEC Fuels and Lubricants Research Facility  
Southwest Research Institute® (SwRI®)  
San Antonio, TX**

**Contract No. W56HZV-09-C-0100 (WD28)**

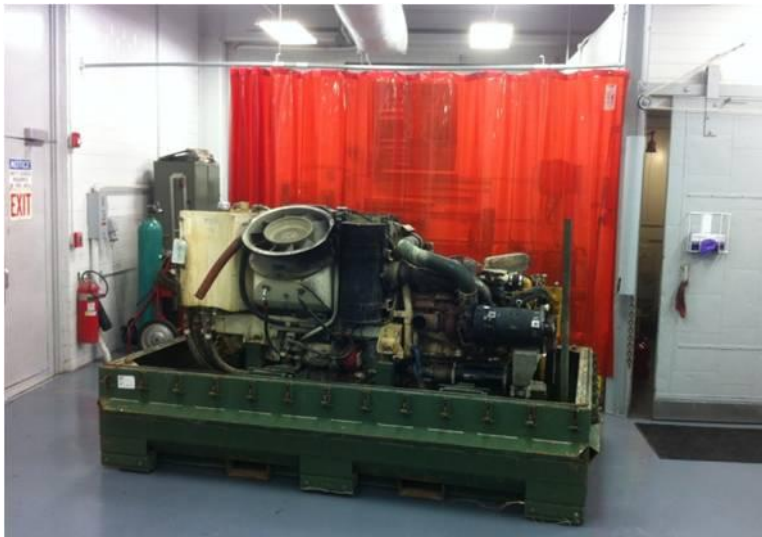
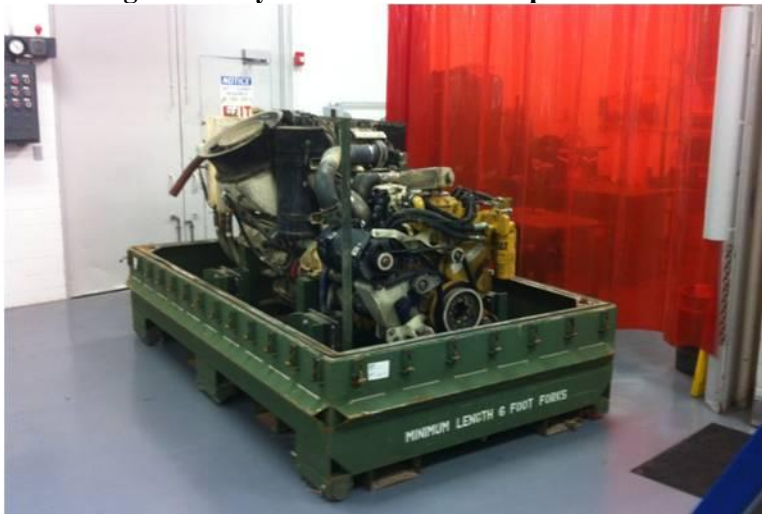
Each transmission was sent to TFLRF in a fully assembled powerpack, in the same manner they would typically be removed from the vehicle for service. This was done as the Caterpillar 3126 engine was needed to support an earlier work directive that covered the engine inspection. Once received, the shipping containers were opened and moved indoors to facilitate disassembly of the full power pack. Figure 1 and Figure 2 show the powerpack assembly of Stryker MEV-013 (CONTROL) prior to removal. The photos below are representative of the condition that both power packs were received in for inspection.

**Figure 1. Stryker MEV-013 Powerpack 1**

**Figure 2. Stryker MEV-013 Powerpack 2**

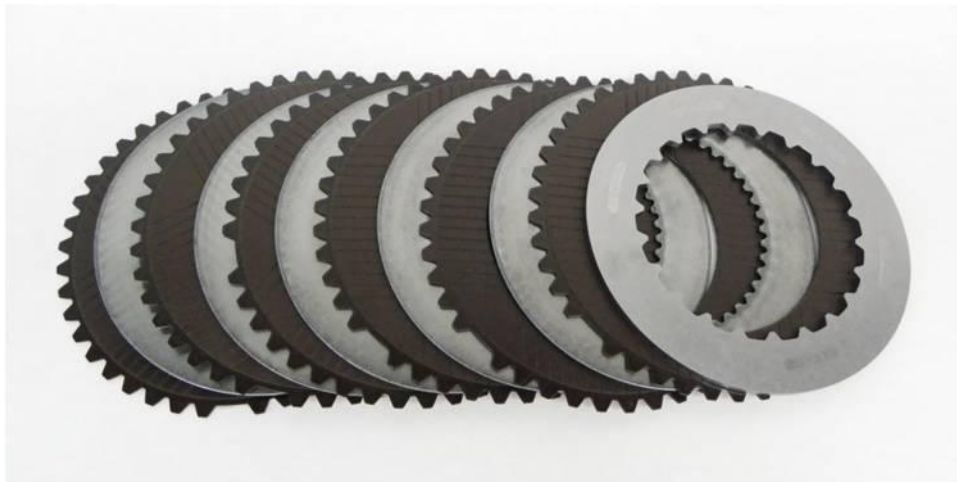
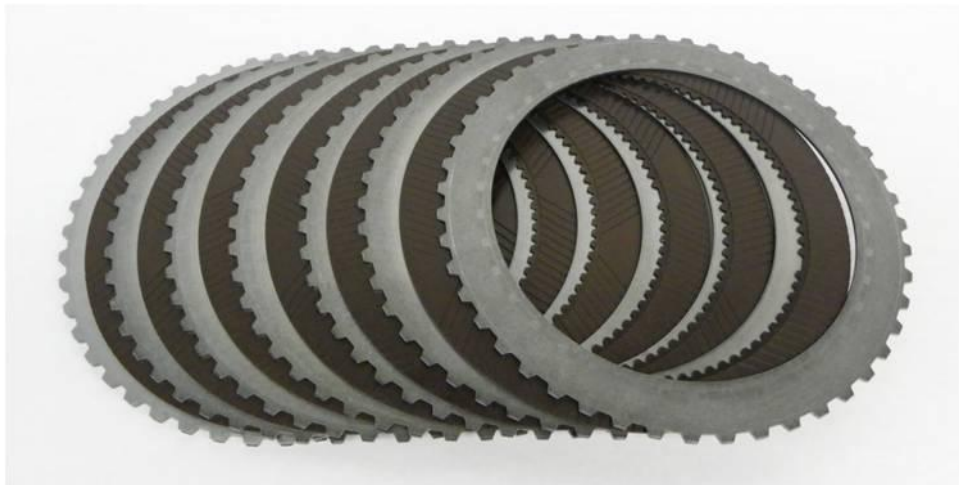
| Component | CONTROL, SN6510652367 | TEST, SN6510637907 |
|---|---|---|
| C1 Clutch | <b>Steel Plates</b> – no abnormal wear, few, very light surface scratch marks with no depth<br><b>Composition Plates</b> – no abnormal wear, no glazing, no discoloration | <b>Steel Plates</b> – no abnormal wear, few, very light surface scratch marks with no depth<br><b>Composition Plates</b> – no abnormal wear, no glazing, no discoloration |
| C2 Clutch | <b>Steel Plates</b> - no abnormal wear, few, very light surface scratch marks with no depth<br><b>Composition Plates</b> – no abnormal wear, no glazing, no discoloration | <b>Steel Plates</b> - no abnormal wear, few, very light surface scratch marks with no depth<br><b>Composition Plates</b> – no abnormal wear, no glazing, no discoloration |

The C1 and C2 clutch assemblies for the TEST and CONTROL transmissions showed nearly identical condition upon removal. No discoloration or glazing was noted on the friction disks, and the reaction plates showed no unusual wear or signs of heat from excessive slipping. Figure 3 through Figure 6 show an overview photo of each C1 and C2 clutch assembly for the TEST and CONTROL units.

**Figure 3. CONTROL Transmission C1 Clutch Assembly**

**Figure 4. TEST Transmission C1 Clutch Assembly**

**Figure 5. CONTROL Transmission C2 Clutch Assembly**

**Figure 6. TEST Transmission C2 Clutch Assembly**

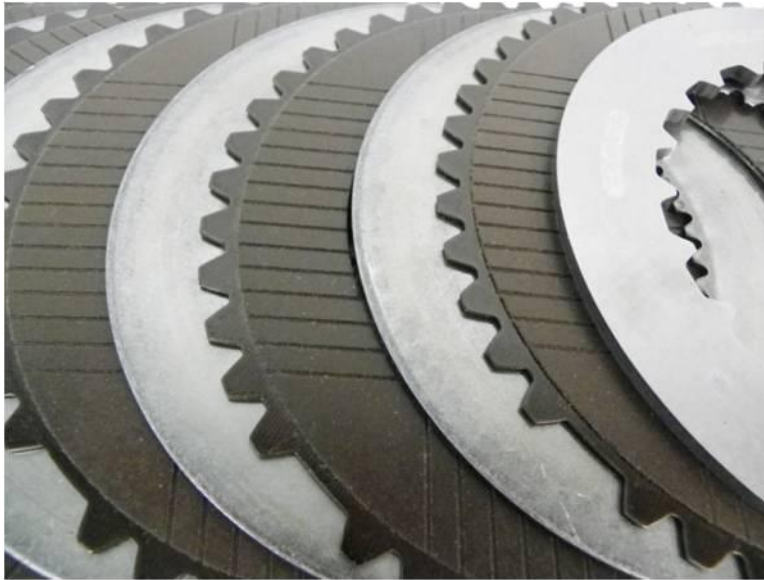
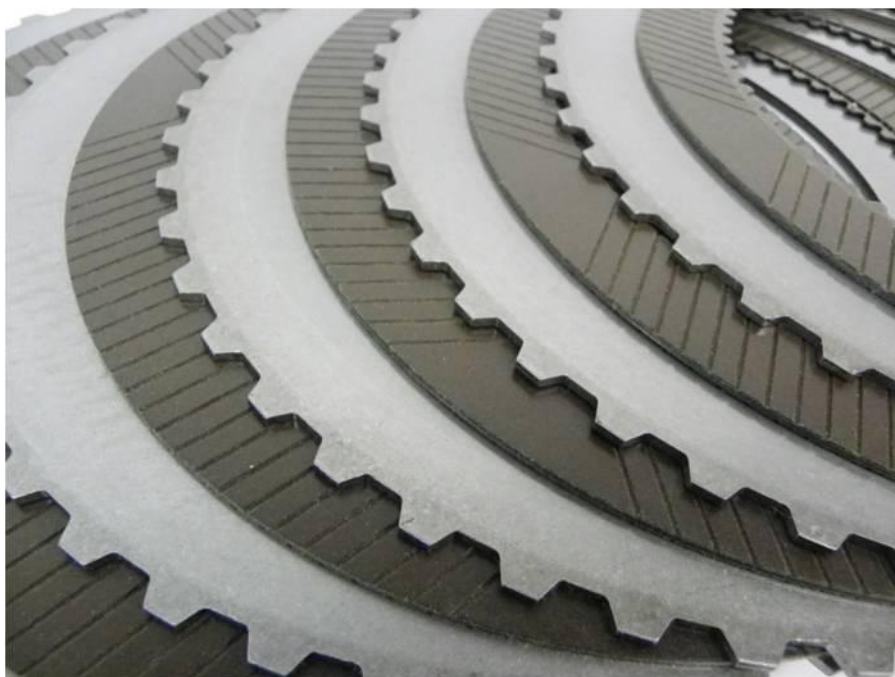
Figure 7 through Figure 10 show close up photos of the C1 and C2 clutch composition surfaces for both the TEST and CONTROL. As shown, both assemblies were found to be in excellent condition, without evidence of excessive heat, wear, or distress of the friction or steel reaction plate surfaces.

**Figure 7. CONTROL Transmission C1 Clutch Assembly (Close-up)**

**Figure 8. TEST Transmission C1 Clutch Assembly (Close-up)**

**Figure 9. CONTROL Transmission C2 Clutch Assembly (Close-up)**

**Figure 10. TEST Transmission C2 Clutch Assembly (Close-up)**

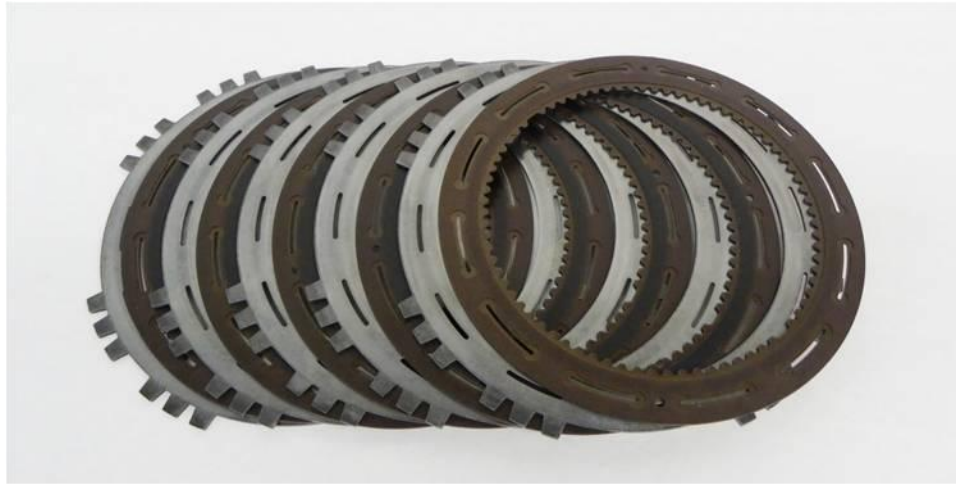
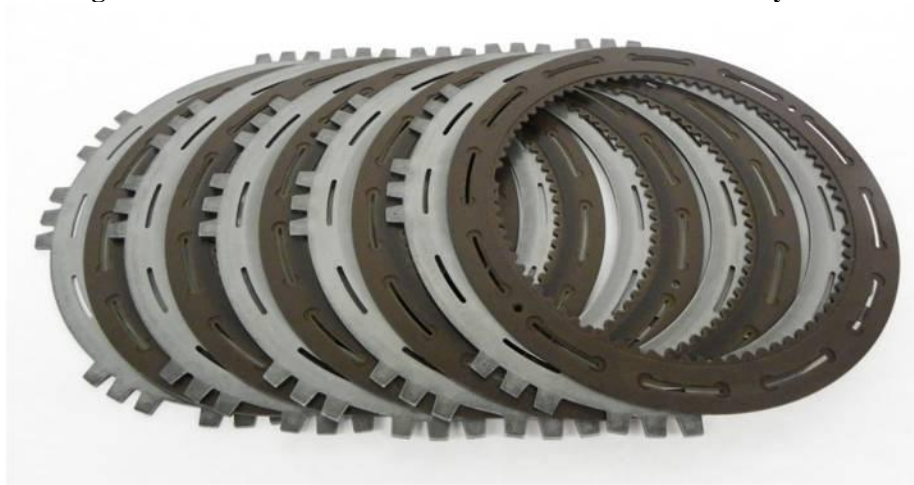
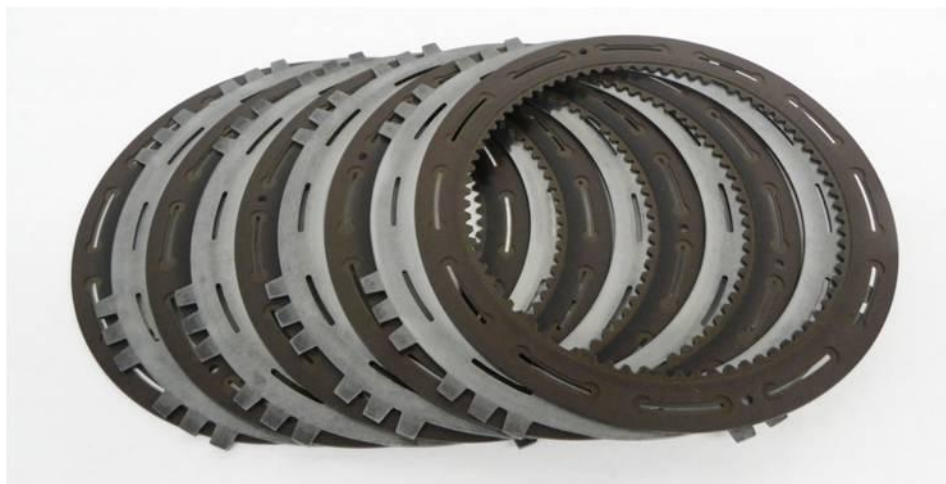
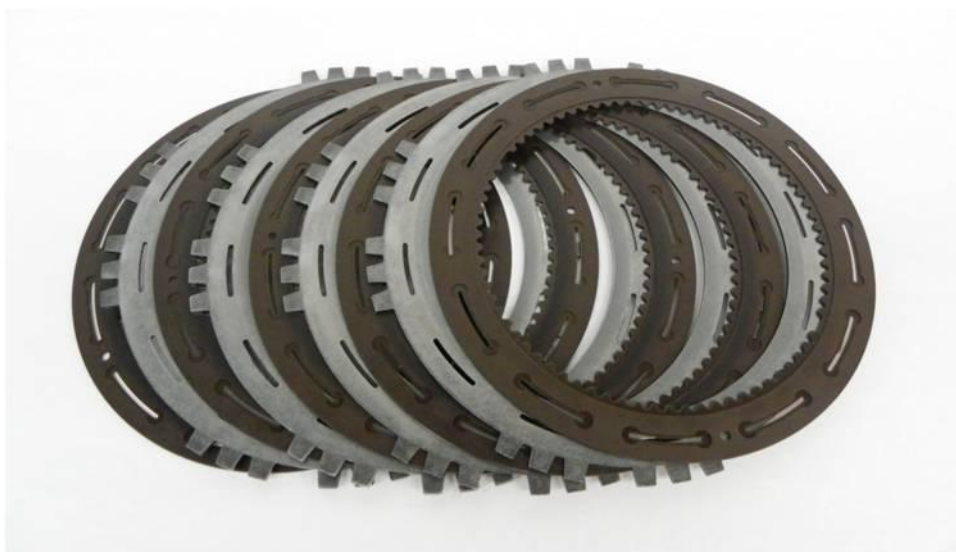
| Component | CONTROL, SN6510652367 | TEST, SN6510637907 |
|---|---|---|
| C3 Clutch | <b>Steel Plates</b> –some grey discoloration on 35 to 40% on inner diameter of plates, no abnormal wear<br><b>Composition Plates</b> – brown to black discoloration on 35 to 40% on inner diameter of plates, no abnormal wear, no glazing | <b>Steel Plates</b> – some grey discoloration on 35 to 40% on inner diameter of plates, no abnormal wear<br><b>Composition Plates</b> – brown to black discoloration on 35 to 40% on inner diameter of plates, no abnormal wear, no glazing |
| C4 Clutch | <b>Steel Plates</b> - some grey discoloration on 35 to 40% on inner diameter of plates, no abnormal wear<br><b>Composition Plates</b> - brown to black discoloration on 35 to 40% on inner diameter of plates, no abnormal wear, no glazing, no abnormal wear | <b>Steel Plates</b> - some grey discoloration on 35 to 40% on inner diameter of plates, no abnormal wear<br><b>Composition Plates</b> - brown to black discoloration on 35 to 40% on inner diameter of plates, no abnormal wear, no glazing, no abnormal wear |

As previously mentioned, the C3 and C4 clutch assemblies for both transmissions did show some discoloration of the friction material. This was found to be relatively minor, and only occurred

on approximately 35-40% of the inner disk diameter on each clutch assembly. As would be expected, the steel reaction plates also showed some light grey discoloration from the additional heat, but results were functionally identical between both the TEST and CONTROL transmissions, suggesting that the SCPL demonstrated comparable performance to the commercial ATF. Figure 11 through Figure 14 show the C3 and C4 clutch assemblies for the TEST and CONTROL transmissions respectively.

**Figure 11. CONTROL Transmission C3 Clutch Assembly**

**Figure 12. TEST Transmission C3 Clutch Assembly**

**Figure 13. CONTROL Transmission C4 Clutch Assembly**

**Figure 14. TEST Transmission C4 Clutch Assembly**

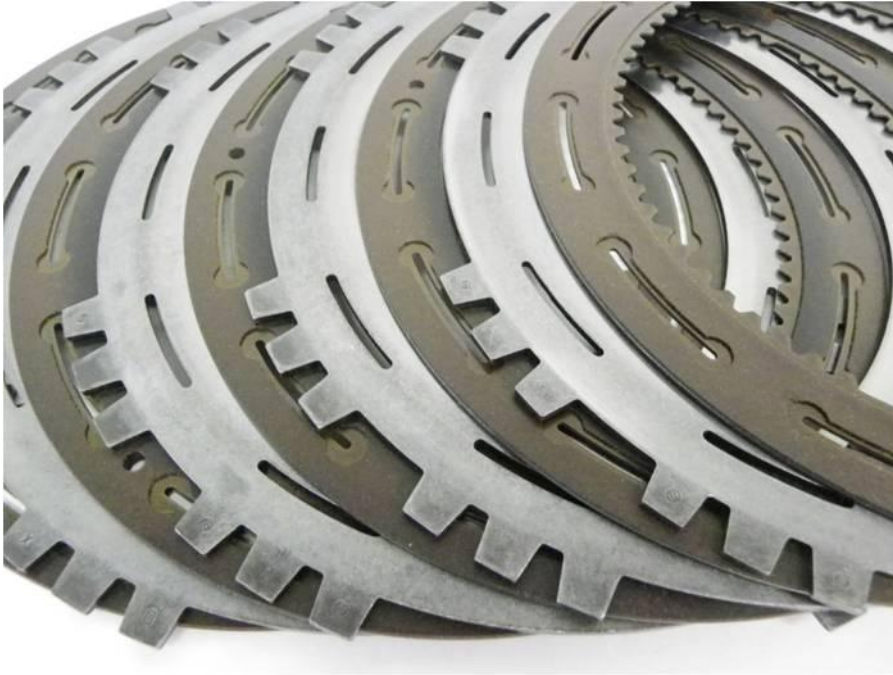
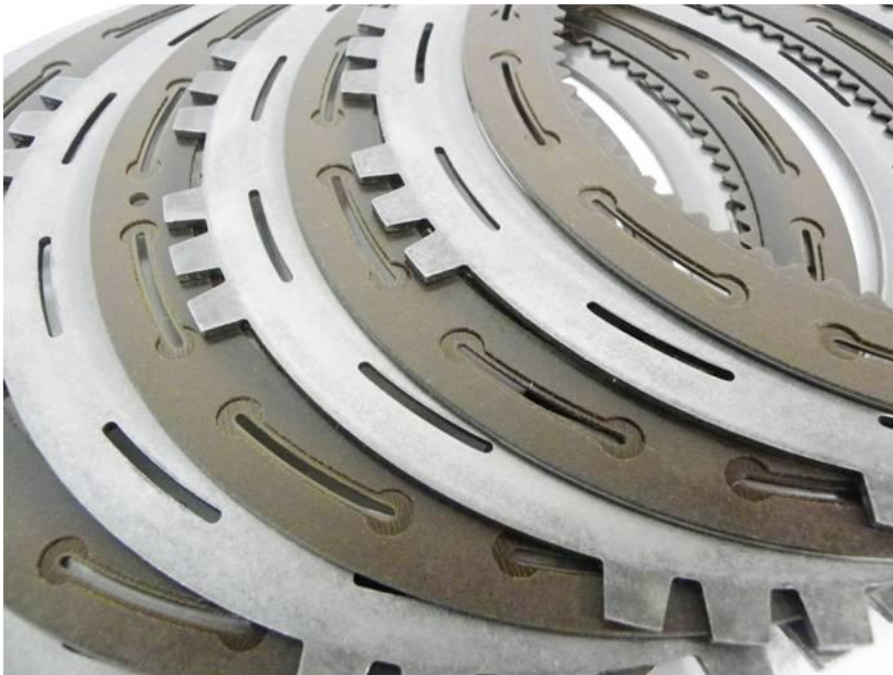
Figure 15 through Figure 18 (next 2 pages) show close up photos of the C3 and C4 clutch disks composition and reaction plates for both transmissions. This close-up shot better shows the discoloration present on the composition disks, but also conveys its overall minor nature.

**Figure 15. CONTROL Transmission C3 Clutch Assembly (Close-up)**

**Figure 16. TEST Transmission C3 Clutch Assembly (Close-up)**

**Figure 17. CONTROL Transmission C4 Clutch Assembly (Close-up)**

**Figure 18. TEST Transmission C4 Clutch Assembly (Close-up)**

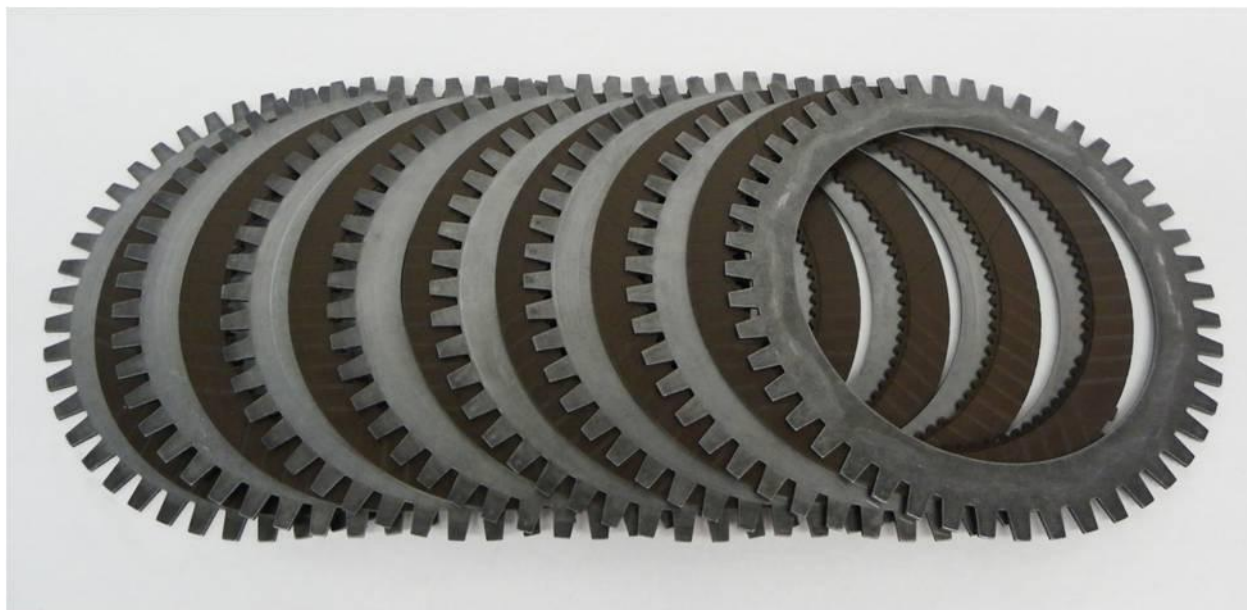
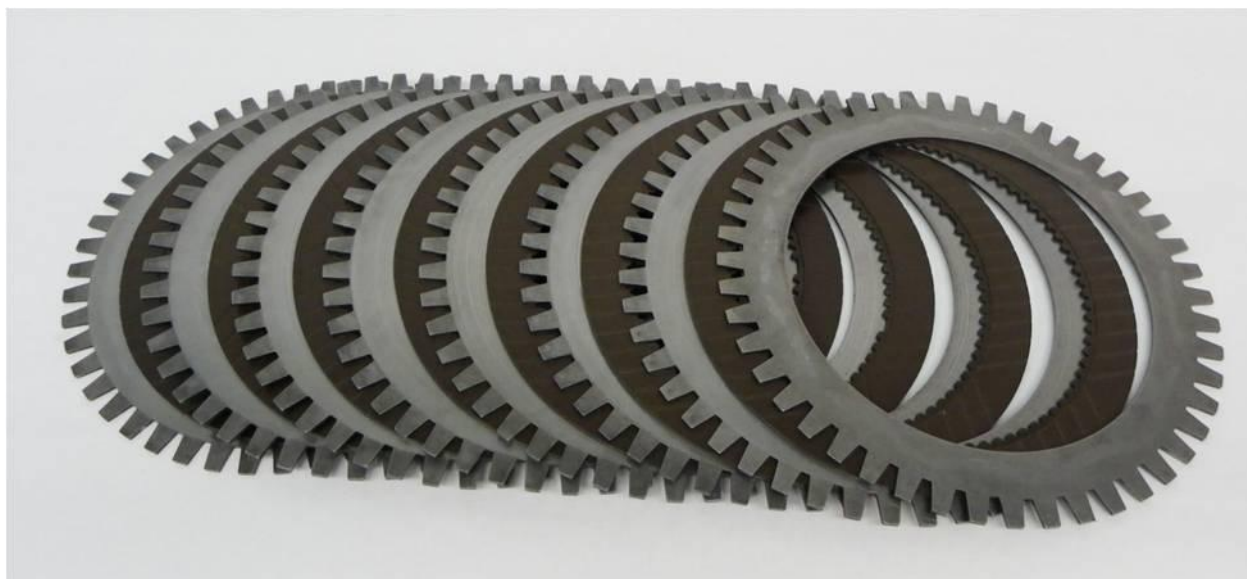
| Component | CONTROL, SN6510652367 | TEST, SN6510637907 |
|---|---|---|
| C5 Clutch | <b>Steel Plates</b> - no abnormal wear, light surface scratch marks with no depth around circumference of plates<br><b>Composition Plates</b> – no abnormal wear, no glazing, no discoloration | <b>Steel Plates</b> - no abnormal wear, light surface scratch marks with no depth around circumference of plates<br><b>Composition Plates</b> – no abnormal wear, no glazing, no discoloration |

Figure 19 and Figure 20 show the C5 clutch assemblies. Like the C1 and C2 clutches, overall condition was found to be good, and both the TEST and CONTROL yielded similar component conditions. Figure 21 and Figure 22 (next page) show the close-up shots of the composition and reaction plates for the C5 assembly.

**Figure 19. CONTROL Transmission C5 Clutch Assembly**

**Figure 20. TEST Transmission C5 Clutch Assembly**

**Figure 21. CONTROL Transmission C5 Clutch Assembly (Close-up)**

**Figure 22. TEST Transmission C5 Clutch Assembly (Close-up)**

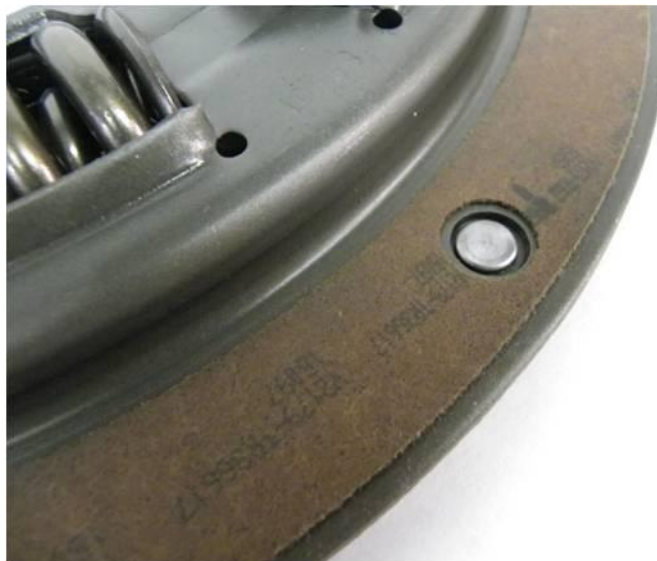
| Component | CONTROL, SN6510652367 | TEST, SN6510637907 |
|---|---|---|
| Converter Lock-Up Plate | <b>Damper Springs</b> – all springs intact, and in good working order<br><b>Composition Material</b> – no abnormal wear, no glazing, identification stamping is still visible on plates | <b>Damper Springs</b> – all springs intact, and in good working order<br><b>Composition Material</b> – no abnormal wear, no glazing, identification stamping is still visible on plates |

For the lockup clutch, neither of the assemblies showed excessive wear or signs of glazing consistent with results seen in all other clutch assemblies. Figure 23 and Figure 24 show the CONTROL transmission lockup clutch. As previously mentioned, factory markings can still be seen on the composition surface indicating little wear occurred to the composition material.

**Figure 23. CONTROL Torque Converter Lockup Clutch**

**Figure 24. CONTROL Torque Converter Lockup Clutch (Close-up)**

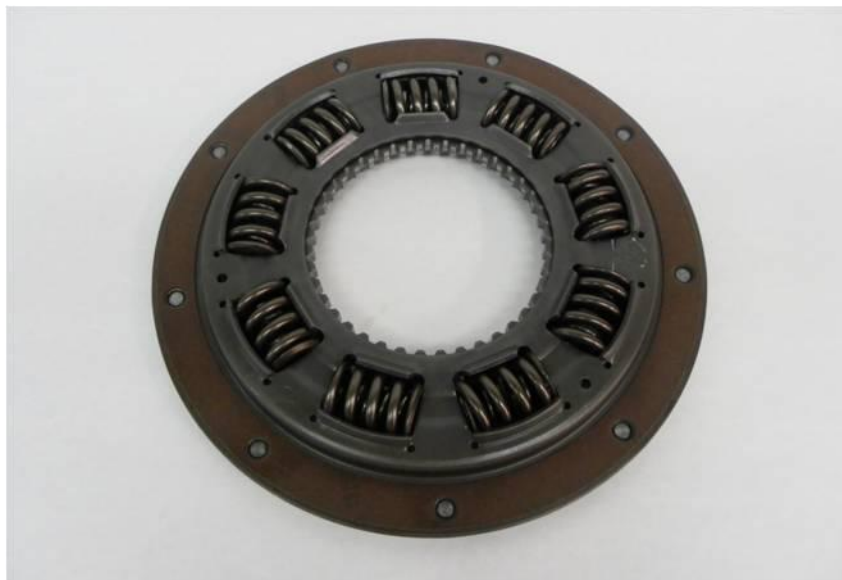
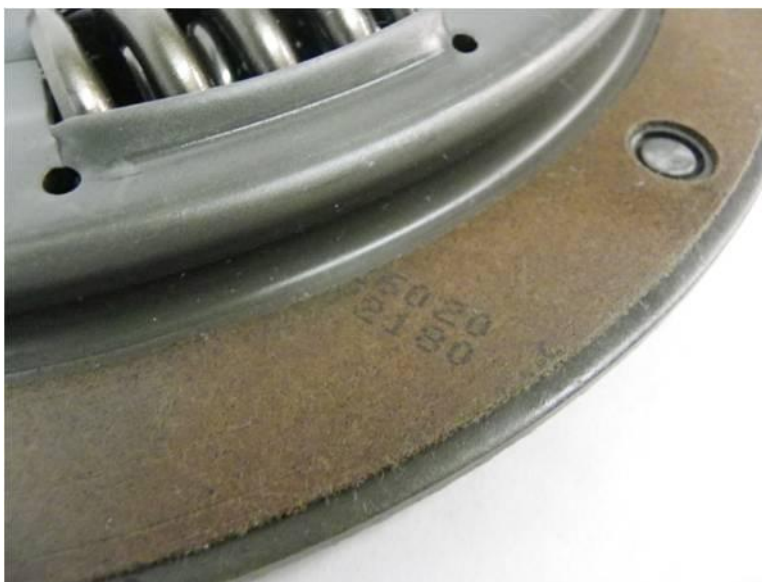
Figure 25 and Figure 26 show the lockup clutch photos for the TEST transmission. Like the CONTROL unit, factory markings can still be seen on its composition surface as well.

**Figure 25. TEST Torque Converter Lockup Clutch**

**Figure 26. TEST Torque Converter Lockup Clutch (Close-up)**

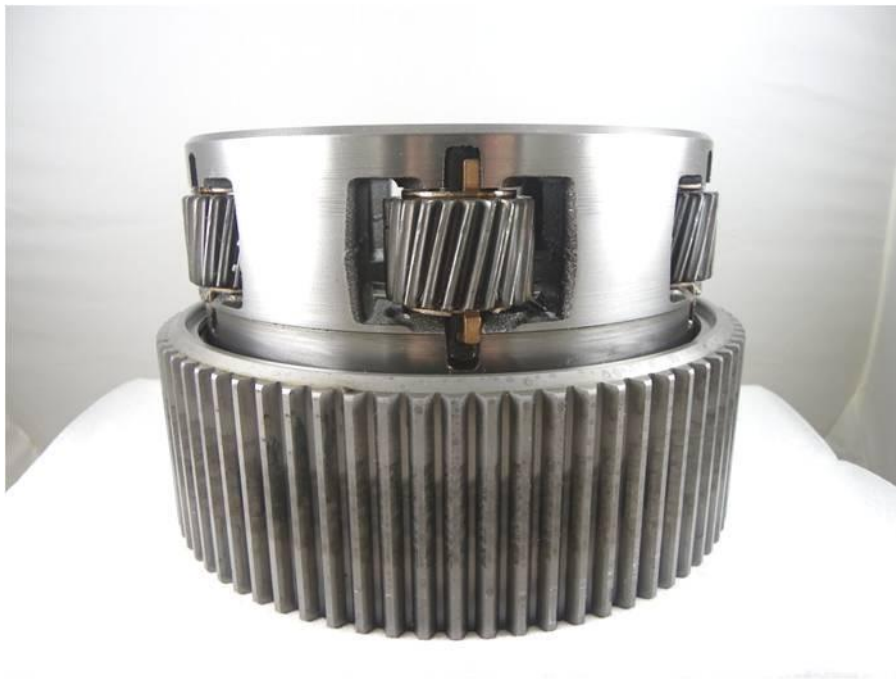
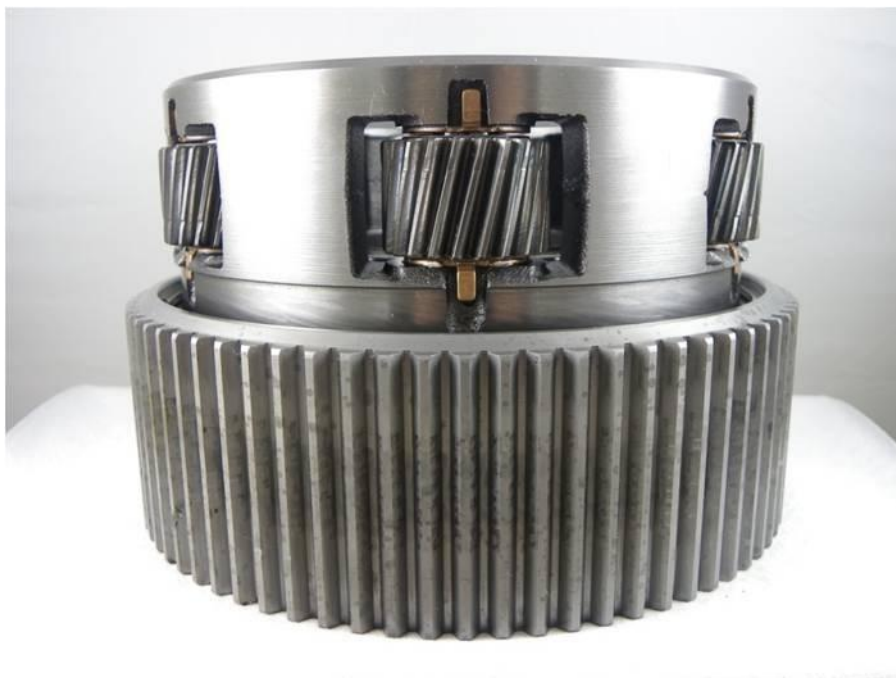
| Component | CONTROL, SN6510652367 | TEST, SN6510637907 |
|---|---|---|
| P1 Planetary Module | Polished gear teeth, no abnormal wear | Polished gear teeth, no abnormal wear |

Consistent with all previous observations, inspection of the planetary gear sets also showed little discrimination between the two evaluated lubricants. All preliminary SCPL candidates had previously undergone standardized FZG gear wear testing during early lubricant development phases yielding positive results, so there was little expectation that the SCPL would show any unusual compatibility with the transmission gear sets themselves. Figure 27 and Figure 28 (next page) shows the P1 planetary module removed from the CONTROL and TEST transmissions, and confirm the SCPL provided adequate protection. As reporting in the ratings, both modules were noted to have normal polishing on the contact surfaces of the planetary gear teeth, but both were found void of any abnormal wear that would suggest lubrication issues. Likewise the outer ring gear of the P1 module which engages the internal splines of the C3 clutch assembly showed no abnormal wear, with only normal contact markings visible on the gear faces from engagement with the internal clutch disk teeth. These same general observations proved true for the P2 and P3 modules as well. All results suggest that the SCPL successfully provided adequate protection of the internal gear sets, and provided performance levels comparable to the specifically tailored commercial ATF. (Note - As a result of their unremarkable nature, photographs of the P2 and P3 modules were not included in reporting).

**Figure 27. CONTROL P1 Planetary Gear Module**

**Figure 28. TEST P1 Planetary Gear Module**

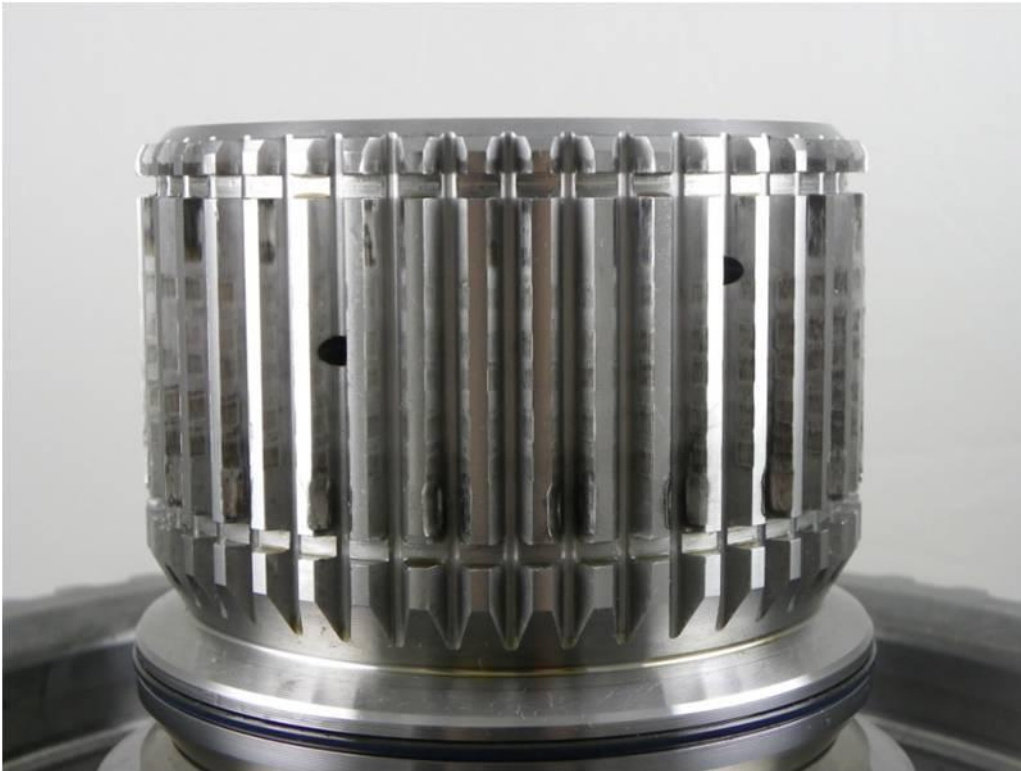
| Component | CONTROL, SN6510652367 | TEST, SN6510637907 |
|---|---|---|
| Rotary Clutch Drum | <b>Balance Piston</b> – no wear<br><b>Shaft</b> – Light contact marks where clutch plate inner teeth mesh | <b>Balance Piston</b> – No Wear<br><b>Shaft</b> - Heavy wear at piston contact area*, light contact marks where clutch plate inner teeth mesh |

As previously mentioned, the main area that did stand out during inspection were signs that the TEST transmission had undergone some sort of previous service or rebuild. The primary support of this was wear noted on the splined shaft of the rotary clutch drum assembly. During its inspection, heavy contact wear was noted on every other spline on the shaft in the area where the balance piston rides and engages. This can be seen below in Figure 29, and again in a close up photo in Figure 30.

**Figure 29. TEST Transmission Balance Shaft Spine Wear**

**Figure 30. TEST Transmission Balance Shaft Spline Wear (Close-up)**

As shown, the wear was found present on every other spline tooth on the shaft, and is consistent with the skip tooth engagement of the balance piston that rides on the shaft and engages the splines (Figure 31).

This unusual wear discrepancy serves as the single biggest indicator that the TEST transmission had sometime in its history received major service/rebuild prior to the RAM-D testing. The balance piston, which is comprised of a relatively soft aluminum alloy, would have been expected to show significant corresponding wear to that seen on the harder splines if in fact the spline wear was a result of current testing. As the TEST transmission balance piston teeth appear to be virtually unworn, this indicates that the orientation of the balance piston upon installation was such that the piston teeth were NOT in contact with worn shaft splines, and had instead sometime previously been re-indexed during service to the unworn splines. As stated by the Allison transmission technicians, this is common practice in transmission overhaul, as the skip tooth engagement allows reinstallation of a new piston and reuse of the partially worn shaft by changing the engagement orientation to the unworn teeth. This type of action reduces the cost of an overhaul, as the rest of the balance shaft would still remain in usable condition apart from the localized wear that cannot be avoided. Since the balance piston removed from the RAM-D TEST transmission showed virtually no wear, it can only be surmised that the wear seen on the balance shaft splines was pre-existing. There was no evidence that the wear occurred as a result of SCPL use, and nothing was found to suggest that this issue could have biased the results of testing.

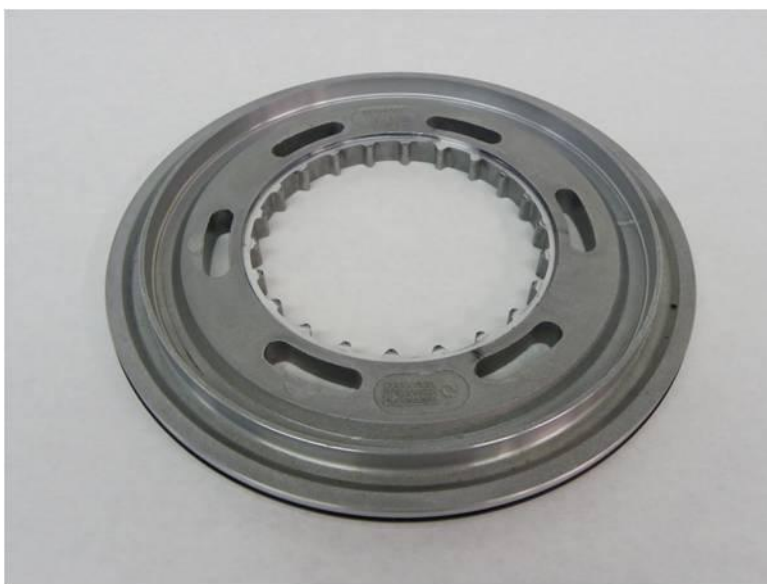
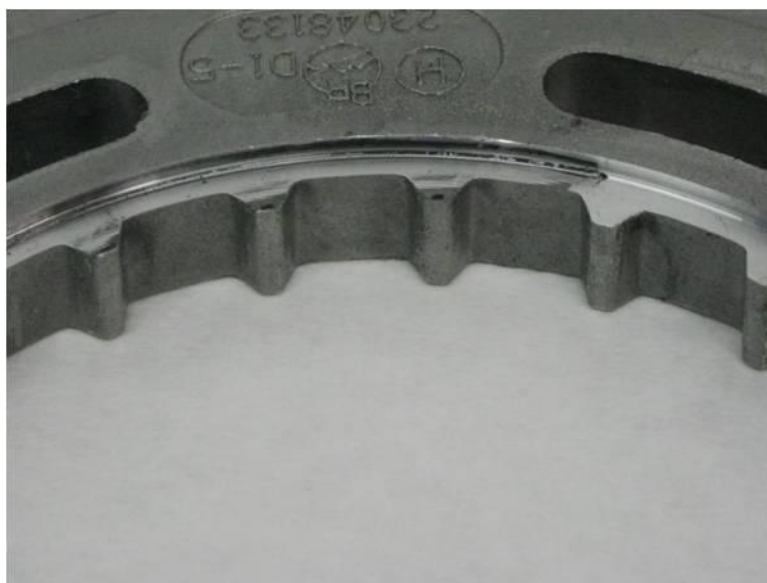
Despite the wear seen on the shaft splines, the engagement teeth of the TEST transmission balance piston (shown in Figure 32 and Figure 33) did not show corresponding damage when inspected. This is inconsistent with what would be expected based on the shaft spline wear.

**Figure 32. TEST Transmission Balance Piston**

**Figure 33. TEST Transmission Balance Piston (Close-up)**
