## **Architectural Survey of Ohio Army National Guard Properties: Volume I**

Under Project 405180, "OHARNG Architectural Survey"

This document is Volume I of a two-volume architectural survey of 85 buildings and structures utilized by the Ohio Army National Guard and located across the state of Ohio. The majority of these structures were constructed from 1920 to 1968, with others constructed from 1969 to 1988. This survey satisfies Section 110 of the National Historic Preservation Act of 1966 as amended, and was used to determine the eligibility of these buildings and structures for inclusion on the National Register of Historic Places (NRHP). It is the recommendation of this report that 19 armories and 4 associated support buildings are significant under NRHP criteria and retain enough integrity to be individually eligible for the NRHP. Volume II of this report is published separately and contains the ERDC-CERL architectural survey forms.

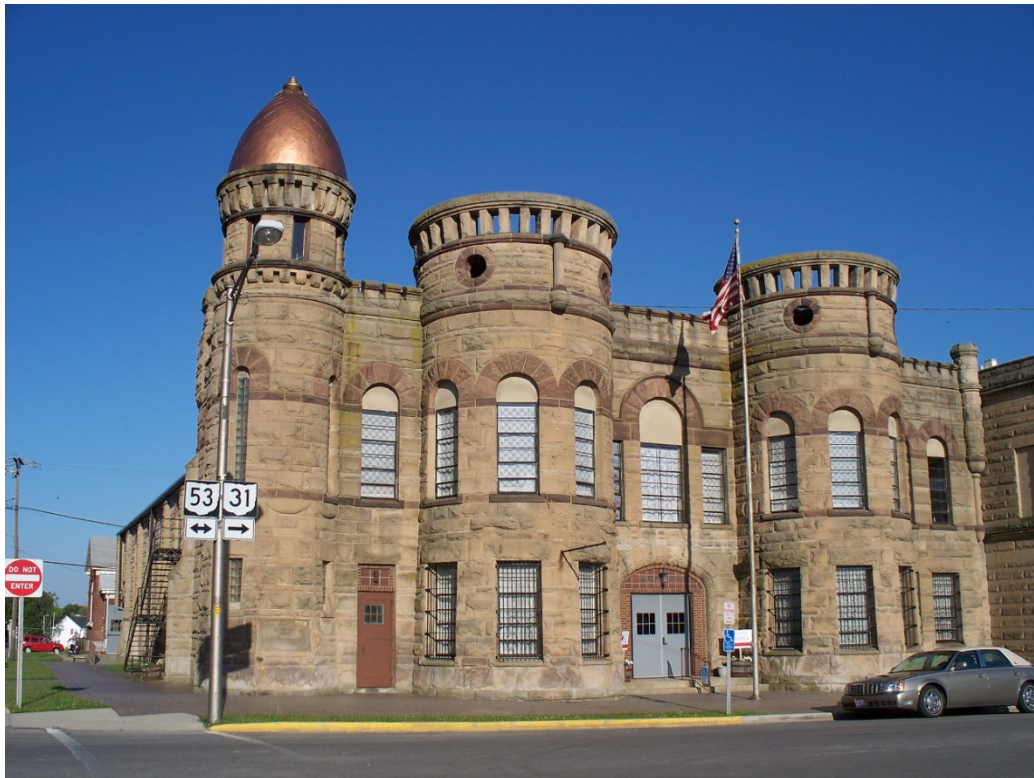
Figure 2. Example of a Castellated-style armory in Kenton, Ohio (courtesy scottamus@flickr.com, 2009).

The Castellated-style armories were designed with details such as thick masonry walls, large arched windows, stone detailing, narrow fenestrations, turrets, towers, and battlements. Interior spaces included a dressing room, offices, central corridor, brick interior walls, and space for amusement and club purposes, which was important for unit morale and promoted successful recruiting, an imperative with volunteer units. The drill hall was the main focus of the interior and was highlighted by a wood plank floor and an elaborate wood truss system. The St. Marys Armory constructed in 1920 follows this style of armory construction

Armories prior to the end of the Civil War were viewed primarily as storage facilities and protection from anticipated attacks. From after the Civil War to the start of World War I (WWI), each National Guard armory served particular areas of the state. After WWI, armories still had this use, but they also served as community centers since the buildings were typically near the center of towns and had large drill spaces. This change in use and function was reflected in armory architectural designs that moved from the heavily fortified and Castellated design of earlier armories (Figure 2) to ones that reflected a multipurpose function.

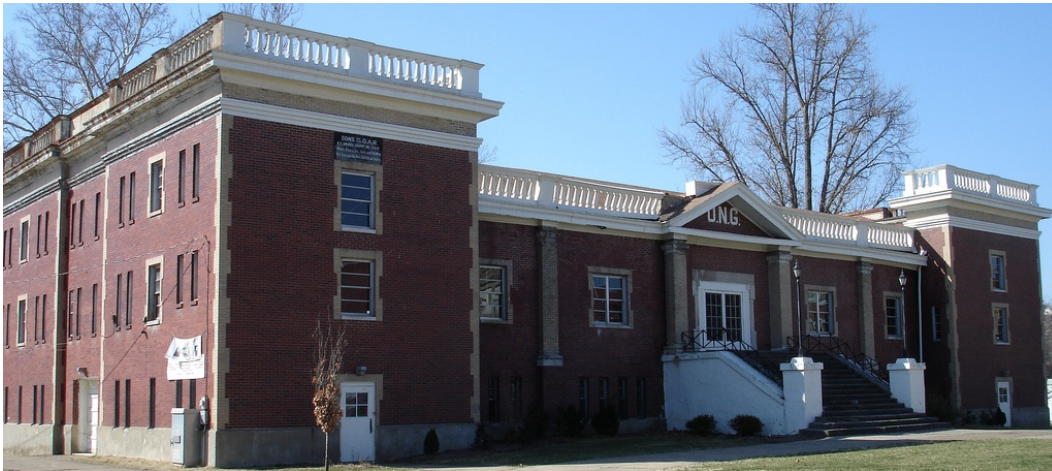
**Figure 3.** Example of a Georgian Revival style armory in Marietta, Ohio (courtesy Seth Gaines@flickr.com, 2006).

The evolution of armory design also followed national trends in architectural design. The Castellated design transformed into various revival designs (Figure 3) and, by the end of the 1930s, designs moved toward the Art Deco and Art Moderne styles (Figure 4). Post-WWI designs typically featured a high roof over a drill hall (Figure 5). This design element made possible the drill hall's use for indoor athletic events and presented a less military and more contemporary appearance on the exterior.

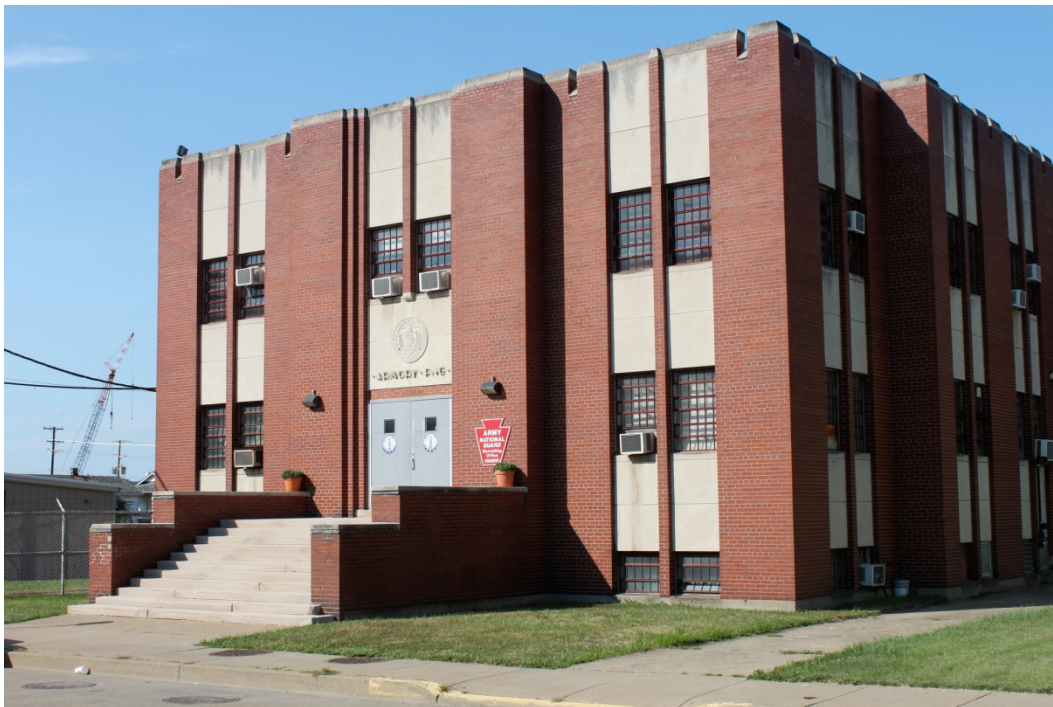
Figure 4. Example of an Art Deco style armory in Coraopolis, Ohio (courtesy Joseph a@flickr.com, 2012).

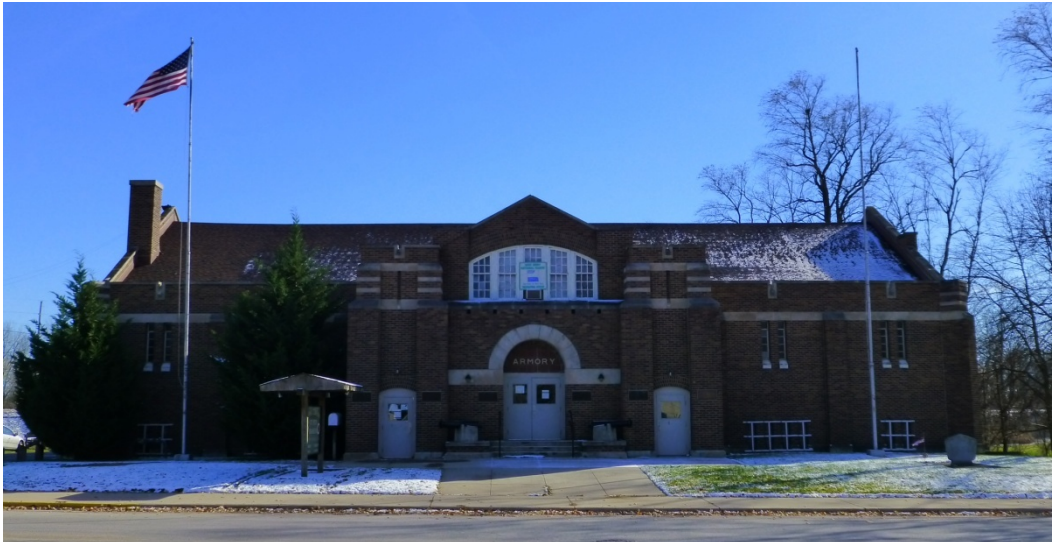
The St. Marys Armory (Figure 6) was designed in 1920 by State Armory Architect Karl Best of Dayton, Ohio, and is a transitional design using a mix of Castellated, Art Moderne, and Art Deco styles (Figure 7). The two-story structure with a partial basement exhibits key elements of design that include rectangular massing; polychromatic effects; facade symmetry; brick exterior; narrow fenestrations; battlements; parapets; gable roofs; arched wood windows; stone beltcourse; arched stone pediment framing a semicircular tile detail above the main entry doors; a large assembly hall space (Figure 8) with exposed scissor truss system (Figure 9), wood flooring, and a viewing balcony; central corridors with arched brick passageways and concrete floors; wood interior doors; and a rifle range in the basement.

Figure 6. North (front) elevation of St. Marys OHARNG Armory (ERDC-CERL, 2013).

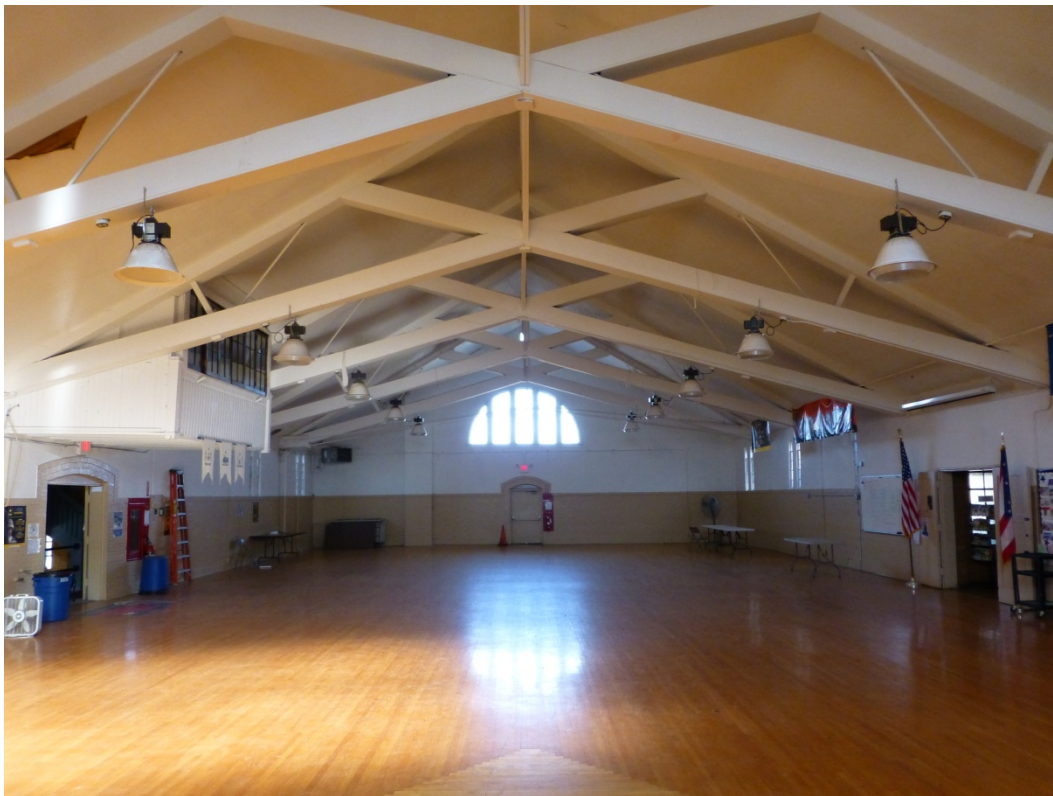
Figure 9. Interior view of the assembly hall at St. Marys OHARNG Armory (ERDC-CERL, 2013).

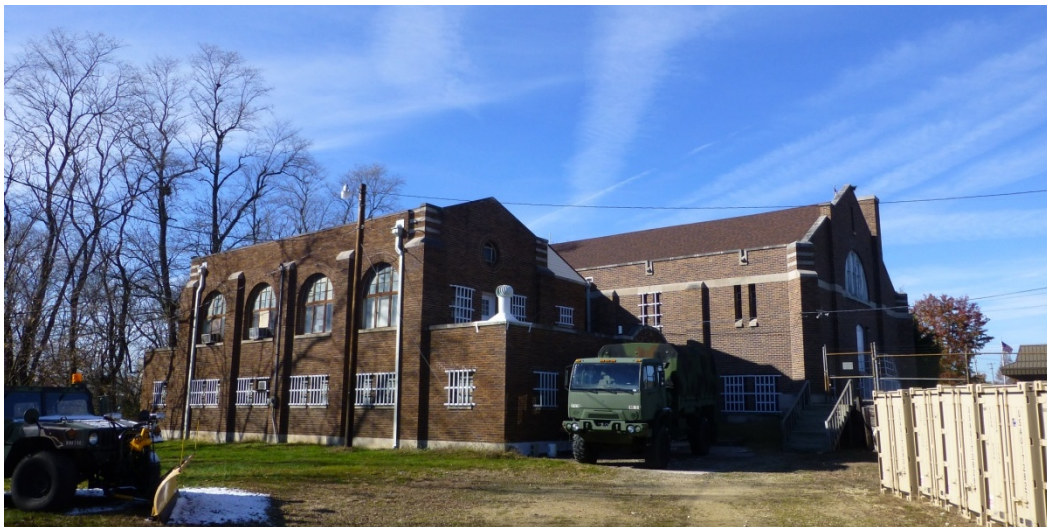
In 1938, a large two-story brick addition was constructed and added to the southeast side (Figure 10) of the original 1920 armory. The addition was connected to the original armory via a two-story hyphen. The addition was done in similar materials and similar design; however, the addition took on more of an Art Deco style than a Castellated style. The addition's design elements include rectangular massing, polychromatic effects, facade symmetry, and rooftop balconies. This building has an approximate area of 15,756 square feet (measuring 102' x 112').

Figure 10. Southeast oblique of St. Marys OHARNG Armory (ERDC-CERL, 2013).

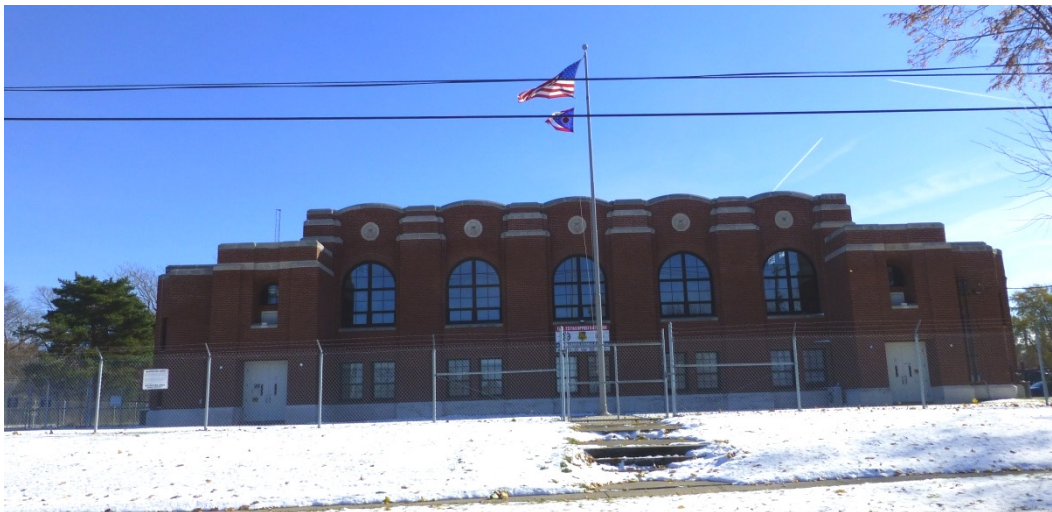
The Lima Armory (Figure 11 and Figure 12) was designed in 1928 by State Armory Architect Fred W. Elliott of Columbus, Ohio, using a mix of Castellated, Art Moderne, and Art Deco styles. The two-story structure exhibits key elements of design that include rectangular massing, polychromatic effects, facade symmetry, brick exterior, narrow fenestrations, barrel-style roof, multi-sided stair towers, prominent front entries, arched windows, scalloped arched parapet wall with horizontal stone detailing on the front elevation, stone coping detail at roofline, and brick chimney stacks (Figure 13 and Figure 14).

**Figure 11.** Northwest (front) elevation of Lima OHARNG Armory (ERDC-CERL, 2013).

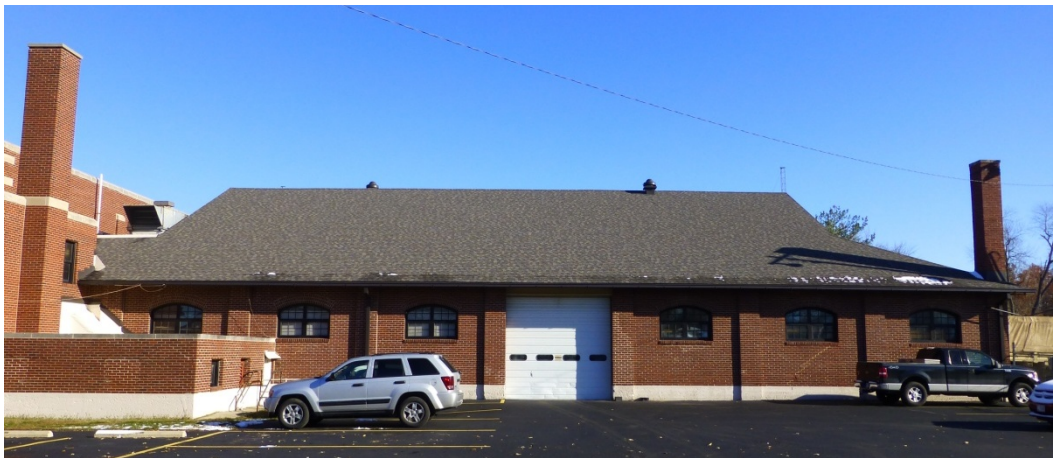
The Lima OHARNG Armory's design included a riding stadium addition on the rear of the two-story armory (Figure 12). The riding stadium was designed with a gable-on-hip roof, brick exterior walls with brick buttresses, paired arched windows with arched brick lintels and brick windowsills, and a large triangular-shaped multipane window in the gable end.

Figure 12. Southwest elevation of the riding stadium at Lima OHARNG Armory (ERDC-CERL, 2013).

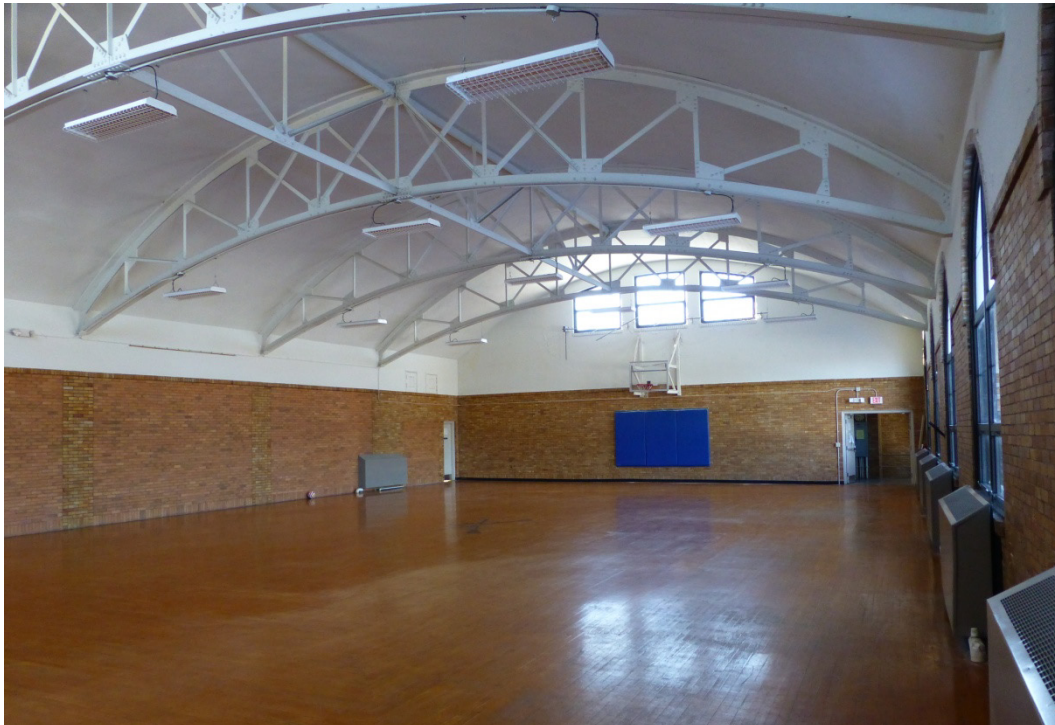
The original interior elements include a large assembly hall space with a barrel ceiling with exposed arched steel truss system and wood flooring (Figure 15), central corridors with arched brick passageways and concrete floors, and wood interior doors. Interior rooms originally included office spaces, locker rooms, latrines, kitchen, and boiler room on the first floor

Figure 15. Interior view of the assembly hall at Lima OHARNG Armory (ERDC-CERL, 2013).

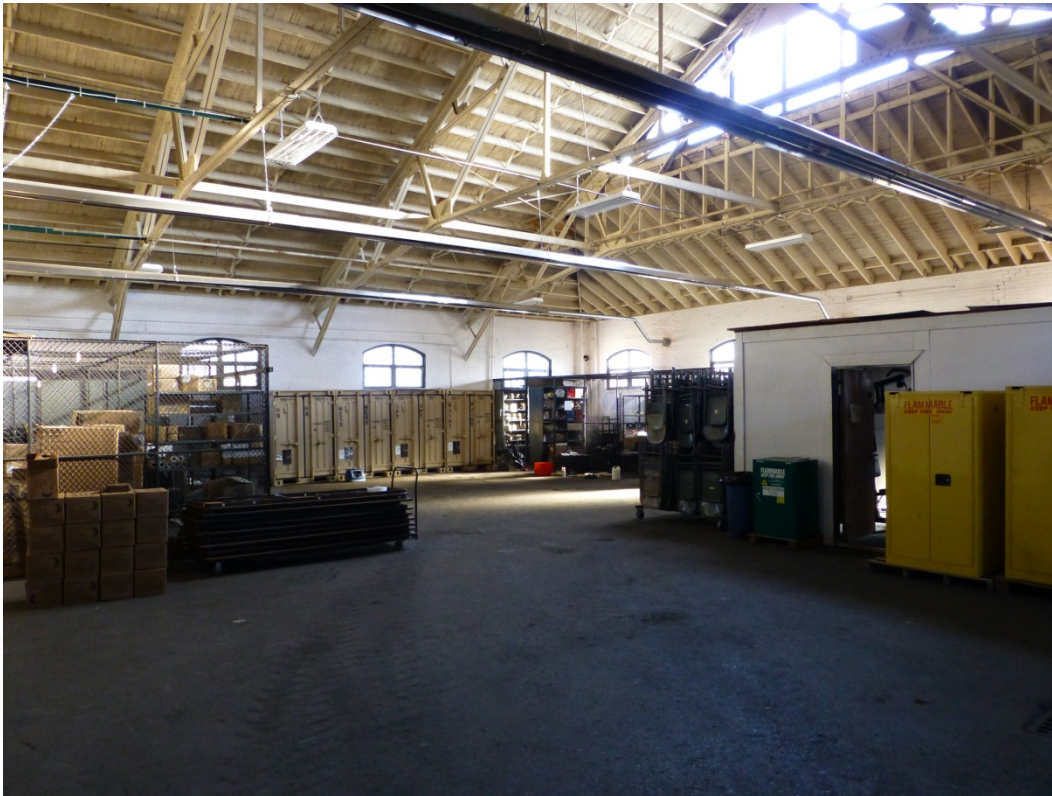
The original interior was a large open space with a dirt floor and exposed wood rafters and steel truss system. The current interior is shown in Figure 16.

Figure 16. Interior view of riding stadium at Lima OHARNG Armory (ERDC-CERL, 2013).

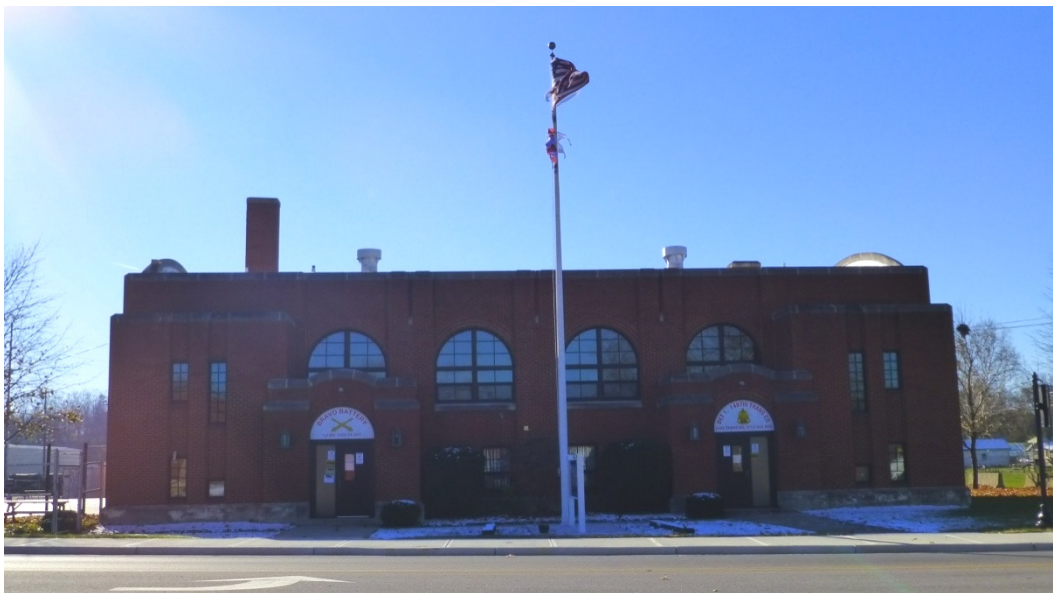
The Piqua Armory was designed in 1929 by State Armory Architect Fred W. Elliott using a mix of Castellated, Art Moderne, and Art Deco styles (Figure 17). The two-story structure exhibits key elements of design that include rectangular massing, polychromatic effects, facade symmetry, brick exterior, narrow fenestrations, barrel-style roof, parapets, prominent

Figure 17. North (front) elevation of Piqua OHARNG Armory (ERDC-CERL, 2013).

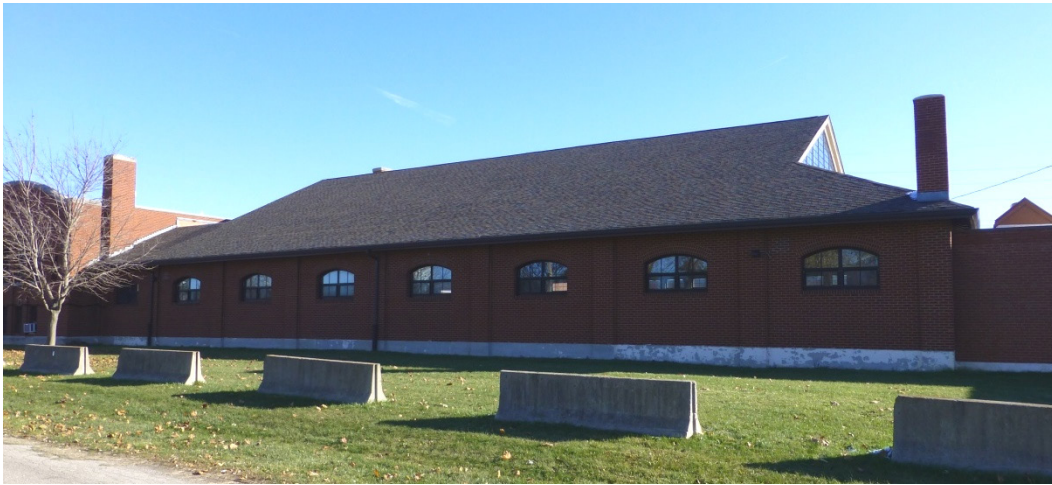
The Piqua OHARNG armory was designed to include the riding stadium appendage on the rear of the two-story armory (Figure 18). There are arched window openings on the south wall of the assembly hall that view into the attached riding stadium (Figure 19 and Figure 20). The riding stadium was designed with a gable-on-hip roof, brick exterior walls with brick buttresses, paired arched windows with arched brick lintels and brick windowsills, and a large triangular-shaped multipane window in the gable end. The interior was a large open space with a dirt floor and exposed wood rafters and steel truss system.

Figure 18. East elevation of the riding stadium at Piqua OHARNG Armory (ERDC-CERL, 2013).

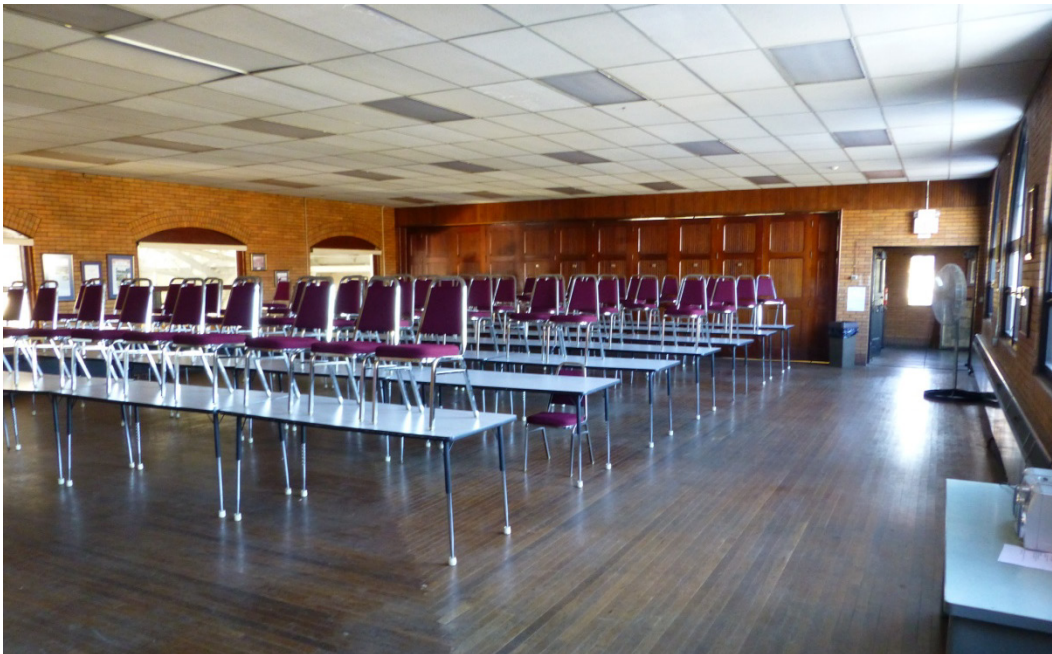
Figure 19. Interior view of the assembly hall at Piqua OHARNG Armory with original window openings on south wall to view into riding stadium and modified drop-ceiling covering the original barrel ceiling (ERDC-CERL, 2013).

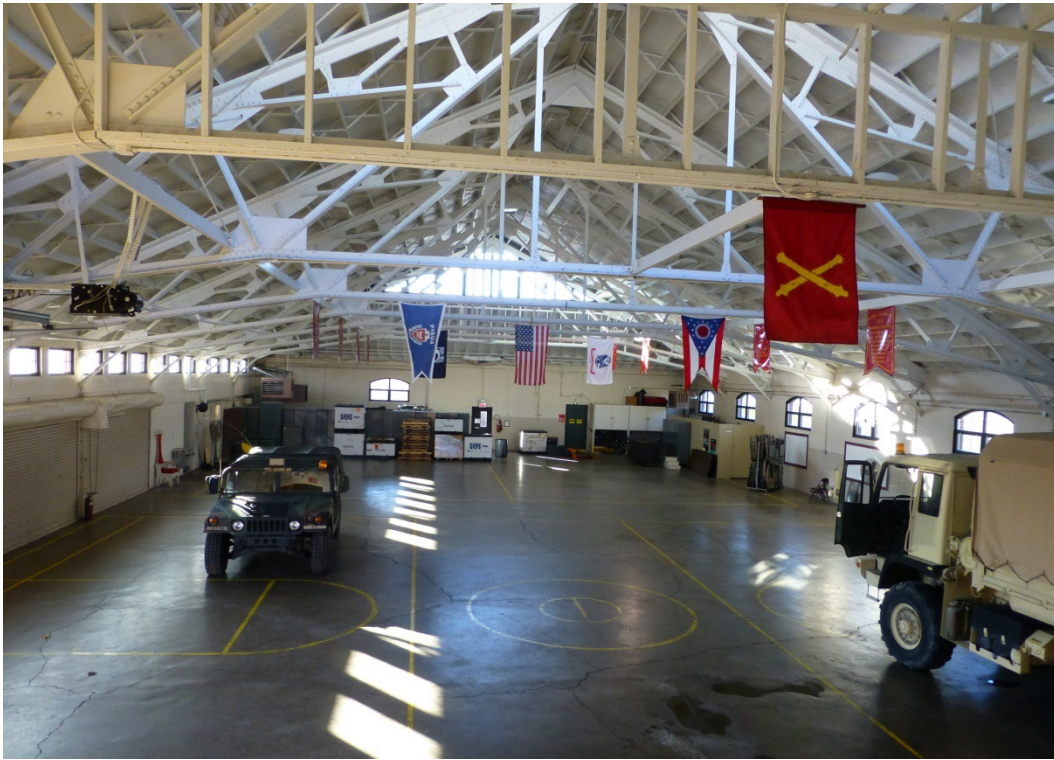
Figure 20. Interior view of riding stadium at Piqua OHARNG Armory (ERDC-CERL, 2013).

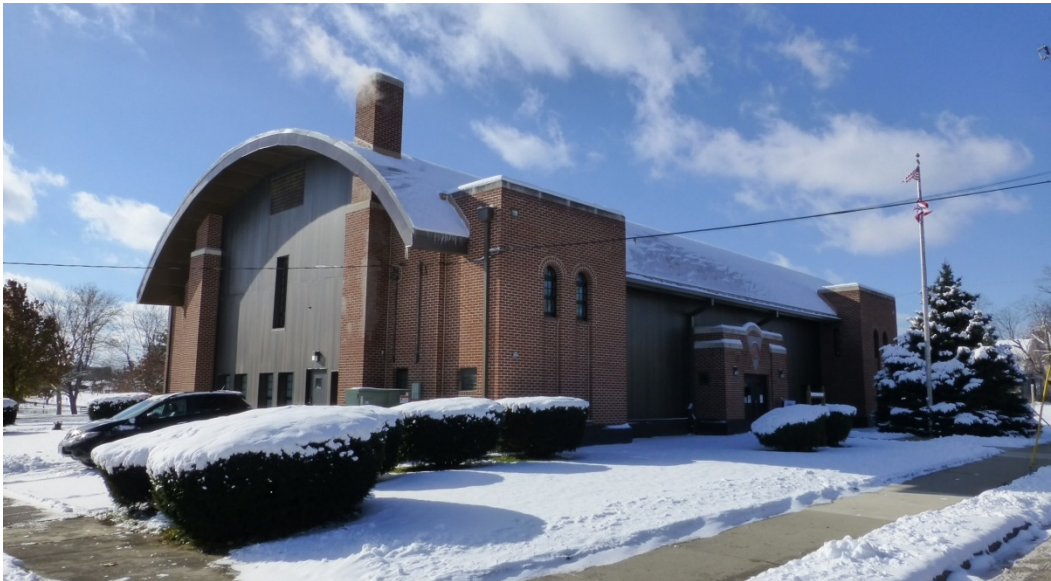
The Xenia Armory was designed in 1930 by State Armory Architect Fred W. Elliott using a mix of Castellated, Art Moderne, and Art Deco styles (Figure 22); however, the building was heavily damaged in a tornado in 1974 and was rehabilitated in 1975, ultimately losing most of its original design and materials (Figure 23). The building still portrays some key features, however, that tie it to the same style as the previously discussed armories of the same time period.

Figure 23. Northeast oblique of Xenia OHARNG Armory (ERDC-CERL, 2014).

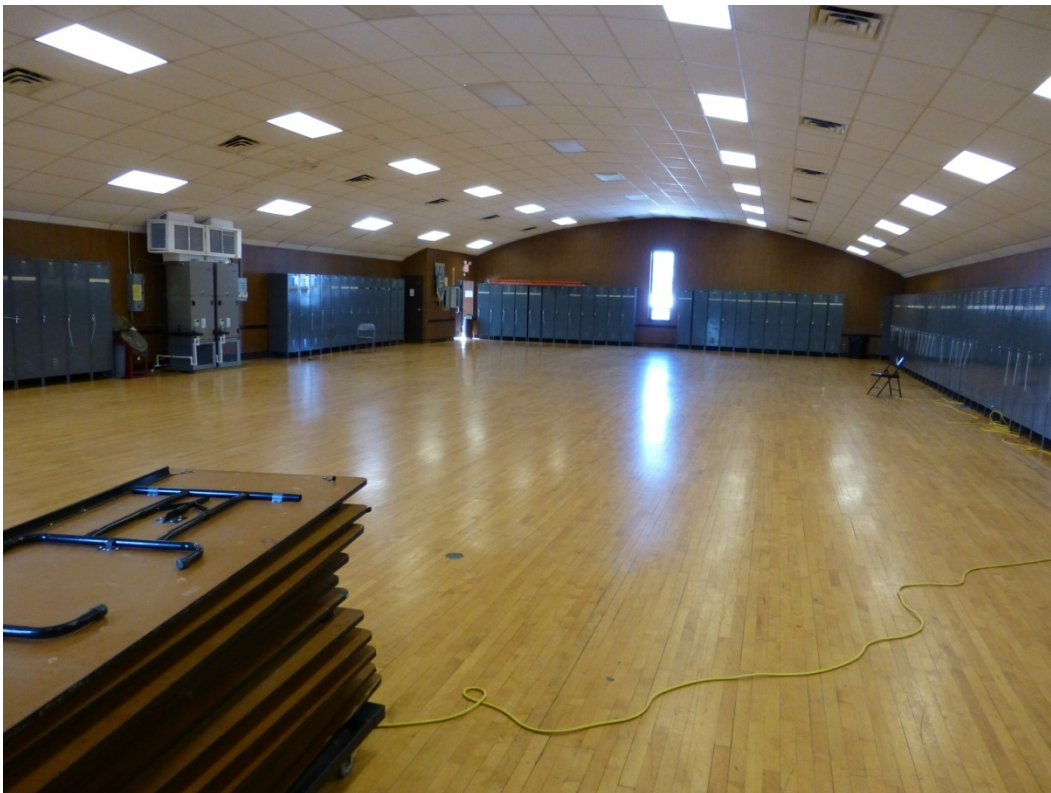
The current two-story structure exhibits elements of design that include rectangular massing, facade symmetry, narrow fenestrations, barrel-style roof, prominent front entries, brick-enclosed stair towers, stone coping detail at roofline, a large drill hall space with a barrel ceiling and wood flooring (Figure 24), and central corridor.

Figure 24. Interior view of the drill hall at Xenia OHARNG Armory (ERDC-CERL, 2014).

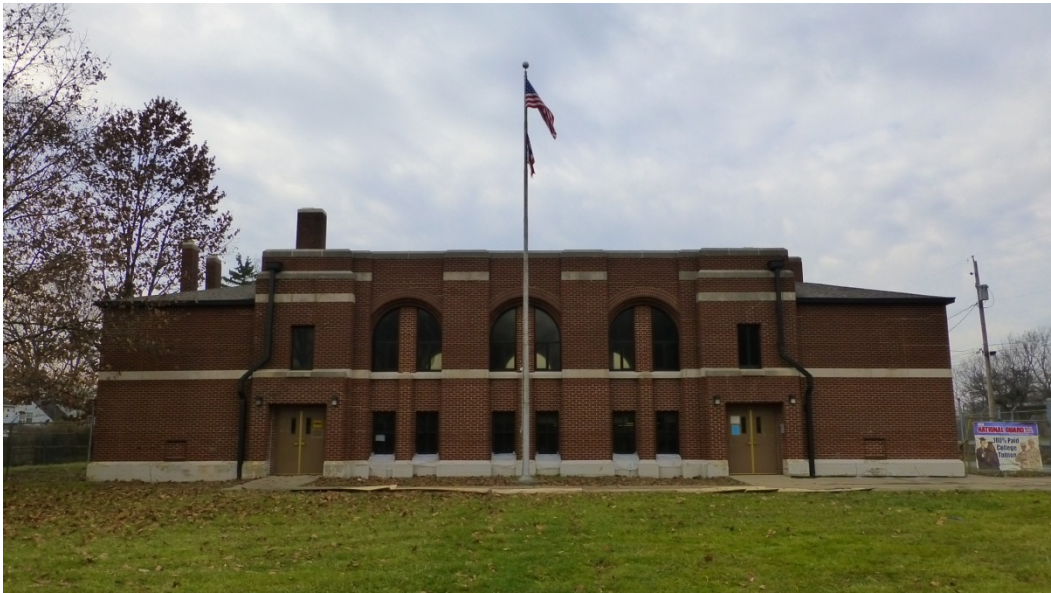
The Akron-Hawkins Armory was designed in 1937 by State Armory Architect Fred W. Elliott using a mix of Castellated, Art Moderne, and Art Deco styles. The two-story structure (Figure 25) exhibits key elements of design that include rectangular massing, polychromatic effects, facade symmetry, brick exterior, narrow fenestrations, barrel-style roof, parapets, brick chimney stacks, prominent front entries, brick-enclosed stair towers, arched windows, stone beltcourse, stone coping detail at roofline, a large assembly hall space with a barrel ceiling and exposed arched steel truss system and wood flooring (Figure 26), H-shaped corridors with arched brick passageways and concrete floors (Figure 27), and wood interior doors.

Figure 25. East (front) elevation of Akron-Hawkins OHARNG Armory (ERDC-CERL, 2013).

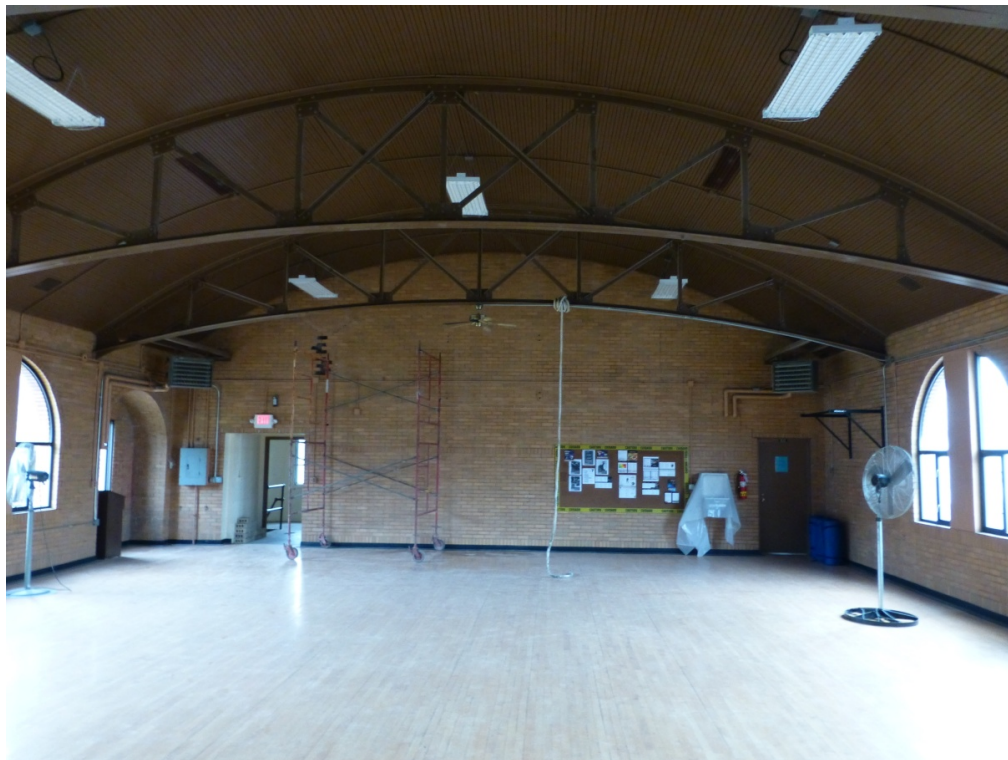
Figure 26. Interior view of the assembly hall at Akron-Hawkins OHARNG Armory (ERDC-CERL, 2013).

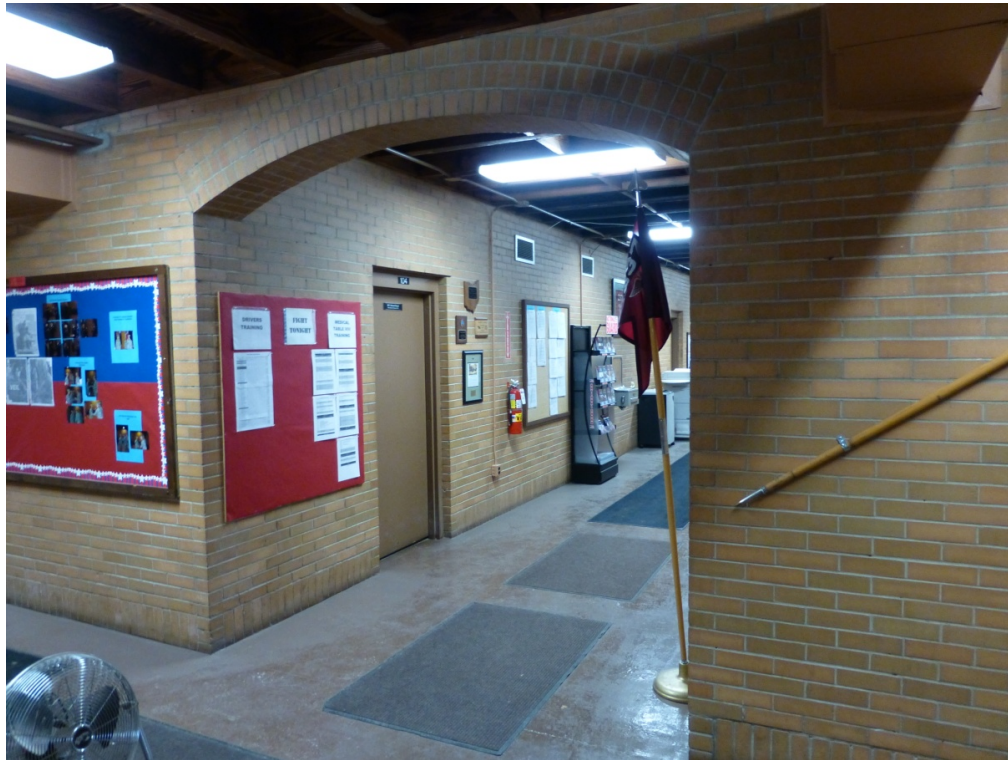
Figure 27. Arched brick passageways in corridors on the first floor of the Akron-Hawkins OHARNG Armory (ERDC-CERL, 2013).

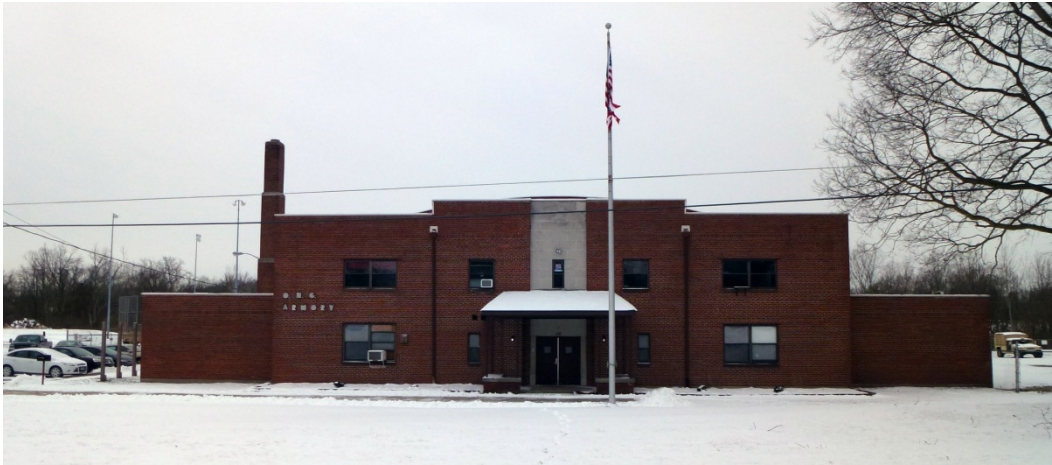
stack, and stainless-steel lettering spelling out “O.N.G. Armory” (Figure 35).

Figure 35. North (front) elevation of Lebanon OHARNG Armory (ERDC-CERL, 2014).

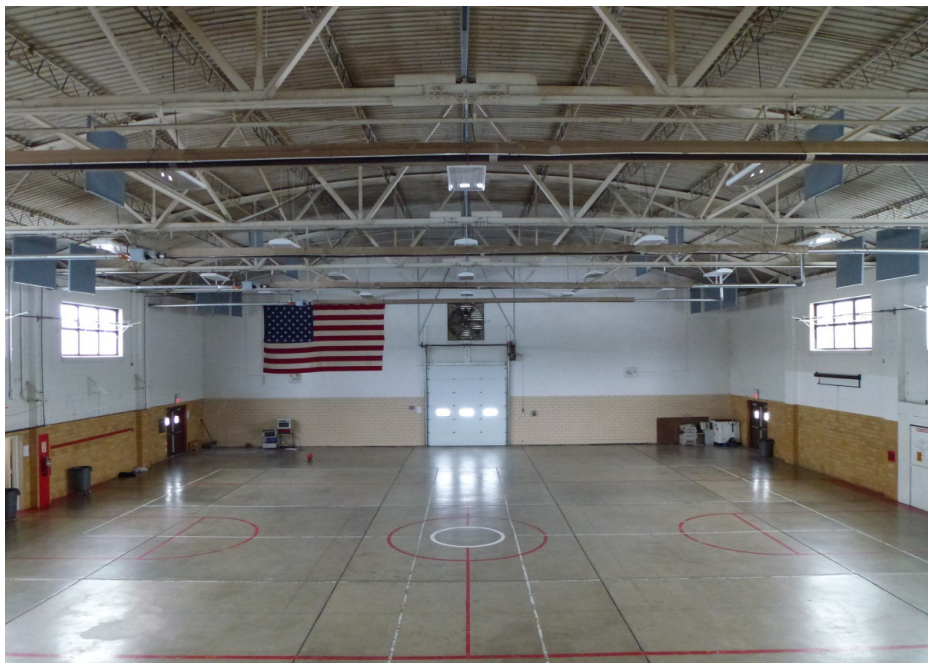
The interior design elements include an open double-height drill hall with concrete floor and exposed arched steel truss system (Figure 36); glazed sanitary tile walls in the stairwell, corridors, drill hall, locker room, and latrines; concrete-block interior walls; and metal and glass doors. Concrete switchback stairs with metal pipe handrails provide access to the second-floor corridor. The corridor overlooks the drill hall space.

Figure 36. Interior view of the drill hall at Lebanon OHARNG Armory (ERDC-CERL, 2014).

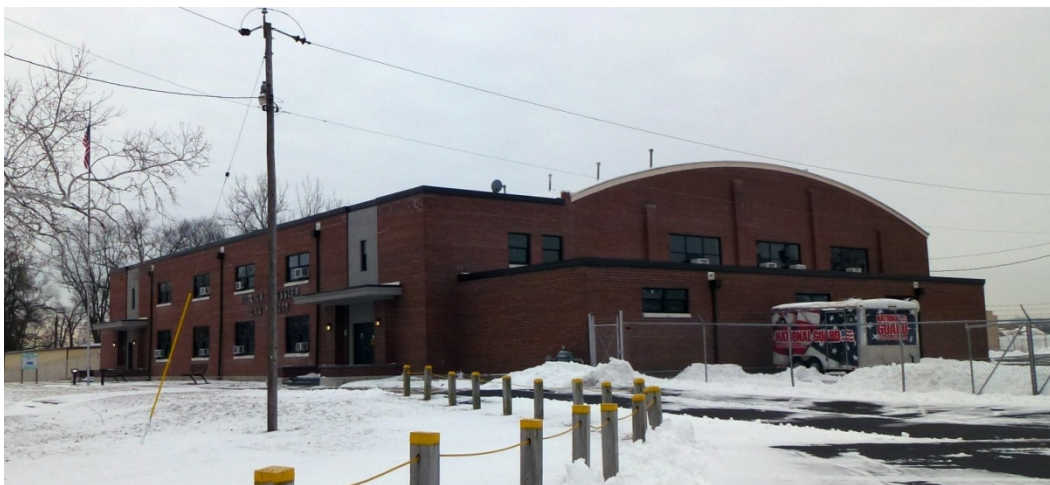
The Middletown-Kessler Armory was designed in 1951 by State Armory Architect Kenneth Warman using a standardized plan for a Type A armory. The structure is a combination of one-and two-stories that encompass a centrally placed double-height drill hall space (Figure 37). This building was designed as a three-unit armory and has approximate area of 27,711 square feet (measuring 146' x 164').

Figure 37. Northeast oblique of Middletown-Kessler OHARNG Armory (ERDC-CERL, 2014).

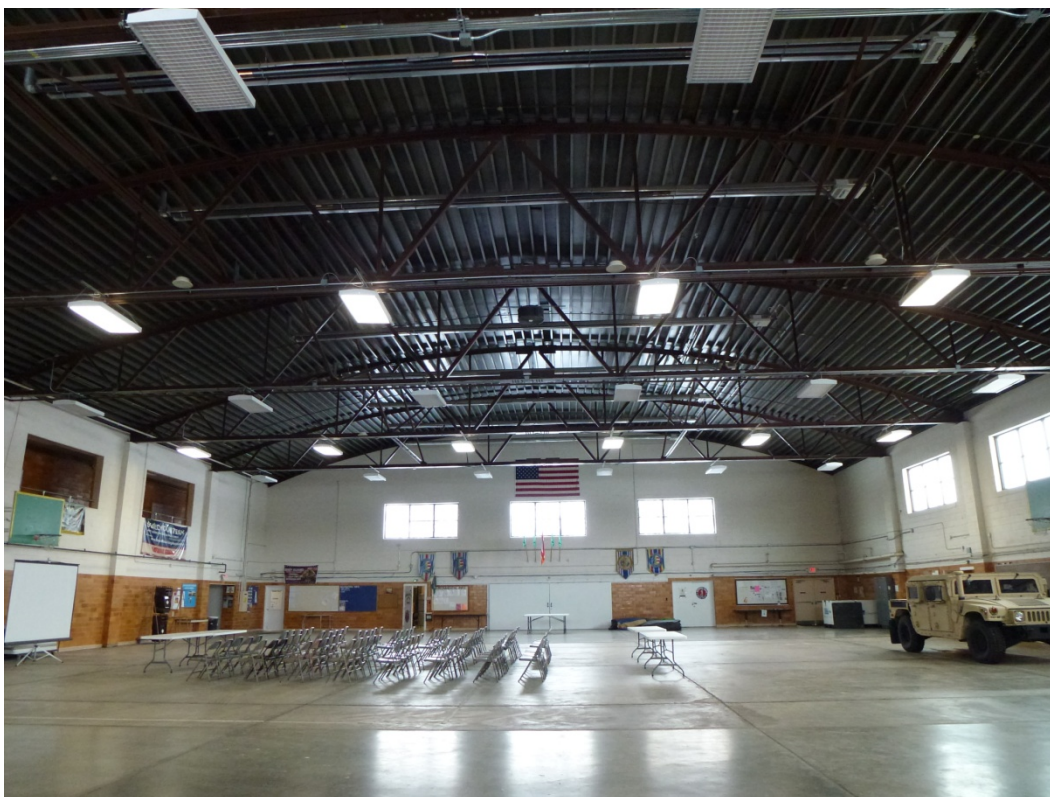
The first-floor plan was originally designed with a centrally placed drill hall space (Figure 38) and the following rooms surrounding it: supply rooms each having a strong room, storage rooms, a boiler room, latrines, a locker room, and classrooms. The second floor had four large offices, one small office, and a small latrine. A rifle butts room is located on the south wall of the drill hall. Concrete switchback stairs with metal pipe handrails provide access to the second-floor corridor. The corridor overlooks the double-height drill hall space.

Figure 38. Interior view of the drill hall at Middletown-Kessler OHARNG Armory (ERDC-CERL, 2014).

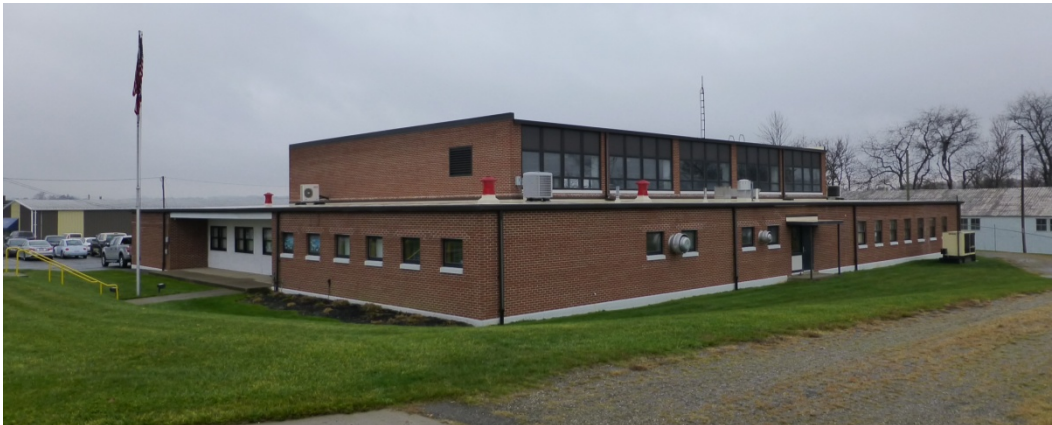
The Wooster Armory was designed in 1949 by State Armory Architect George P. Guthrie of Columbus, Ohio, using a standardized plan for a Type B armory. The structure is a combination of a one-story structure that encompasses a centrally placed, double-height drill hall space (Figure 41). This building was designed as a one-unit armory and has approximate area of 11,729 square feet (measuring 104' x 136').

Figure 41. Northwest oblique of Wooster OHARNG Armory (ERDC-CERL, 2014).

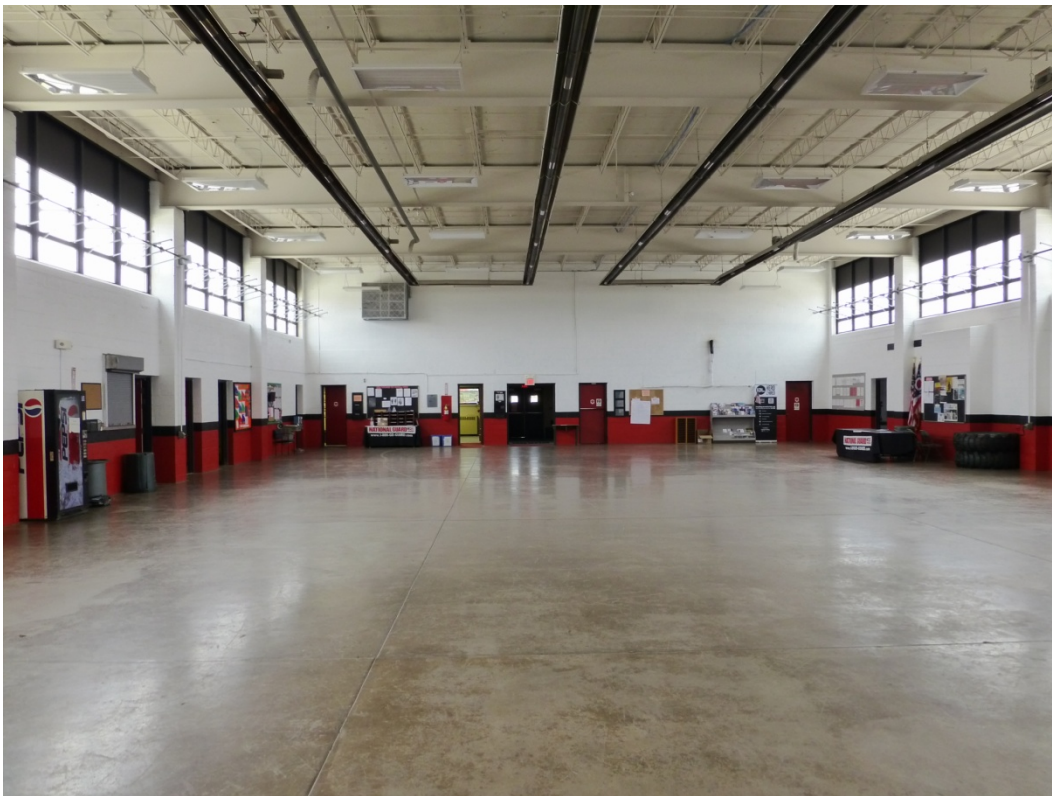
The interior design elements include an open double-height drill hall with concrete floor and exposed arched steel truss system (Figure 42), glazed sanitary tile walls in the latrines and locker room, concrete-block interior walls, metal supply room doors, and metal and glass office doors.

Figure 42. Interior view of the drill hall of Wooster OHARNG Armory (ERDC-CERL, 2014).

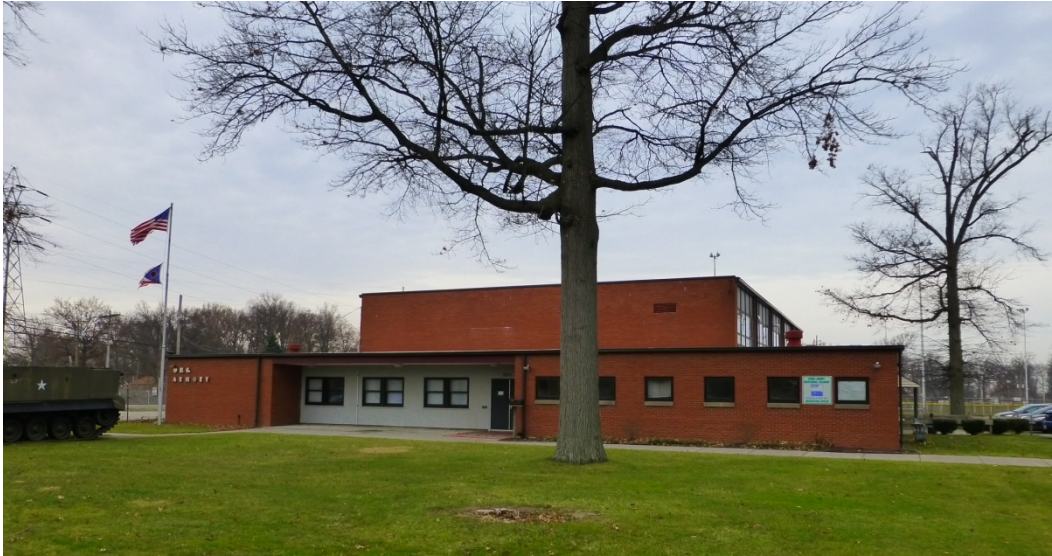
The armory exhibits key elements of design that include brick exterior walls, a cubist form, flat roofs, repetitive window pattern with concrete windowsills, clerestory windows, minimal architectural ornamentation, recessed entry with wood veneer detailing, and stainless-steel lettering spelling "O.N.G. Armory" (Figure 43).

Figure 43. East elevation of Lorain OHARNG Armory (ERDC-CERL, 2013).

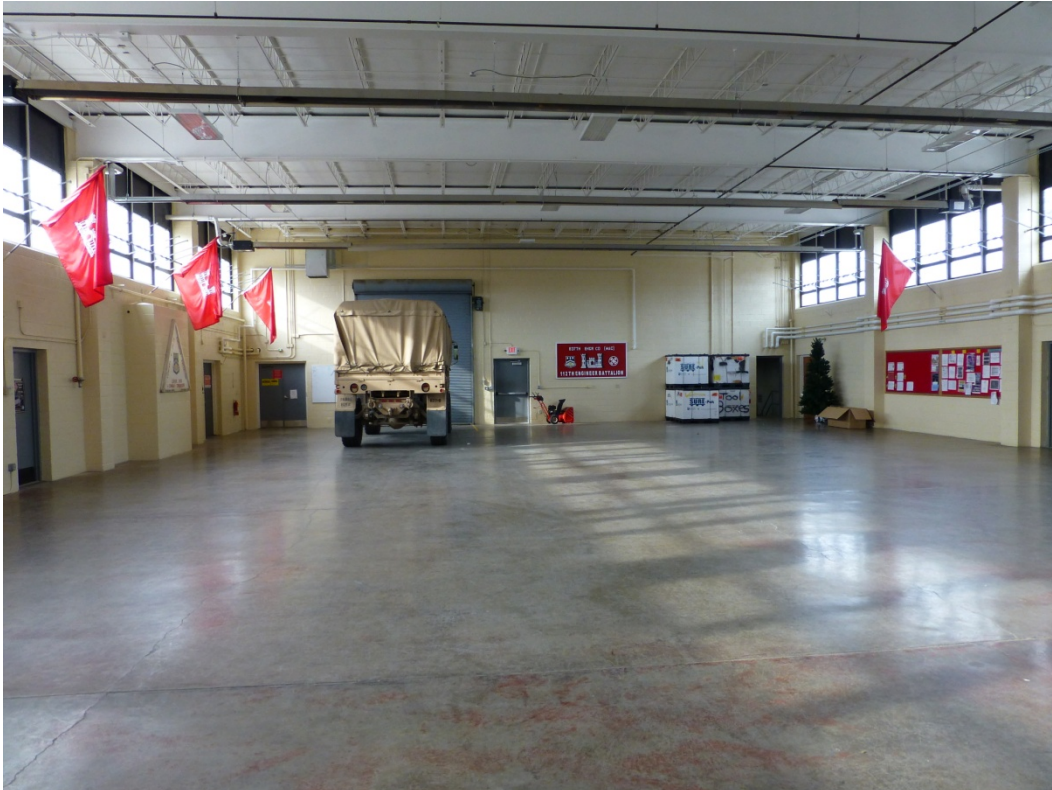
The interior design elements include an open double-height drill hall with concrete floor and exposed arched steel truss system (Figure 44), glazed sanitary tile walls in the latrines and locker room, concrete-block interior walls, metal supply room doors, and metal and glass office doors.

Figure 44. Interior view of the drill hall of Lorain OHARNG Armory (ERDC-CERL, 2013).

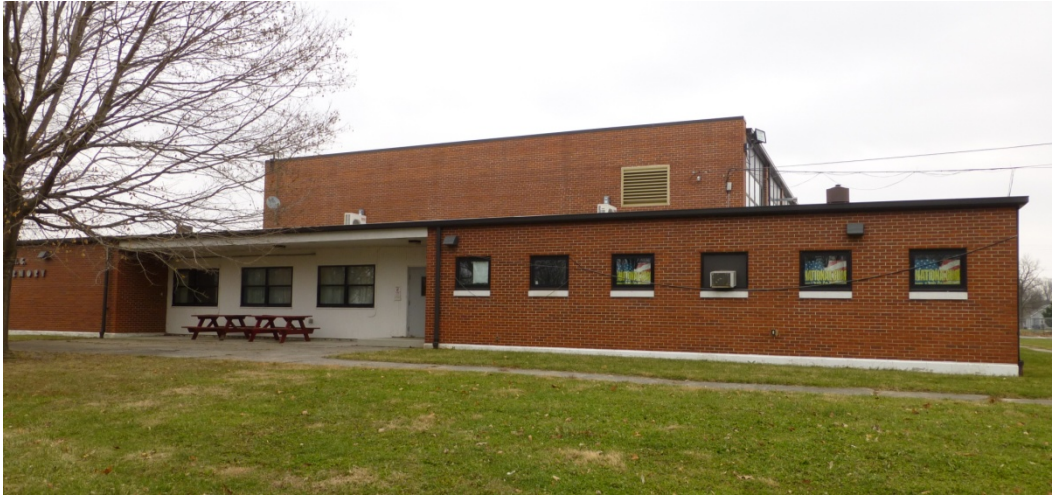
The armory exhibits key elements of design that include brick exterior walls, a cubist form, flat roofs, repetitive window pattern with concrete windowsills, clerestory windows, minimal architectural ornamentation, recessed entry with wood veneer detailing, clerestory windows, and Stainless-steel lettering spelling "O.N.G. Armory" (Figure 45).

Figure 45. West elevation of Tiffin OHARNG Armory (ERDC-CERL, 2013).
