## **Architectural Survey of Ohio Army National Guard Properties: Volume I**

Under Project 405180, "OHARNG Architectural Survey"

This document is Volume I of a two-volume architectural survey of 85 buildings and structures utilized by the Ohio Army National Guard and located across the state of Ohio. The majority of these structures were constructed from 1920 to 1968, with others constructed from 1969 to 1988. This survey satisfies Section 110 of the National Historic Preservation Act of 1966 as amended, and was used to determine the eligibility of these buildings and structures for inclusion on the National Register of Historic Places (NRHP). It is the recommendation of this report that 19 armories and 4 associated support buildings are significant under NRHP criteria and retain enough integrity to be individually eligible for the NRHP. Volume II of this report is published separately and contains the ERDC-CERL architectural survey forms.

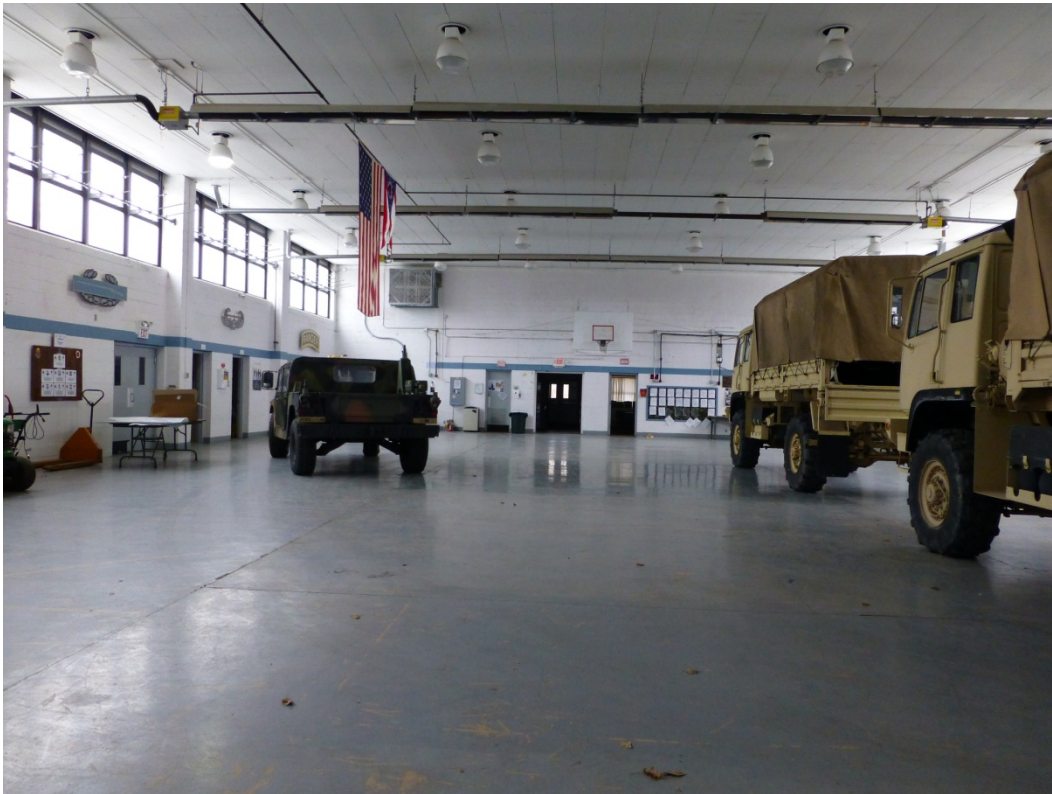
The interior design elements include an open double-height drill hall with concrete floor and exposed arched steel truss system (Figure 46), glazed sanitary tile walls in the latrines, and locker room, concrete-block interior walls, metal supply room doors, and metal and glass office doors. Interior rooms originally included a lobby, one large classroom with an accordion divider wall, offices, a kitchen, storage rooms, a boiler room, latrines with adjacent locker room, and a rifle range. All of these rooms were accessible via the centrally placed drill hall space.

Figure 46. Interior view of the drill hall of Tiffin OHARNG Armory (ERDC-CERL, 2013).

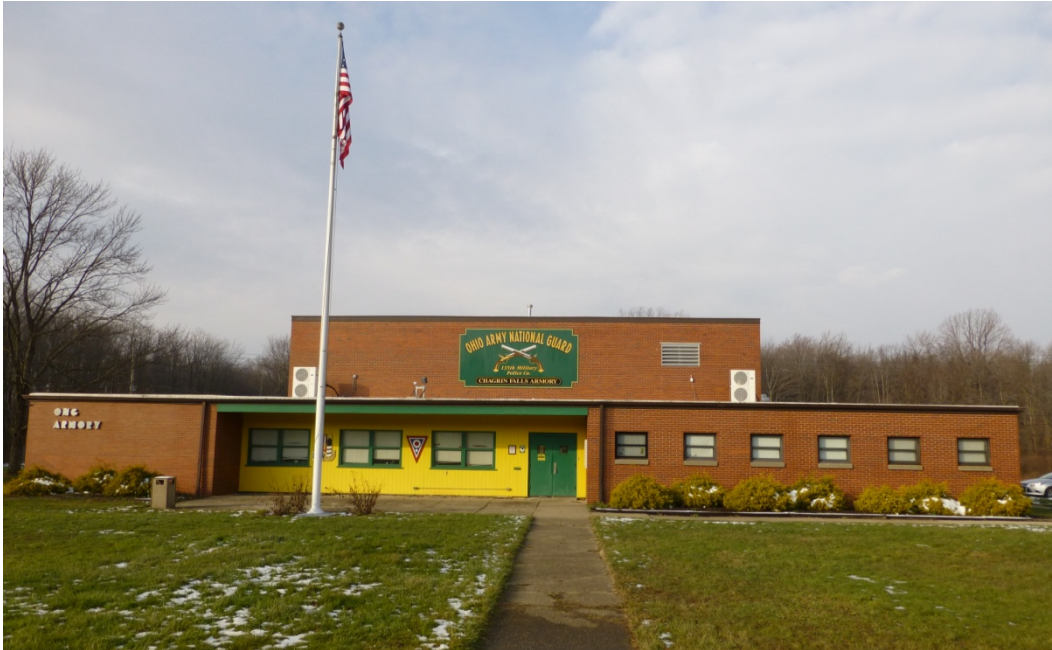
The armory exhibits key elements of design that include brick exterior walls, a cubist form, flat roofs, repetitive window pattern with concrete windowsills, clerestory windows, minimal architectural ornamentation, recessed entry with wood veneer detailing, and stainless-steel lettering spelling "O.N.G. Armory" (Figure 47).

Figure 47. East elevation of Chagrin Falls OHARNG Armory (ERDC-CERL, 2013).

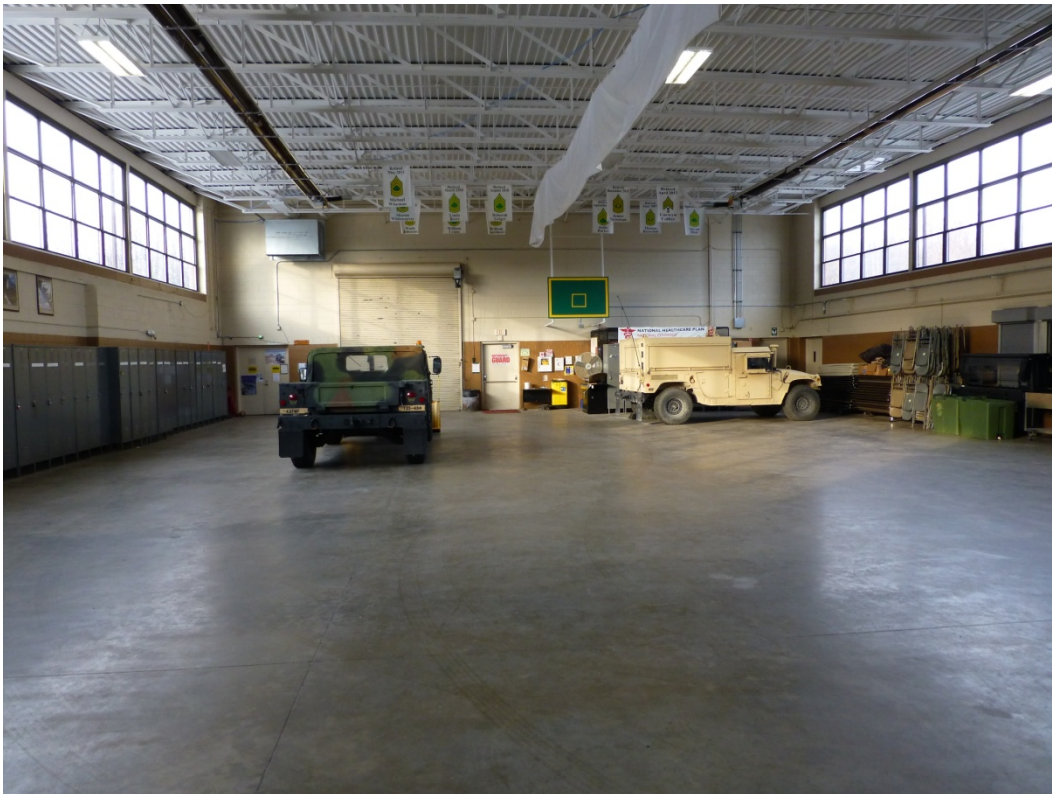
The interior design elements include an open double-height drill hall with concrete floor and exposed arched steel truss system (Figure 48), glazed sanitary tile walls in the latrines, locker room, and the bottom half of the drill hall walls, concrete-block interior walls, metal supply room doors, and metal and glass office doors. Interior rooms originally included a lobby, one large classroom with an accordion divider wall, offices, a kitchen, storage rooms, a boiler room, latrines with adjacent locker room and a rifle range. All of these rooms were accessible via the centrally placed drill hall space.

Figure 48. Interior view of the drill hall of Chagrin Falls OHARNG Armory (ERDC-CERL, 2013).

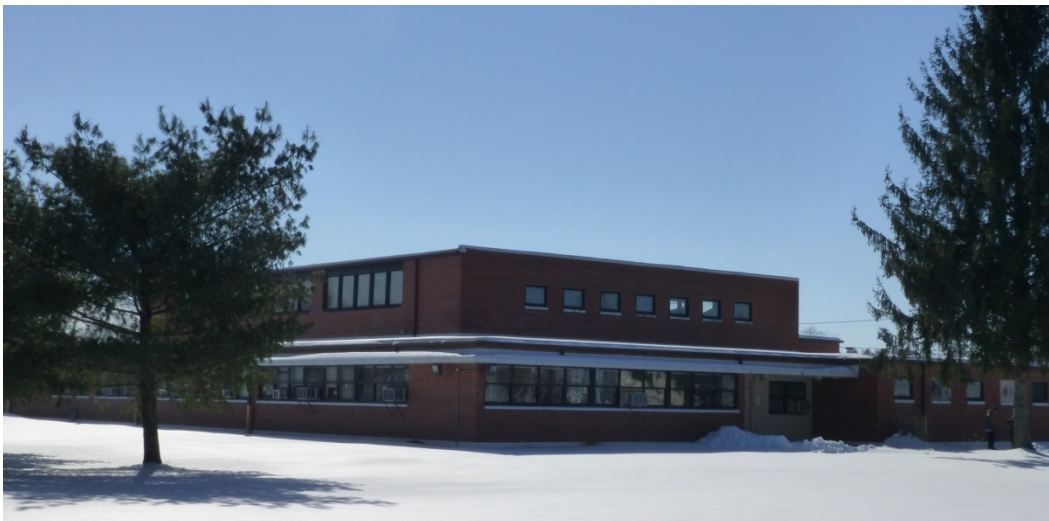
The armory was originally designed to exhibit key elements that included brick exterior walls, a cubist form, flat roofs, ribbon-style windows with concrete windowsills, clerestory windows (a curtain wall of windows on the side elevations and smaller individual windows on the front and rear elevations), few architectural ornamentations, a recessed main entry, concrete canopy sunshade over the main entry that wraps around to the side elevation over the ribbon-style windows, and Stainless-steel lettering spelling "O.N.G. Armory."

Figure 51. Northeast oblique of the Newark OHARNG Armory (ERDC-CERL, 2014).

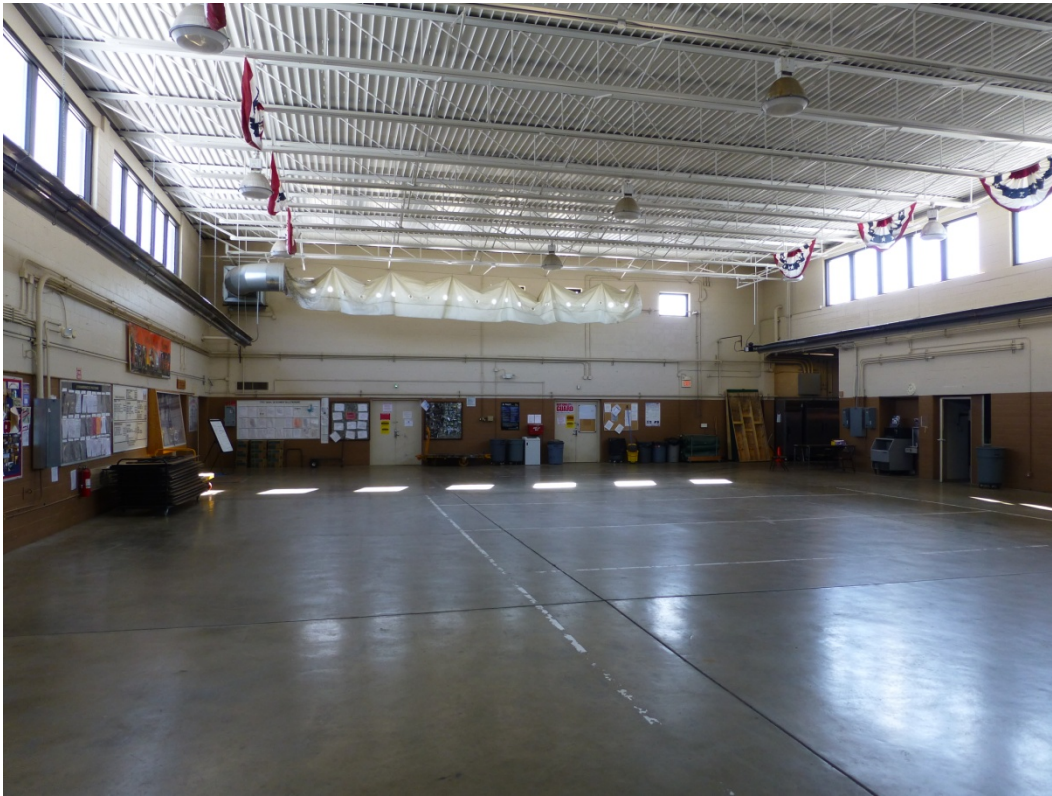
Interior rooms originally included a lobby, one large classroom with an accordion divider wall, offices, a kitchen, storage rooms, a boiler room, latrines with an adjacent locker room, and a rifle range. All of these rooms were accessible via the centrally placed drill hall space, with the exception of the rifle range that was accessible from a short corridor off the drill hall.

Figure 52. Interior view of the drill hall of Newark OHARNG Armory (ERDC-CERL, 2014).

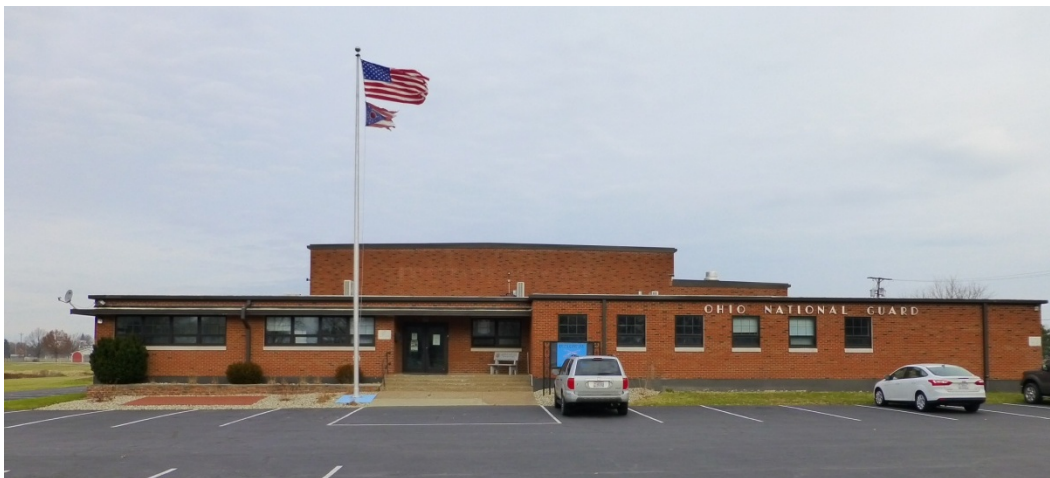
The armory was originally designed to exhibit key elements that included brick exterior walls, a cubist form, flat roofs, ribbon-style windows with concrete windowsills, clerestory windows, few architectural ornamentation, recessed main entry, concrete canopy sunshade over the main entry that wraps around to the side elevation over the ribbon-style windows, and Stainless-steel lettering spelling “Ohio National Guard.”

Figure 53. South (front) elevation of the Sandusky OHARNG Armory (ERDC-CERL, 2013).

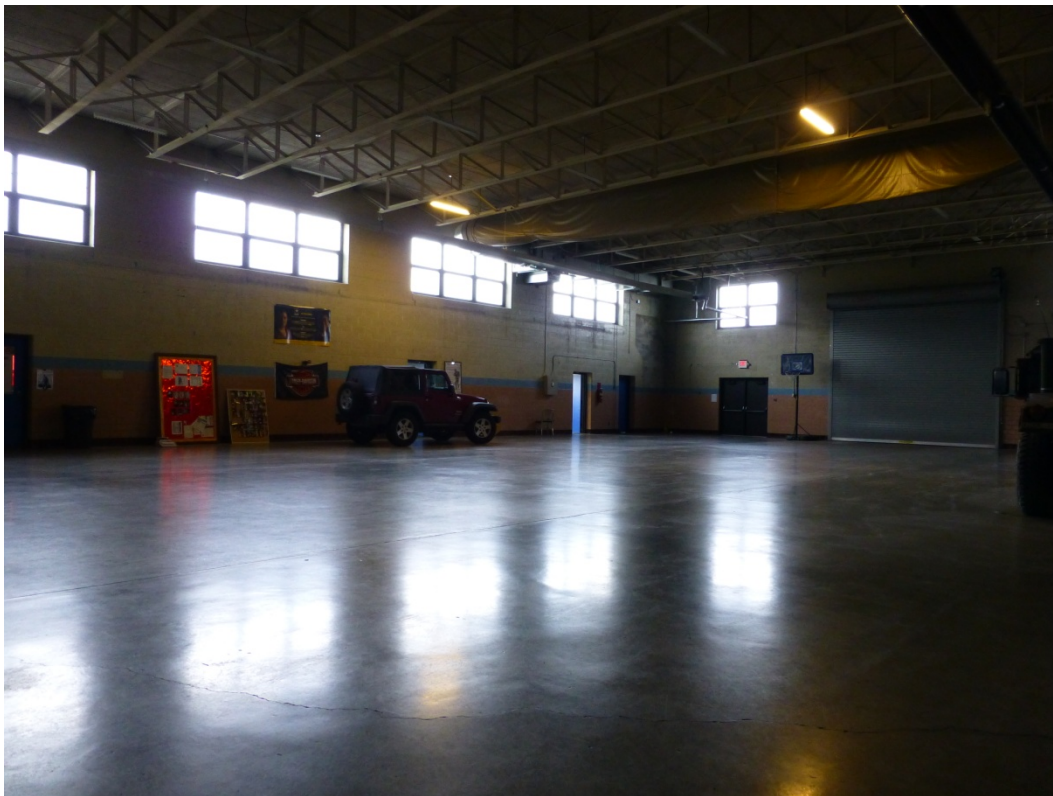
Interior rooms originally included a lobby, one large classroom with an accordion divider wall, offices, a kitchen, storage rooms, a boiler room, latrines with adjacent locker room, and a rifle range. All of these rooms were accessible via the centrally placed drill-hall space with the exception of the rifle range that was accessible from a short corridor off the drill hall.

Figure 54. Interior view of the drill hall of Sandusky OHARNG Armory (ERDC-CERL, 2013).

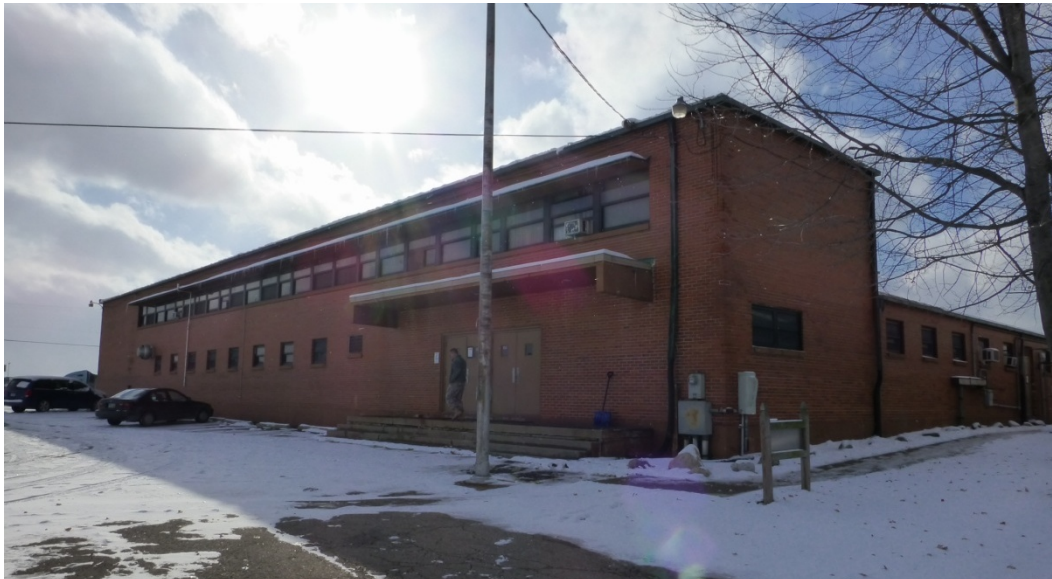
**Figure 57. East (front) elevation of the Springfield OHARNG Armory (ERDC-CERL, 2014).**

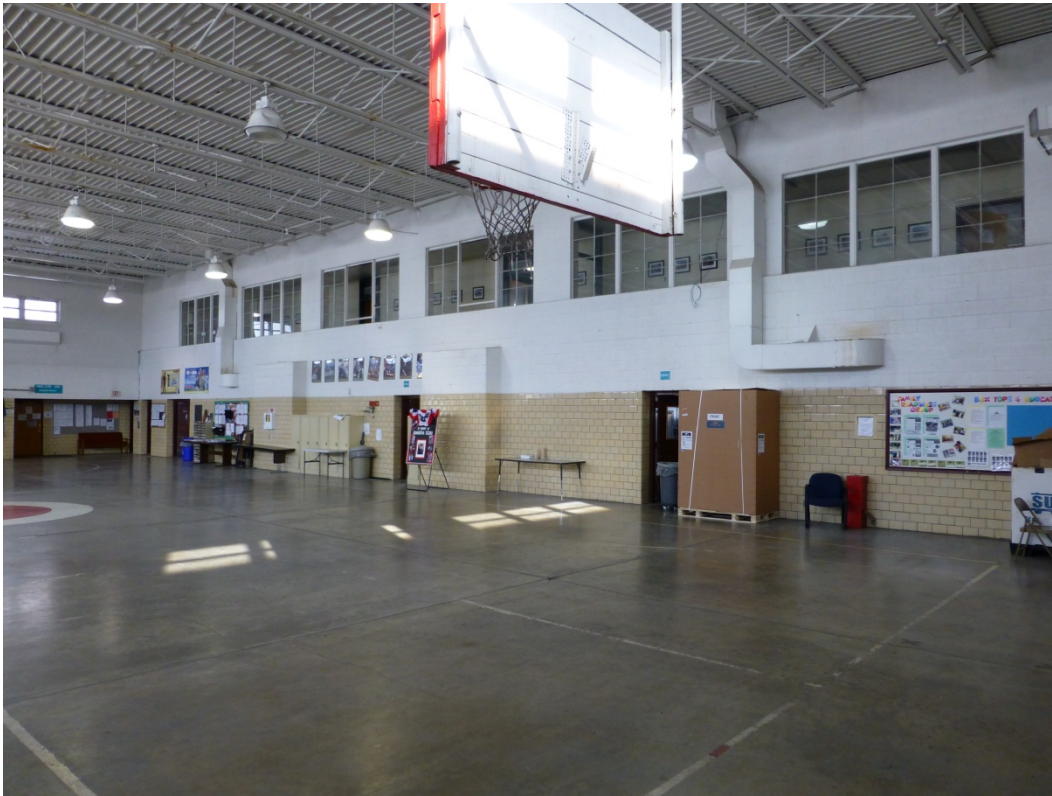
Architectural finishes that were used throughout these Type D armories, like the Springfield Armory, included metal switchback staircases with wood and metal handrails; metal interior doors; metal and glass interior doors; metal and plate-glass vestibule doors; concrete-block interior walls; glazed sanitary tile walls in the drill hall, latrine, and locker room; tile floor in the latrines; concrete interior windowsills; and interior metal-sash windows overlooking the drill hall space from the second-floor corridor.

Figure 58. Interior view of the drill hall, looking at interior windows of the second-floor corridor of Springfield OHARNG Armory (ERDC-CERL, 2014).

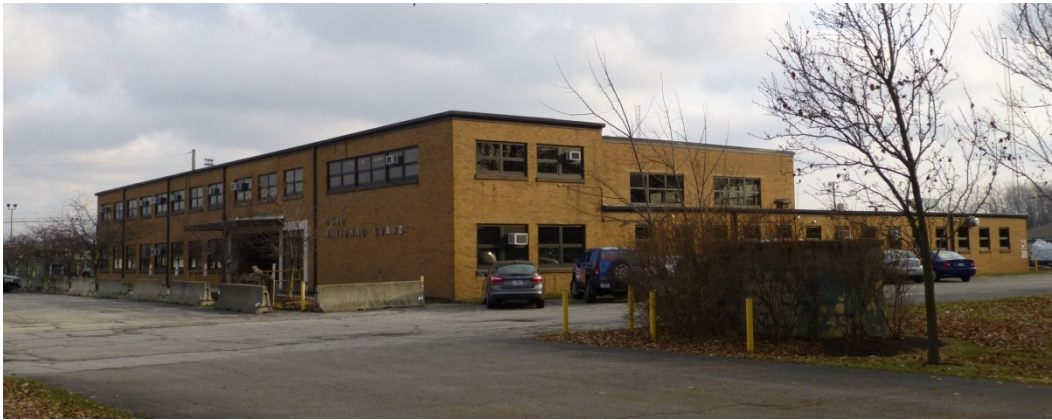
The armory was designed with key elements that included yellow/tan brick exterior walls, a cubist form, flat roofs, repetitive window patterns, ribbon-style windows with concrete windowsills, paired windows, single windows, clerestory windows, few architectural ornamentations, a concrete canopy over the main entry, and stainless-steel lettering spelling “Ohio National Guard” (Figure 59). The original windows were multipane steel-sash windows.

Figure 59. Northeast (front) elevation of Brook Park OHARNG Armory (ERDC-CERL, 2013).

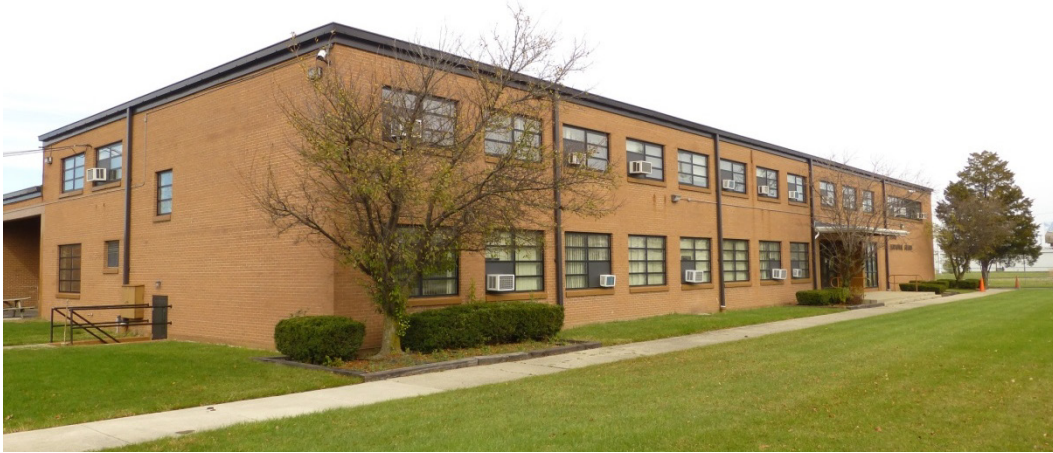
The armory was designed with key elements that included yellow/tan brick exterior walls, a cubist form, flat roofs, repetitive window patterns, ribbon-style windows with concrete windowsills, paired windows, single windows, clerestory windows, metal and plate-glass front entry doors with sidelights, minimal architectural ornamentation, a concrete canopy over the main entry, and Stainless-steel lettering spelling "Ohio National Guard." The original windows were multipane steel-sash windows.

**Figure 61. South (front) elevation of Columbus-Haubrich OHARNG Armory (ERDC-CERL, 2014).**

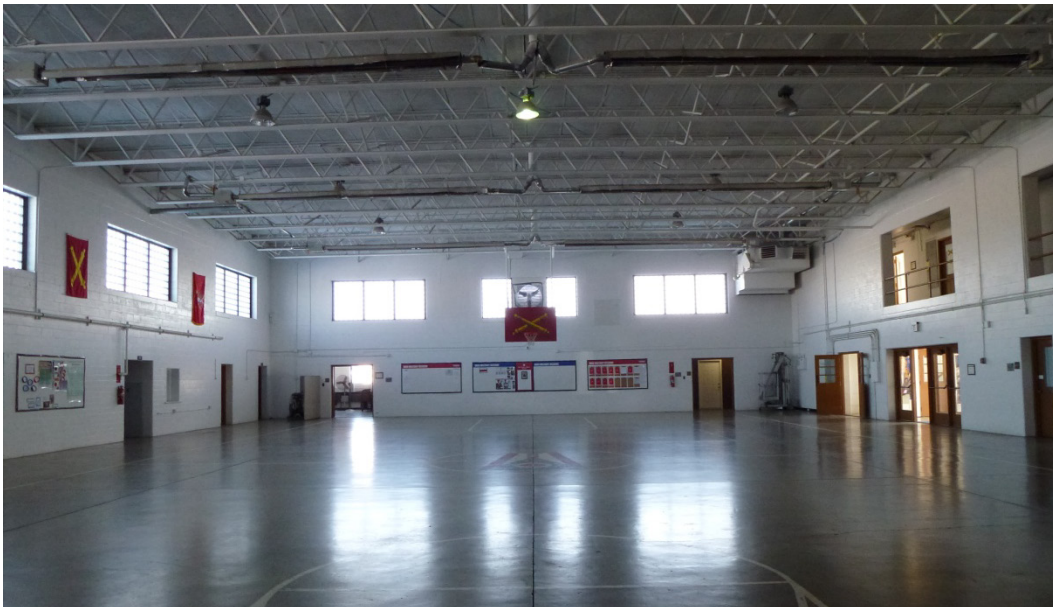
The drill hall was designed as a double-height space and was the heart of the structure, providing access to all adjacent rooms (Figure 62). It was designed with a concrete floor, a mix of concrete block and glazed sanitary tile walls, and an exposed steel-truss roof system for the flat roof. Large

**Figure 62. Interior view of the drill hall of Columbus-Haubrich OHARNG Armory (ERDC-CERL, 2014).**

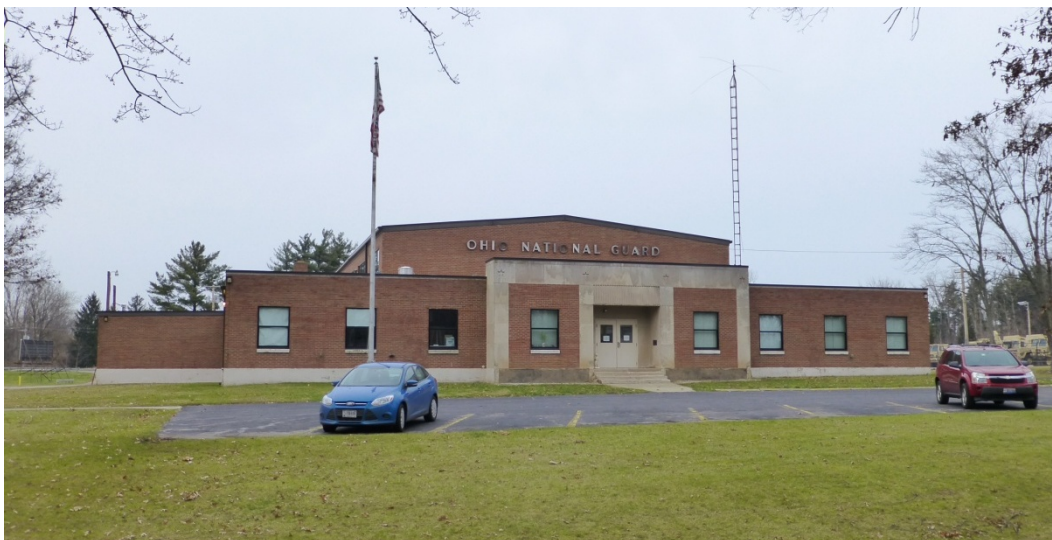
The armory was designed with key elements that included a symmetrical front elevation (Figure 67), brick exterior walls, a cubist form, flat roofs over the one-story areas, a shallow gable roof over the double-height drill hall space, a raised concrete foundation, a repetitive window pattern with concrete windowsills, clerestory windows, minimal architectural ornamentation, a recessed entry framed with a band of stone tiles, stainless-steel lettering spelling “Ohio National Guard”, and one large garage bay door.

**Figure 67. South (front) elevation of Norwalk OHARNG Armory (ERDC-CERL, 2013).**

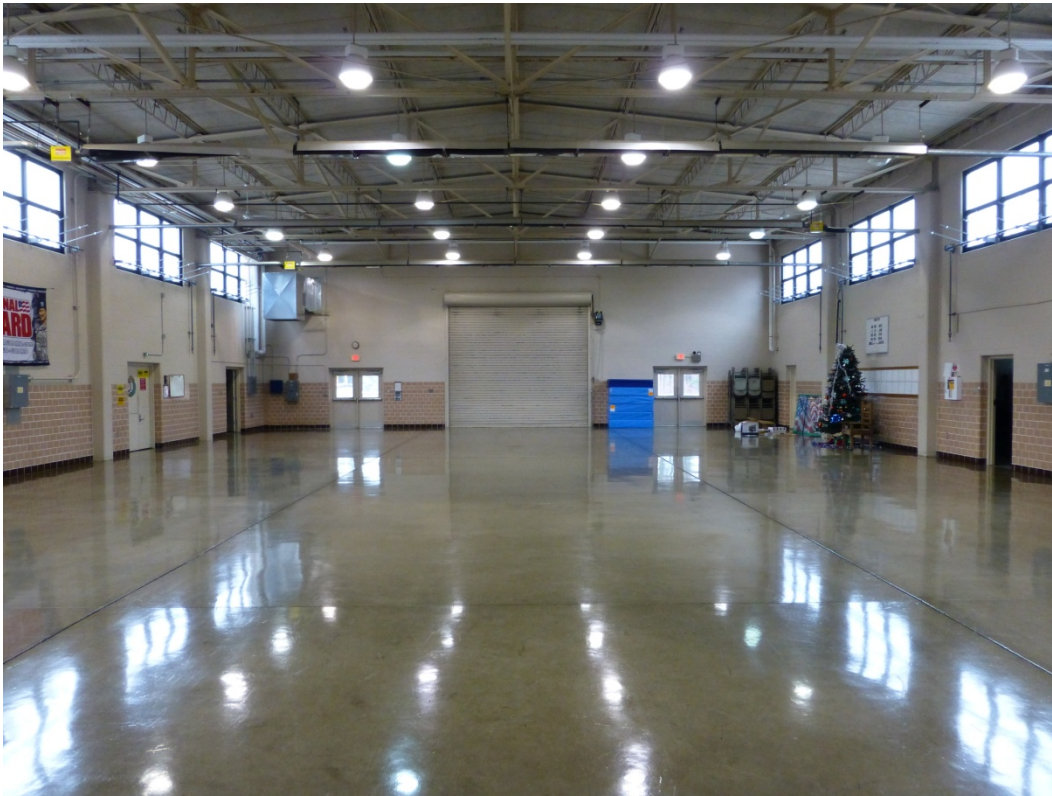
The original interior design elements included an open double-height drill hall with concrete floor and exposed arched steel-truss system (Figure 68); glazed sanitary tile walls in the latrines, locker room and drill hall; mosaic tile floor in the latrines; concrete-block interior walls; metal supply room doors; and metal and glass office doors.

Figure 68. Interior view of the drill hall of Norwalk OHARNG Armory (ERDC-CERL, 2013).

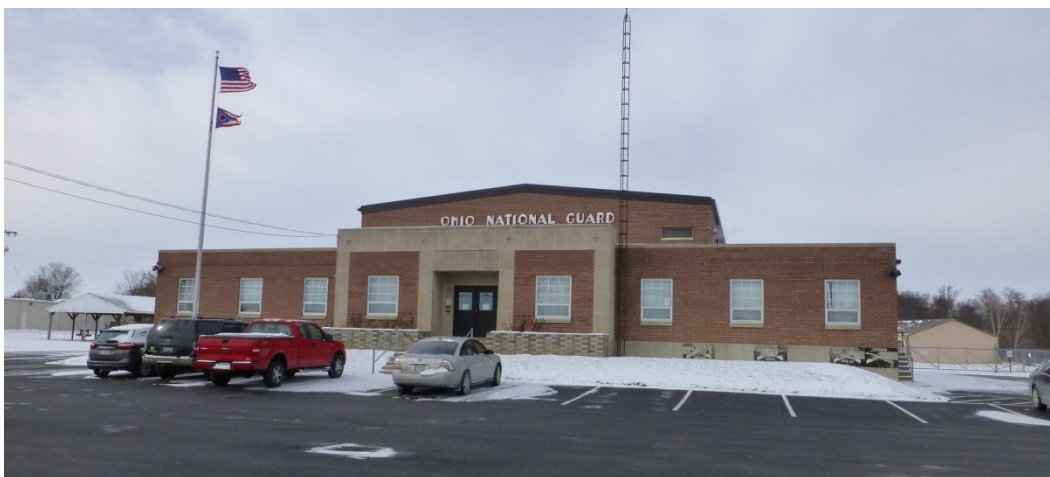
The armory was designed with key elements that included a symmetrical front elevation (Figure 69), brick exterior walls, a cubist form, flat roofs over the one-story areas, a shallow gable roof over the double-height drill hall space, a raised concrete foundation, repetitive window patterns with concrete windowsills, clerestory windows, minimal architectural ornamentation, a recessed entry framed with a band of stone tiles, Stainless-steel lettering spelling “Ohio National Guard”, and one large garage bay door.

Figure 69. East (front) elevation of Greenville OHARNG Armory (ERDC-CERL, 2014).

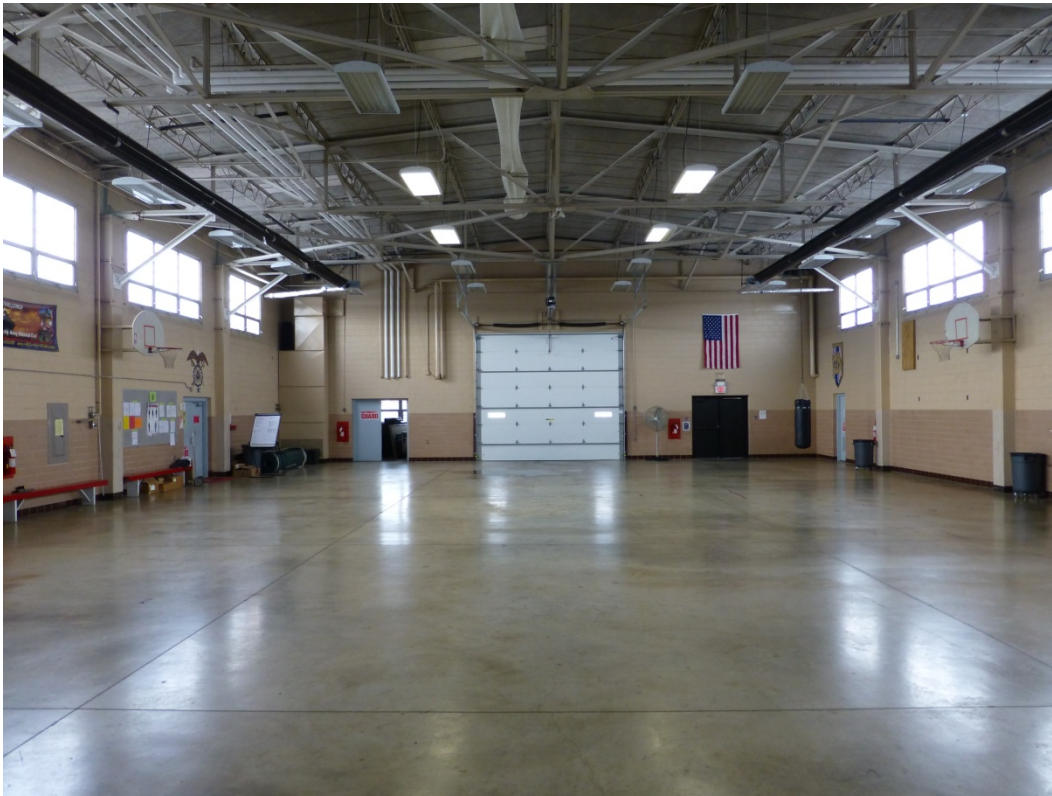
The original interior design elements included an open double-height drill hall with concrete floor and exposed arched steel-truss system (Figure 70); glazed sanitary tile walls in the latrines, locker room, drill hall, and kitchen; mosaic tile floor in the latrines; concrete-block interior walls; metal supply room doors; and metal and glass office doors.

Figure 70. Interior view of the drill hall of Greenville OHARNG Armory (ERDC-CERL, 2014).

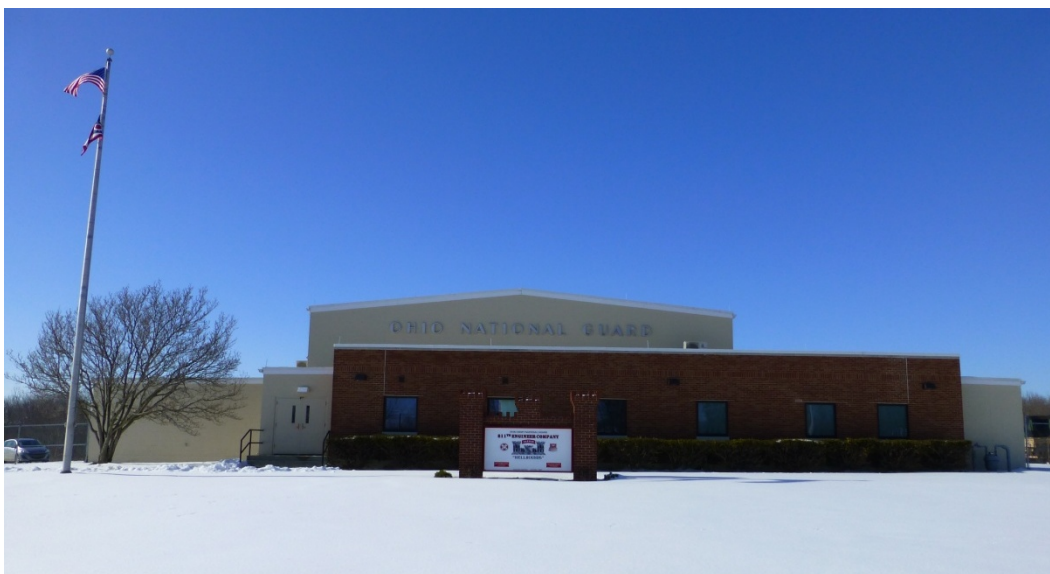
Type E armory was built with concrete-block walls and lacked the brick veneer like the other two armories (Figure 71). The front elevation is the only side that exhibits brickwork. This armory was not originally designed with a rifle range or as a many individual offices. The front elevation is different as well. It is not symmetrical, nor does it boast the stone tile detailing around the main entry like the other two armories previously discussed (Norwalk and Greenville).

Figure 71. East (front) elevation of Tarlton OHARNG Armory (ERDC-CERL, 2014).

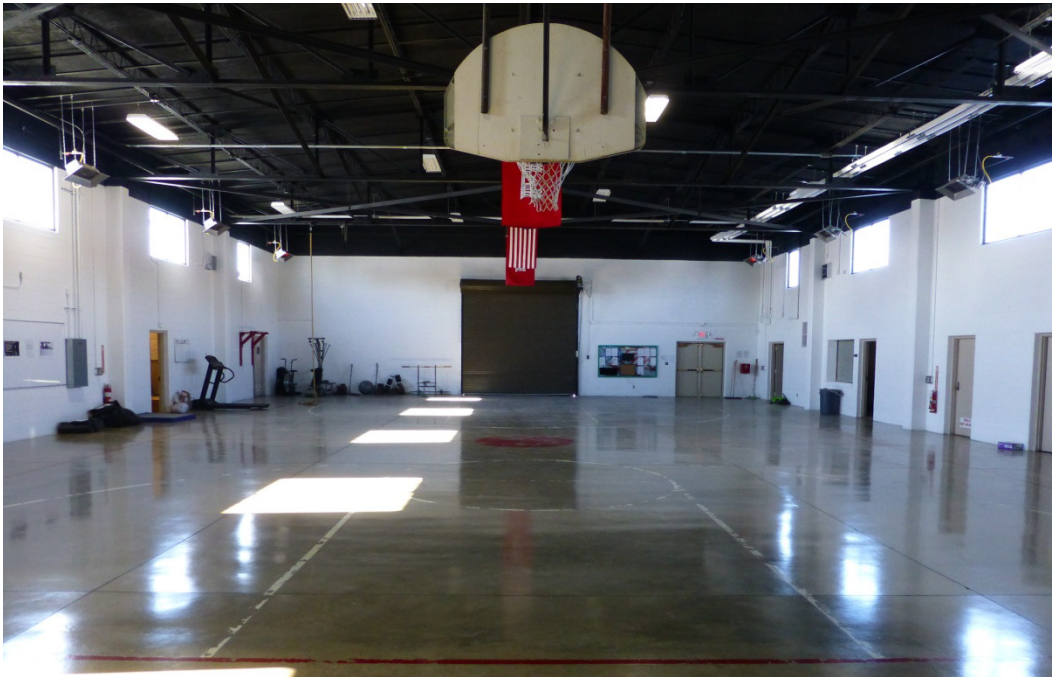
The original interior design elements included an open double-height drill hall with concrete floor and exposed arched steel truss system (Figure 72); glazed sanitary tile walls in the latrines, and locker room; concrete-block interior walls; and metal interior doors.

Interior rooms originally included a lobby, one large classroom with an accordion divider wall, offices, a kitchen, a unit storage room with a vault, a maintenance room, and latrines with adjacent locker room. All of these rooms were accessible via the centrally placed drill hall space (Figure 72).

Figure 72. Interior view of the drill hall of Tarlton OHARNG Armory (ERDC-CERL, 2014).

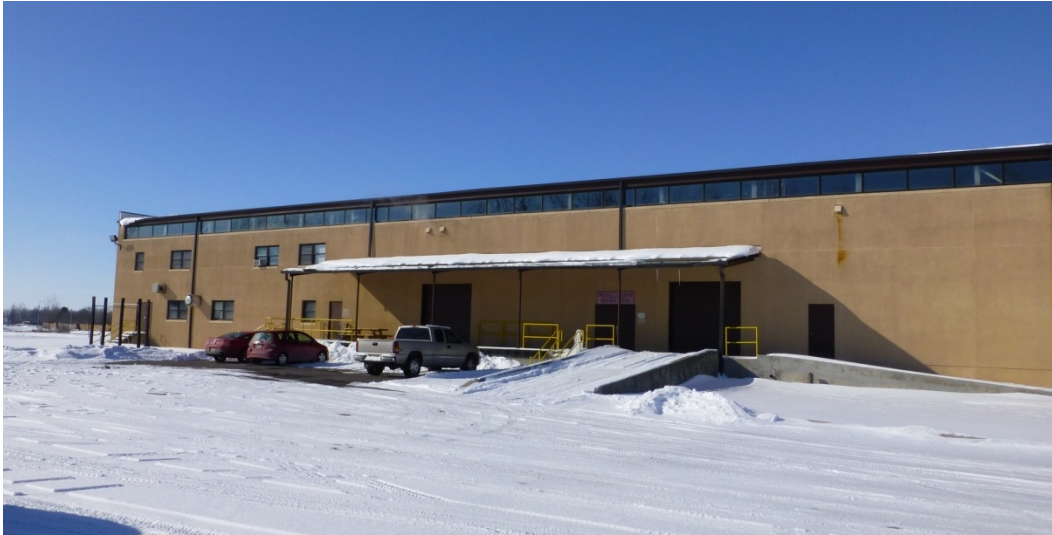
The building that now houses the Marion Armory was constructed by the War Department in 1942 as part of the Marion Engineer Depot. The depot was utilized for handling and storing the heaviest type of engineering equipment. The Department of the Army closed the facility in 1961. Most of the original depot was abandoned, and many of the original warehouses were demolished. The OHARNG acquired the structure and surrounding site in 1964. It was intended to be used as a one-unit armory. The acquired building was an open high-bay structure with a simple design (Figure 77), a rectangular footprint, a flat roof, concrete-block walls (later clad with a stucco-like material), and ribbon-style clerestory windows (Figure 76).

Figure 76. South (front) elevation of Marion OHARNG Armory (ERDC-CERL, 2014).

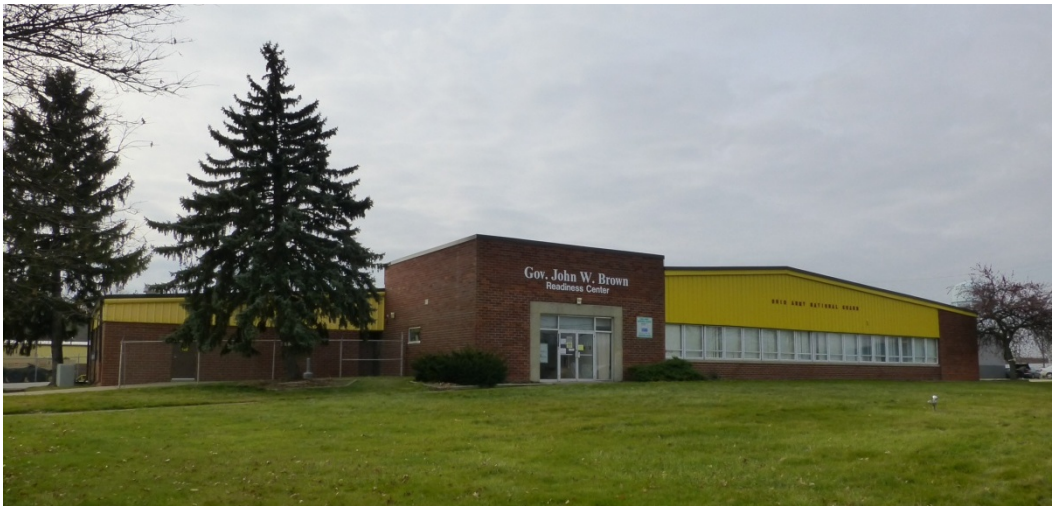
The Medina armory was originally constructed in 1959 as a factory building. The OHARNG acquired the structure and surrounding site in 1992. The former factory had brick exterior walls, shallow gable roofs, ribbon-style bright-aluminum windows, rectangular shape, stone detailing around the front entry, and open high-bay interior spaces (Figure 78 and Figure 79).

Figure 78. North (front) elevation of Medina OHARNG Armory (ERDC-CERL, 2013).

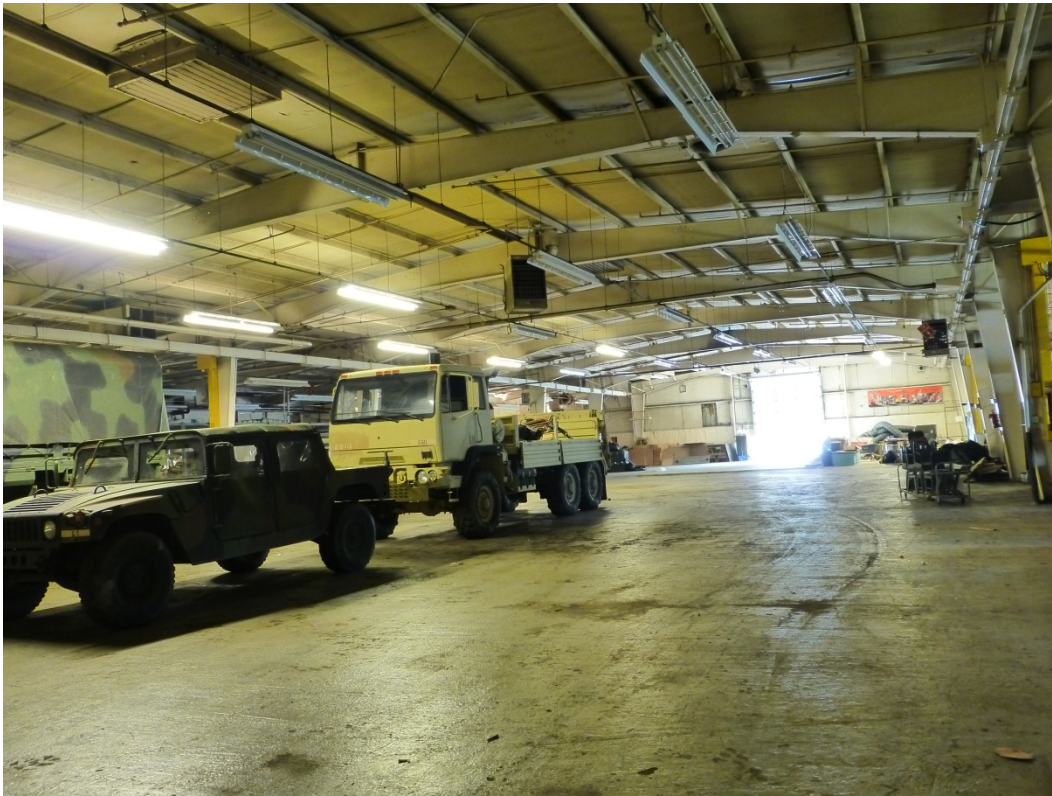
Figure 79. Interior view of the open high-bay area of the Medina OHARNG Armory (ERDC-CERL, 2013).

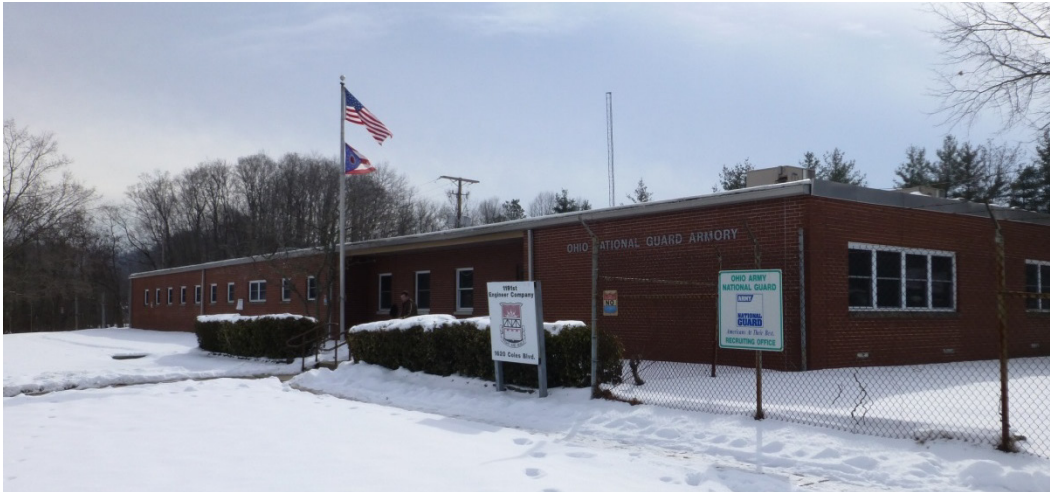
The Portsmouth armory was built in 1959 and was originally used as a one-unit U.S. Army Reserve Center. The OHARNG acquired the structure and surrounding site in 1996. The building was originally designed with a one-story office/classroom wing (Figure 80), a high-bay drill hall wing, and a hyphen that connects the two spaces. The exterior walls were done in brick, and all three spaces were covered with separate, shallow shed roofs. The original windows were multipane steel-sash awning windows. The entry doors were metal with a large glass on the top half.

Figure 80. North (front) elevation of the Portsmouth OHARNG Armory (ERDC-CERL, 2014).

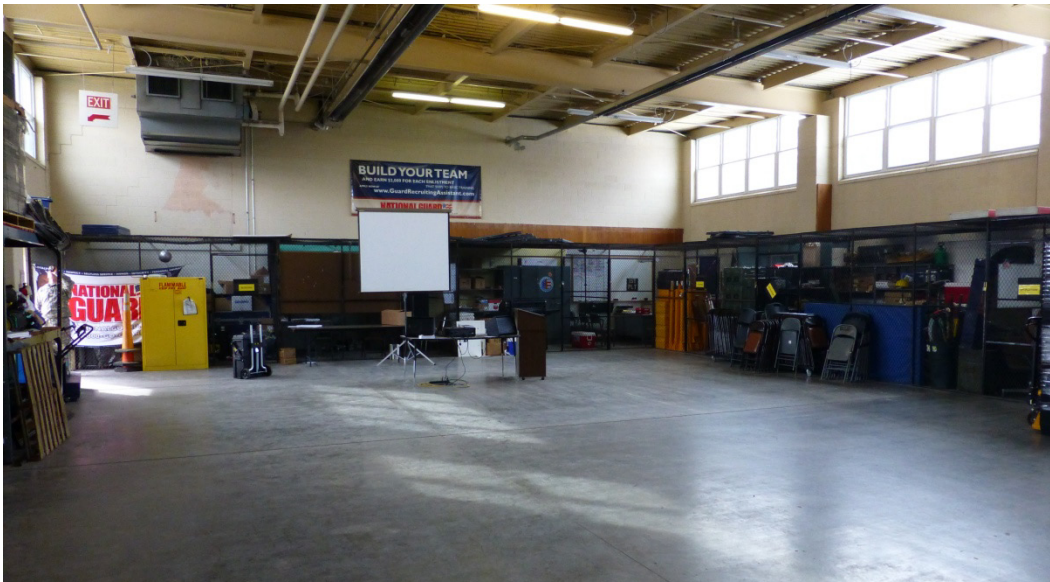
The one-story wing originally had a central corridor with concrete-block interior walls. There were two large classrooms that were each divided into two smaller classrooms by an accordion room divider. Each classroom had a chalkboard and corkboard with a wood frame. The latrines had plaster and tile walls including tiled shower stalls. There was a large locker room space adjacent the latrines. The one-story wing also had several smaller offices and one large unit storage room, as well as a kitchen. The drill hall space was designed as an open interior with concrete-block walls, concrete floor, and an exposed truss roofing system (Figure 81).

Figure 81. Interior view of the drill hall of Portsmouth OHARNG Armory (ERDC-CERL, 2014).

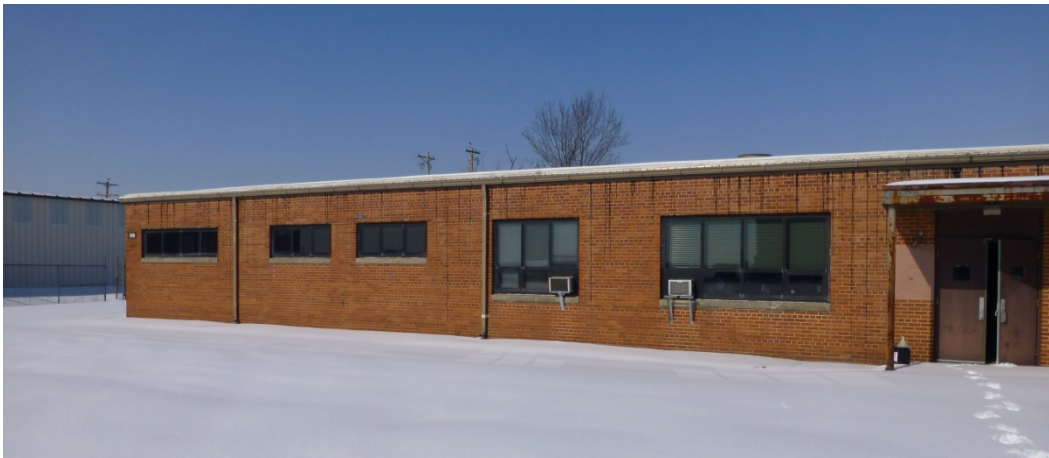
Building 915 is at 7704 Tuskegee Airman Road on the northeast side of the RAE parcel. South Access Road is on the northwest side, and an aircraft parking apron is on the southeast side of the building. Building 915 was constructed in 1957 with some modern elements including a flat roof, brick exterior walls, concrete windowsills, a cubist form, and minimal architectural details (Figure 84). The building was designed as a one-story rectangular structure.

Figure 84. Southeast elevation of Building 915 (ERDC-CERL, 2014).

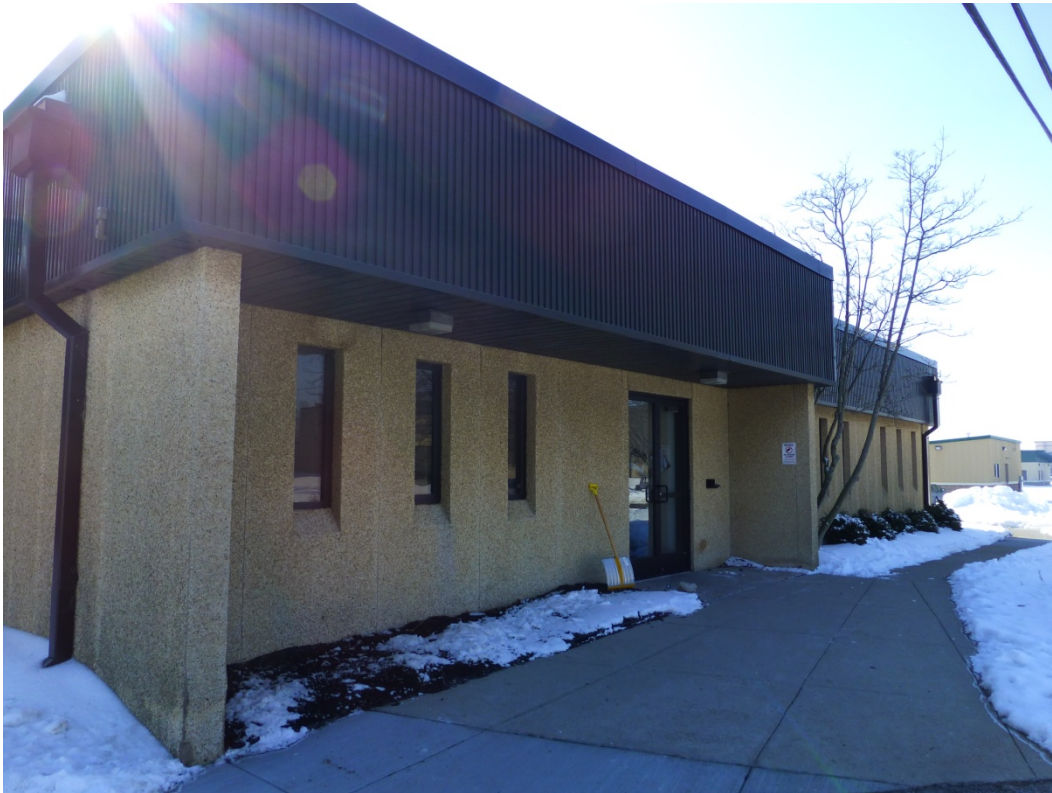
Building 920 is located at 8174 South Access Road, just west of the aircraft parking apron. Building 921 is to the northwest, and Building 941 is to the southwest. Building 920 was constructed in 1959. The building was originally designed with some modern and mid-century elements such as brick exterior walls, a flat roof, repetitive window patterns, ribbon windows, multipane steel-sash windows, and minimal architectural details. It was constructed as a one-story building (Figure 85) with a T-shaped footprint and an approximate area of 16,491 square feet. Since the original construction, Building 920 has undergone significant modifications (Figure 86). None of the original construction materials or design elements remains intact.

Figure 86. Modified main entry with new window pattern, new windows, new doors, new exterior wall cladding material, and new metal fascia system (ERDC-CERL, 2014).

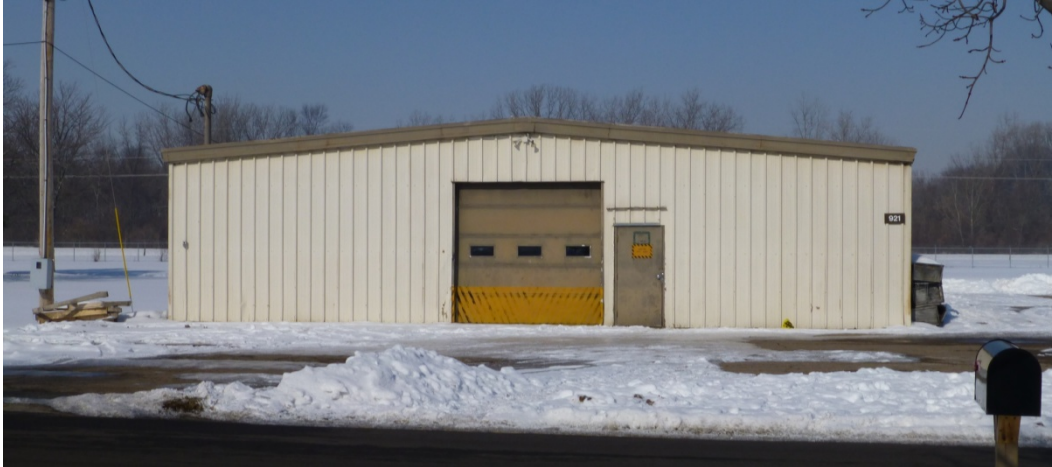
with a rectangular footprint, metal-clad exterior walls, a gable roof clad with metal panels, and metal entry doors and overhead door (Figure 87).

Figure 87. Southeast (front) elevation of Building 921 (ERDC-CERL, 2014).

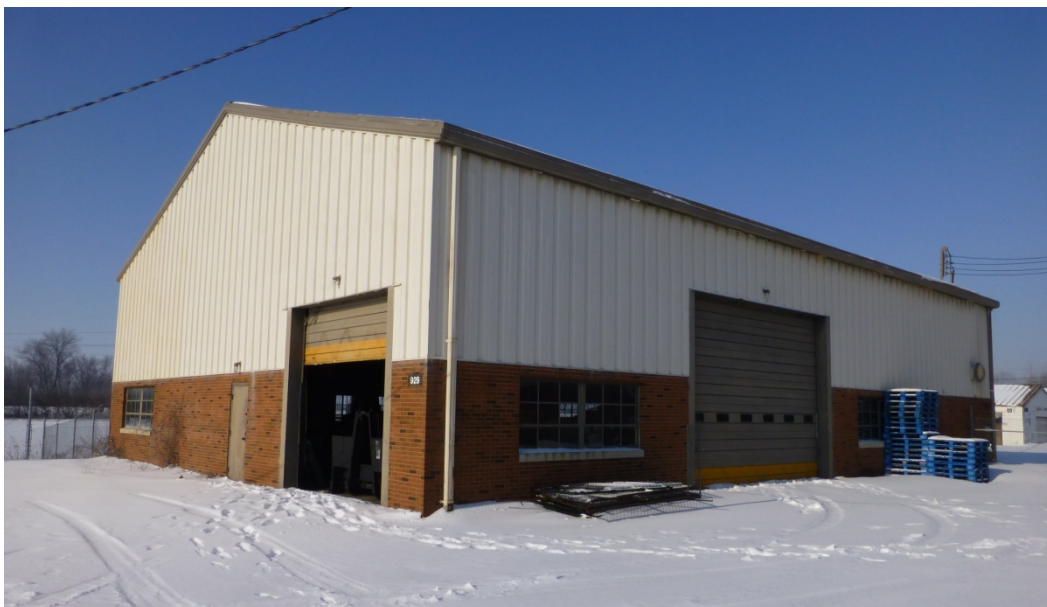
Figure 88. East oblique of Building 929 (ERDC-CERL, 2014).

Building 929 is located at 8227 South Access Road on the south side of the RAE parcel. South Access Road ends on the north side of the building and Rickenbacker Parkway, and the fence line is located on the west side of the building. Building 931 is to the northeast, and Buildings 939 and 940 are to the northwest. Building 929 was constructed in 1965 as a repair shop. The building was designed as a high-bay, steel-frame structure with a rectangular footprint (Figure 88). The exterior walls were built with a combination of brick on the bottom half and metal siding on the top half. The windows were paired multipane steel-sash windows with concrete windowsill. The windows were placed within the brick portion of the wall just below the metal siding. It has a gable roof. There are two large garage bay doors and two metal entry doors that provide access into the structure. The interior was an open bay space.
