## **Architectural Survey of Ohio Army National Guard Properties: Volume I**

Under Project 405180, "OHARNG Architectural Survey"

This document is Volume I of a two-volume architectural survey of 85 buildings and structures utilized by the Ohio Army National Guard and located across the state of Ohio. The majority of these structures were constructed from 1920 to 1968, with others constructed from 1969 to 1988. This survey satisfies Section 110 of the National Historic Preservation Act of 1966 as amended, and was used to determine the eligibility of these buildings and structures for inclusion on the National Register of Historic Places (NRHP). It is the recommendation of this report that 19 armories and 4 associated support buildings are significant under NRHP criteria and retain enough integrity to be individually eligible for the NRHP. Volume II of this report is published separately and contains the ERDC-CERL architectural survey forms.

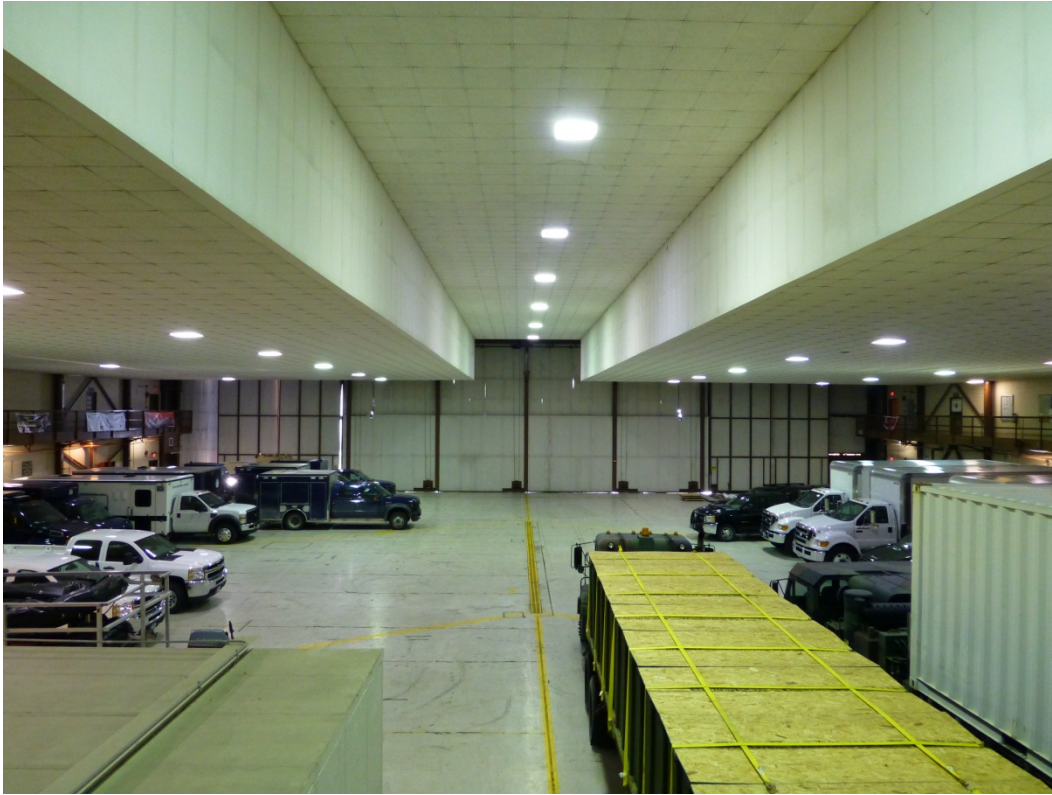
The original first floor consisted of the main squadron operations office, a food service room, a latrine, several large maintenance/shop rooms, and a parachute tower. These rooms were located around the center open interior of the hangar space. The hangar space had ribbons of clerestory windows on the side and rear elevations and had a concrete floor (Figure 93). The original second floor consisted of several large classrooms, an office space, and a large latrine and locker room. These rooms opened out to a catwalk/balcony that encompassed the upper portion of the open hangar space. Two concrete switchback stairs provided access to the second floor spaces.

Figure 93. Interior view of the high-bay hangar of Building 931 (ERDC-CERL, 2014).

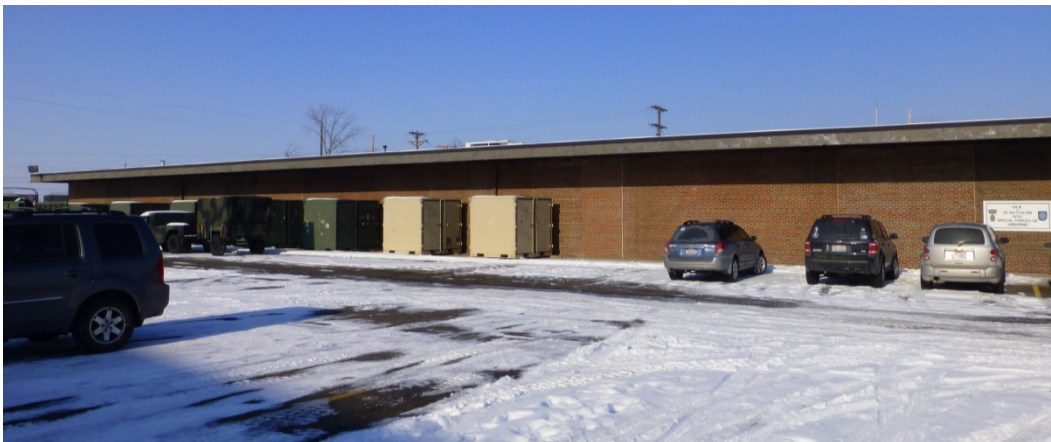
Building 933 is located at 8226 South Access Road. Building 930 is to the northeast, and Building 931 is to the southeast. A large paved lot is located on the southeast side of the building, and the property fence line runs along the southwest and northwest sides of the building. Building 933 was constructed in 1956 as warehouse building. It was originally built as a one-story structure with a rectangular footprint (Figure 95). Key design elements included brick exterior walls, a flat roof with an overhanging concrete eave, metal garage bay doors, and multipane steel-sash windows with concrete windowsills. The original interior was mostly open space with small rooms located on the northeast end of the building.

Figure 95. Southeast (front) elevation of Building 933 (ERDC-CERL, 2014).

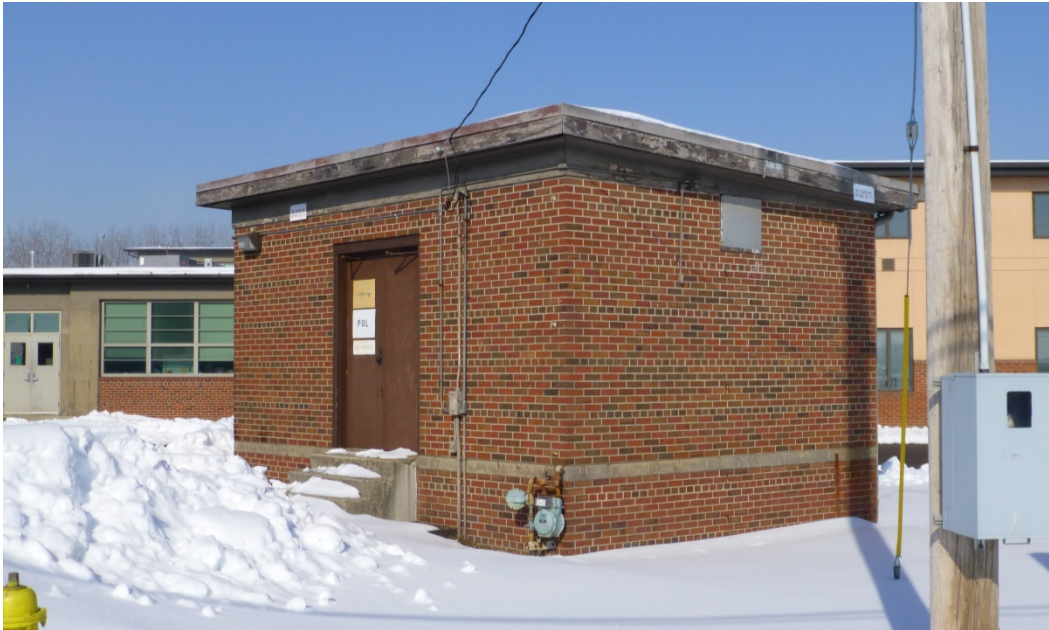
Figure 96. South oblique of Building 934 (ERDC-CERL, 2014).

Building 934 is located at 8227 South Access Road. Building 930 is to the northwest, Buildings 935 and 936 are to the northeast, and Building 932 is to the southwest. A large paved lot is located on the southeast side of the building. Building 934 was constructed in 1956 as a flammable materials storehouse. It was originally designed as small one-story brick structure with a square footprint, a raised concrete foundation, brick exterior walls, a flat concrete roof, and metal doors (Figure 96). There is a set of metal doors located on the southwest elevation.

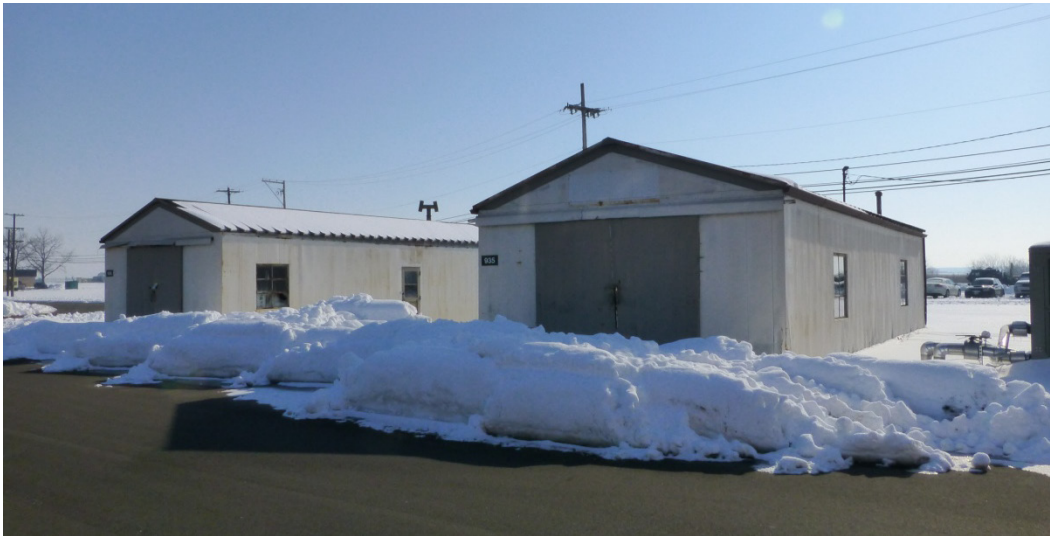
Buildings 935 and 936 are located at 8227 South Access Road. Building 930 is to the northwest, and Building 934 is to the southwest. A large paved lot is located on the southeast side of the buildings. Building 935 and 936 were constructed in 1963 as storage buildings. These buildings were designed as prefabricated metal structures using standardized plans as simple one-story rectangular structures with a gable roof clad with metal, metal-sided exterior walls, metal sliding doors, and multipane metal-sash windows (Figure 97).

Figure 97. West oblique of Building 935 (right) and Building 936 (left)  
(ERDC-CERL, 2014).

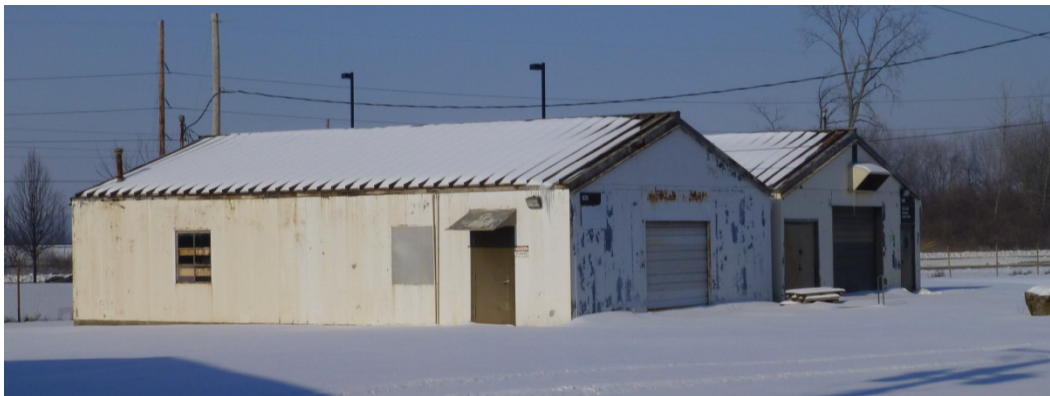
Building 939 was constructed in 1966 and Building 940 was constructed in 1965. Both buildings were built as storage buildings. These buildings were designed as prefabricated metal structures using standardized plans as simple one-story rectangular structures with a gable roof clad with metal, metal-sided exterior walls, metal overhead doors, and multipane metal-sash windows (Figure 98).

Figure 98. East oblique of Building 939 (left) and Building 940 (right)  
(ERDC-CERL, 2014).

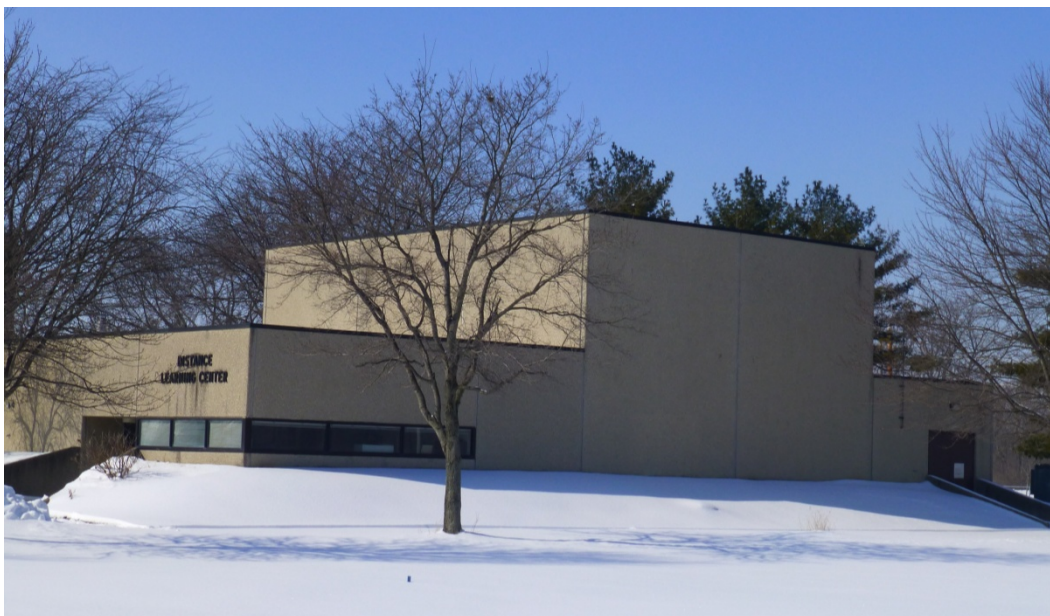
The northeast elevation is three-part with the middle being the high-bay area (Figure 100). There is a band of replacement anodized-bronze aluminum windows on the left side of the elevation and a set of replacement

Figure 100. East oblique of Building 944 (ERDC-CERL, 2014).

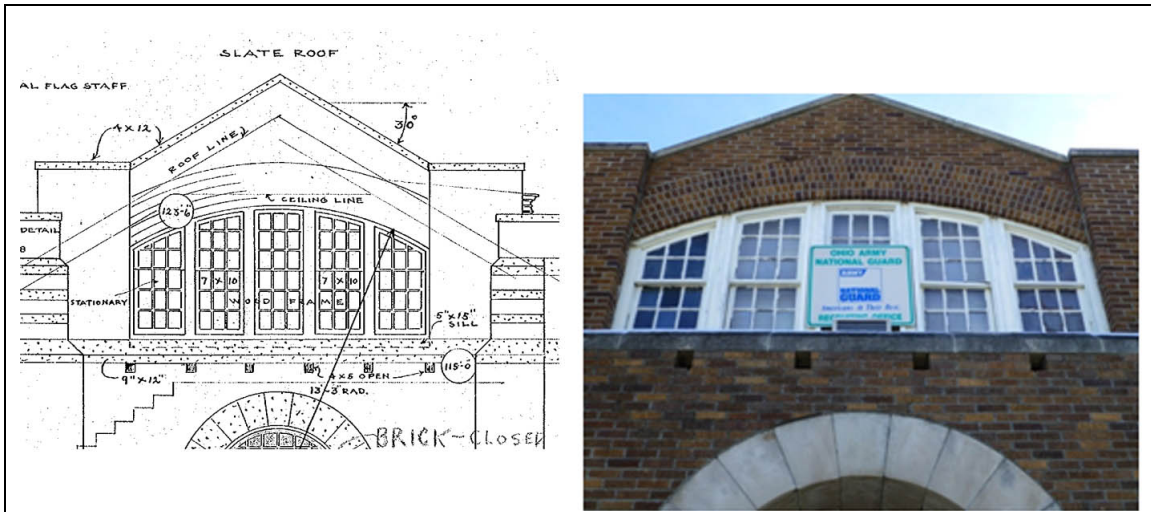
**Main entry on the northwest (front) elevation: original design and materials on the left (1920 drawing), compared to the current condition with replacement entry doors and light fixtures on the right (ERDC-CERL, 2013).**

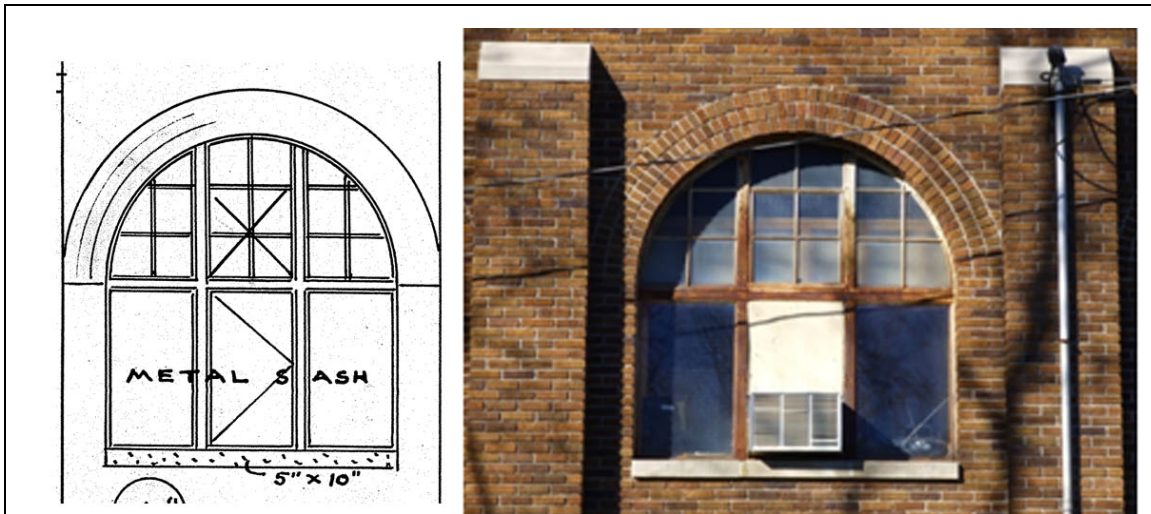
Windows on the southeast (rear) elevation of the 1938 addition: original design and materials with metal frame with wire glass, brick lintels, and stone windowsills on the left (drawing), compared to the current condition of the modified window openings on the right (ERDC-CERL, 2013).

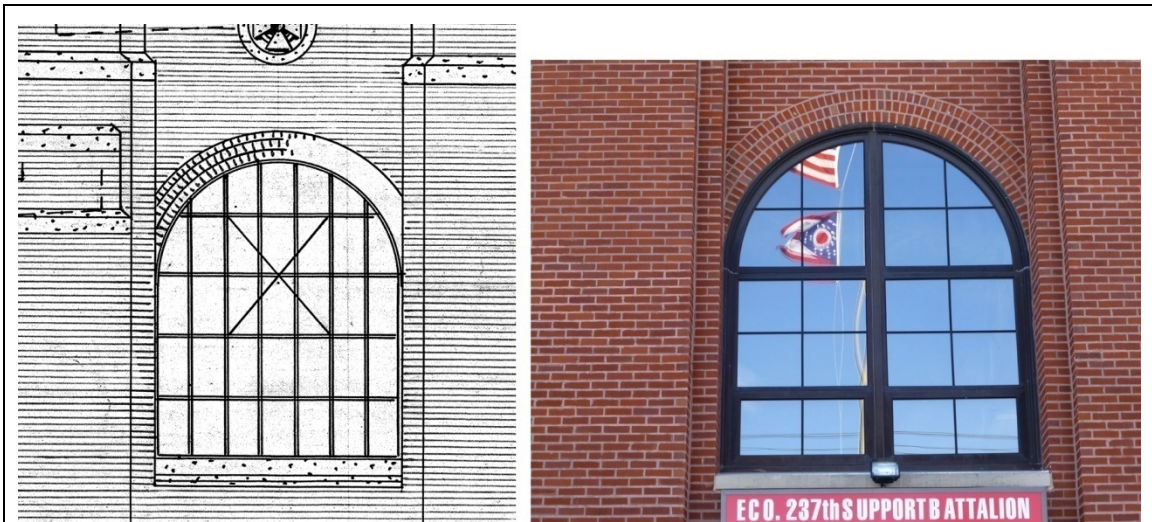
Arched window on northwest (front) elevation: original design and materials (metal frame with wire-glass awning window) on the left (drawing), compared to the current condition of the elevation with replacement anodized-bronze aluminum windows on the right (ERDC-CERL, 2013).

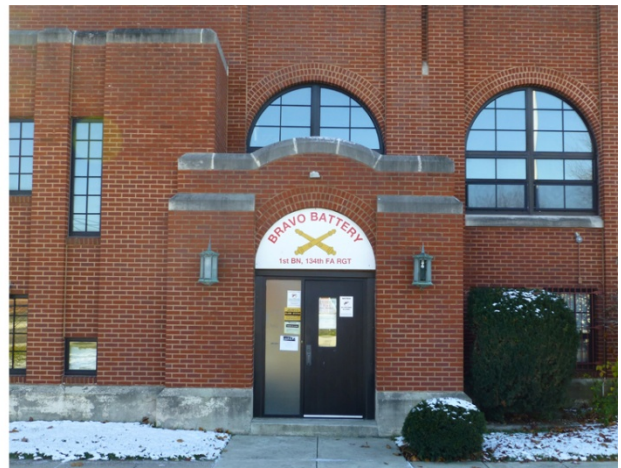
Entry bay on the north (front) elevation: original design and materials with multipane steel-sash industrial windows and metal and glass entry doors on the left (original drawing), compared to the current condition of the elevation with replacement anodized-bronze aluminum windows and metal door with sidelight on the right (ERDC-CERL, 2013).

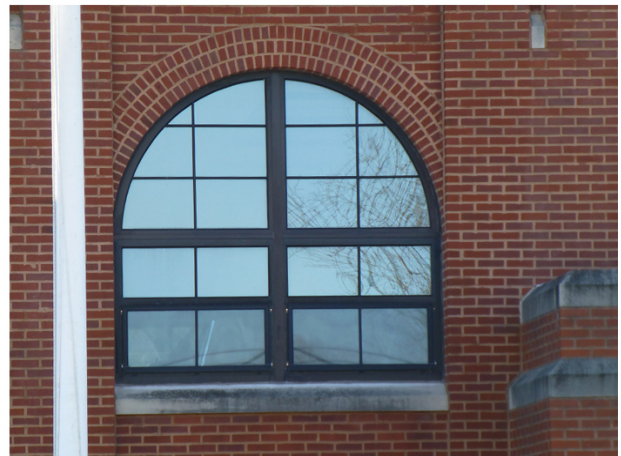
Arch windows on the north (front) elevation : original design and materials with multipane steel-sash industrial window on the left (original drawing), compared to the current condition of the elevation with replacement anodized-bronze aluminum window on the right (ERDC-CERL, 2013).

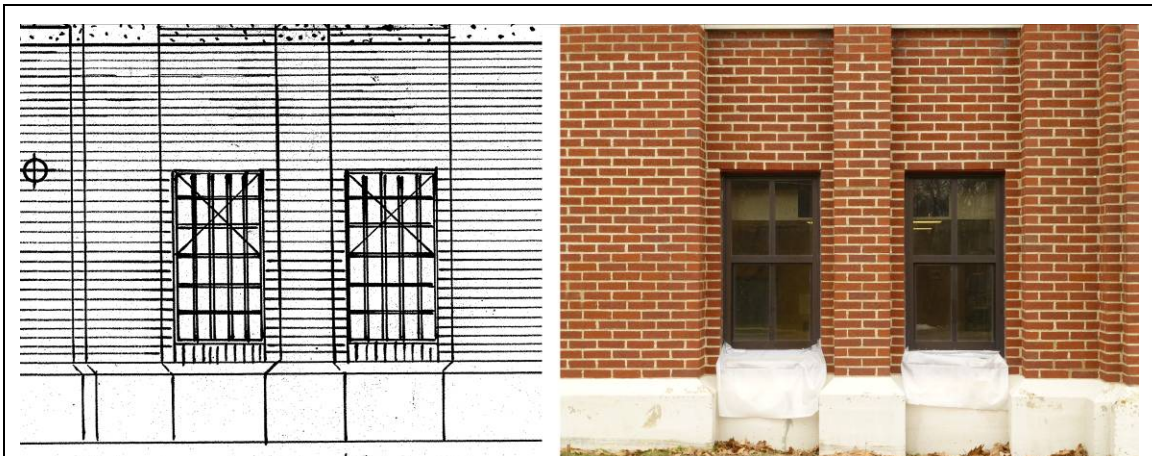
**Rectangular window comparison: original on the left (1937 drawing), and the current photograph on the right (ERDC-CERL, 2013). Original multipane metal-sash awning window was replaced with anodized-bronze aluminum windows.**

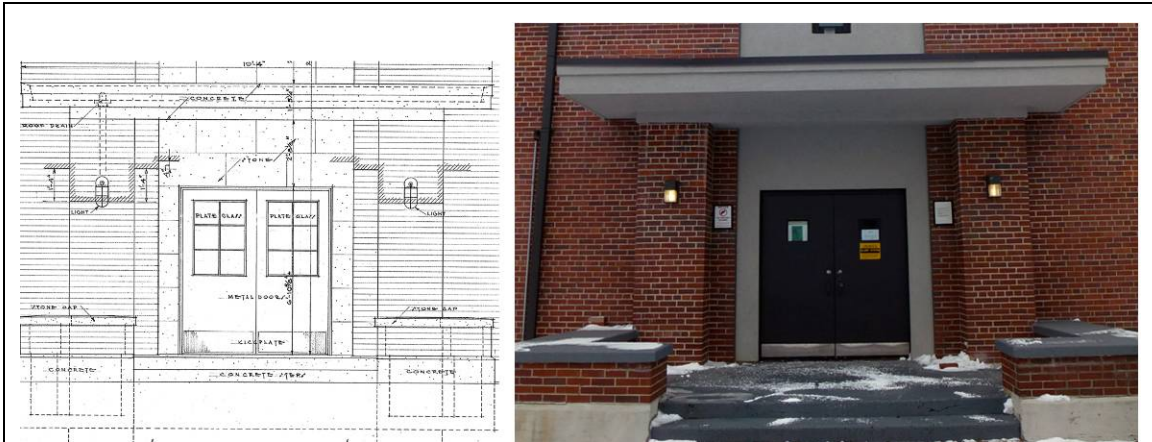
Close-up North main entry on the east (front) elevation: original design and materials: flat canopy, stone-capped bench/half walls, light fixtures, metal and glass windows, and stone tiles framing the entry bay on the left (1950 drawing), compared to the current replacement one-over-one anodized-bronze aluminum window, replacement entry doors, and replacement light fixtures on the right (ERDC-CERL, 2014).

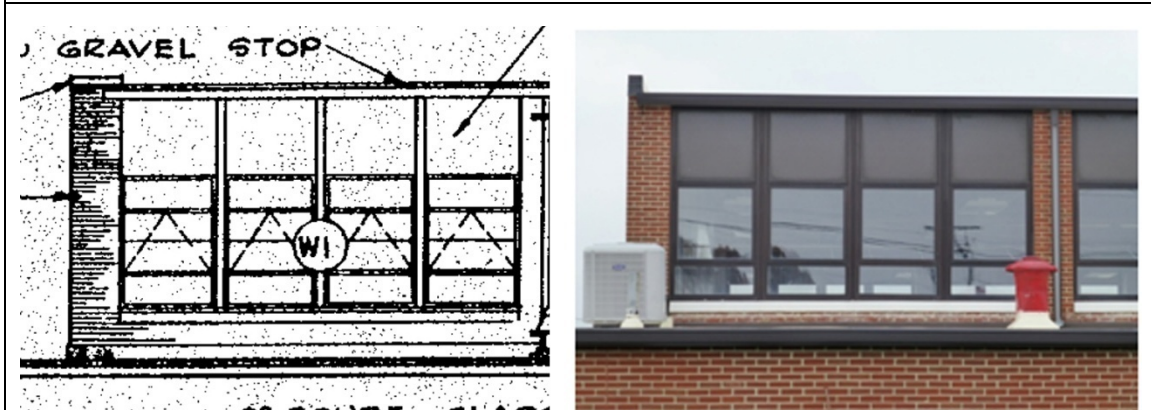
Main entry bay on the north (front) elevation: original design and materials with wood veneer wall, three-pane awning windows, metal and glass entry doors on the left (1952 drawing), compared to the current condition, replacement one-over-one anodized-bronze aluminum windows and metal doors on the right (ERDC-CERL, 2014).

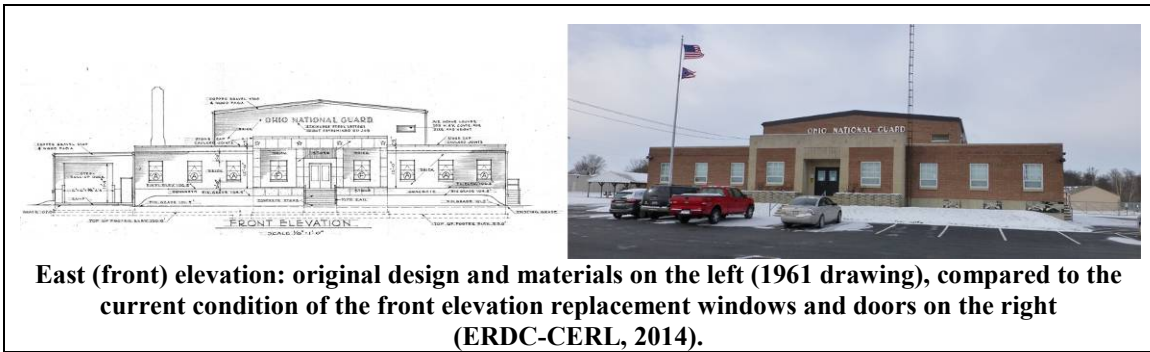
**East (front) elevation: original design and materials on the left (1961 drawing), compared to the current condition of the front elevation replacement windows and doors on the right (ERDC-CERL, 2014).**

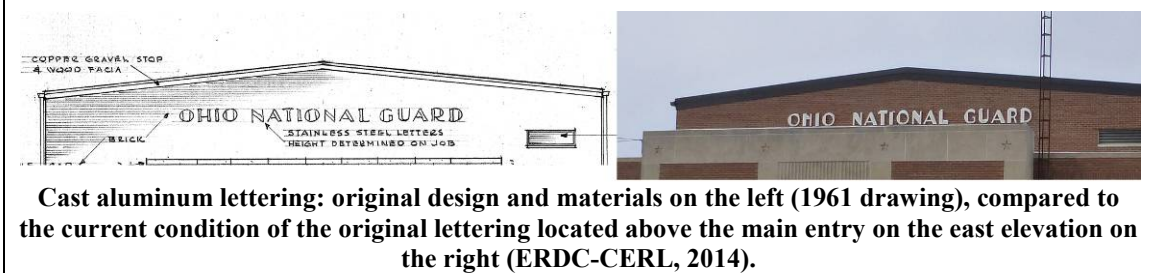
**Cast aluminum lettering: original design and materials on the left (1961 drawing), compared to the current condition of the original lettering located above the main entry on the east elevation on the right (ERDC-CERL, 2014).**

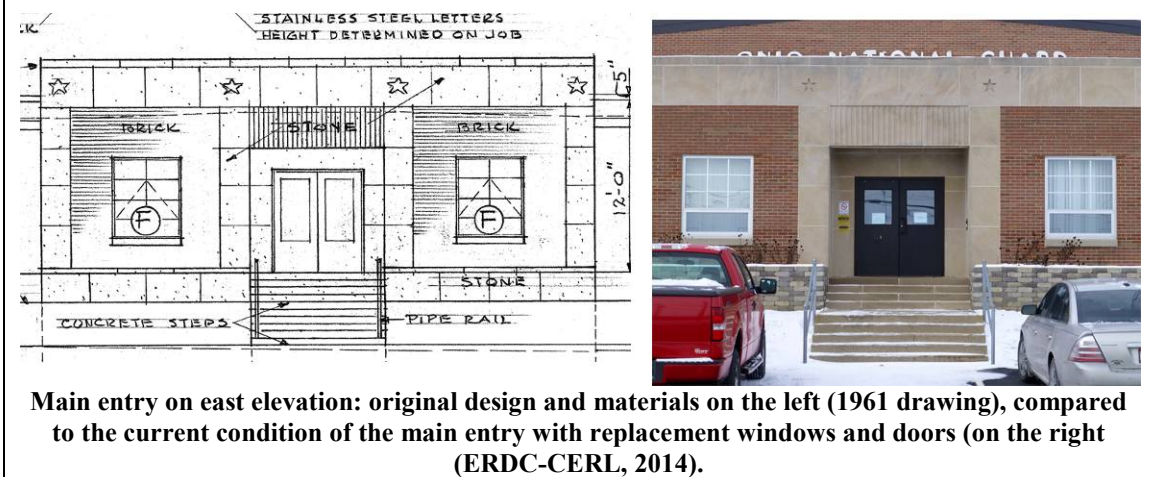
**Main entry on east elevation: original design and materials on the left (1961 drawing), compared to the current condition of the main entry with replacement windows and doors (on the right (ERDC-CERL, 2014).**

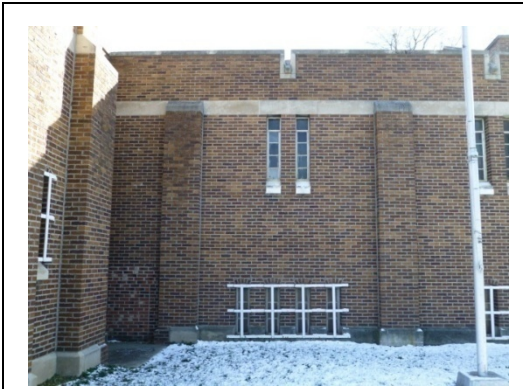
Narrow window openings [metal-sash windows are noncontributing] (St. Marys OHARNG Armory, ERDC-CERL, 2013).

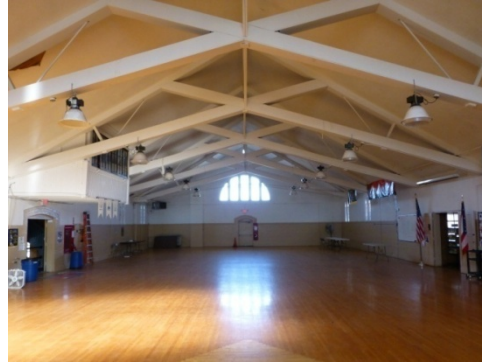
St. Marys OHARNG Armory, open interior of assembly hall space with exposed wood scissor trusses and wood plank floor (ERDC-CERL, 2013).

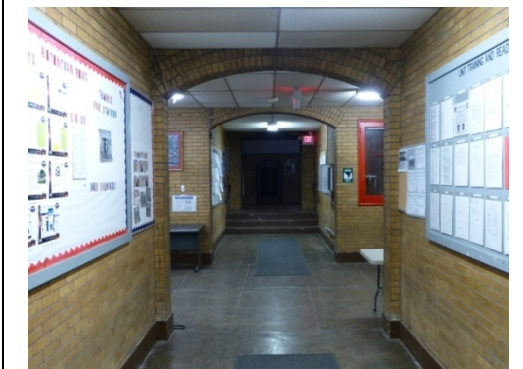
St. Marys OHARNG Armory, interior corridor with brick walls, concrete floor, and arched passageways [drop-ceiling is noncontributing] (ERDC-CERL, 2013).

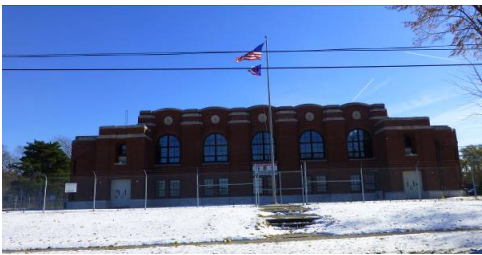
| <p>Northwest (front) elevation; symmetrical facade (ERDC-CERL, 2013).</p> | <p>Arched openings on the front elevation [replacement windows are not character defining] (ERDC-CERL, 2013).</p> |

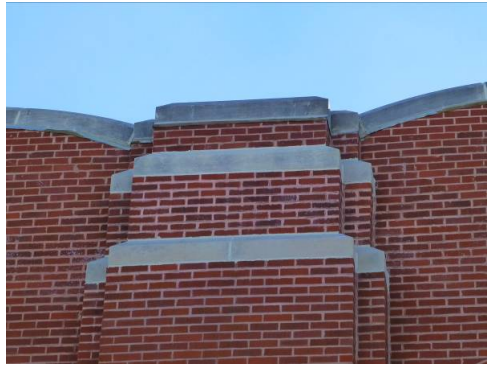
Stone coping and horizontality of details on front elevation (ERDC-CERL, 2013).

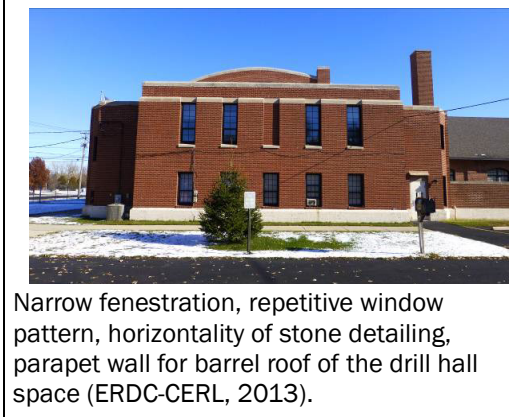
Narrow fenestration, repetitive window pattern, horizontality of stone detailing, parapet wall for barrel roof of the drill hall space (ERDC-CERL, 2013).

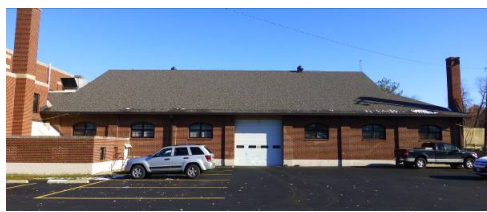
Gable-on-hip roof of riding stadium (ERDC-CERL, 2013).

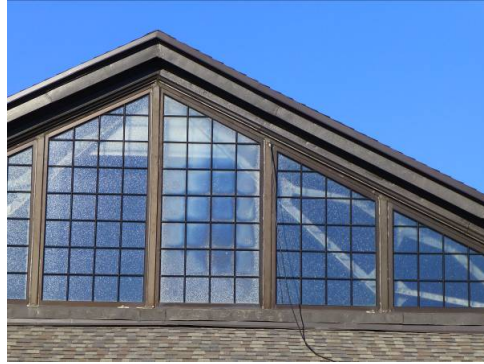
Triangular window in the gable end of the riding stadium roof (ERDC-CERL, 2013).

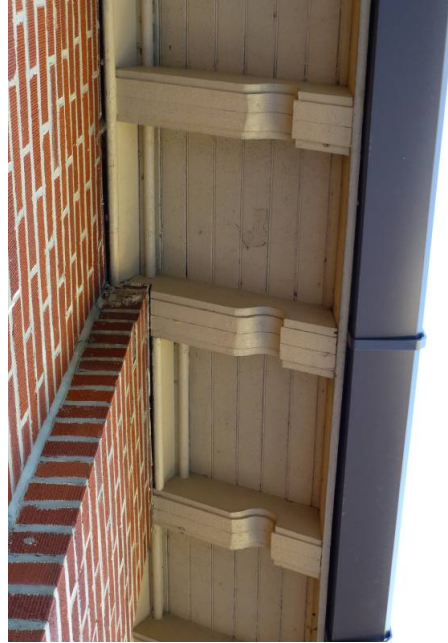
Decorative wood rafters and overhanging eave of the riding stadium roof (ERDC-CERL, 2013).

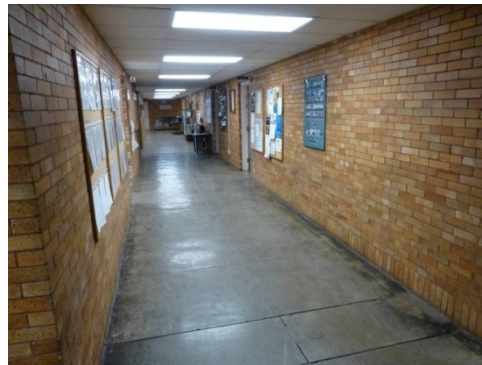
Central corridor with brick walls and concrete floor (ERDC-CERL, 2013).

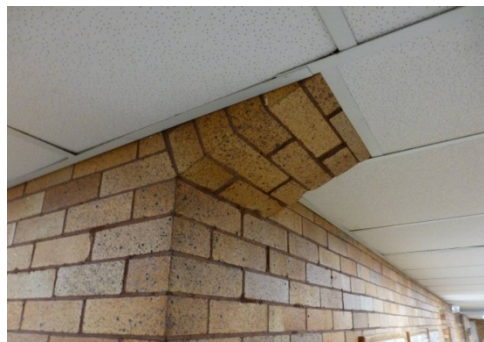
Arched brick passageways in the first floor of the central corridors (ERDC-CERL, 2013).

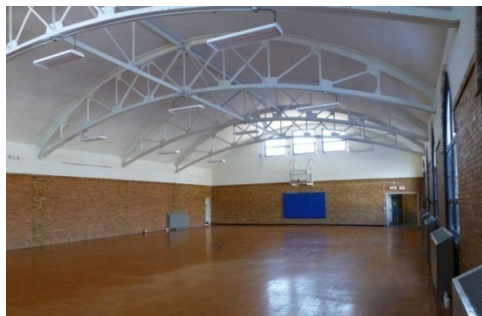
Interior view of the open assembly hall space on the second floor with wood floor, brick walls, barrel roof, and arched steel truss system (ERDC-CERL, 2013).

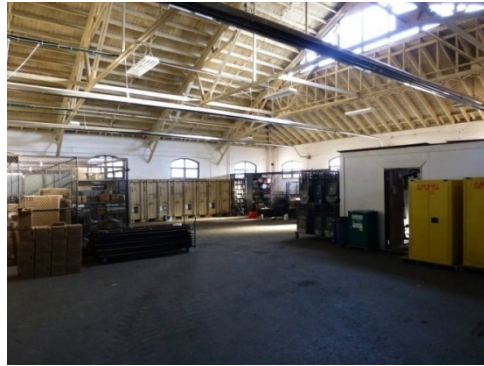
Interior view of the open riding stadium with exposed wood rafters and steel truss roofing system (ERDC-CERL, 2013).

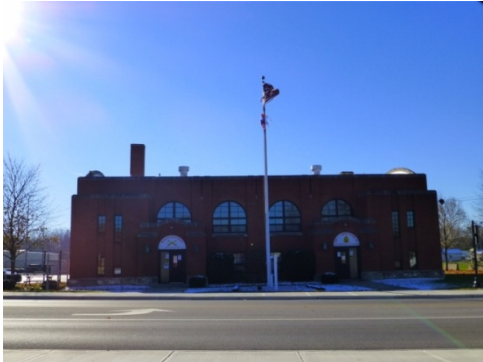
| <p>East (front) elevation, symmetrical facade (ERDC-CERL, 2013).</p> | <p>Entry bay, stone coping, horizontality of stone details, narrow fenestration (ERDC-CERL, 2013).</p> |

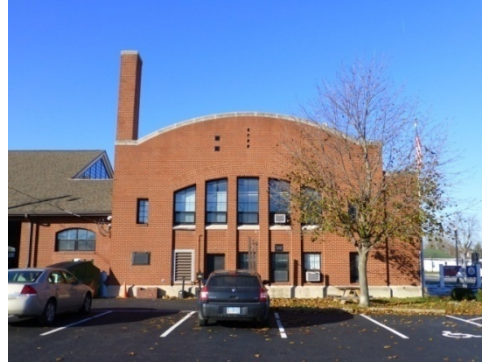
Repetitive window pattern, narrow fenestration, parapet wall, barrel roof (ERDC-CERL, 2013).

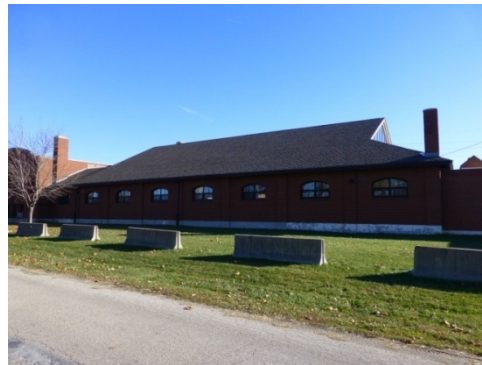
Gable-on-hip roof of the riding stadium (ERDC-CERL, 2013).

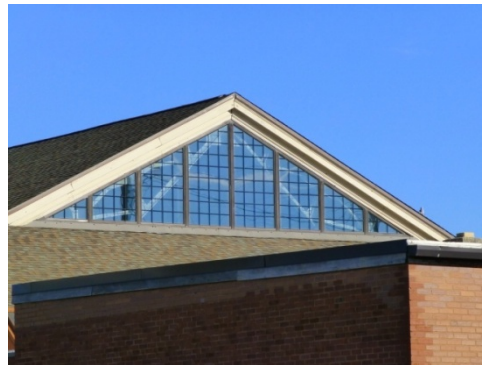
Triangular window in the gable end of the roof over the riding stadium (ERDC-CERL, 2013).

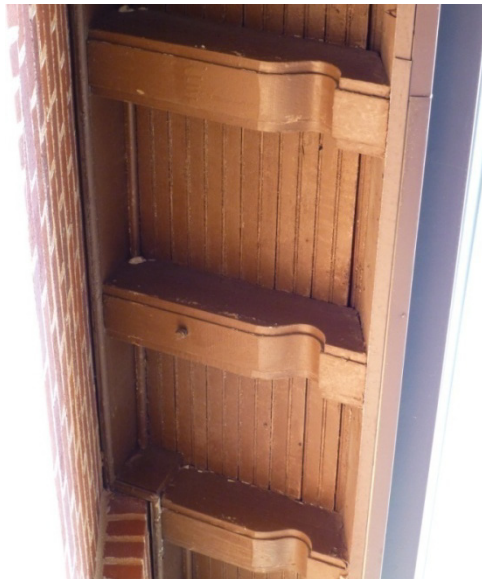
Decorative wood rafters and overhanging eave of the roof over the riding stadium (ERDC-CERL, 2013).

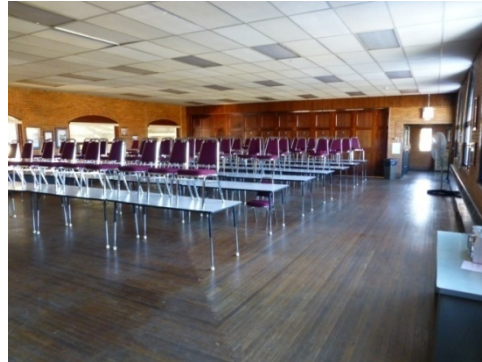
Interior view of the assembly space with wood floor [modified drop-ceiling in not character defining] on the second floor (ERDC-CERL, 2013).

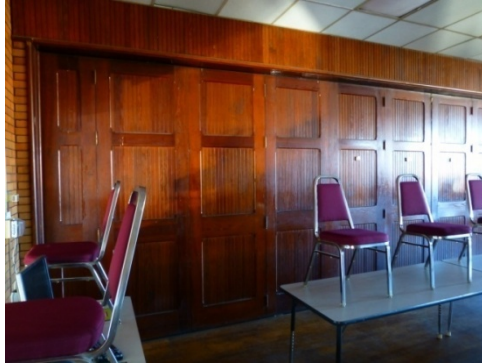
Wood panel pocket doors opening up from the lecture room into the assembly hall space (ERDC-CERL, 2013).

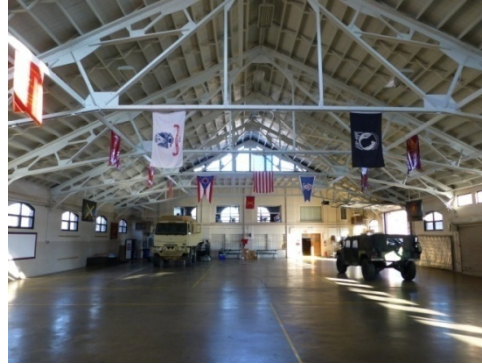
Interior view of the open riding stadium space with exposed wood rafters and steel truss roofing system (ERDC-CERL, 2013).

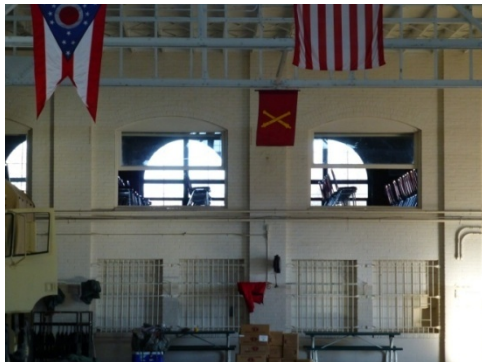
Window opening on the wall of the assembly hall overlooking the riding stadium area (ERDC-CERL, 2013).

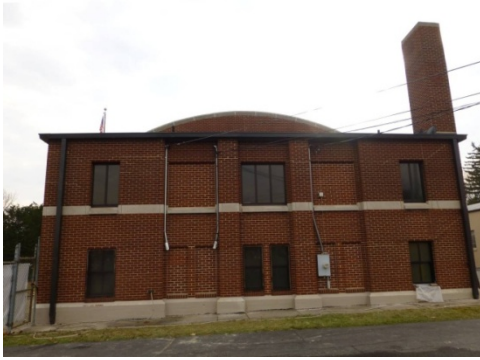
Repetitive window pattern, barrel roof (ERDC-CERL, 2013).

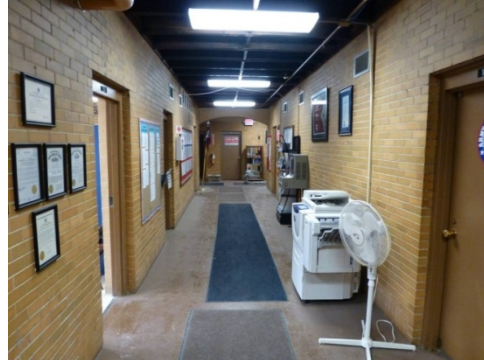
Central corridor with brick walls and concrete floor (ERDC-CERL, 2013).

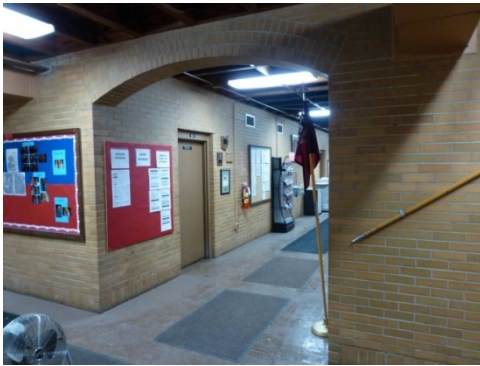
Arched brick passageways (ERDC-CERL, 2013).

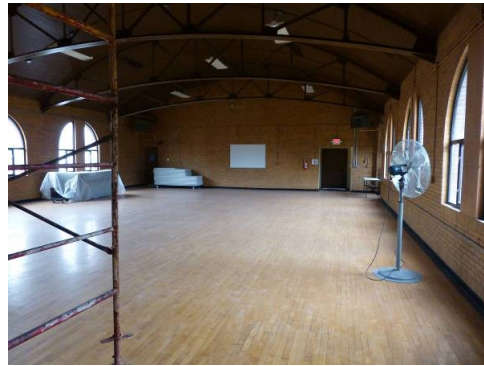
Interior view of open assembly hall with wood floor, brick wall, barrel roof, and arched steel truss roof system (ERDC-CERL, 2013).

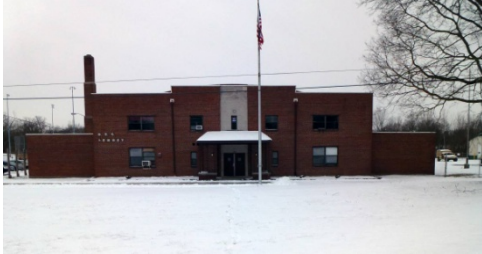
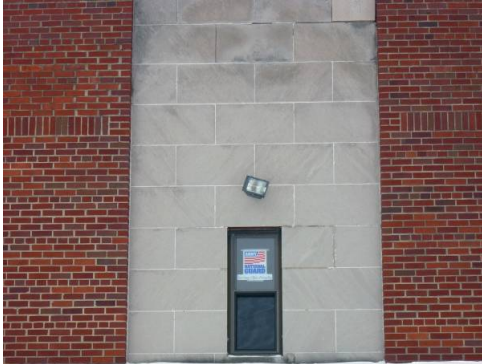
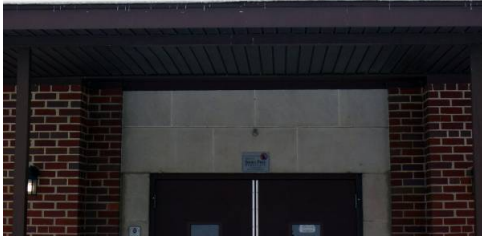
| <p>North (front) elevation, symmetrical façade, brick exterior wall, parapet (ERDC-CERL, 2014).</p> | <p>Stone tile detailing highlighting the main entry on the north elevation (ERDC-CERL, 2014).</p> |

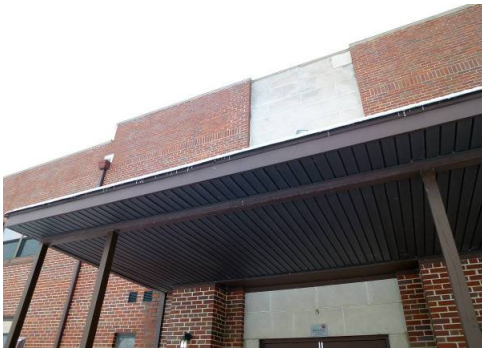
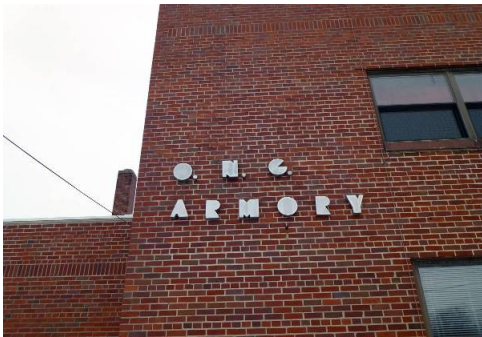
| <p>Concrete canopy structure (modified) over the main entry on the north elevation (ERDC-CERL, 2014).</p> | <p>Stainless-steel lettering on the north elevation (ERDC-CERL, 2014).</p> |

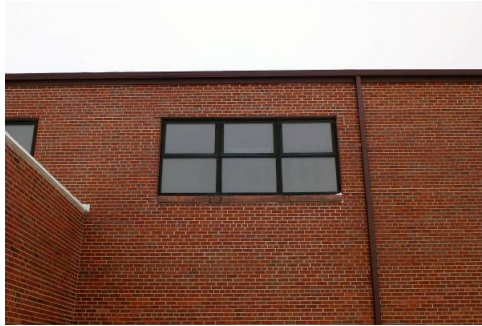
Large clerestory windows (replacement) (ERDC-CERL, 2014).

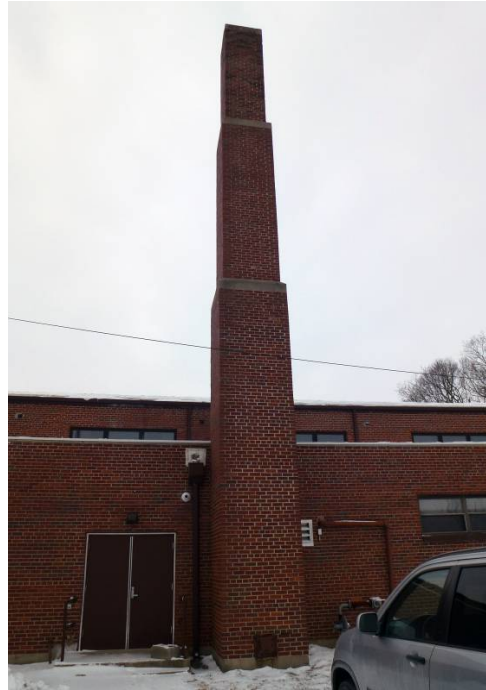
Brick chimney stack (ERDC-CERL, 2014).

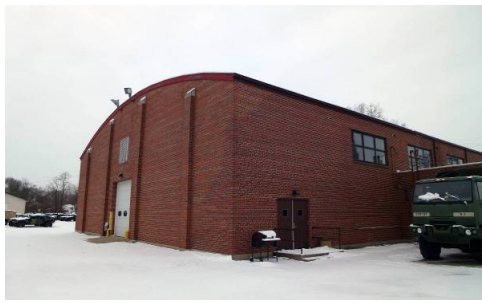
Barrel roof over the drill hall (ERDC-CERL, 2014).

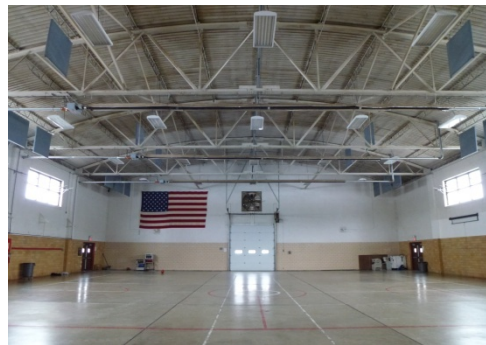
Interior view of the open drill hall space with concrete floor, glazed sanitary tile walls, barrel roof, and expose arched steel truss roofing system (ERDC-CERL, 2014).

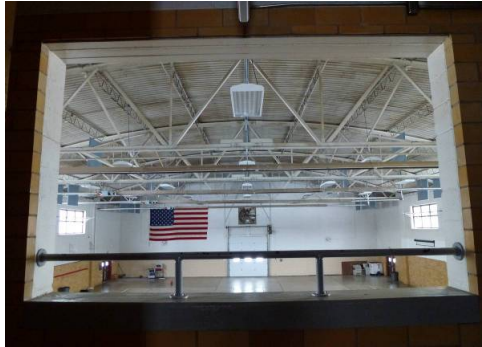
Large window opening from the second floor corridor overlooking the open space of the drill hall (ERDC-CERL, 2014).

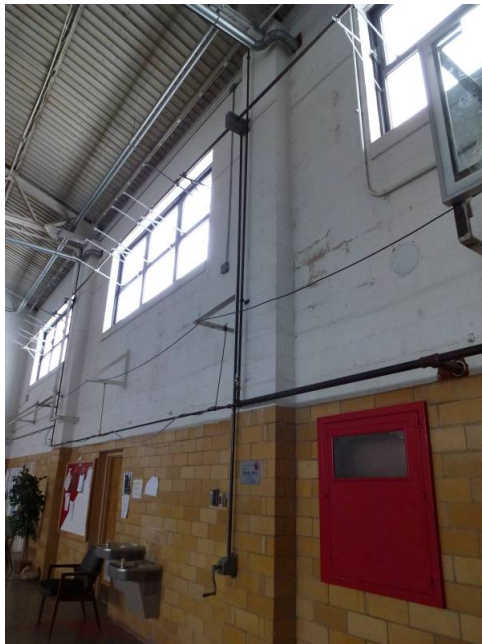
Glazed sanitary tile wall and clerestory windows in the drill hall space (ERDC-CERL, 2014).

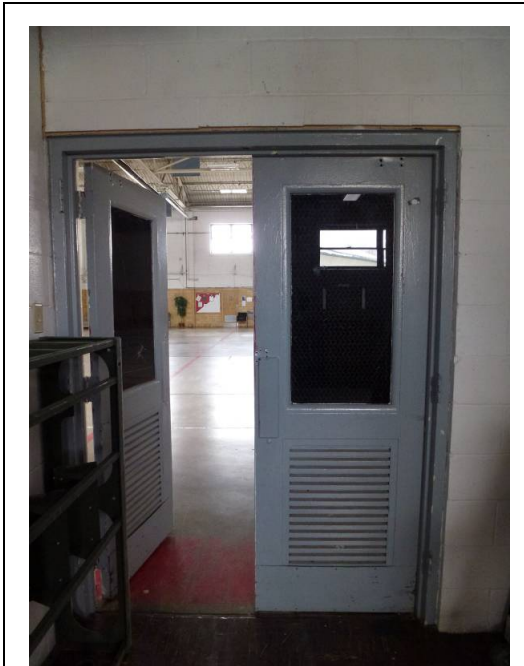
Metal, glass, and louvered vent interior doors (ERDC-CERL, 2014).

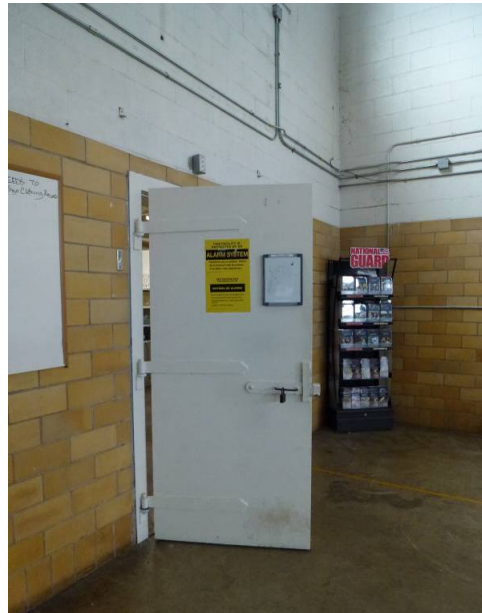
Steel interior door for supply rooms (ERDC-CERL, 2014).

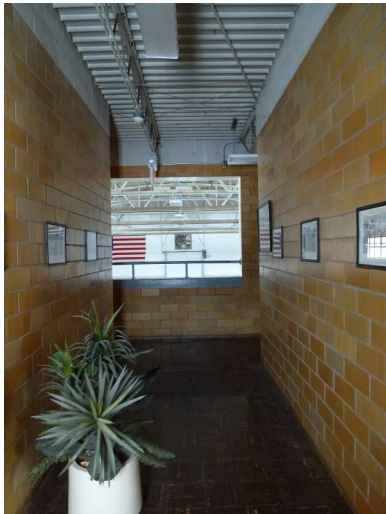
Second floor corridor with glazed sanitary tile walls and exposed roofing system for the ceiling (ERDC-CERL, 2014).

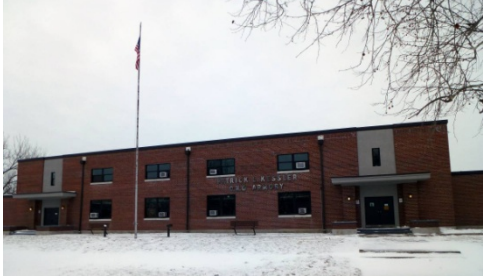
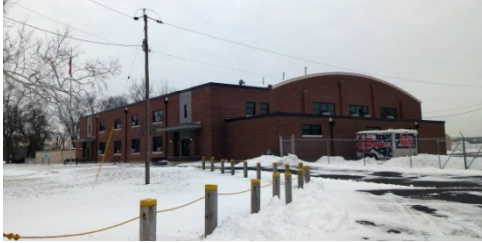
| <p>East (front) elevation, symmetrical façade, brick exterior walls, repetitive window pattern, two main entries (ERDC-CERL, 2014).</p> | <p>Two-story structure with a combination of flat roof and barrel roof (ERDC-CERL, 2014).</p> |

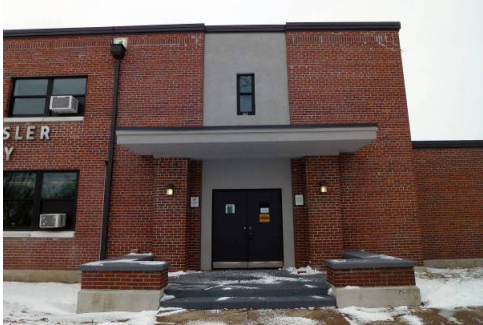
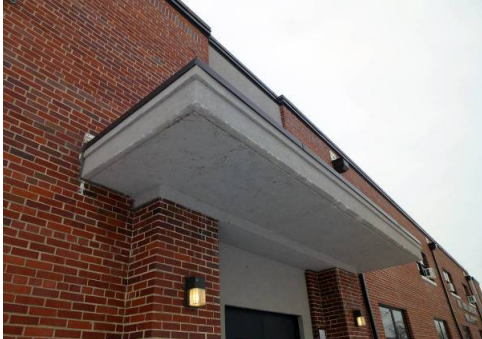
| <p>Stone tile detailing highlighting the entry bay, brick/concrete/slate benches, slate porch (ERDC-CERL, 2014).</p> | <p>Flat concrete canopy over the main entry (ERDC-CERL, 2014).</p> |

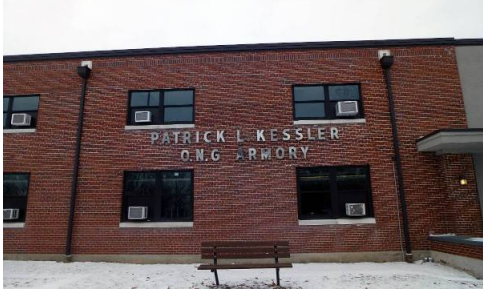
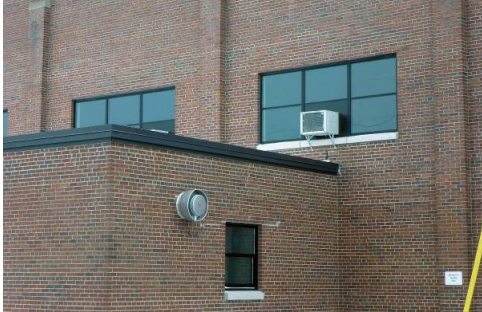
| <p>Stainless-steel lettering, paired window placement (ERDC-CERL, 2014).</p> | <p>Clerestory windows, not original (ERDC-CERL, 2014).</p> |

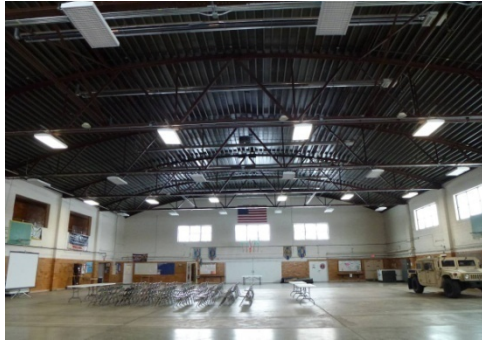
Interior view of the double-height drill hall space with concrete floor, concrete and glazed sanitary tile walls, barrel roof with exposed arched truss system (ERDC-CERL, 2014).

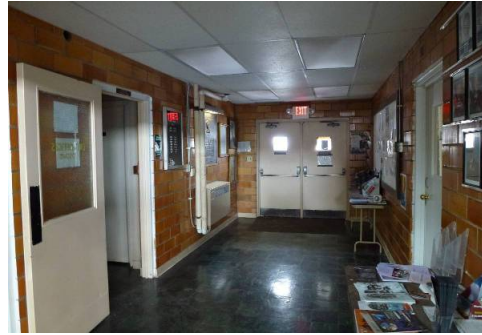
Glazed sanitary tile walls in the lobby (ERDC-CERL, 2014).

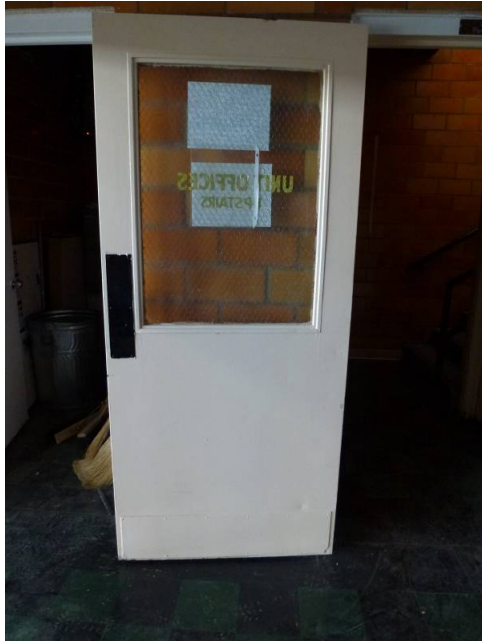
Metal and glass interior door (ERDC-CERL, 2014).

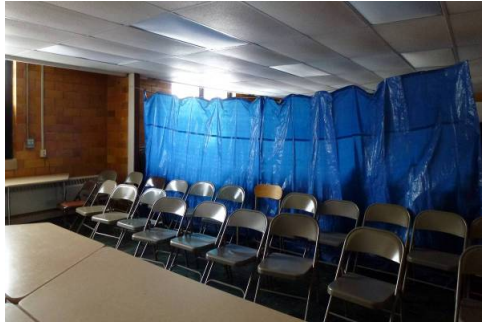
Large classroom space (missing accordion room divider) with glazed sanitary tile walls (ERDC-CERL, 2014).

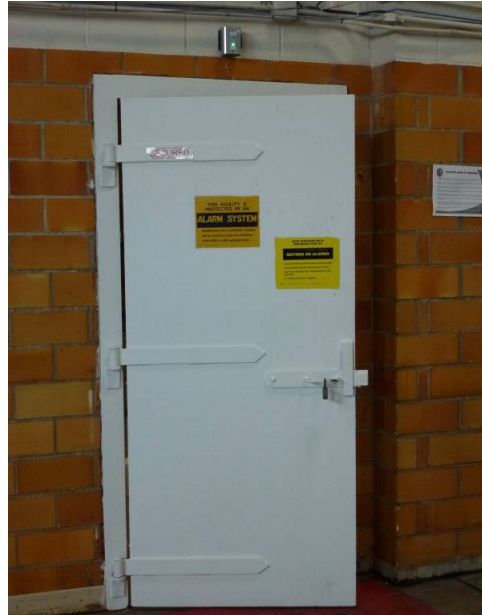
Steel supply room door (ERDC-CERL, 2014).

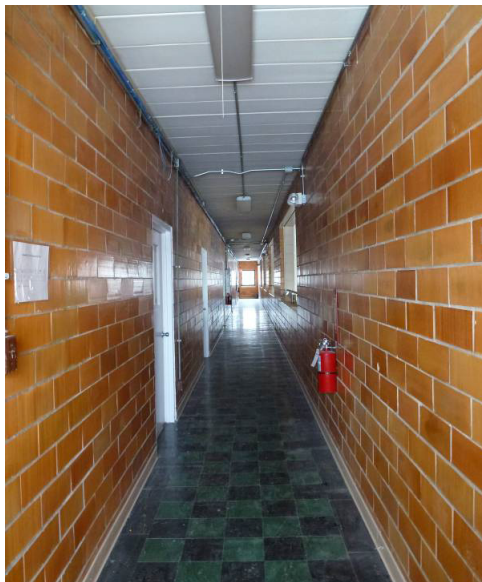
Second floor corridor with glazed sanitary tile walls (ERDC-CERL, 2014).

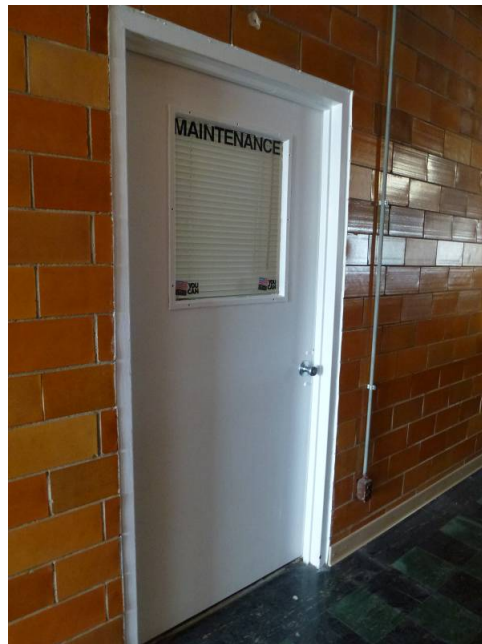
Typical metal and glass office door (ERDC-CERL, 2014).

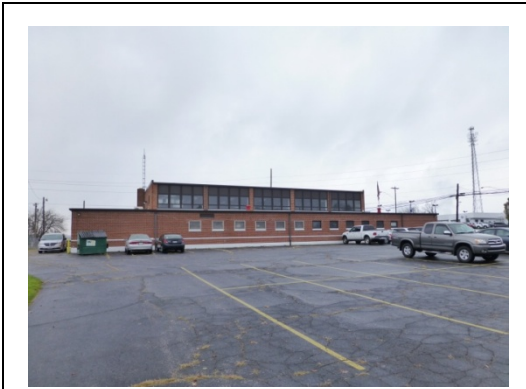
Repetitive window patterns (ERDC-CERL, 2014).

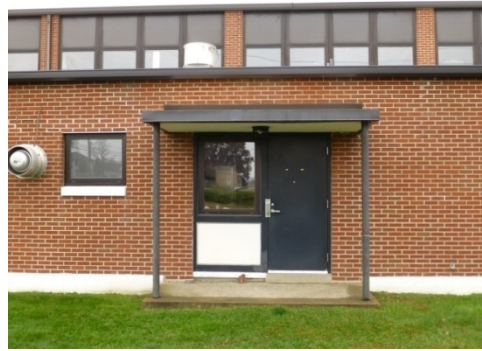
Replacement anodized-bronze aluminum single-pane window with fiberglass panel below, replacement metal entry door, and flat roof canopy the west elevation (ERDC-CERL, 2014).

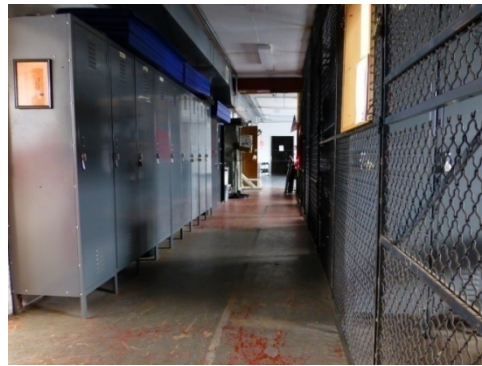
Interior view of the modified space of the original rifle range (ERDC-CERL, 2014).
