## **Architectural Survey of Ohio Army National Guard Properties: Volume I**

Under Project 405180, "OHARNG Architectural Survey"

This document is Volume I of a two-volume architectural survey of 85 buildings and structures utilized by the Ohio Army National Guard and located across the state of Ohio. The majority of these structures were constructed from 1920 to 1968, with others constructed from 1969 to 1988. This survey satisfies Section 110 of the National Historic Preservation Act of 1966 as amended, and was used to determine the eligibility of these buildings and structures for inclusion on the National Register of Historic Places (NRHP). It is the recommendation of this report that 19 armories and 4 associated support buildings are significant under NRHP criteria and retain enough integrity to be individually eligible for the NRHP. Volume II of this report is published separately and contains the ERDC-CERL architectural survey forms.

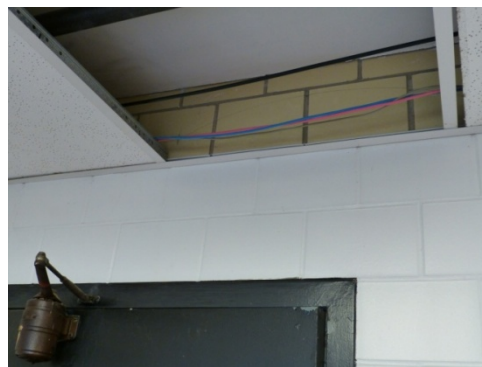
Looking up at the original unpainted glazed sanitary tile walls of the latrine (ERDC-CERL, 2014).

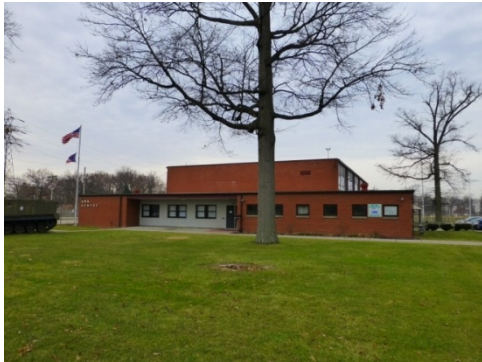
Brick exterior walls, one-story administration wings with central high-bay drill hall space, flat roofs (ERDC-CERL, 2013).

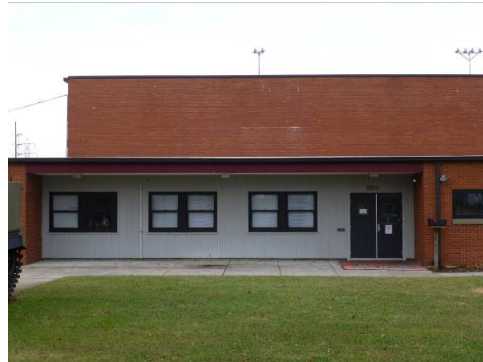
Entry bay on the east (front) elevation with original wood paneled wall, replacement one-over-one anodized-bronze aluminum paired windows, and paired replacement metal entry doors (ERDC-CERL, 2013).

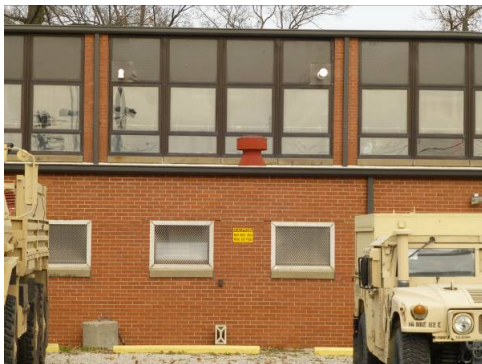
Original clerestory window openings with replacement anodized-bronze aluminum windows with fiberglass panel inserts (ERDC-CERL, 2013).

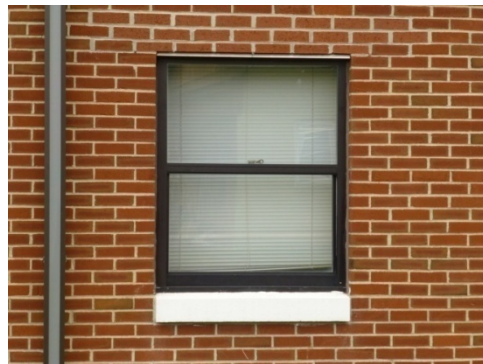
Original single window opening with replacement anodized-bronze aluminum one-over-one window on the right side of the west elevation (ERDC-CERL, 2013).

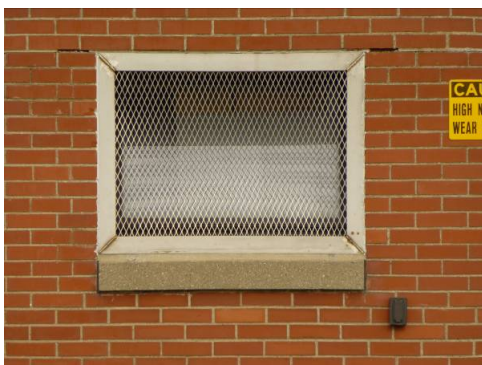
Original small single window opening with replacement anodized-bronze aluminum window with metal mesh screen cover (ERDC-CERL, 2013).

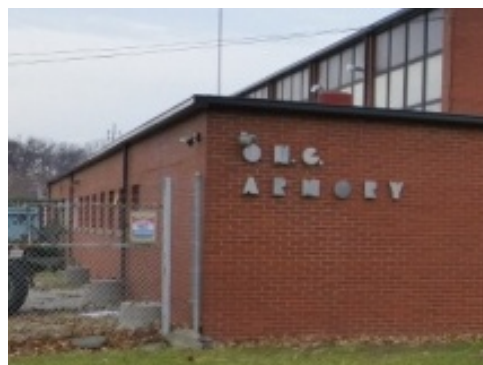
Original Stainless-steel lettering (ERDC-CERL, 2013).

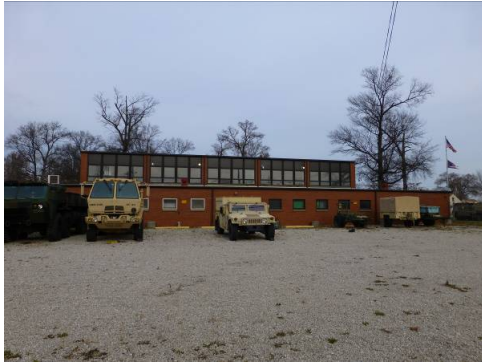
Repetitive window patterns (ERDC-CERL, 2013).

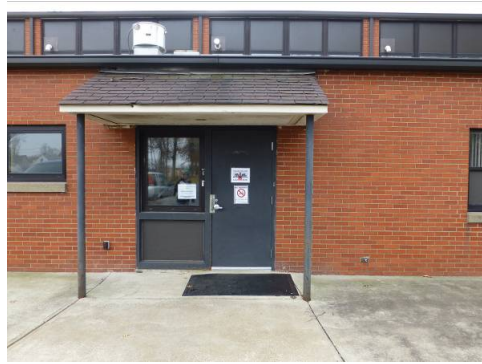
Replacement anodized-bronze aluminum single-pane window with fiberglass panel below, replacement metal entry door, and modified flat roof canopy on the north elevation (ERDC-CERL, 2013).

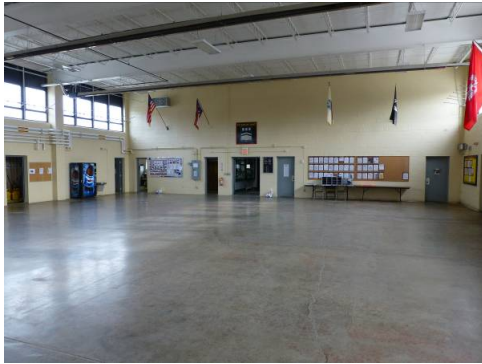
Interior view of the open drill hall, concrete floor, clerestory windows, concrete-block walls, and steel I-beam roofing system (ERDC-CERL, 2013).

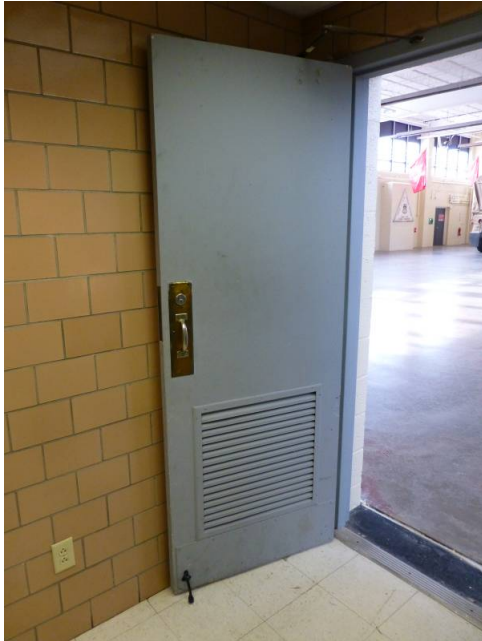
Original door into the men's latrine (ERDC-CERL, 2013).

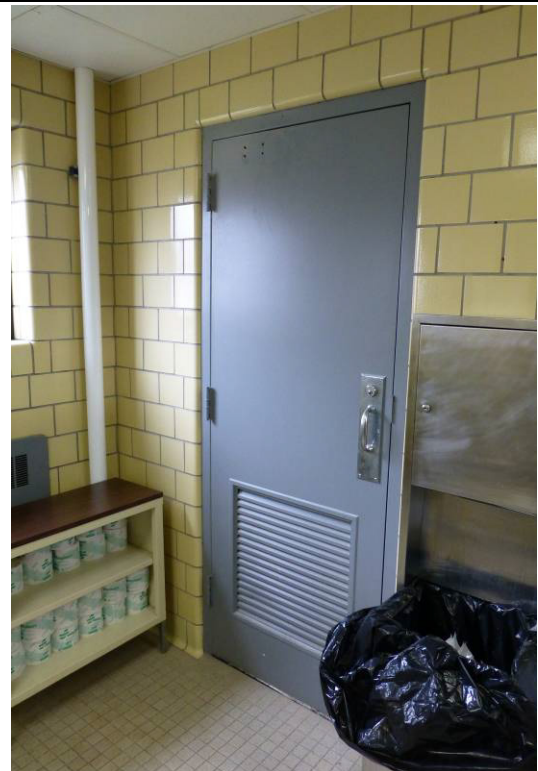
Original glazed sanitary tile walls of the latrine and original metal door leading from men's latrine into the adjacent locker room (ERDC-CERL, 2013).

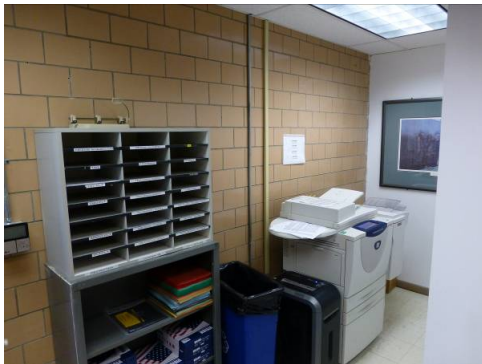
Original glazed sanitary tile wall in the locker room (modified into office space) (ERDC-CERL, 2013).

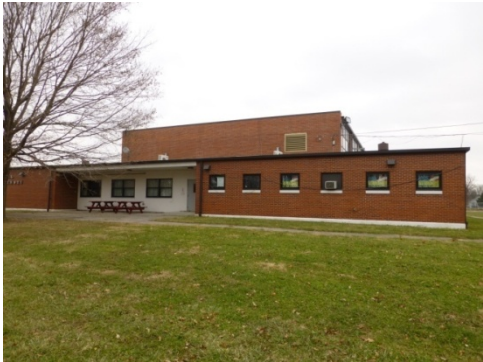
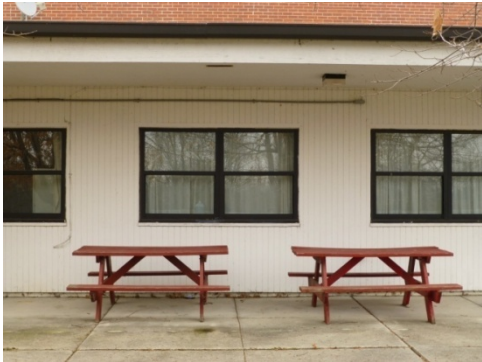
| <p>Brick exterior walls, one-story administration wings with central high-bay drill hall space, flat roofs (ERDC-CERL, 2013).</p> | <p>Entry bay on the west (front) elevation with original wood paneled wall and paired replacement one-over-one anodized-bronze aluminum paired windows (ERDC-CERL, 2013).</p> |

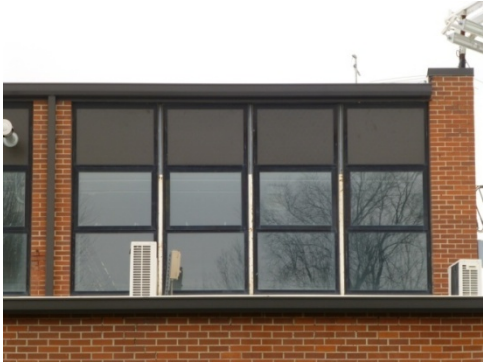
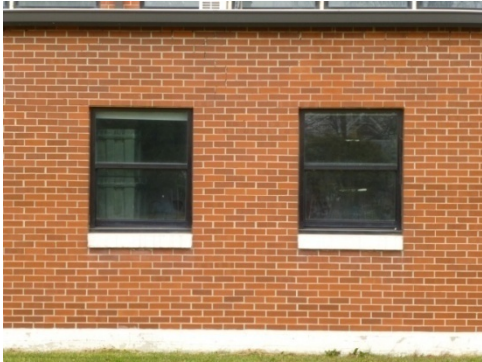
| <p>Original clerestory window openings with replacement anodized-bronze aluminum clerestory windows with fiberglass panel inserts (ERDC-CERL, 2013).</p> | <p>Original single window openings with replacement anodized-bronze aluminum one-over-one window on the right side of the west elevation (ERDC-CERL, 2013).</p> |

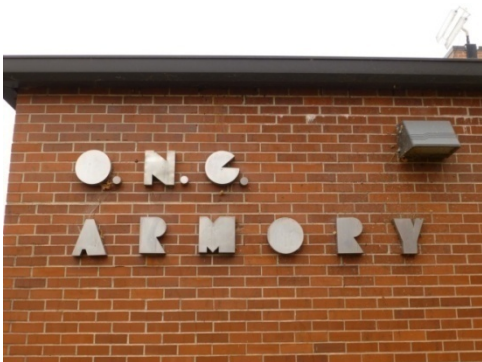
| <p>Original small single window opening with replacement anodized-bronze aluminum window with metal mesh screen cover (ERDC-CERL, 2013).</p> | <p>Original stainless-steel lettering (ERDC-CERL, 2013).</p> |

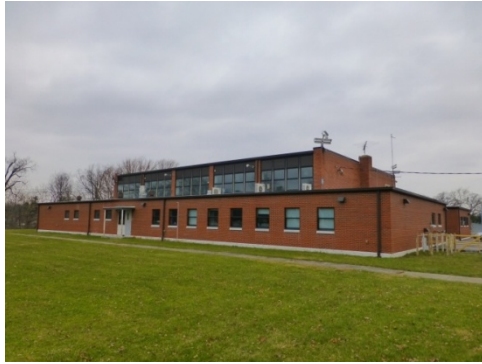
Repetitive window patterns (ERDC-CERL, 2013).

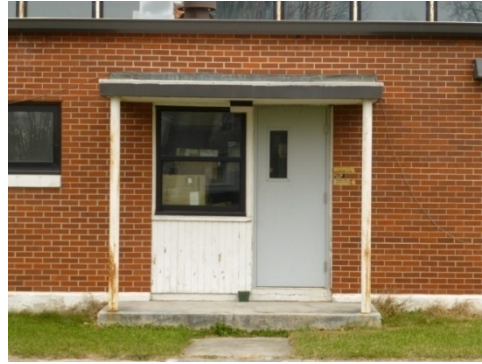
Replacement anodized-bronze aluminum single-pane window with fiberglass panel below, replacement metal entry door, and flat roof canopy on the south elevation (ERDC-CERL, 2013).

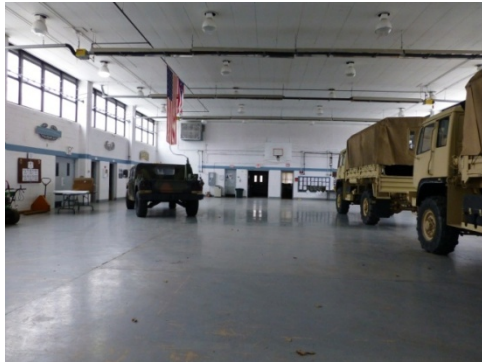
Interior view of the open drill hall, concrete floor, clerestory windows, concrete-block walls, and steel I-beam roofing system (ERDC-CERL, 2013).

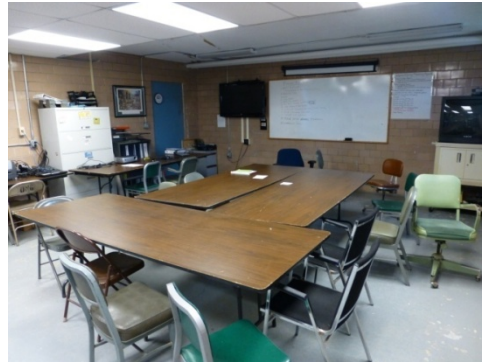
Interior view of the modified space of the original locker room, glazed sanitary tile walls intact (ERDC-CERL, 2013).

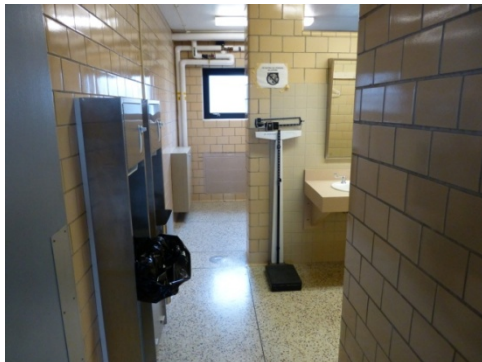
Original glazed sanitary tile walls in the women's latrine (ERDC-CERL, 2013).

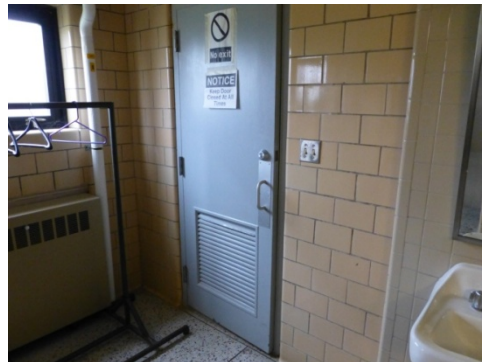
Original glazed sanitary tile walls of the latrine and original metal door leading from men's latrine into the adjacent locker room (ERDC-CERL, 2013).

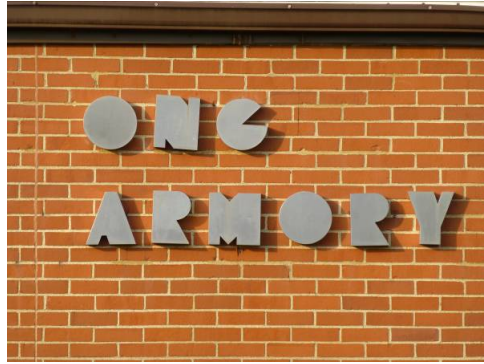
Original Stainless-steel lettering (ERDC-CERL, 2013).

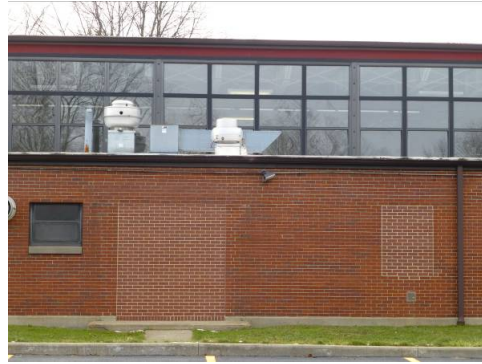
Modified single door opening with sidelight and flat roof canopy, opening filled with brick on the north elevation (ERDC-CERL, 2013).

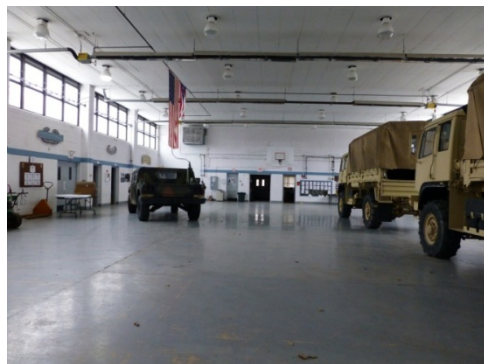
Interior view of the open drill hall, concrete floor, clerestory windows, concrete-block walls, and steel I-beam roofing system (ERDC-CERL, 2013).

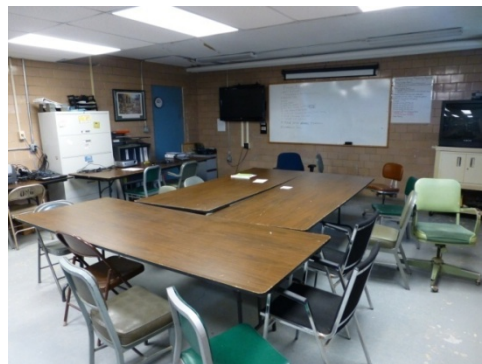
Interior view of the modified space of the original locker room, glazed sanitary tile walls intact (ERDC-CERL, 2013).

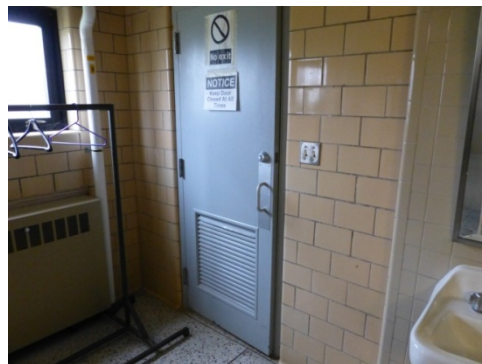
Original glazed sanitary tile walls of the latrine and original metal door leading from men's latrine into the adjacent locker room (ERDC-CERL, 2013).

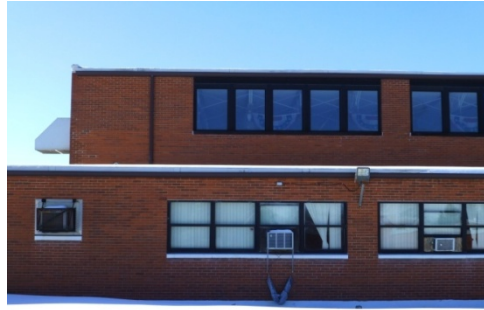
Original group window openings and clerestory window openings with replacement anodized-bronze aluminum window (ERDC-CERL, 2014).

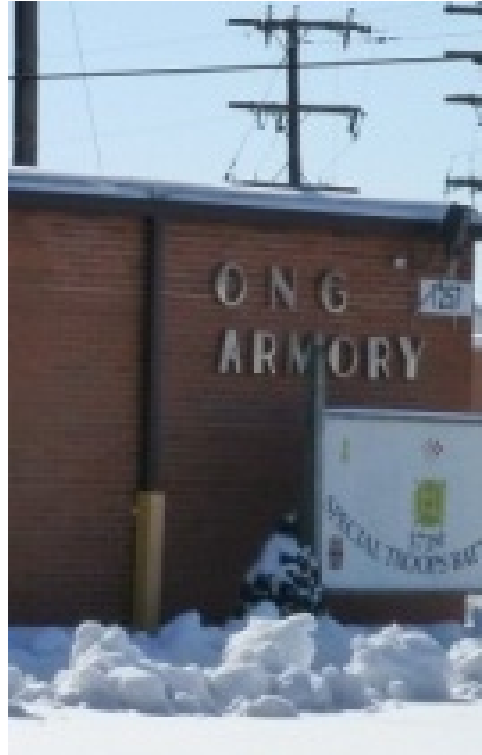
Stainless-steel lettering (ERDC-CERL, 2014).

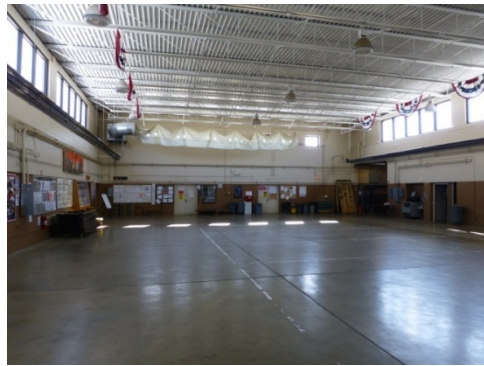
Interior view of the open drill hall, concrete floor, clerestory windows, concrete-block and glazed sanitary tile walls, and truss roofing system (ERDC-CERL, 2014).

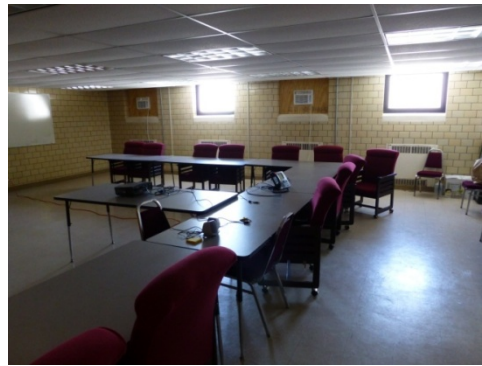
Interior view of the modified space of the original locker room, glazed sanitary tile walls intact (ERDC-CERL, 2014).

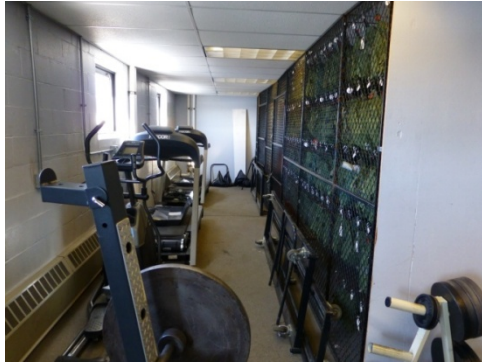
Interior view of the modified space of the original rifle range now used for storage/weight room/offices (ERDC-CERL, 2014).

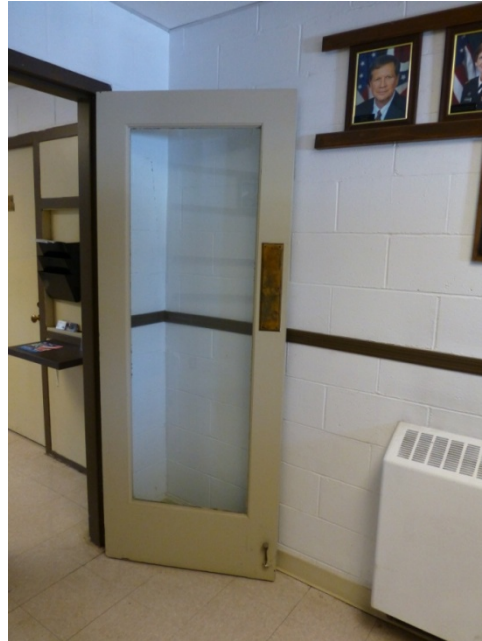
Original metal and plate-glass vestibule doors (ERDC-CERL, 2014).

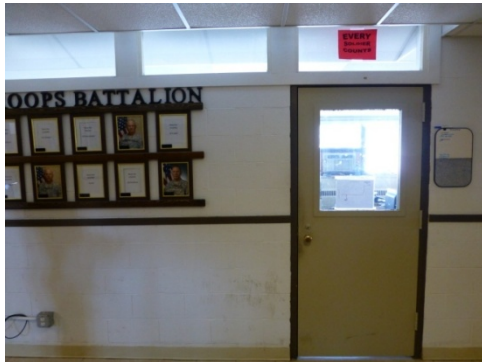
Typical metal and glass interior door (ERDC-CERL, 2014).

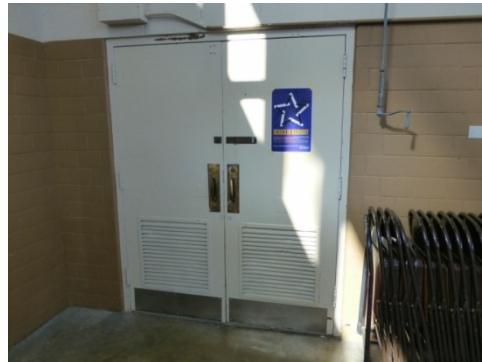
Typical metal and louvered vent doors (ERDC-CERL, 2014).

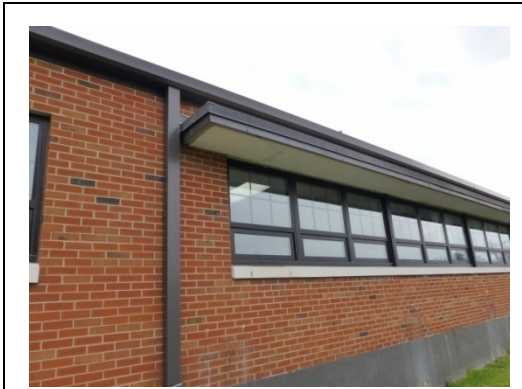
Original ribbon-style window opening and concrete sunshade canopy above with replacement anodized-bronze aluminum windows (ERDC-CERL, 2013).

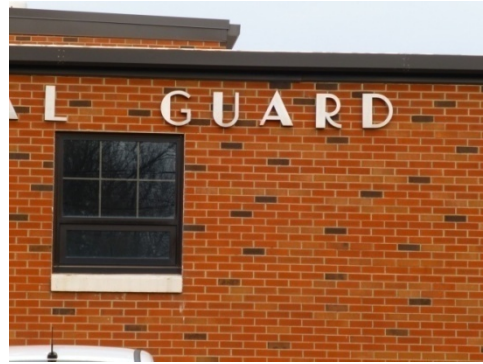
Stainless-steel lettering (ERDC-CERL, 2013).

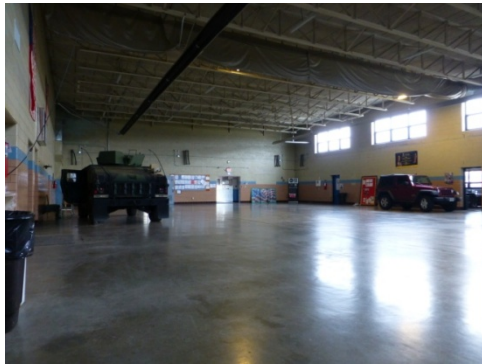
Interior view of the open drill hall, concrete floor, clerestory windows, concrete-block and glazed sanitary tile walls, and truss roofing system (ERDC-CERL, 2013).

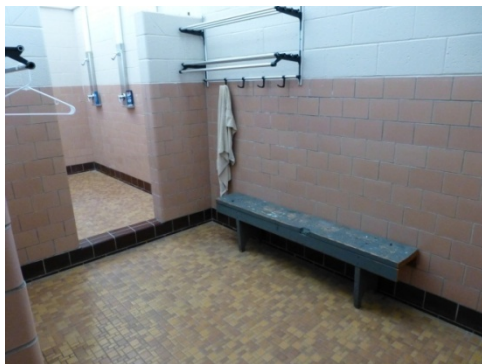
Glazed sanitary tile walls and mosaic tile floor in the latrines (ERDC-CERL, 2013).

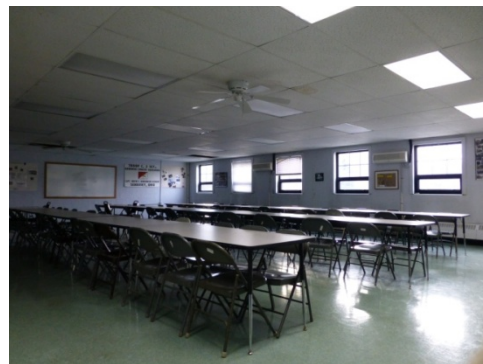
Modified locker room into classroom space (ERDC-CERL, 2013).

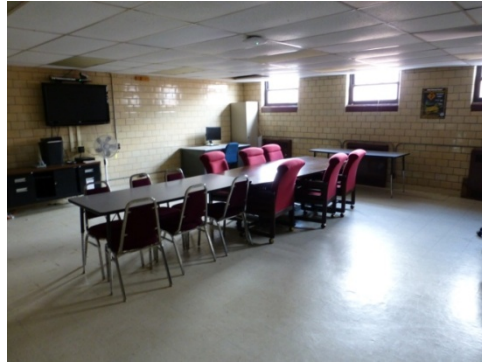
Modified locker room into classroom/meeting room, glazed sanitary walls intact (ERDC-CERL, 2014).

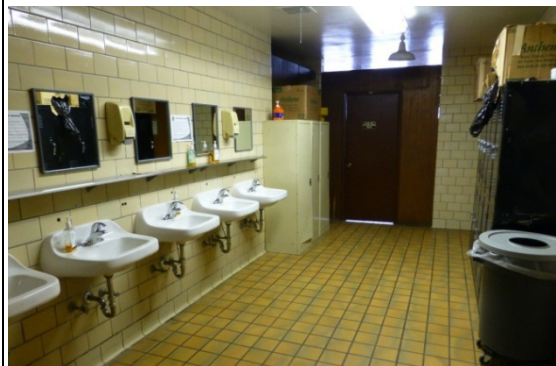
Original glazed sanitary tile walls in the latrines (ERDC-CERL, 2014).

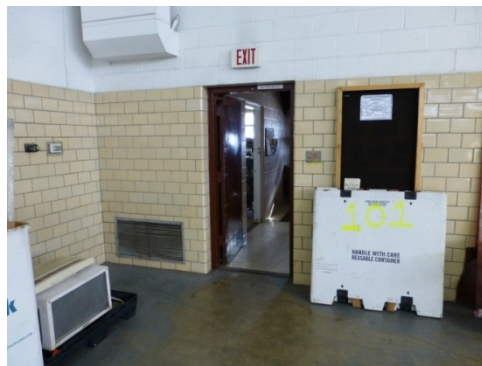
Original glazed sanitary tile walls in the drill hall (ERDC-CERL, 2014).

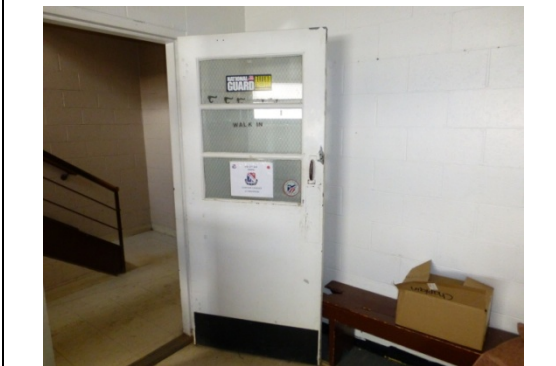
Typical metal and glass interior door (ERDC-CERL, 2014).

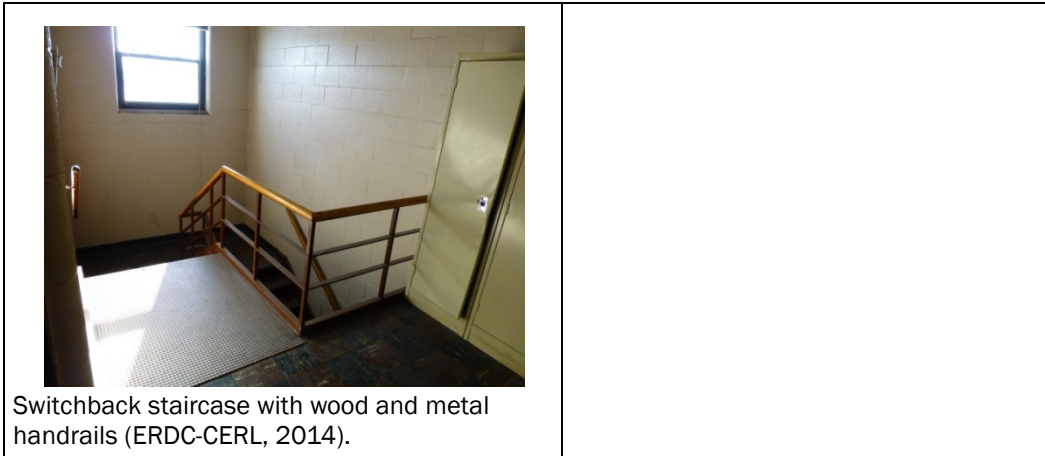
Switchback staircase with wood and metal handrails (ERDC-CERL, 2014).

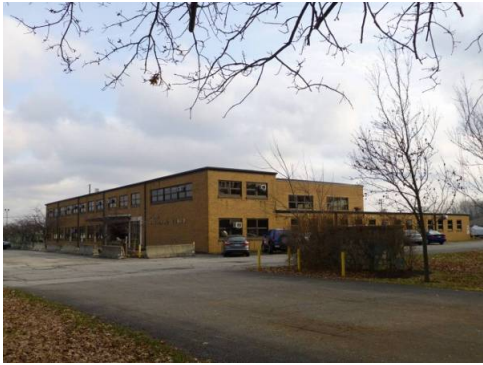
| <p>Brick exterior walls, combination of one-and two-story structure with central high-bay drill hall space, flat roofs (ERDC-CERL, 2013).</p> | <p>Repetitive window pattern (ERDC-CERL, 2013).</p> |

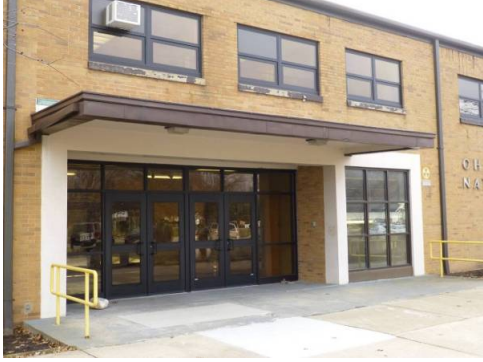
| <p>Concrete canopy structure over the main entry doors on the front elevation (ERDC-CERL, 2013).</p> | <p>Original paired window opening with replacement one-over-one anodized-bronze aluminum windows (ERDC-CERL, 2013).</p> |

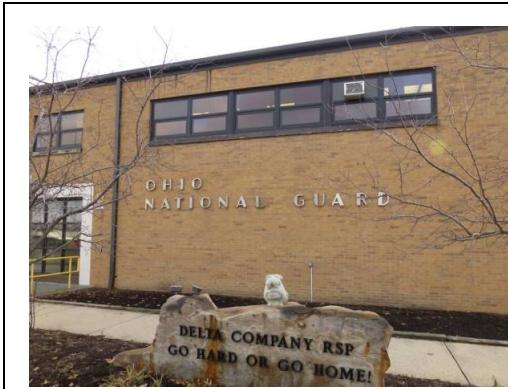
Original ribbon-style window opening with replacement one-over-one anodized-bronze aluminum windows and original Stainless-steel lettering (ERDC-CERL, 2013).

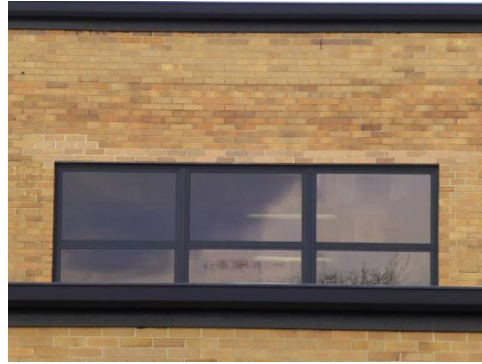
Original clerestory window opening with replacement one-over-one anodized-bronze aluminum windows (ERDC-CERL, 2013).

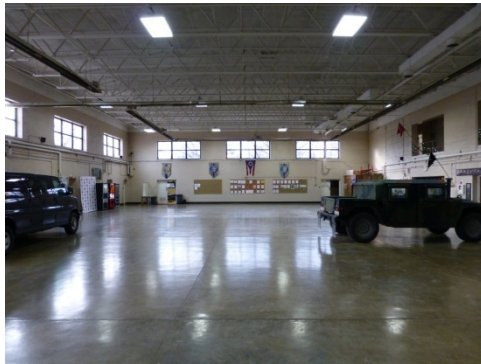
Interior view of the open drill hall space with concrete floor, clerestory windows, exposed truss system, and glazed sanitary tile walls (ERDC-CERL, 2013).

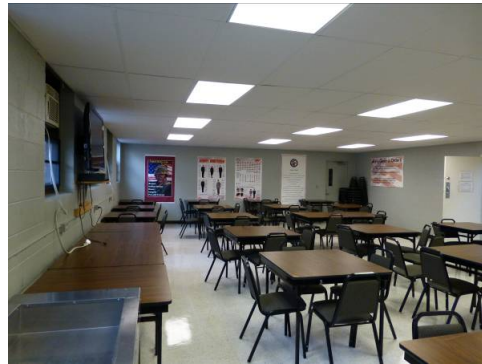
Modified locker room used as dining hall (ERDC-CERL, 2013).

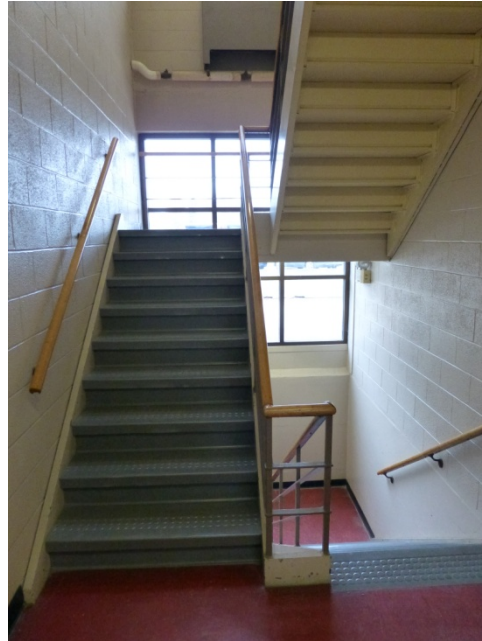
Metal switchback staircase with original wood and metal handrails (ERDC-CERL, 2013).

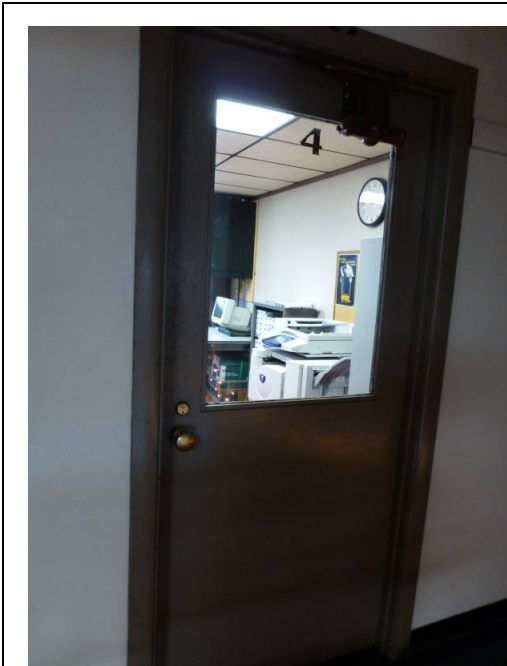
Typical metal and glass interior door (ERDC-CERL, 2013).

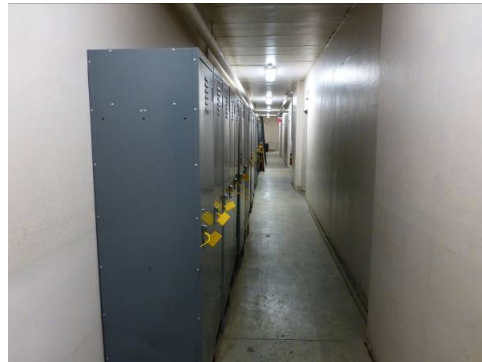
Looking down the corridor in the basement, with the original rifle range on the right side of the hall (ERDC-CERL, 2013).

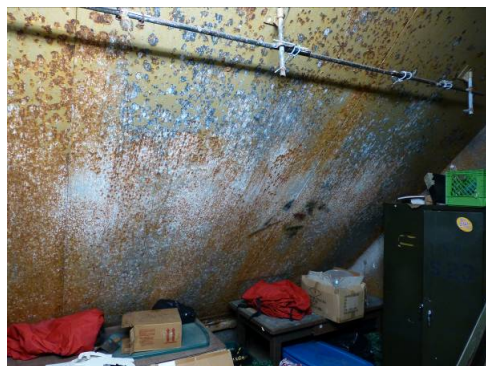
Original target butt in the old rifle range (ERDC-CERL, 2013).

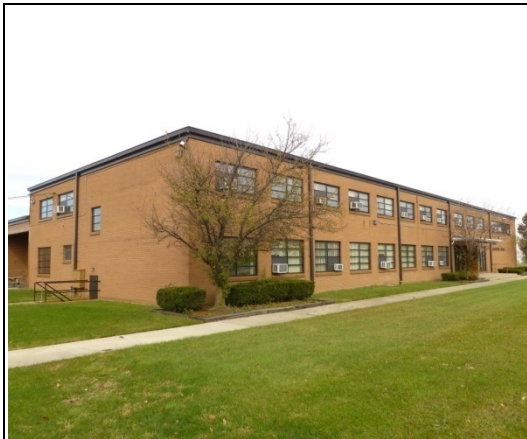
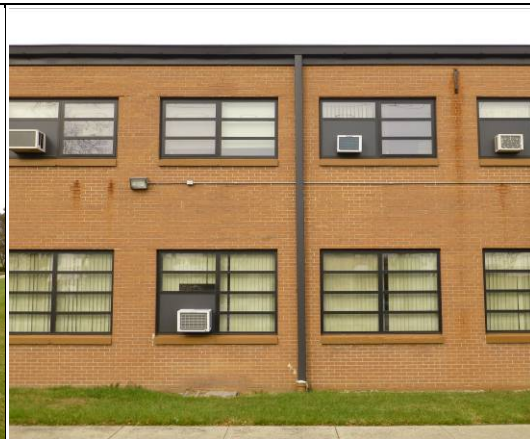
| <p>Brick exterior walls, combination of one- and two-story structure with central high-bay drill hall space, flat roofs (ERDC-CERL, 2014).</p> | <p>Repetitive window pattern (ERDC-CERL, 2014).</p> |

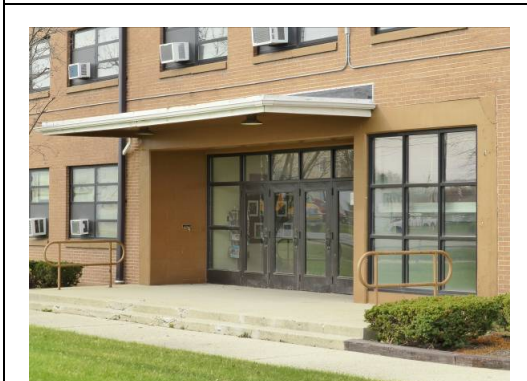
| <p>Concrete canopy structure over the main entry doors on the front elevation (ERDC-CERL, 2014).</p> | <p>Original light fixtures under concrete canopy (ERDC-CERL, 2014).</p> |

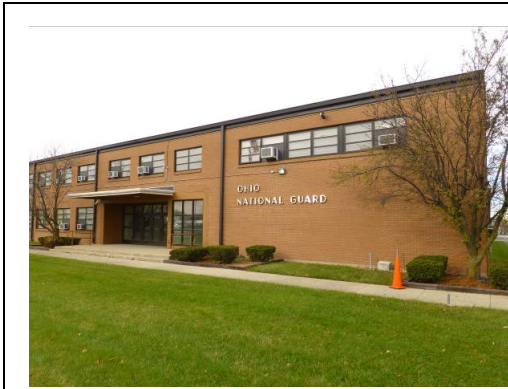
Original ribbon-style window opening with replacement anodized-bronze aluminum windows and original Stainless-steel lettering (ERDC-CERL, 2014).

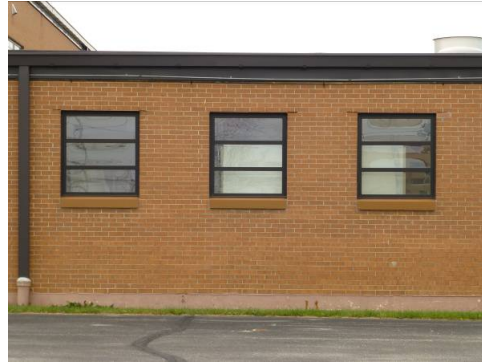
Original single window openings with replacement three-pane anodized-bronze aluminum windows (ERDC-CERL, 2014).

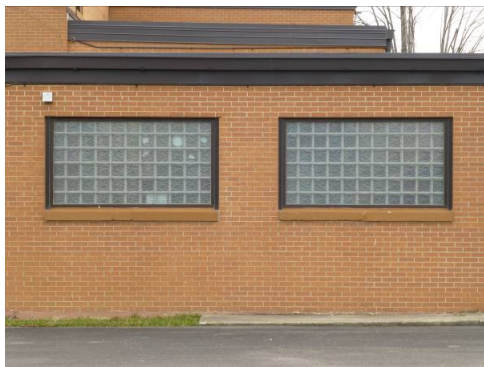
Original paired window openings with replacement windows (ERDC-CERL, 2014).

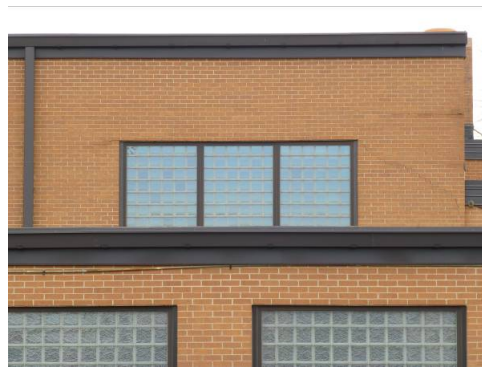
Original clerestory window opening with replacement window (ERDC-CERL, 2014).

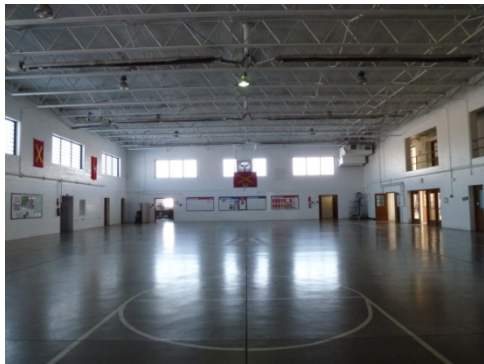
Interior view of the drill hall with concrete floor, combination of concrete-block and glazed sanitary tile walls, flat roof, exposed truss system (ERDC-CERL, 2014).

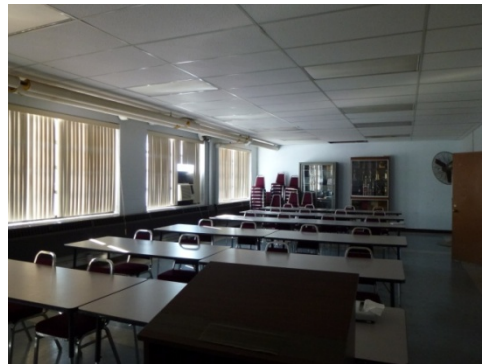
Modified classroom space (ERDC-CERL, 2014).

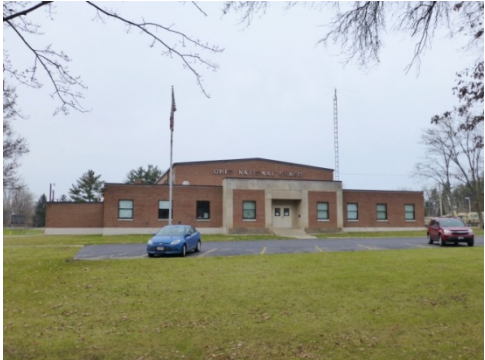
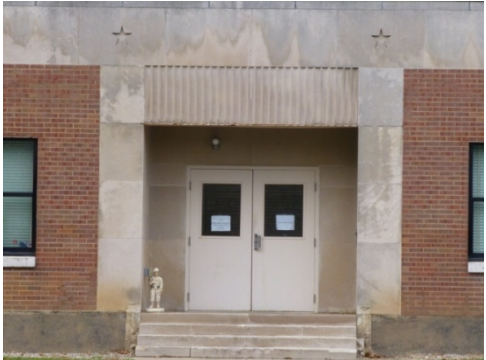
| <p>Brick exterior walls, one-story support areas with a double-height drill hall space, flat roofs over one-story sections and shallow gable roof over double-height drill hall space, symmetrical front elevation, raised concrete foundation (ERDC-CERL, 2013).</p> | <p>Stone tile detailing framing the main entry on the south (front) elevation (ERDC-CERL, 2013).</p> |

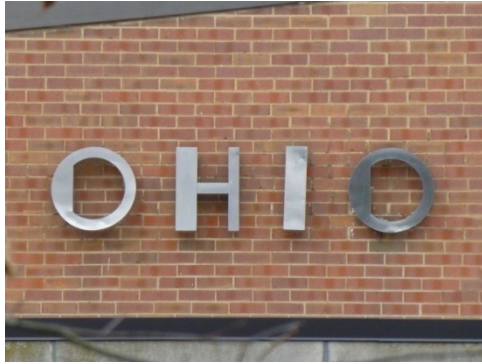
Stainless-steel lettering (ERDC-CERL, 2013).

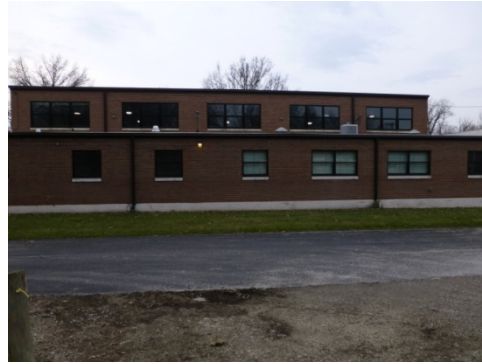
Repetitive window pattern (ERDC-CERL, 2013).

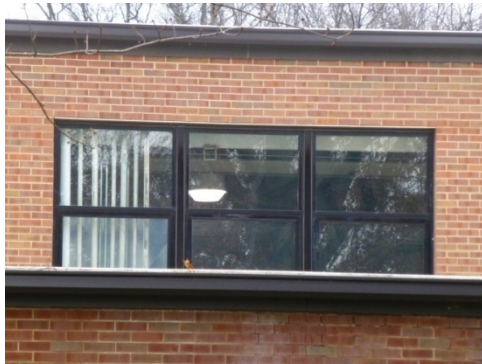
Original clerestory opening with replacement anodized-bronze aluminum windows (ERDC-CERL, 2013).

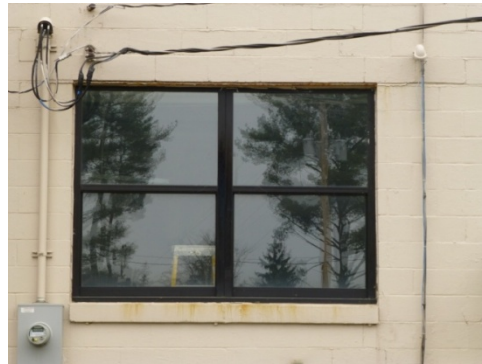
Original paired window openings with replacement one-over-one anodized-bronze aluminum windows (ERDC-CERL, 2013).

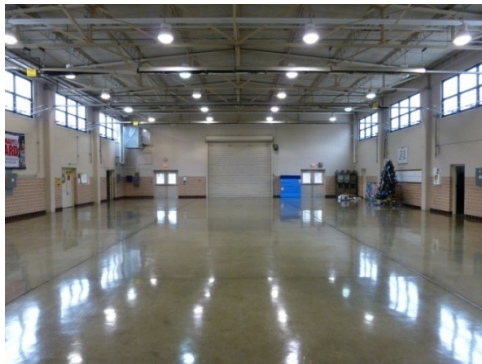
Interior view of the open double-height drill hall with concrete floor, combination of concrete-block and glazed sanitary tile walls, clerestory windows, and exposed truss roof system (ERDC-CERL, 2013).

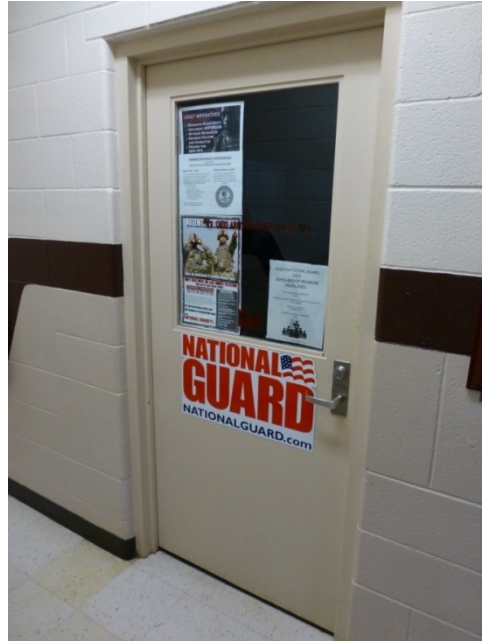
Typical metal and glass interior door (ERDC-CERL, 2013).

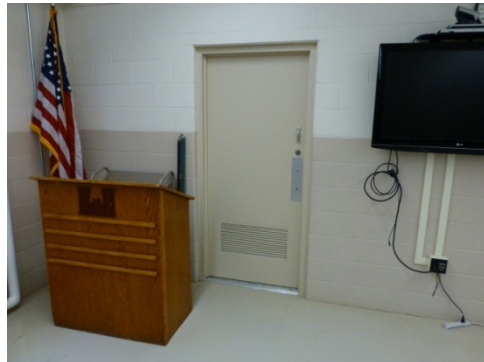
Typical metal door with louvered vent (ERDC-CERL, 2013).

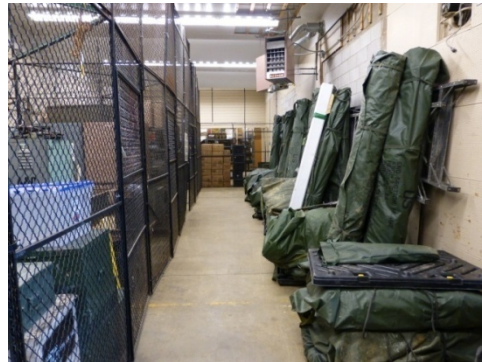
Interior view of modified rifle range (ERDC-CERL, 2013).

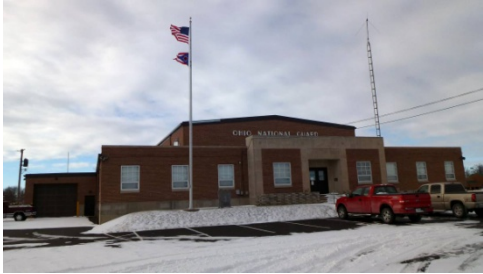
| <p>Brick exterior walls, one-story support areas with a double-height drill hall space, flat roofs over one-story sections and shallow gable roof over double-height drill hall space, symmetrical front elevation, raised concrete foundation (ERDC-CERL, 2014).</p> | <p>Stone tile detailing framing the main entry on the east (front) elevation (ERDC-CERL, 2014).</p> |

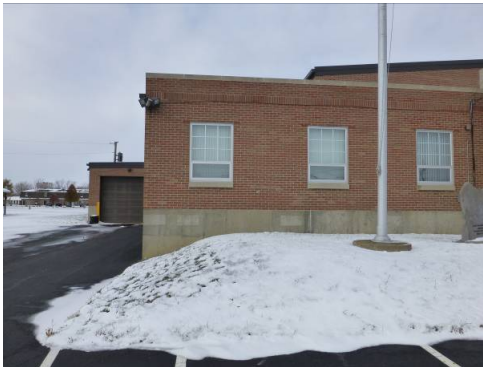
| <p>Original single window opening with replacement windows (ERDC-CERL, 2014).</p> | <p>Original paired window openings with replacement one-over-one windows (ERDC-CERL, 2014).</p> |

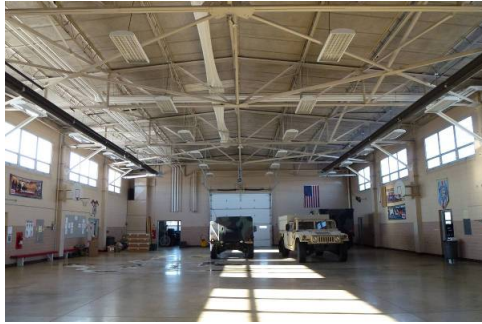
Interior view of the open double-height drill hall with concrete floor, combination of concrete-block and glazed sanitary tile walls, clerestory windows, and exposed truss roof system (ERDC-CERL, 2014).

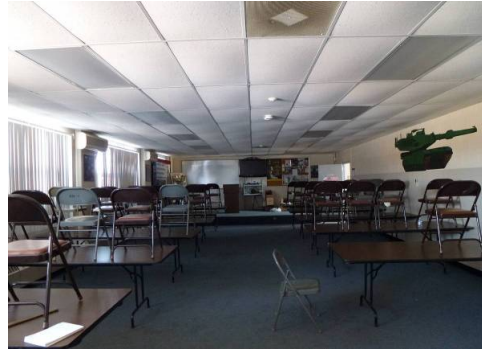
Locker room modified to class room space (ERDC-CERL, 2014).

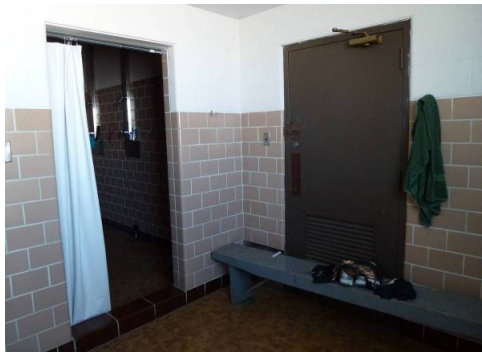
Glazed sanitary tile walls in the latrines and original metal door leading to the old locker room (ERDC-CERL, 2014).

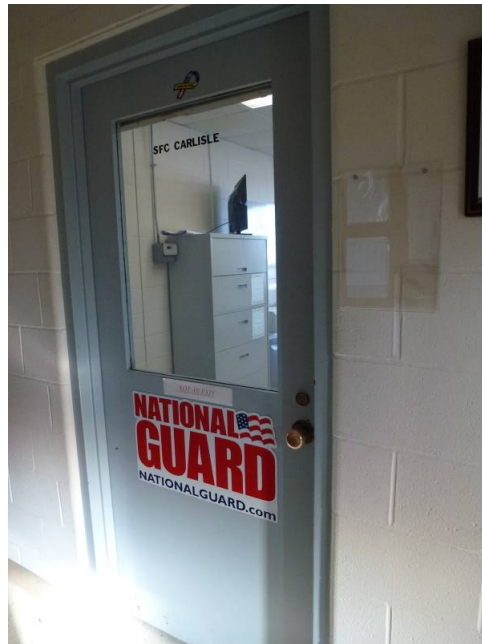
Typical metal and glass interior door (ERDC-CERL, 2014).

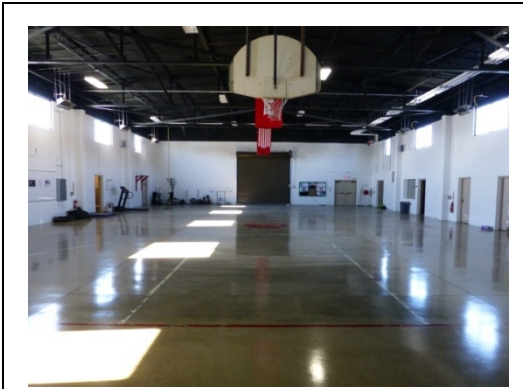
Interior view of the open double-height drill hall with concrete floor, combination of concrete-block and glazed sanitary tile walls, clerestory windows, and exposed truss roof system (ERDC-CERL, 2014).

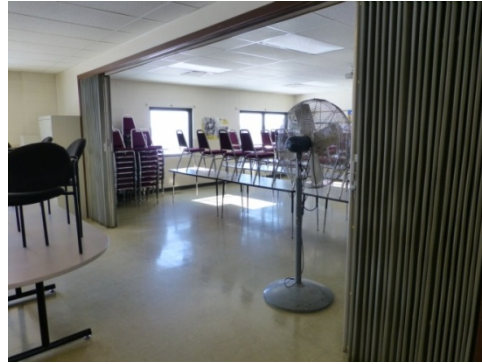
Original classroom space with original accordion room divider (ERDC-CERL, 2014).

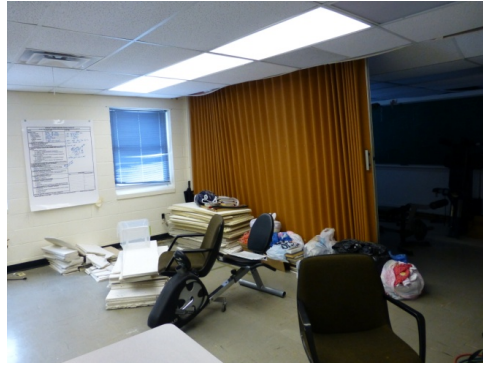
Classroom with original accordion-style divider wall (ERDC-CERL, 2014).

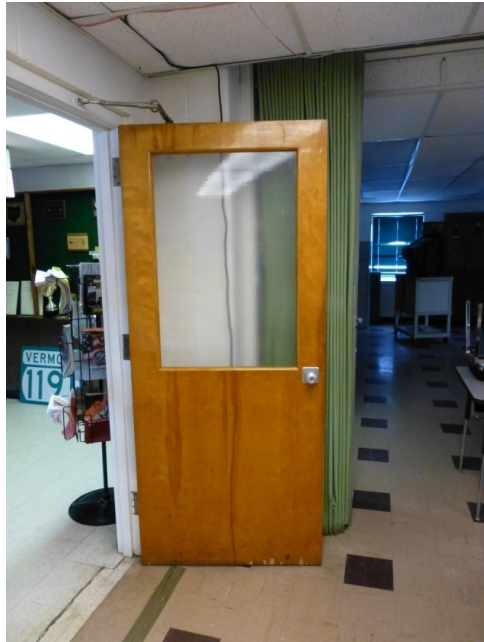
Original blonde wood and glass interior doors (ERDC-CERL, 2014).
