HOW CAN IMPROVEMENTS BE MADE TO THE UNITED STATES METRORAIL  
SYSTEM (WITH A FOCUS ON THE WASHINGTON METROPOLITAN  
AREA TRANSIT AUTHORITY METRORAIL SYSTEM)  
TO ENHANCE SAFETY FOR ITS RIDERS?

A thesis presented to the Faculty of the U.S. Army  
Command and General Staff College in partial  
fulfillment of the requirements for the  
degree

MASTER OF MILITARY ART AND SCIENCE  
Homeland Security Studies

KEVIN R. WALLEN, MAJOR, U.S. ARMY  
B.S., Eastern Kentucky University, Richmond, Kentucky, 2002

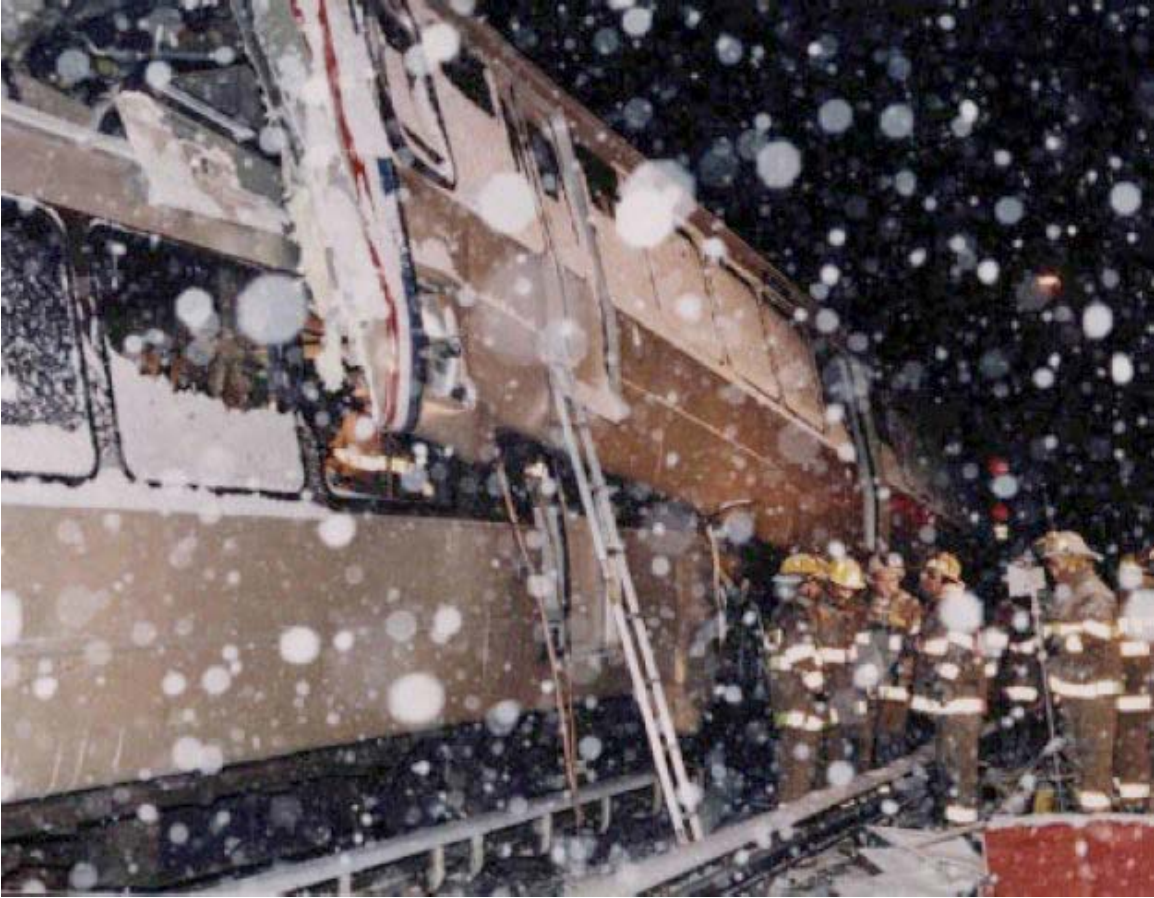
Figure 4. Final Train Positions of the 6 January 1996 Accident  
at the Shady Grove Station

Train Damage: Car 3252, the lead car of Train T-111, sustained the most extensive damage. The shell of the car became partially disengaged from the frame and came to rest partially on top of the lead car of the gap train. Car 3191, the lead car of the gap train, sustained a uniform crush of approximately 10 inches across the front of the car. The remaining cars of Train T-111 and the gap train received only minor damages. Total estimated damages were between \$2.1 and \$2.6 million.<sup>23</sup>

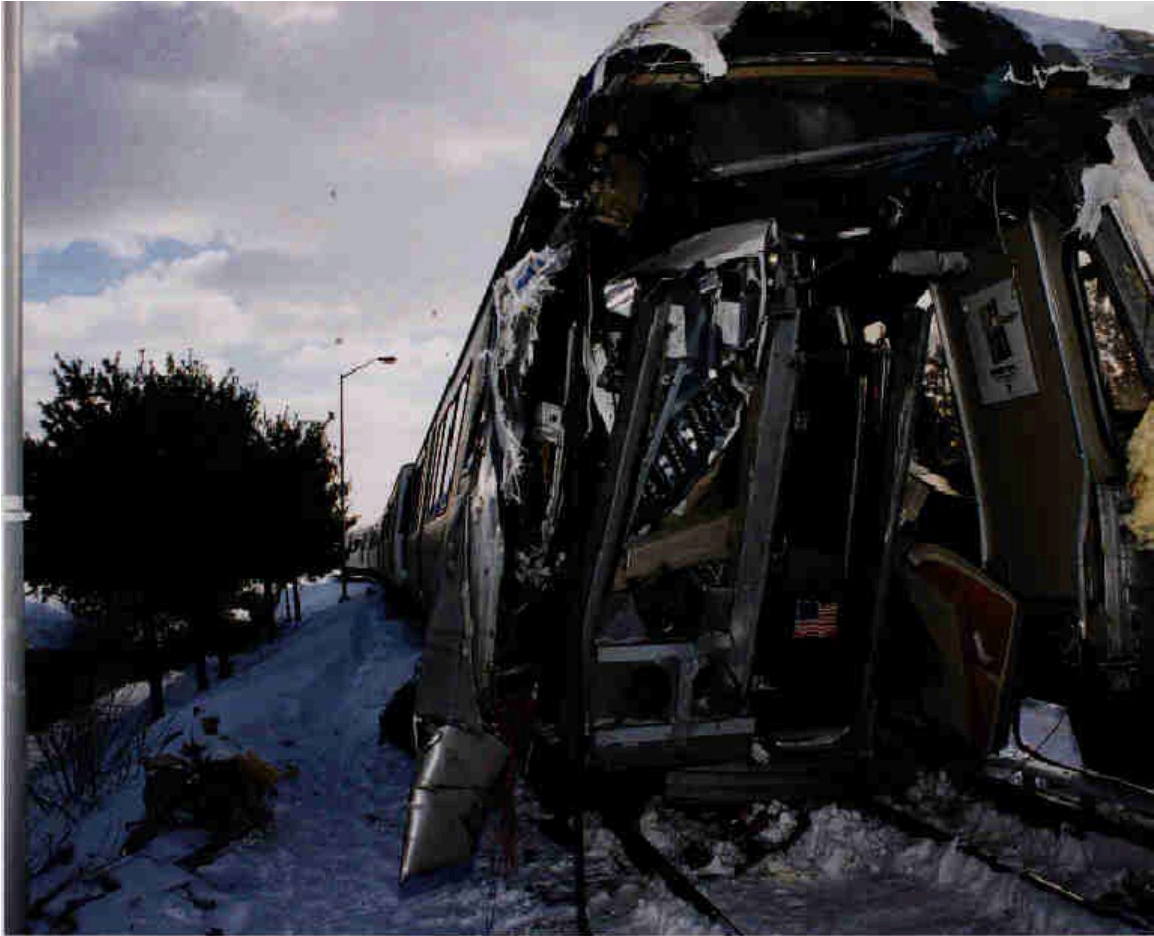
Figure 5. Figure 5. Head end of Train T-111 during Shady Grove Accident, where Operator's Unit was Completely Crushed

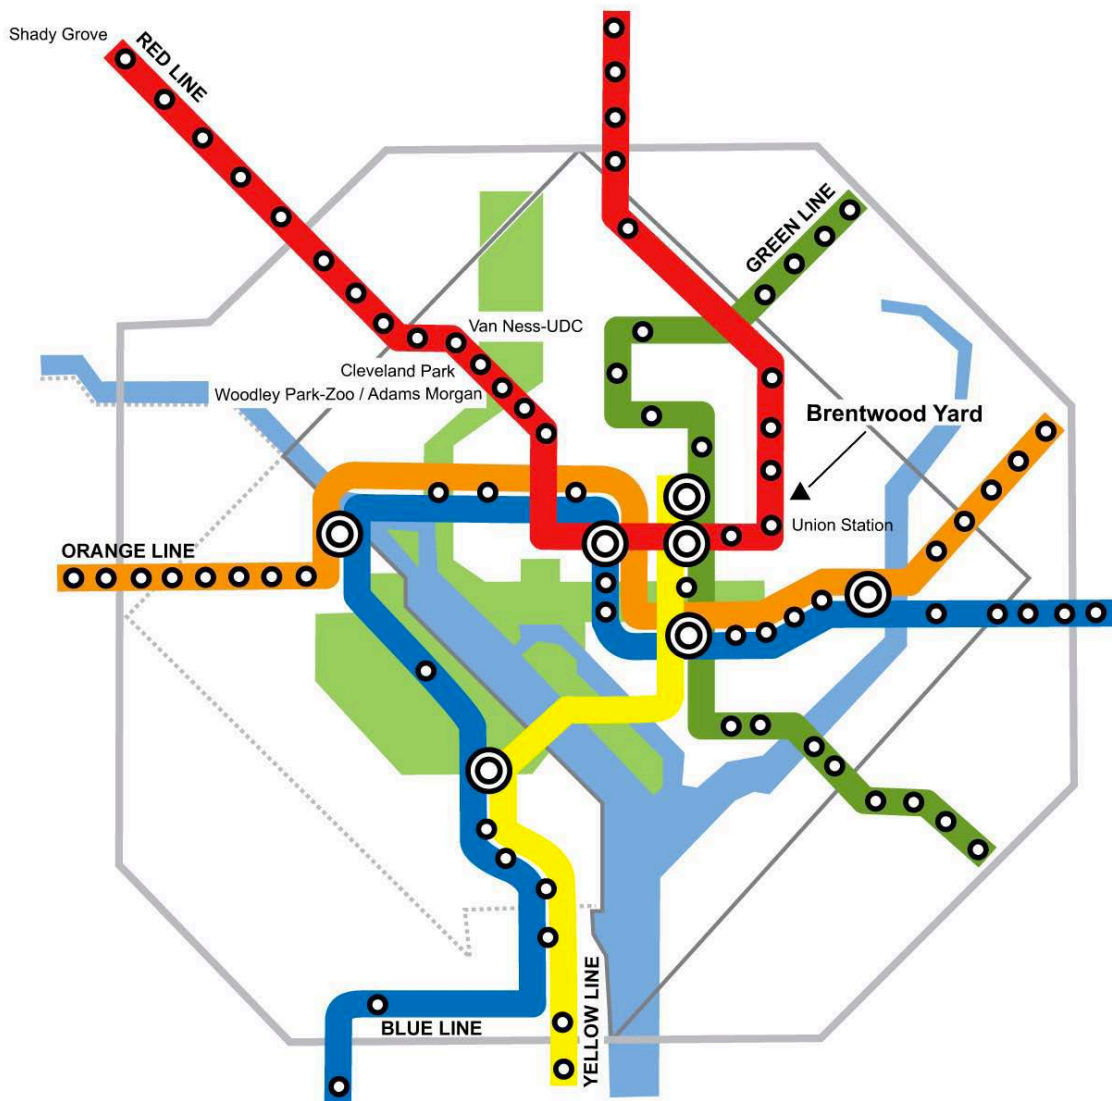
Figure 6. Woodley Park Station Accident Locations

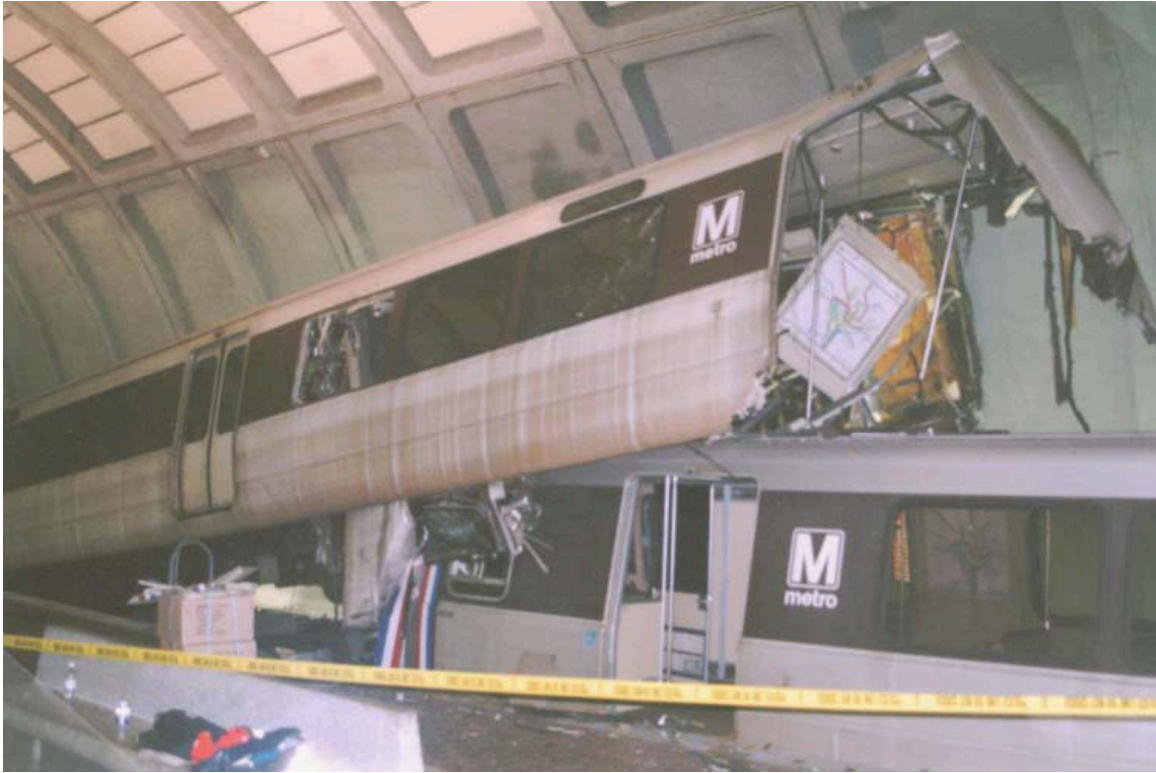
Figure 7. Train 703 Resting on Top of Train 105

ringer. About 12:49 p.m., Train 703 rolled backwards about 2,246 feet downhill for about 78 seconds and collided with Train 105, which was stopped at the outbound platform the Woodley Park Station, where passengers were boarding and exiting the train. The operator was the only employee on board Train 703 when the collision occurred.

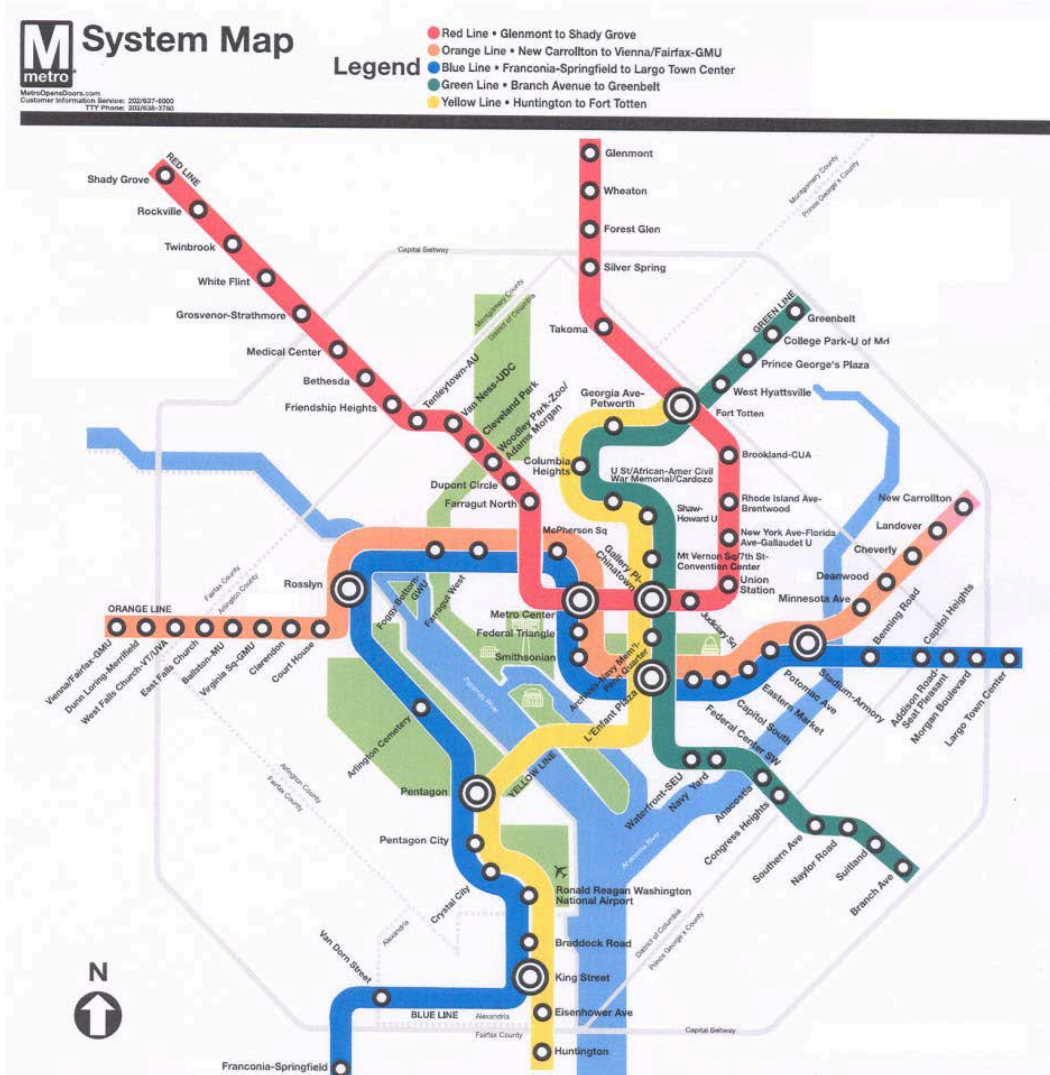
Figure 8. Fort Totten Station Accident Locations

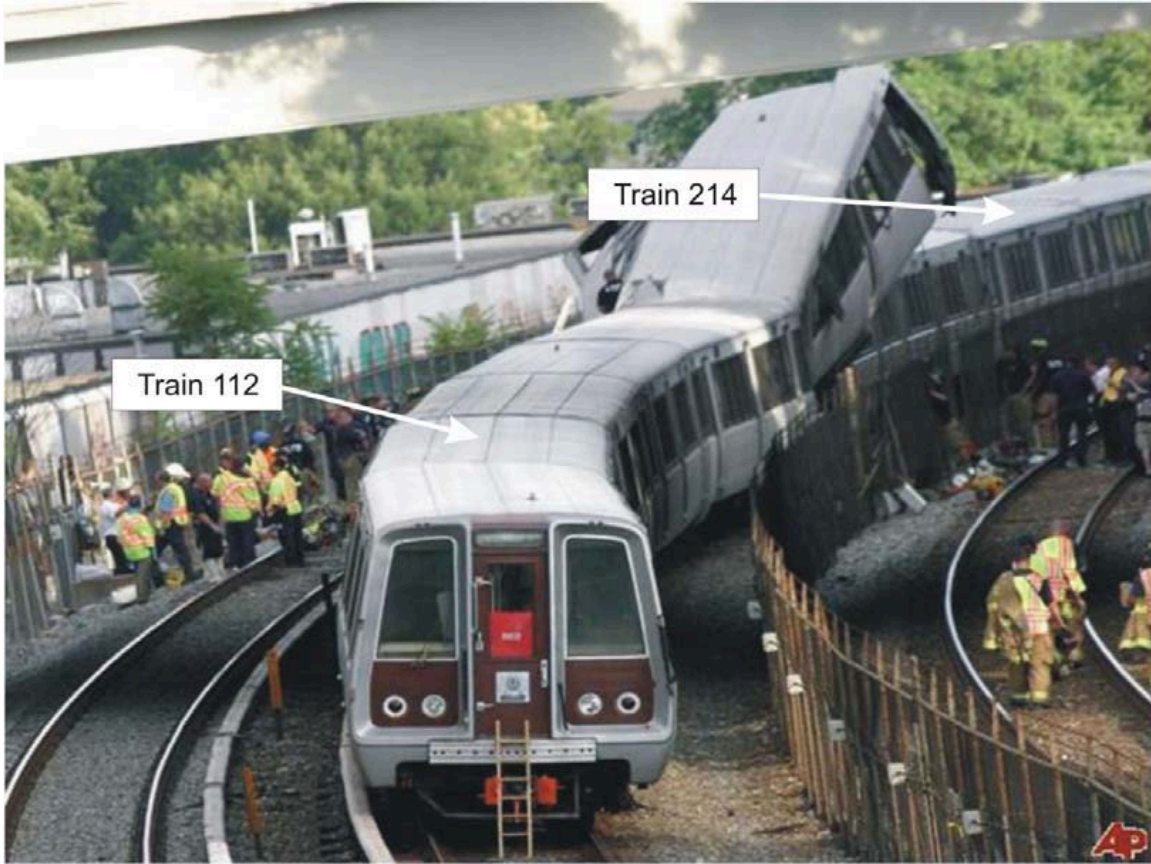
Figure 9. Lead Car of Striking Train (Train 112) has Overridden the Last Car of Struck Train (Train 214), which has Telescoped into the Lead Car of Train 112

214. The accident occurred on aboveground track on the Metrorail Red Line near the Fort Totten Station in Washington, DC. The lead car of Train 112 struck the rear car of Train 214, causing the rear car of Train 214 to telescope into the lead car of Train 112, resulting in a loss of occupant survival space in the lead car of about 63 feet (about 84 percent of its total length). Nine people aboard Train 112, including the train operator, were killed. Emergency response agencies reported transporting 52 people to local hospitals. Damage to train equipment was estimated to be \$12 million.<sup>35</sup>
