## **Field Testing and Summary Report for Road 5 (Morris Road) Over Road 3 (Toftoy Throughway) at Redstone Arsenal, AL**

Contractor's Supplemental Report for Project F09-AR16

Bridge 18 at Redstone Arsenal is a bridge deck replacement project located at the intersection of Morris and Toftoy Roads in Huntsville, Alabama. The superstructure consists of four original wide flange beams (W33x118) and a new 7" ZellComp Composite FRP Deck with a ½" bituminous wearing surface. The four bridge spans are continuous, and divided into two end spans of 40'-0", an interior span of 64'-4½", and an interior span of 52'-4½". The overall bridge width is 22'-5", with a curb-to-curb roadway width of 20'-0".

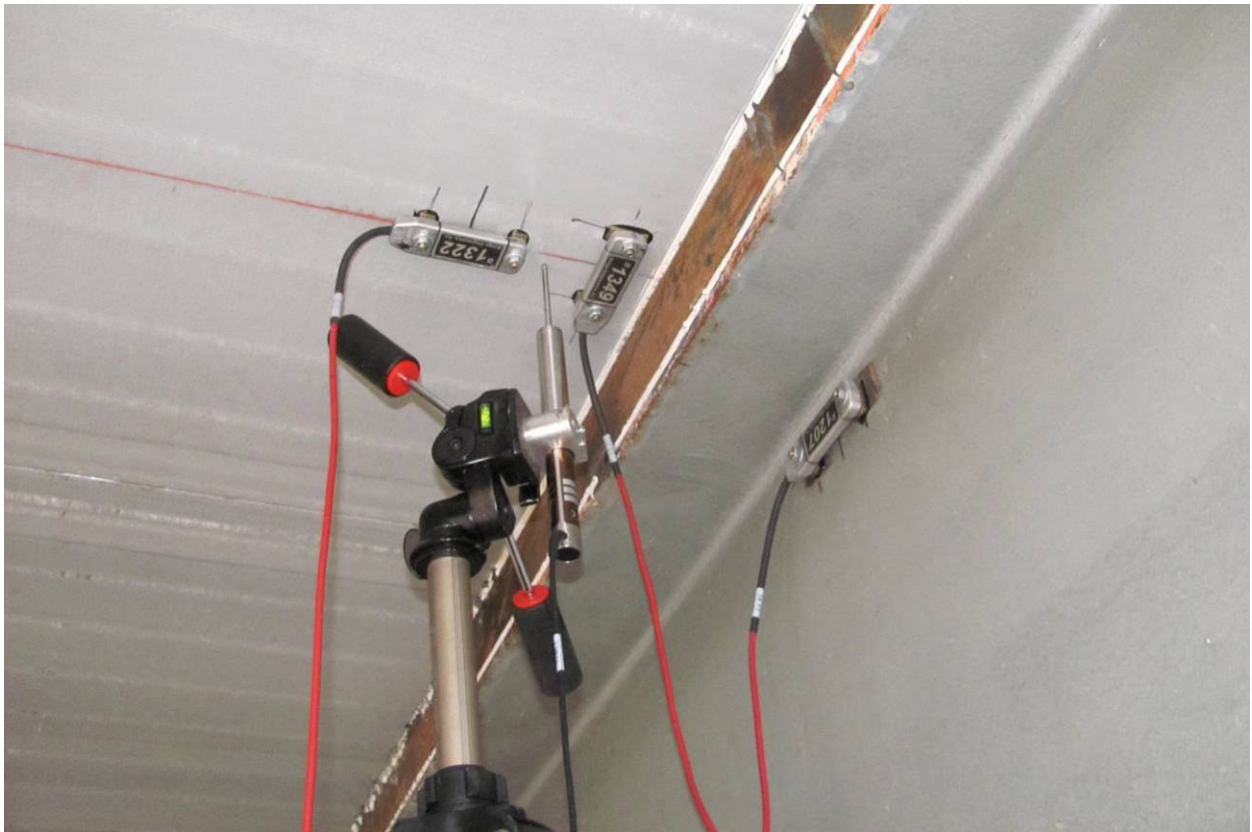
**Figure 1.2 Typical strain gages and LVDT at top of beam and edge of FRP deck panel.**

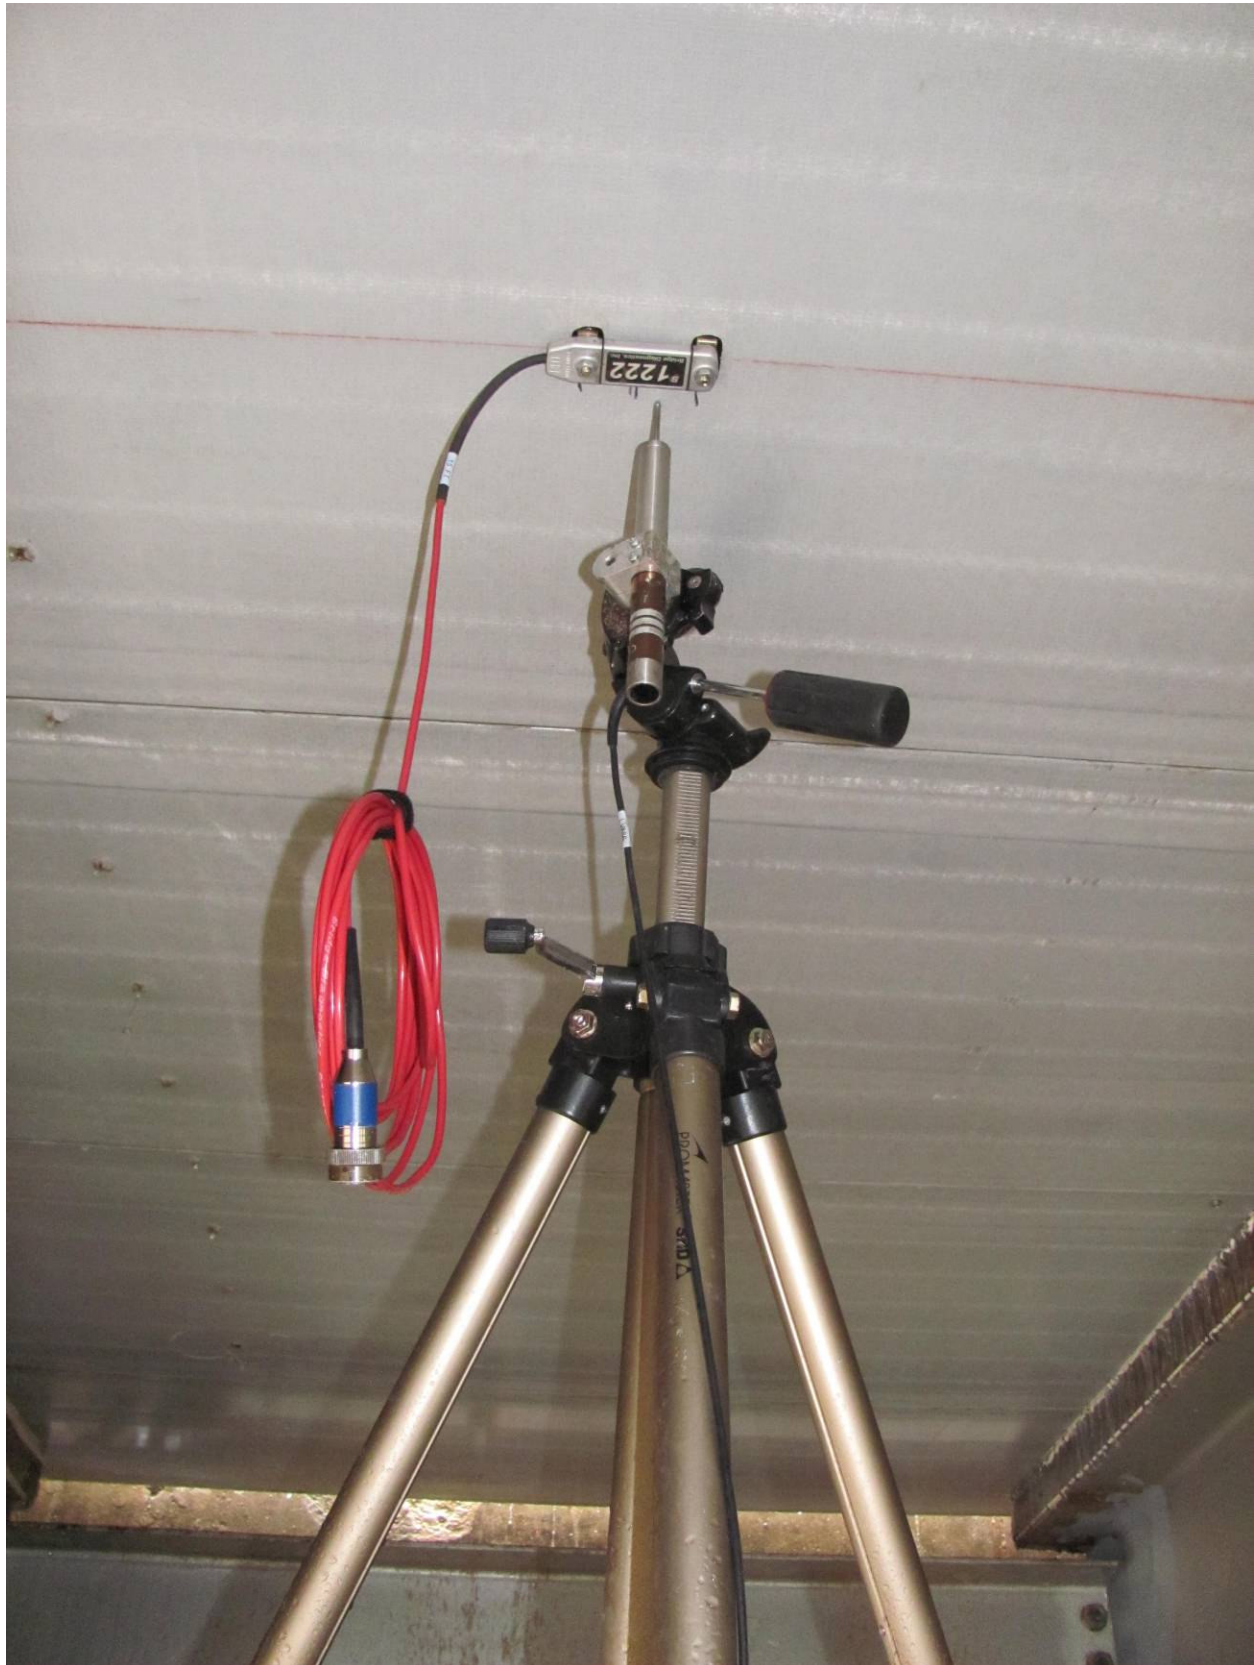
**Figure 1.3 Typical strain gage and LVDT at midspan of FRP deck panel.**

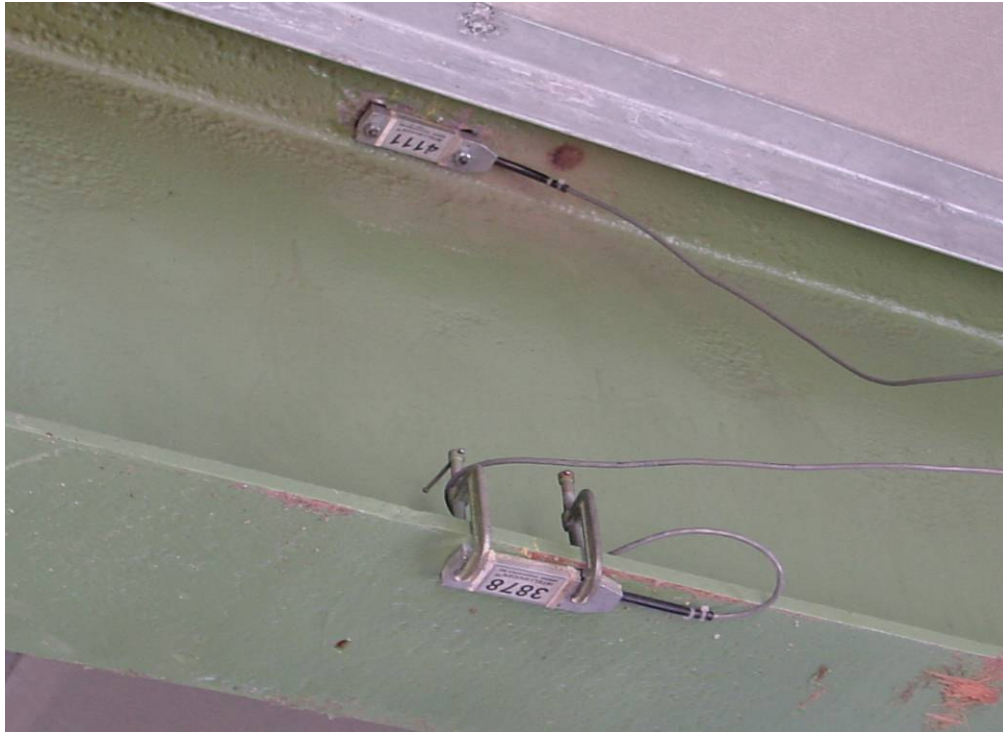
**Figure C.1 Strain Transducers Mounted on Steel Girder**

If the above steps are followed, it should be possible to mount each transducer in approximately five to ten minutes. The following figures illustrate transducers mounted on both steel and reinforced concrete members.

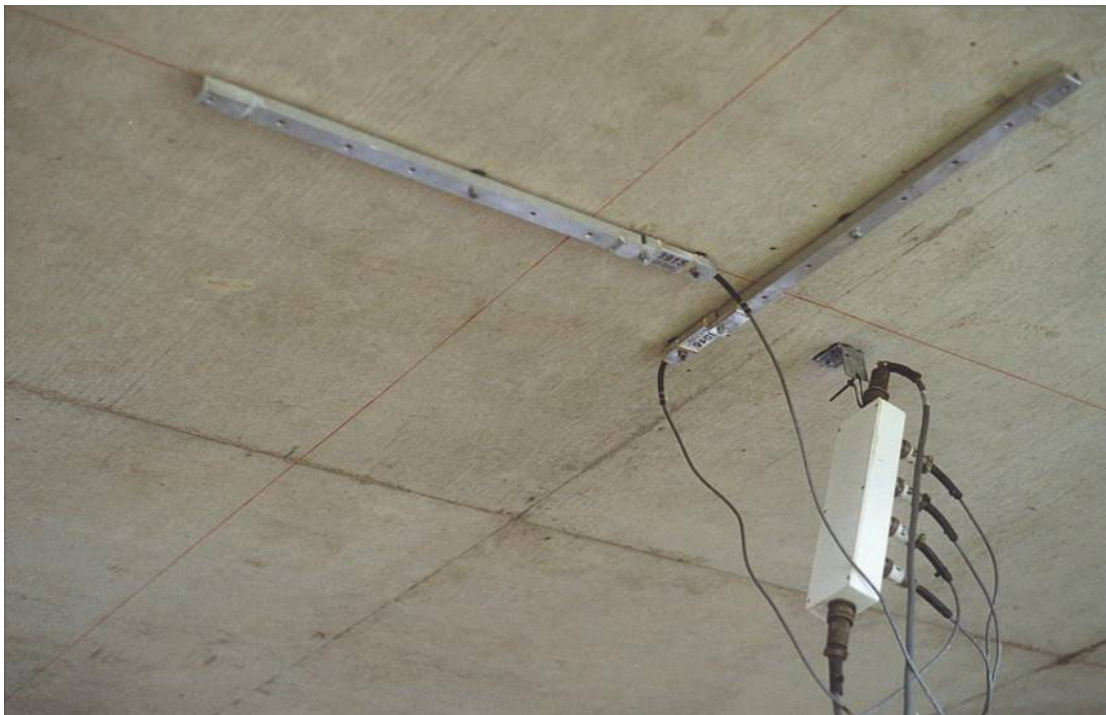
**Figure C.2 Transducers w/Gage Extensions Mounted On R/C Slab**

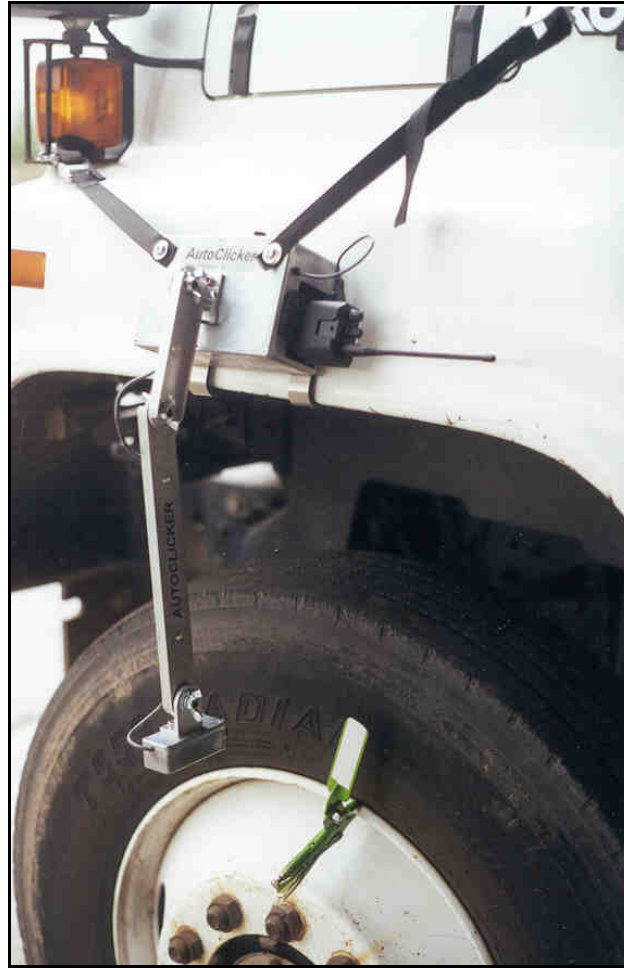
***SPECIFICATIONS: BDI AUTOCLICKER***

| 3 Handheld Radios | Motorola P1225 2-Channel (or equal) modified for both “Rx” and “Tx”. |
