# FINAL REPORT

Zinc Bromide Flow Battery Installation  
for Islanding and Backup Power

ESTCP Project EW-201242

SEPTEMBER 2016

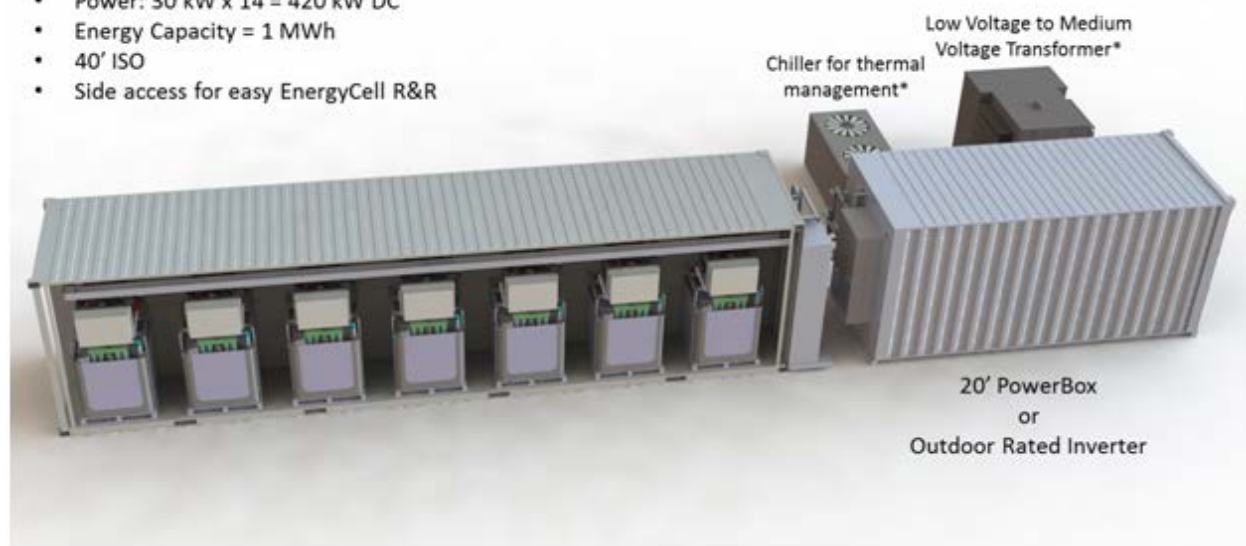
**Figure 2-4: Illustration of Primus EnergyPod system complete with Zn/Br cells, power electronics, and thermal management.**

- Power: 30 kW x 14 = 420 kW DC
- Energy Capacity = 1 MWh
- 40' ISO
- Side access for easy EnergyCell R&R

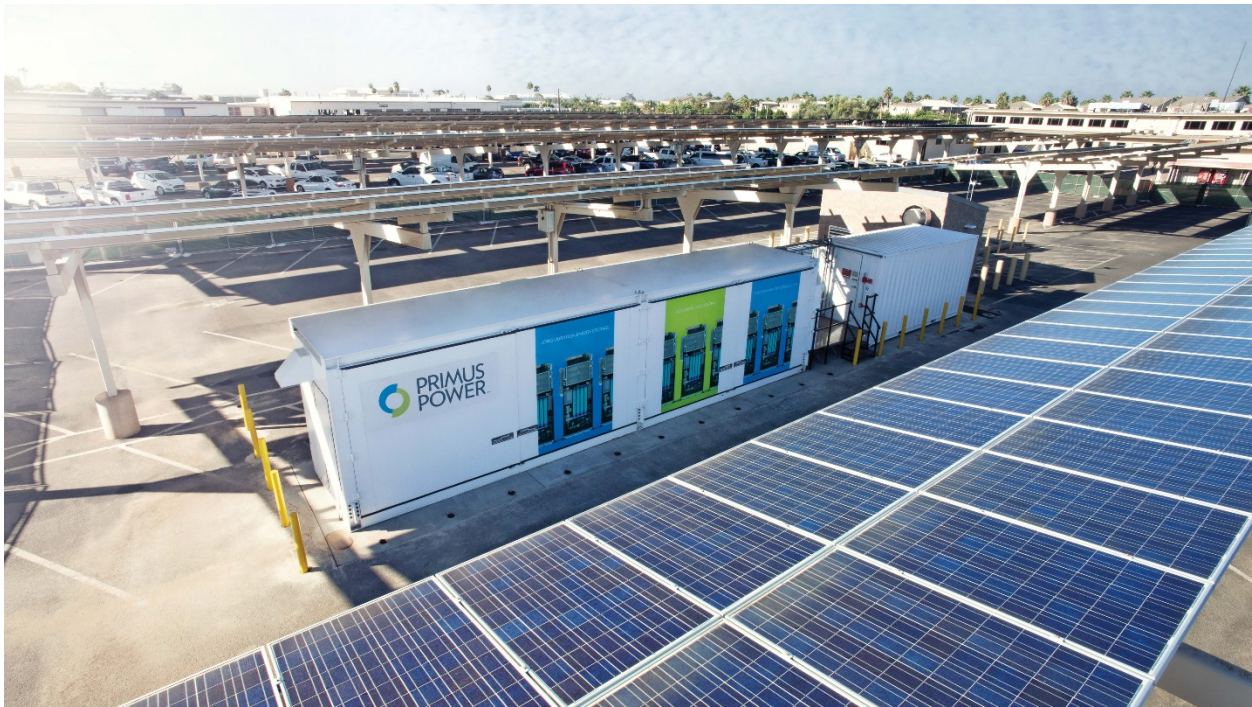
**Figure 2-6: Photo of installed system at MCAS Miramar.**

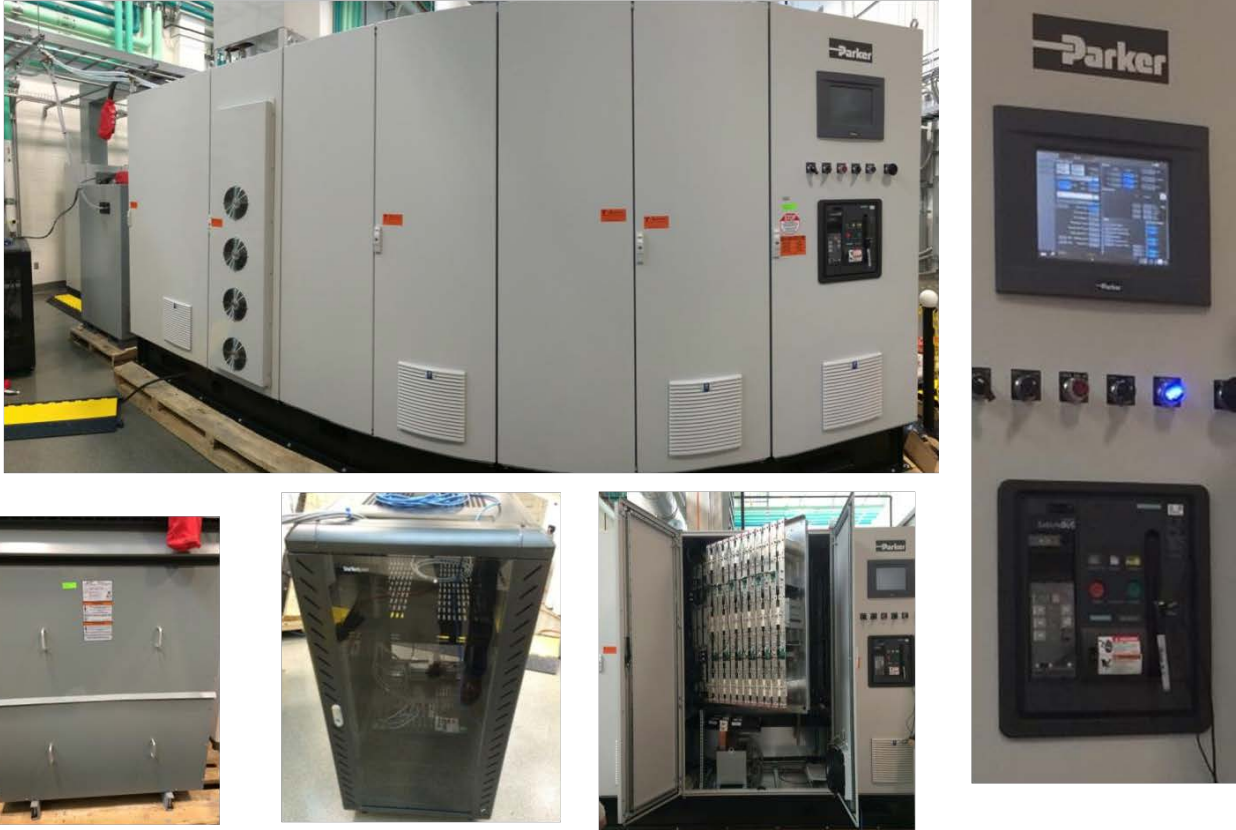
**Figure 2-14: Photos of the various equipment that is part of the NREL testing. The top left image is of Primus Powers 760kVA Parker grid tied inverter that is the main element in Primus' power electronics subsystem. The bottom left is of a 480 to 208 transformer, the bottom second from the left is Primus' EnergyBlock controller which manages Primus AC & DC busses. The bottom third from the left shows the capacitor bank within the Parker inverter. The right most image shows the AC breaker for the Parker inverter and the local HMI display.**

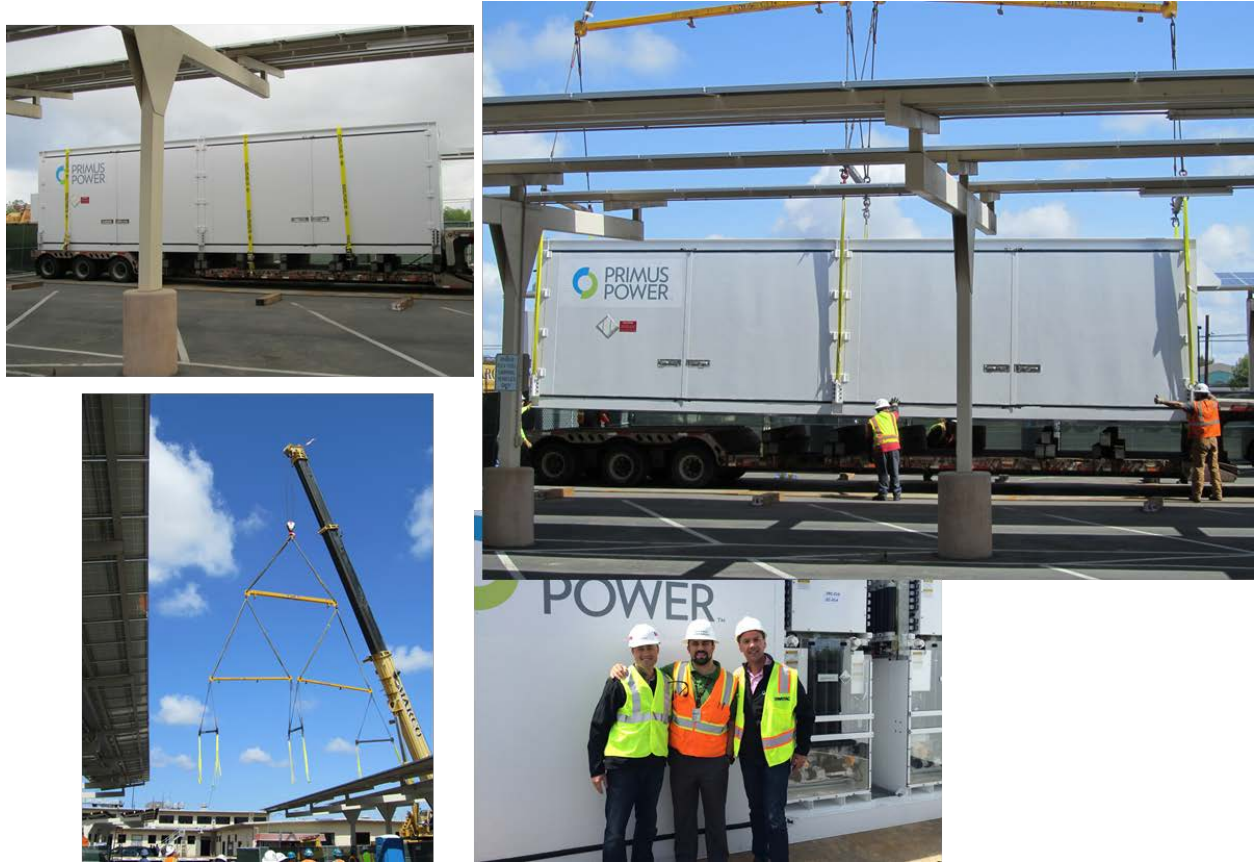
**Figure 5-10: Photos of the Primus ESS being delivered to MCAS Miramar. The EnergyPod need to have a large crane in order to lift it off of the delivery truck.**

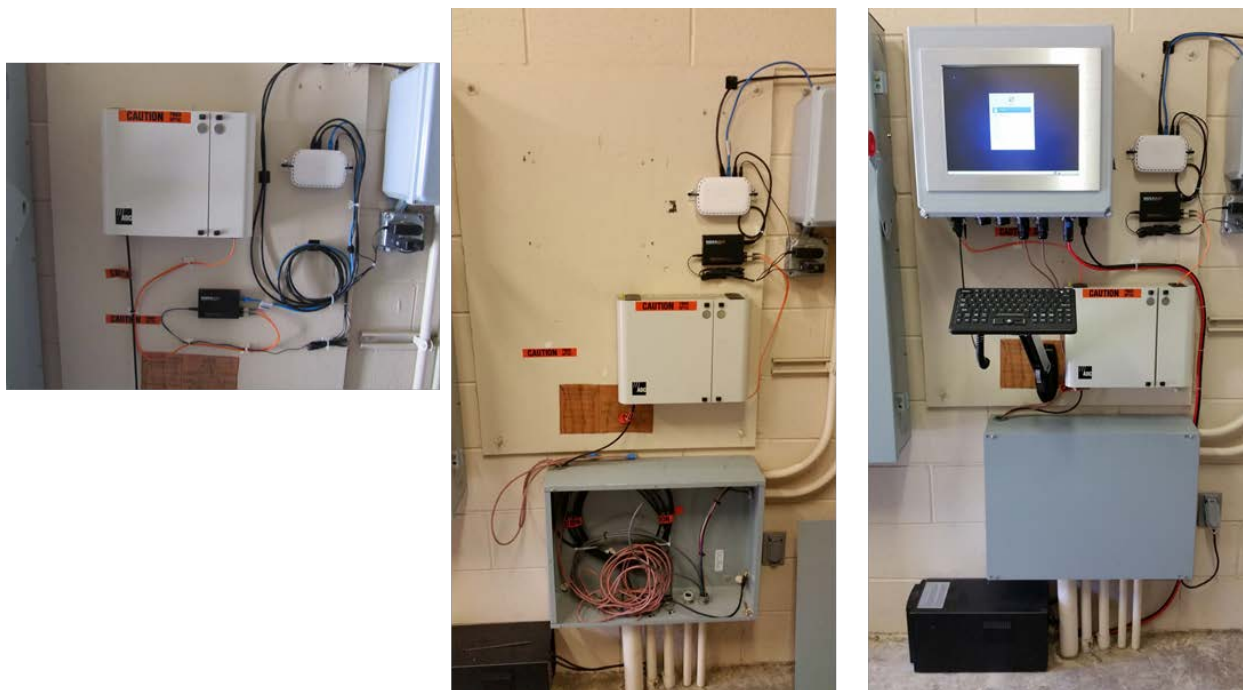
**Figure 5-14: Photos of inside the P196 inverter room where the IPEM controller was installed. The image on the left shows the location pre IPEM. The middle image shows some of the existing fiber termination block and equipment moved to accommodate the IPEM controller. The right image shows the IPEM controller and ancillary equipment installed.**

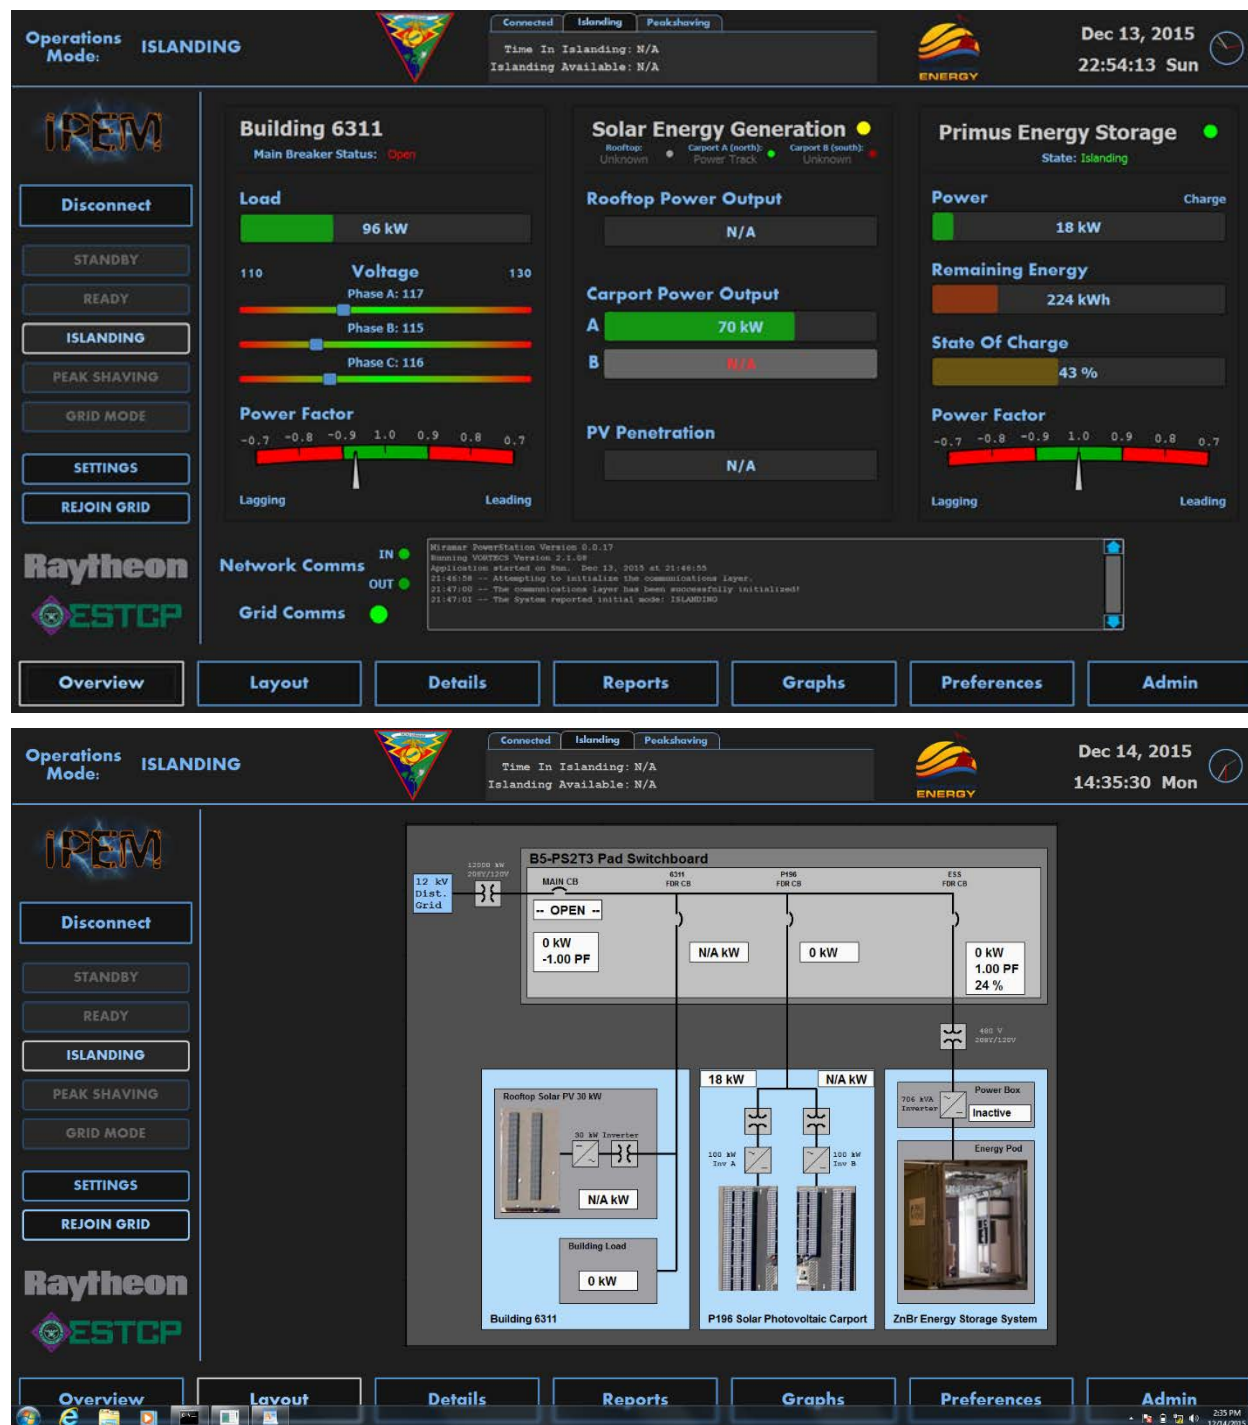
Figure 5-15: Screen shots of the IPEM HMI .

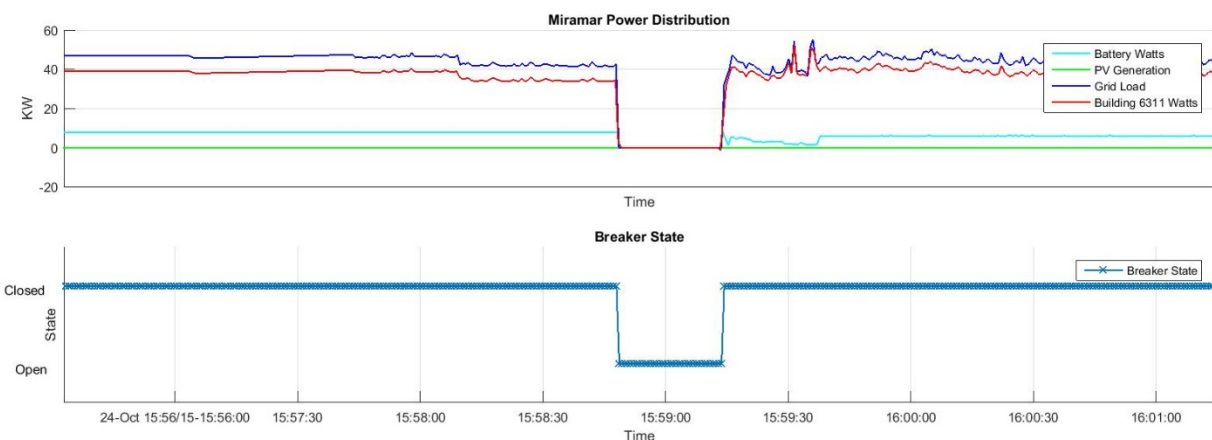
**Figure 5-25: Timeline for Islanded Operation with Battery Only test on 10/25/15.**

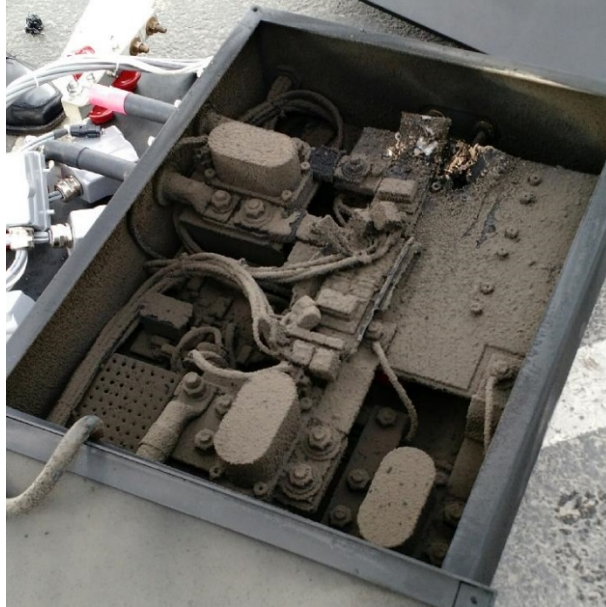
**Figure 5-26: Photo of damaged H-bridge system.**

This test was repeated on the morning of 12/12/15 after Primus Power was able to validate the proper sequencing for the shutdown of EnergyCells when exiting Islanding Mode. Once validated another islanding demonstration test was scheduled for 12/11/15 to 12/13/15. On 12/10/15 a component failure occurred in one of the H-Bridges of one of the EnergyCells activated a smoke detector within the EnergyPod. The audible alarms were triggered and MCAS personnel heard

the alarm and notified the Miramar Fire Department. The event did not result in a fire however the event signifies the importance of having proper safety monitoring and fire protection mechanisms in place. Due to the damaged H-Bridge the EnergyCell with that component as well as an adjacent EnergyCell would not be available during the 12/11-12/13 islanding tests. Therefore the system would only have 12 of the 14 EnergyCells available for testing.

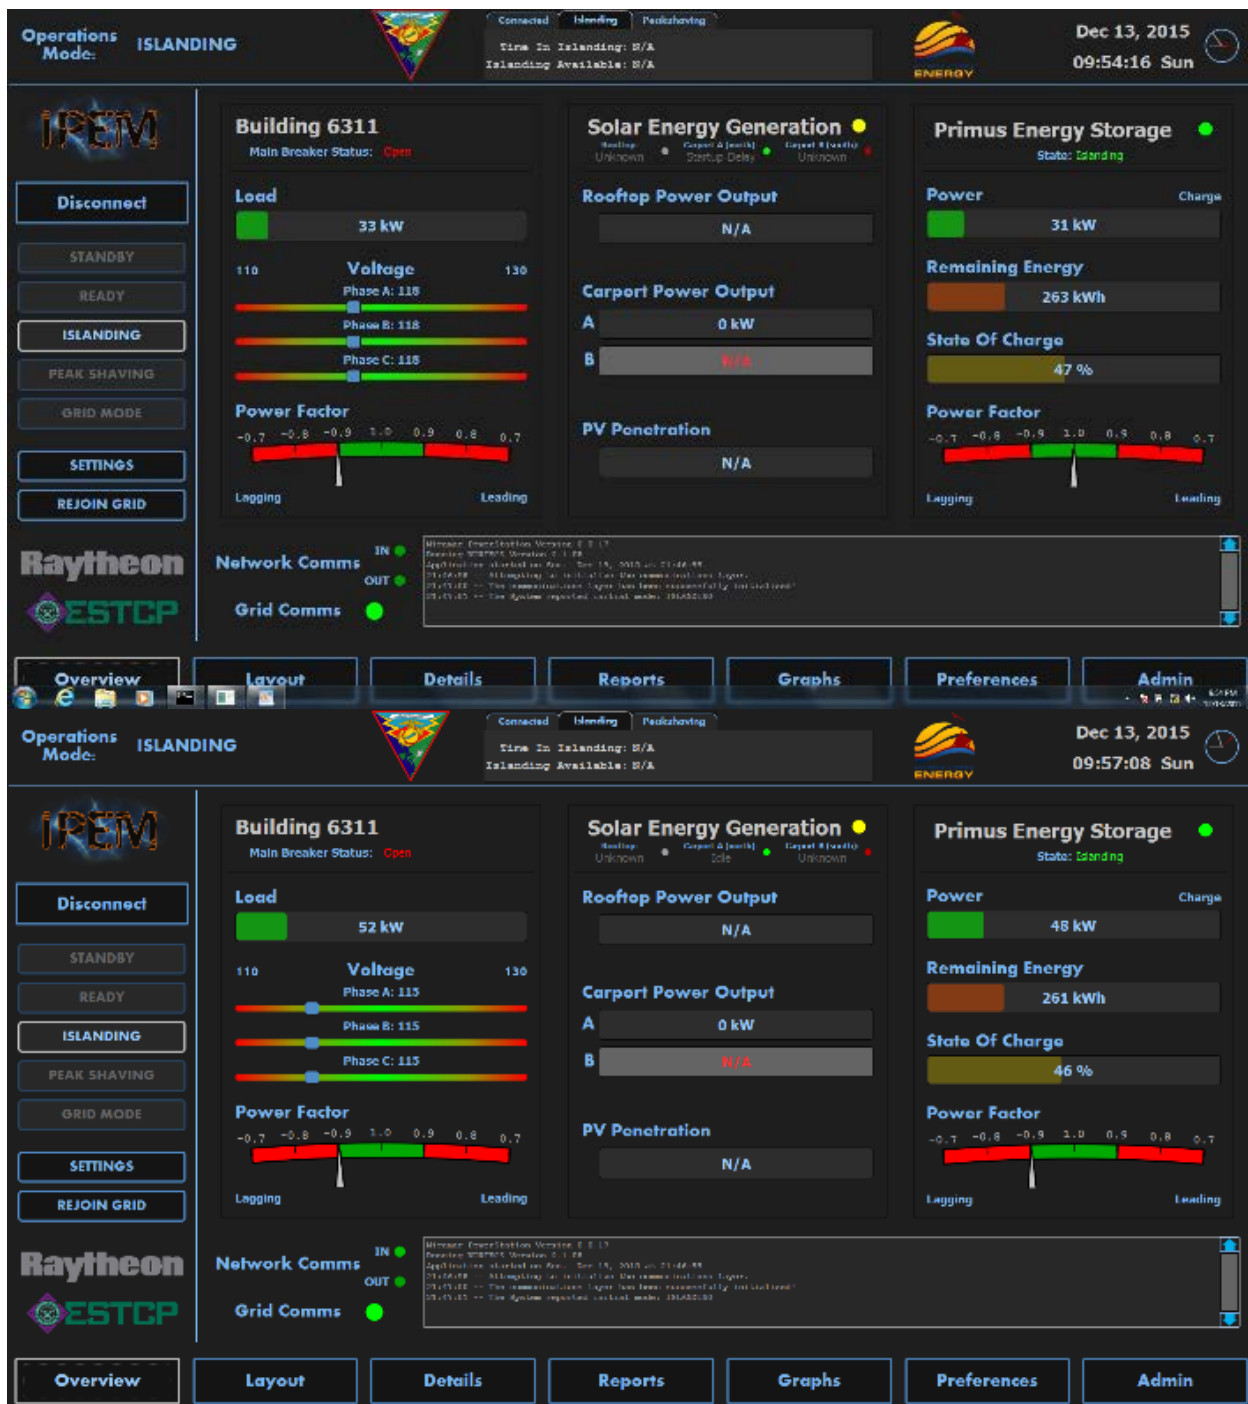
Figure 5-38: Screenshots of the IPEM HMI during the 12/13/15 islanding event. Screenshot shows the initial loads of building 6311, ESS status and PV generation status. There is currently no PV output but the status on Carport A inverter (shown in red square) indicates the inverter is online and in its Startup/Bootup delay per UL1741 in the left image and in its Idle mode ready to output power in the right image.

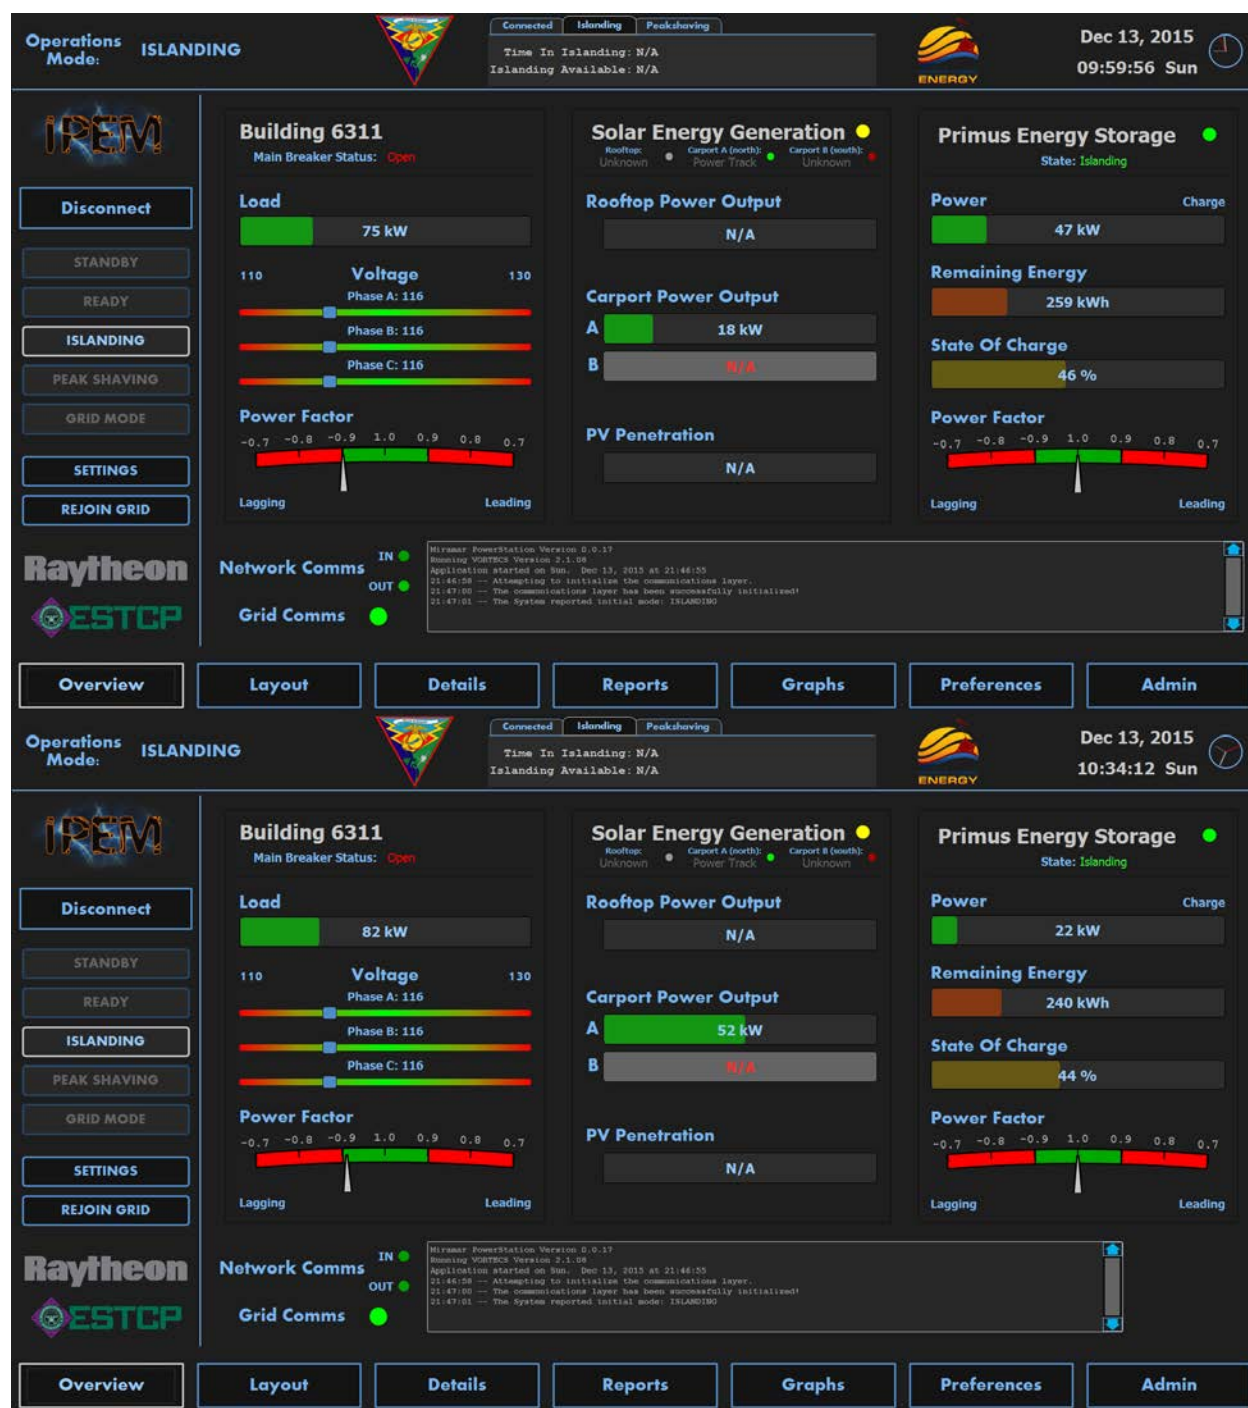
Figure 5-39: Screenshots of the IPEM HMI during the 12/13/15 islanding event. These screenshots show the initial output power of the PV system and its relationship with the load and the ESS output power. The image on the top is at 9:59AM when the PV penetration level was initial set at 30%. The image on the right is at 10:34AM when the PV penetration level was set at 65%.
