Report No. CG-D-08-16

# Immersion Suit Flotation Testing

## REACT Report

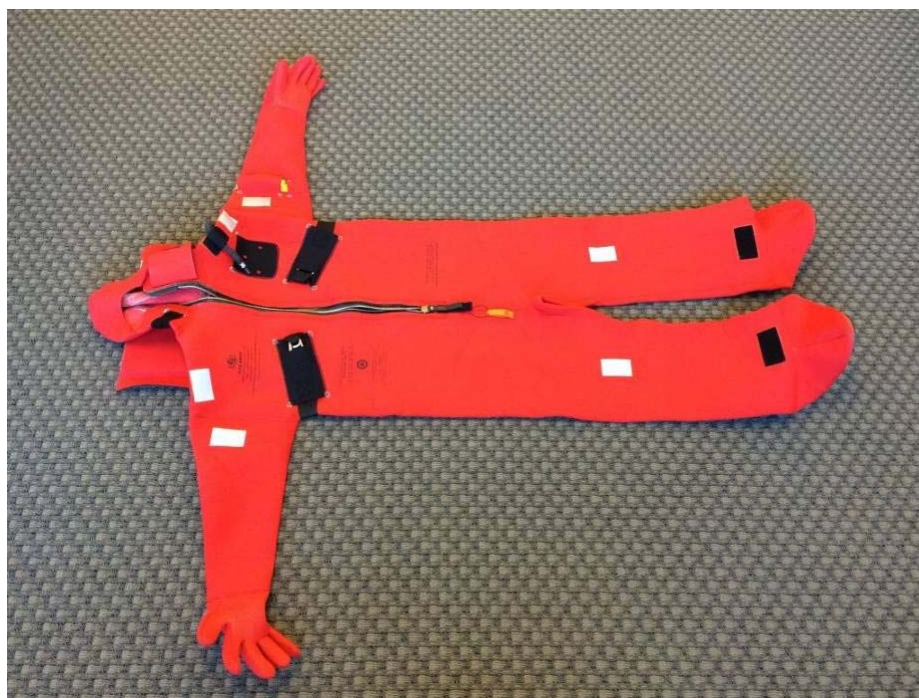
The Coleman-Stearns I590 immersion suit is designed to provide both flotation and prevention from water ingestion/aspiration, and also provides protection against hypothermia.

Figure 2. Coleman-Stearns I590 immersion suit.

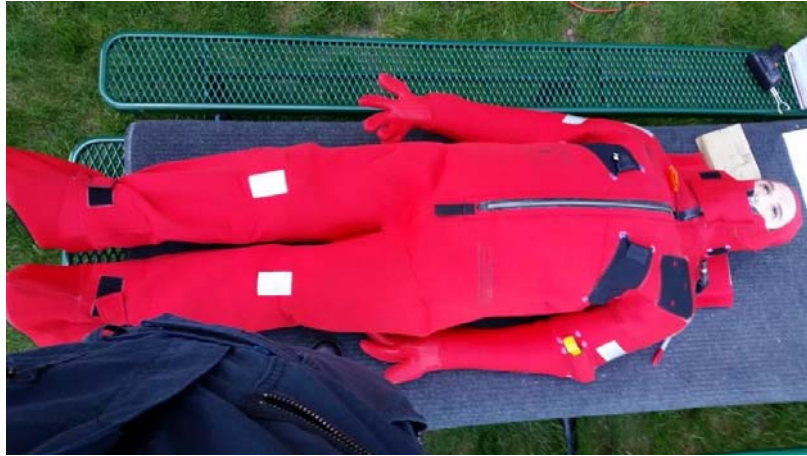
Figure 4. Ballasted mannequin in immersion suit.

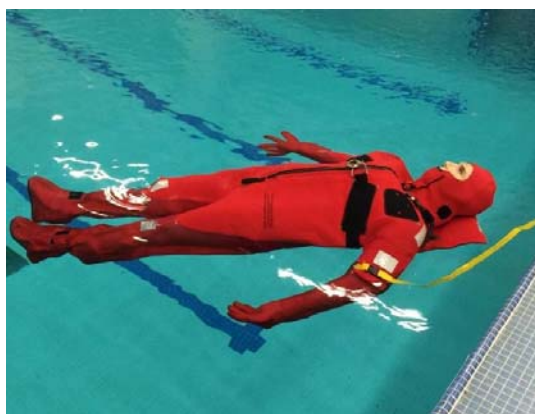
Figure 5. Weighted mannequin/immersion suit flotation trial.

The initial flotation test (see Figure 5) indicated conditions that differ from a “real world” situation. First, in “normal” immersion-suit wear, the wearer’s posture is often different than shown in Figure 5. In a resting position, a wearer’s body would exhibit a bend at the waist-pelvis region, where the rump would sink lower, with the feet and legs tending upward. This, in-turn, would cause the wearer’s torso and head to rest at a greater angle with respect to the surface of the water. Second, for our mannequin, both weighted arms appeared to swivel or detach from their initial positions alongside the mannequin torso. The immersion suit kept the arms captive, but did not provide the rigidity as initially desired. For comparison, Figure 6 gives an example of an actual wearer’s position in the water. For our purposes, we accepted the difference in flotation aspect as an experiment constraint.

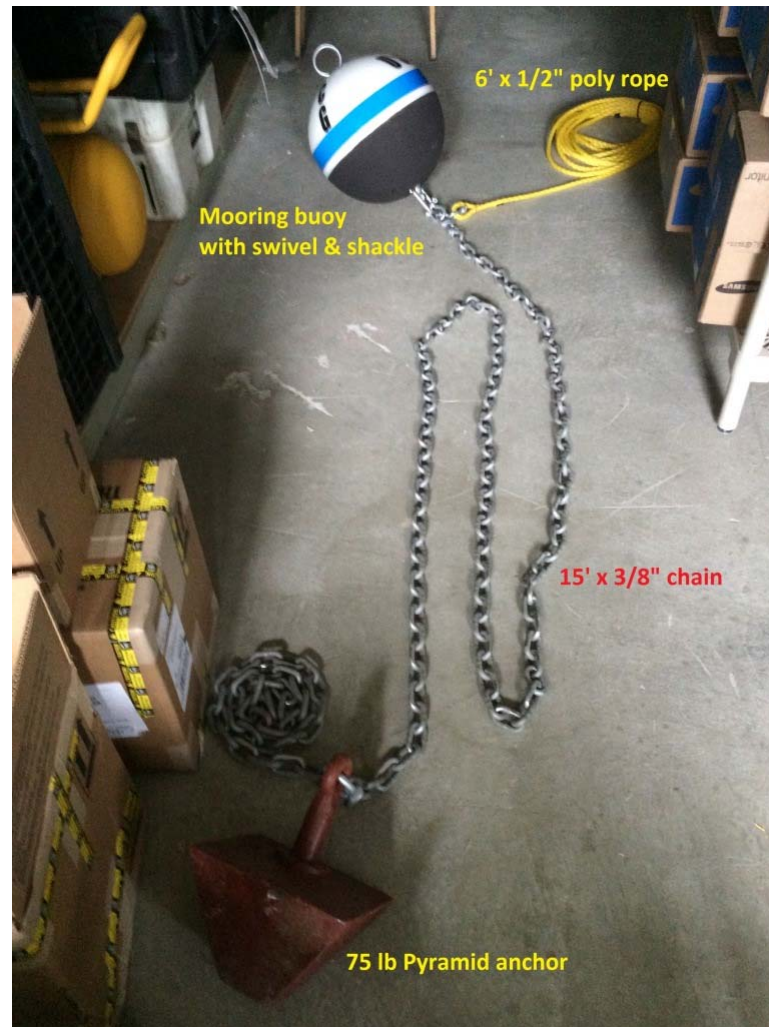
Figure 7. Mooring arrangement.

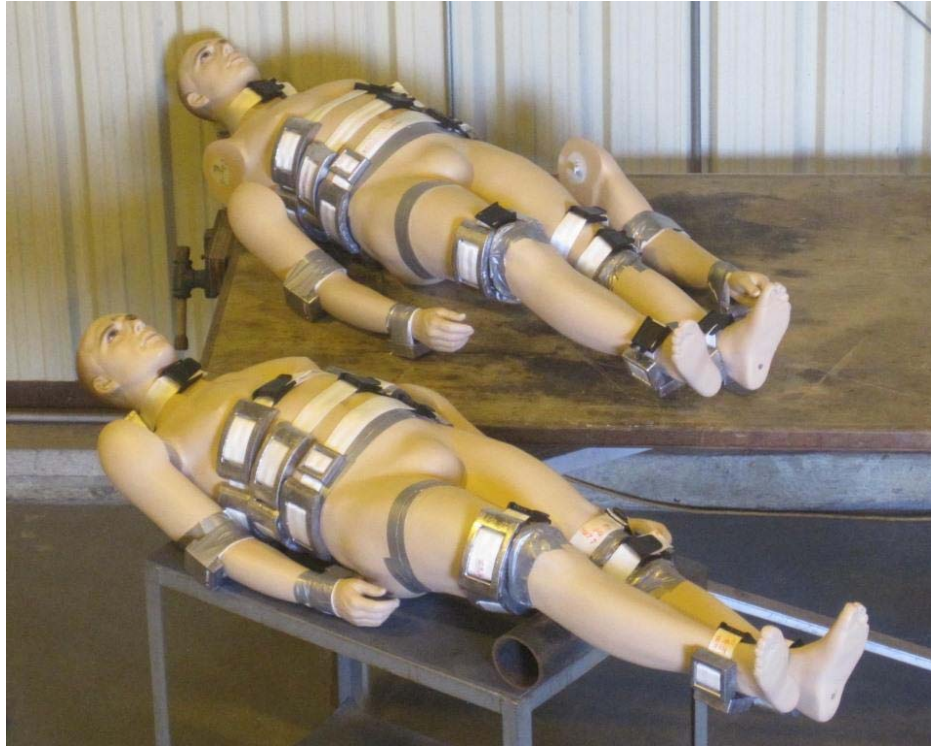
Figure 8. Weighted mannequins before taping at JMTF.

The first step was to re-ballast the mannequins as before, using the divers' weights, belts and buckles, and over-taping (Figure 8). After initial ballasting, a problem occurred. During a logistics run for PVC tubing, the fiberglass thigh stub-end for a removable leg mount detached at the seam due to shear force created by the weights. Though the display mannequin was not designed for anything but a "stand-up" mode, the failure indicated the joint relied only on a narrow, resin and filler seam (Figure 9). We tried, unsuccessfully, to find a fiberglass repair-kit at one of the CG units at the Mobile facility, so decided to try to "bandage" the seam with duct tape, applied parallel to the axis of the leg, then wrapped circumferentially (Figure 10).

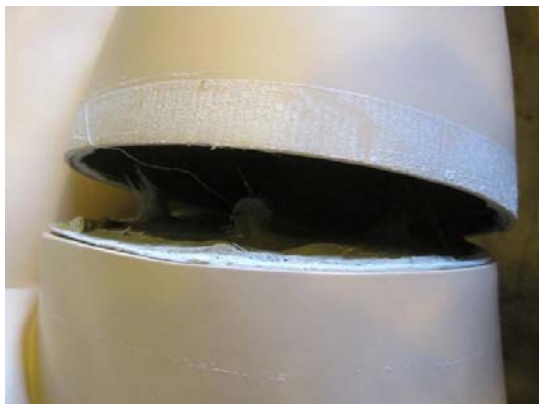
Figure 9. Mannequin leg-joint separation.

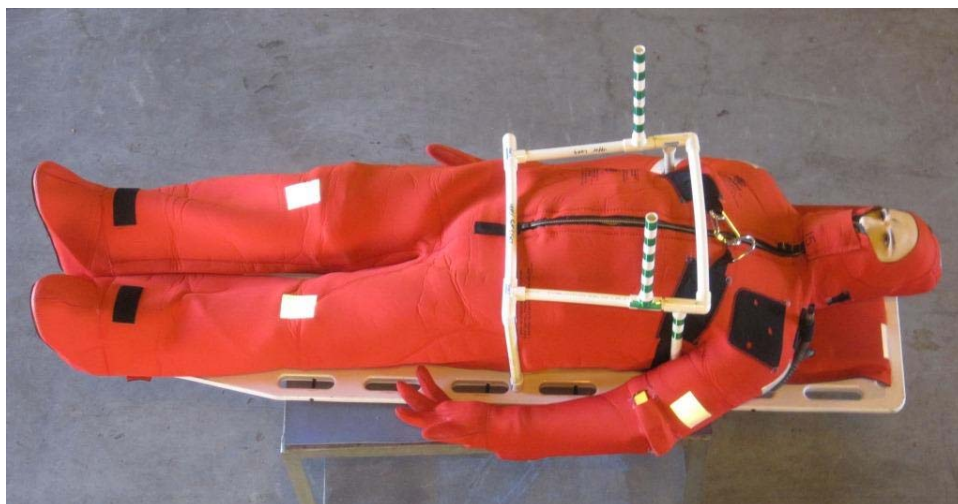
Figure 11. Mannequin in suit with measuring posts.

After ballasting and suiting the mannequins, the team constructed a frame of  $\frac{3}{4}$ -in CPVC tube and fittings around each mannequin to support vertical "measurement posts." One-inch red and green retro-reflective tape strips, spaced one inch apart, provided a means to tell whether the mannequins lost buoyancy during the deployment (Figure 11).

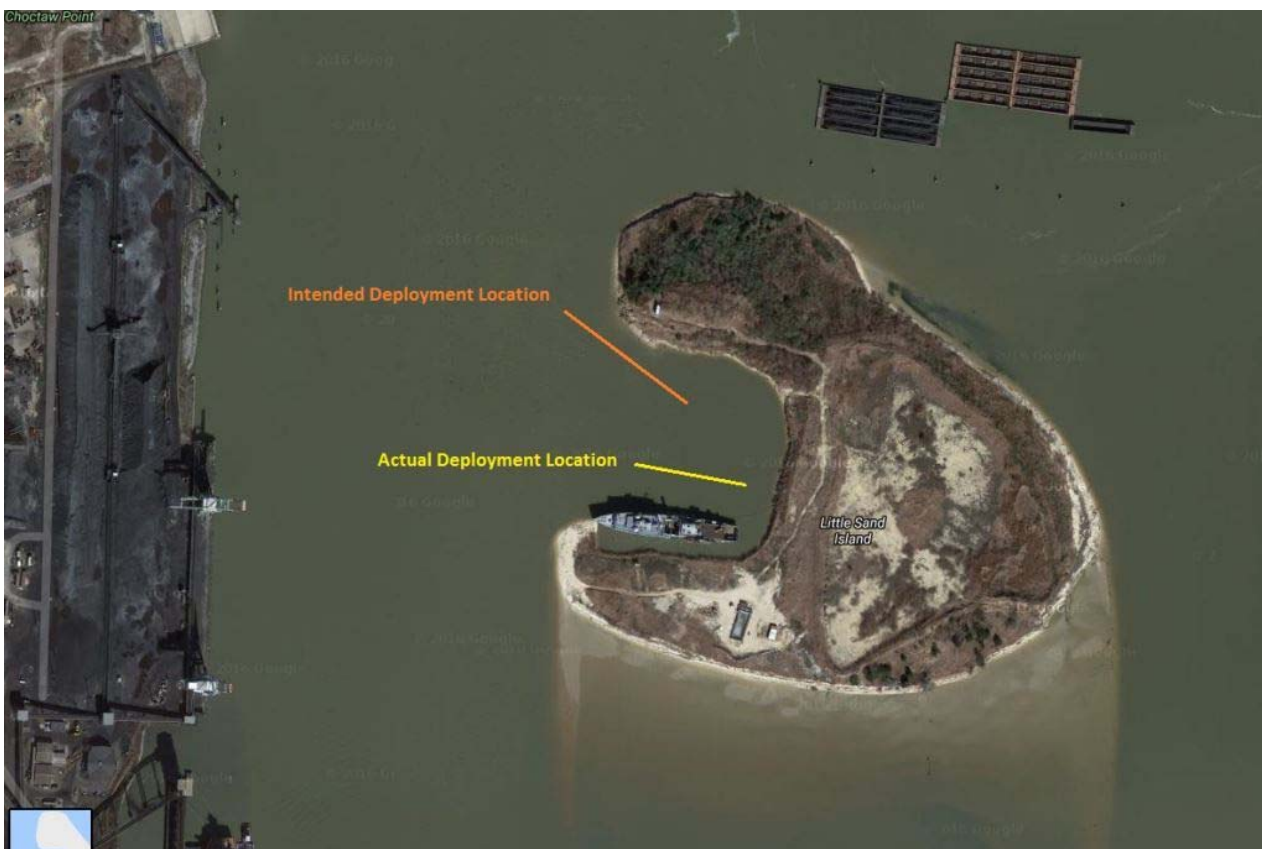
Figure 12. Actual versus intended deployment site, Little Sand Island basin.

Using a telehandler and pallets, JMTF staff and test team loaded all gear onboard the 35-foot NRL Landing Craft Mechanized (LCM-3), and proceeded to the test site in the Little Sand Island basin. The NRL LCM operator recommended a site closer to the east side of the basin than indicated on the test plan due to recent dredge-pipe staging activity (Figure 12). Estimated water depth was 12 feet.

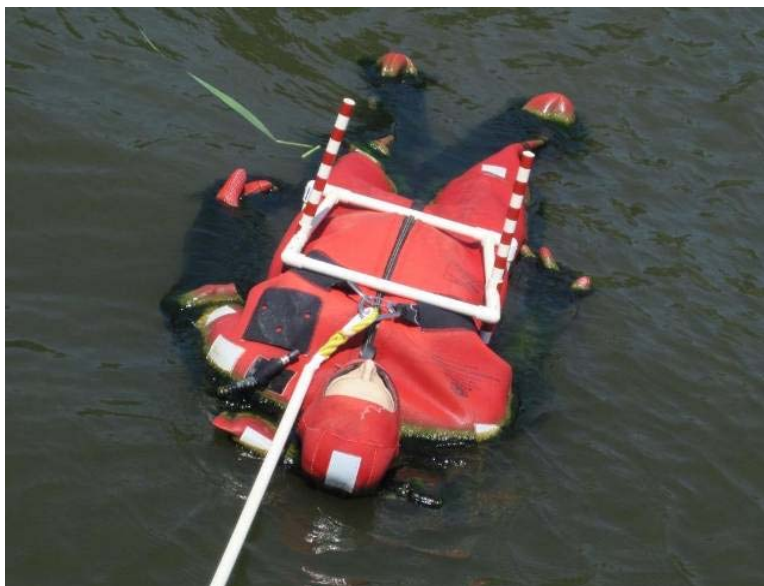
Figure 17. Mannequin B – pre recovery 23 June 2016.

Figures 16 and 17 taken just before the time of recovery clearly indicate that both mannequins exhibit **significant** grassy marine growth about their “waterlines,” especially over the legs and arms.

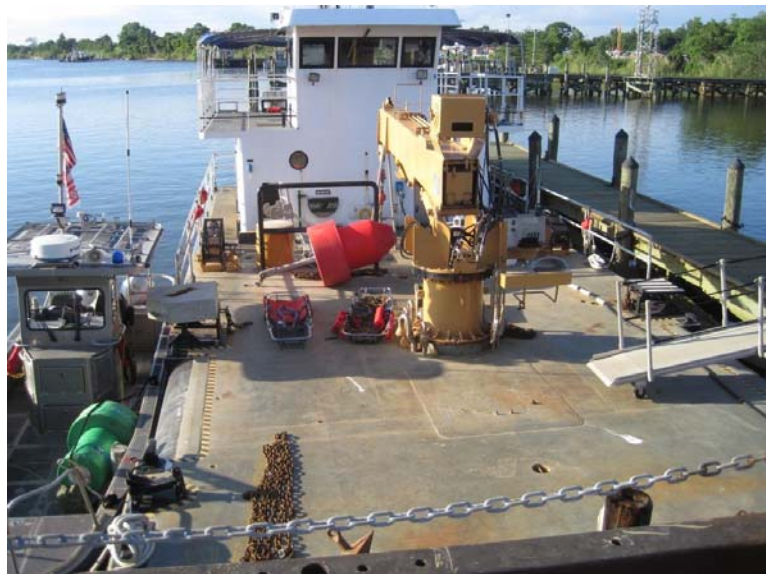
Figure 20. CG 64350 deck with Stokes litters.

As Figure 20 above shows, the amount of clear, working deck space and the large boom available on CG 64350 more than made up for the TANB's low freeboard. One other additional benefit (not shown) is CG64350's ability to "spud-down" into the bottom by lowering two columns near the deck edge, providing an extremely stable recovery platform, and minimizing the effect of wind and current.

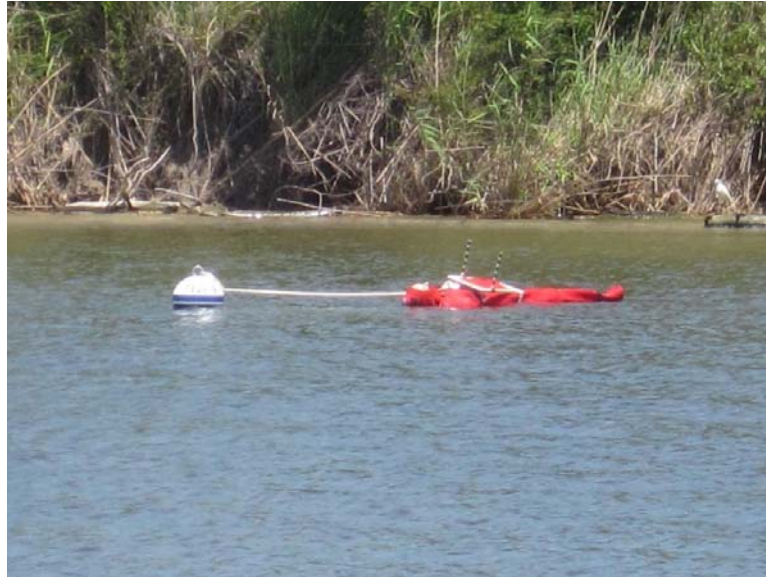
Figure 22. Mannequin A- deployment 0800 8 June 2016.

Initial readings on “measurement posts,” with one-inch tape bands, one-inch apart, indicated that both mannequins were floating higher than the lowest mark. At this stage, there was nothing to do about the measurement marks, however the accompanying photos for each reading allowed a good comparison of flotation height. Comparison of Figures 22 and 23 indicate a distinct “list” for Mannequin A.

Regarding Mannequin A's list, the test team believes that as they fastened the ballast weights, they may have skewed the weight to one side of the mannequin torso. From the photos or the observation records, we cannot determine if Mannequin B's "broken leg" affected its list or trim. What is apparent in all photos is the overall trim of the mannequins (torso higher than the legs) due to the nature of the rigid mannequins used.

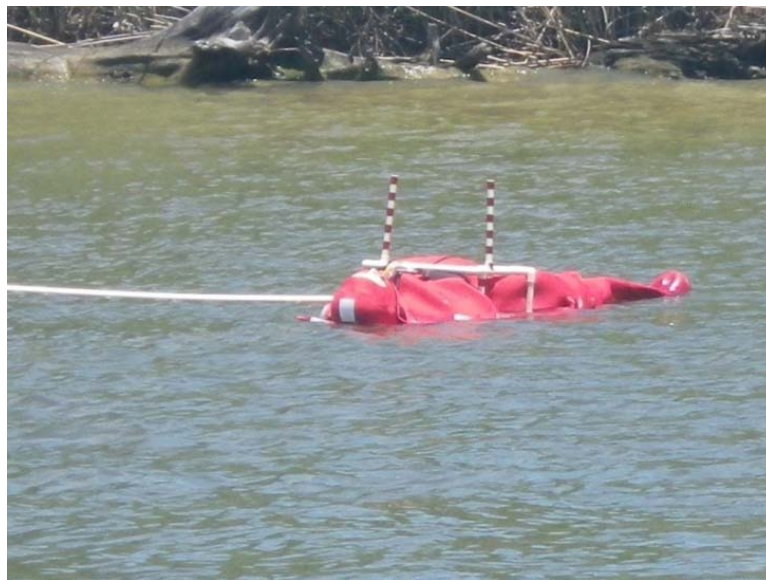
Figure 23. Mannequin B – deployment 0800 8 June 2016.

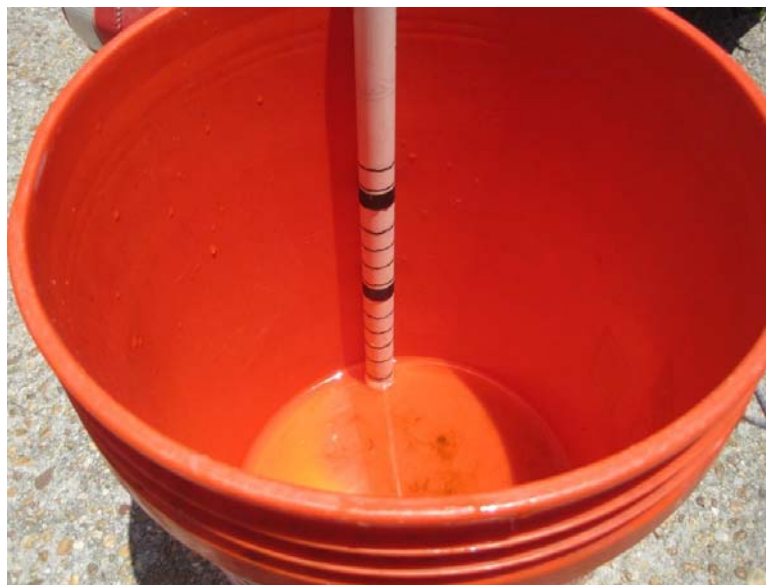
Figure 24. Mannequin A- post-recovery drained water.

After the post-recovery weighing, the RDC team opened the immersion suit for Mannequin A, and noticed pooled water in area of lower back/buttocks, as mentioned earlier. As best possible, we collected this and any additional water from the legs and arms into a six-gallon bucket. Using a pre-marked tube section (smallest gradation of one liter), we measured approximately three-quarters liter (approximately 1.7 pounds) from Mannequin A. We followed the same procedures, and recovered less than one-third liter (approximately 0.7 pounds) from Mannequin B. Figures 24 and 25 show the measure results.

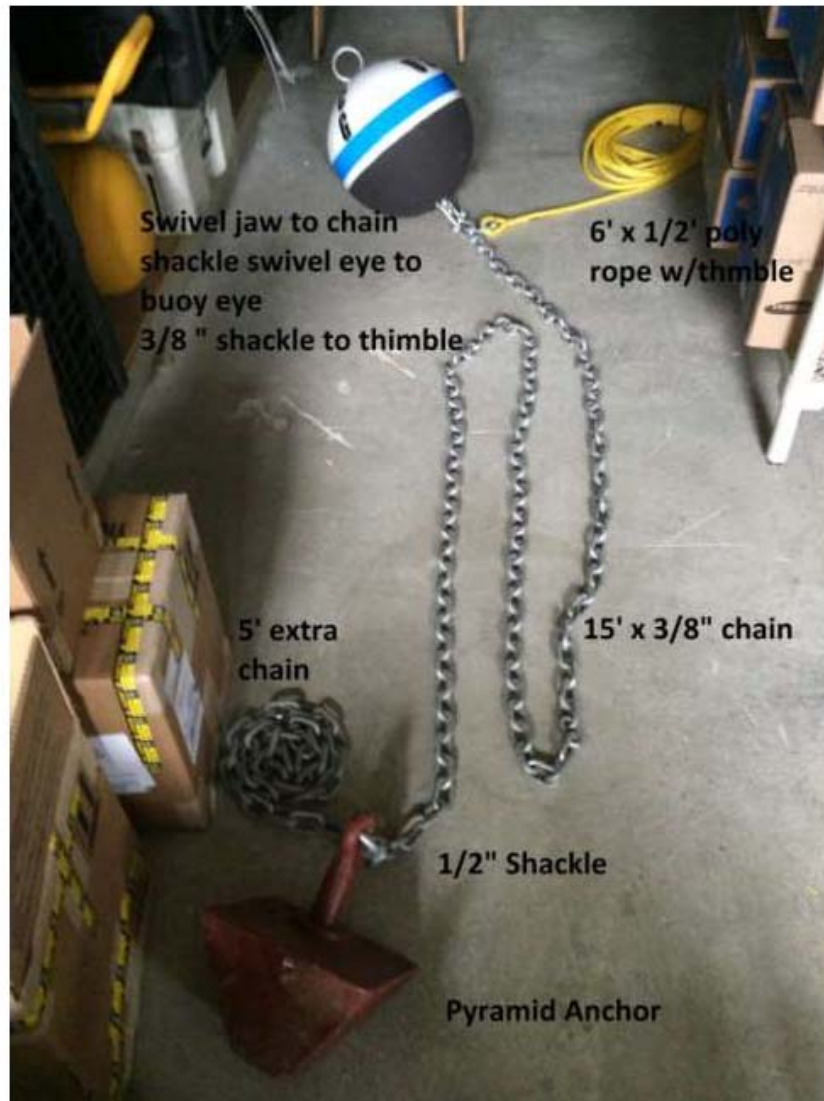
Note: (1) Reeve approximately 7-1/2' of the 1/2" poly line through 6-1/2' x 3/4" CPVC pipe ("spreader-arm"), then splice second thimble into eye for connecting to immersion suit harness clip.

**Note (2) In actual deployment, if necessary to provide a better "lie" between the mooring and the chest-mount harness clip, attach the 3/8" shackle and thimble to the mooring buoy-top ring.**
