ARL-RP-0594 APR 2017

# The Performance of PS400 Subjected to Sliding Contact at Temperatures from 260 to 927°C

by Kevin C Radil and Chris DellaCorte

Reprinted from Tribology Transactions. 2016 Sep 14:1–8.  
doi: <http://dx.doi.org/10.1080/10402004.2016.1231357>.

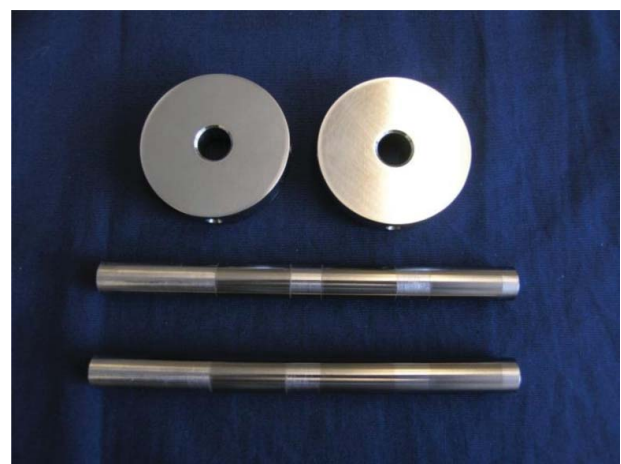
**Figure 1.** Bushing and rod test specimens. The three dark bands on the two rods are PS400.

Shown in Fig. 1 is the initial test hardware. The bushings were made from a cobalt-based superalloy with an inner diameter of 12.73 mm, outer diameter of 56.39 mm, and width of 12.7 mm. This material was chosen based on its common usage in high-temperature aerospace applications. The entire bushing's surface was polished with an average roughness of 0.302  $\mu\text{m}$ . Material hardness was measured to be HRC 39.

The rods are made from a nickel-based superalloy and are coated with PS400 at three different locations along its axial length to allow for three separate tests per rod. The substrate material was chosen based on its common usage in high-temperature aerospace applications. A flat at one of the ends (not shown) helped to secure the rod in place with a set screw. Surface preparation for plasma spraying the PS400 followed the directions in DellaCorte and Edmonds (8). The rod was coated and then ground to a final diameter of 12.67 mm, which provided a radial clearance of 30  $\mu\text{m}$  between the rod and the

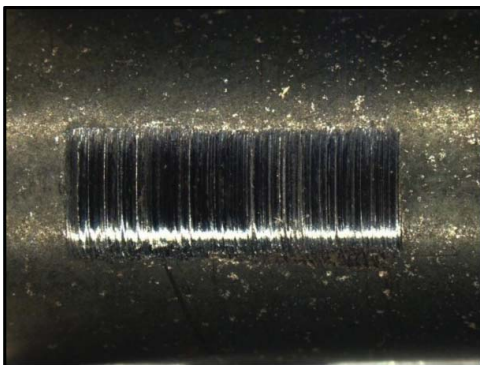
**Figure 5.** PS400 wear scar after testing at 760°C and 444.4 N. The scar exhibits a fully formed black oxide layer with light abrasive wear marks and polishing.

trate the PS400 and bushing wear scars produced during testing at 760°C and 444.4 N. As Fig. 5 shows, the PS400 wear scar exhibits a glossy black finish indicative of the oxide coating typically produced during sliding contact. The presence of a black finish demonstrates that an oxide layer is still able to form while in constant sliding contact with the bushing. Its rectangular shape also suggests mostly uniform load distribution between the specimens. Optical microscopy identified the presence of two wear mechanisms, polishing and light abrasion. The sliding marks are in the direction of motion, most likely from wear debris and/or the initial high surface roughness of the EDM bushing surface rubbing against a softer PS400 surface. Polishing was mainly evident between the sliding marks.

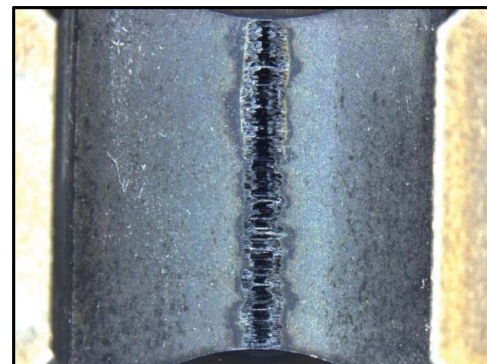
**Figure 6.** Bushing wear scar after testing at 760°C and 444.4 N. The wear scar exhibits light abrasive wear marks and polishing. The black film indicates a transfer of fluoride lubricants from the PS400.

The wear scar on the bushing in Fig. 6 has characteristics similar to the PS400 wear scar with sliding marks and areas of polishing. Its black finish suggests that material transfer occurred from PS400 to the bushing. To check, an energy-dispersive spectroscopy (EDS) X-ray was performed on the wear scar and the results are shown in Fig. 7. The analysis confirmed the presence of all of PS400's matrix and lubricant phases on the bushing's surface, especially the high-temperature solid lubricants  $\text{BaF}_2/\text{CaF}_2$ , which are pertinent to achieving low friction and wear.

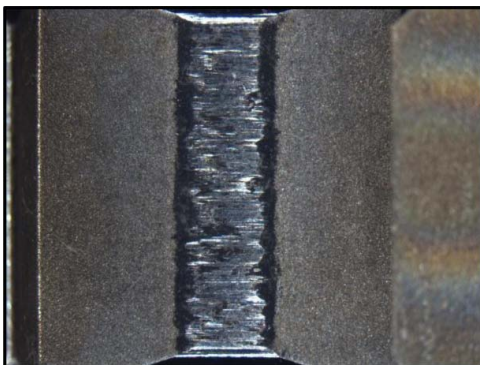
**Figure 11.** Bushing wear scar after testing for 2 h at 260°C and 333.6 N. The scar exhibits severe abrasive wear and is without the black lubricious transfer film.

The results for the PS400 coating and bushing tests at 260°C and 333.6 N are shown in Figs. 10 and 11 and exhibit definite signs of severe abrasive wear. The test at 260°C and 222.4 N was run to completion but the excessive wear rate at 333.6 N caused the test duration to be shortened to 2 h (7,200 cycles) and cancellation of the subsequent test at 444.8 N.

Both wear scars demonstrate severe abrasive wear and are void of the black finish. The coating's performance at this temperature was not unexpected because PS400 is tailored for high-temperature environments, as the tests at 760 and 538°C demonstrated. An EDS analysis on the bushing wear scar, shown in Fig. 12, indicates that material transfer from PS400 to the bushing did occur, but 260°C is not high enough to activate the lubricating properties of the fluorides. Hence, the black lubricious oxide layer failed to form during sliding contact, leaving silver as the predominant solid lubricant to control the coating's friction and wear characteristics. Most likely silver's low concentration of 5% is insufficient to provide adequate lubrication at contact pressures present in this study, resulting in high wear.

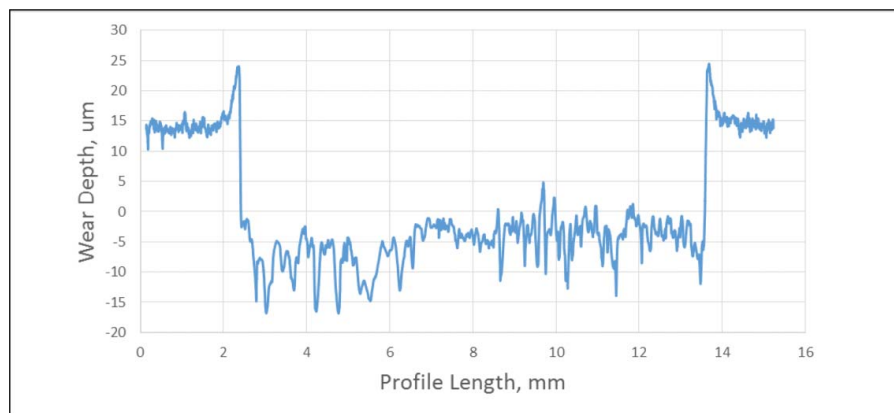
Figure 13. Profilometer profile of the PS400 wear scar from testing at 760°C and 444.8 N.

To evaluate the accuracy of this subjective approach the wear scar area from Fig. 13 was determined using numerical integration. For depth measurements the original surface was taken to reside at a height of 15  $\mu\text{m}$ . Using the area measurement from numerical integration, the wear factor was found to be  $1.32 \times 10^{-5} \text{ mm}^3/\text{N}\cdot\text{m}$ , which is a little more than the subjective result of  $1.10 \times 10^{-5} \text{ mm}^3/\text{N}\cdot\text{m}$ . This is a 20% increase in the mantissa but, more important, the exponents are identical. Therefore, the subjective measurement approach provides reasonable estimates for the resulting wear factors.
