**TECHNICAL REPORT**  
**TR-NAVFAC-EXWC-EV-1706**  
**DECEMBER 2016**

**Final Report : Innovative Acoustic Sensor Technologies for  
Leak Detection in Challenging Pipe Types**

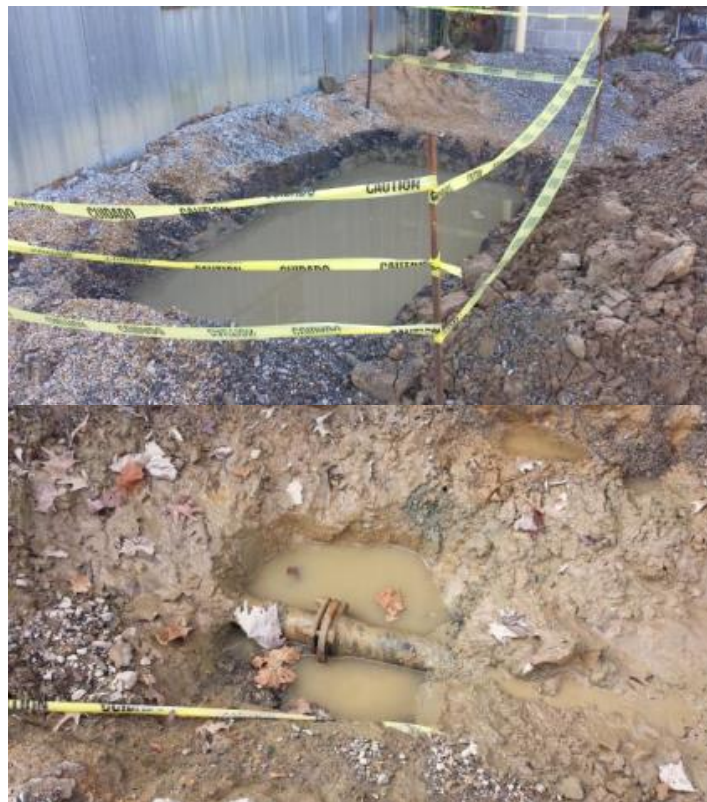
**Figure 6-13. Excavation of the Large Leak Identified at ERDC**
