**TECHNICAL REPORT**  
**TR-NAVFAC-EXWC-EV-1706**  
**DECEMBER 2016**

**Final Report : Innovative Acoustic Sensor Technologies for  
Leak Detection in Challenging Pipe Types**

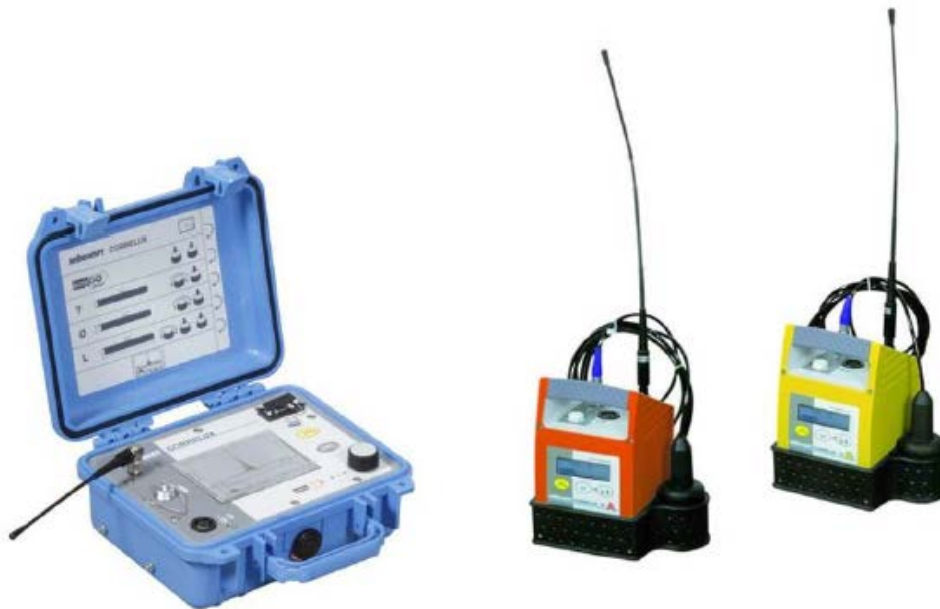
The Correlux HL6000X is a correlator system used for automatically pinpointing leaks in water pipes (see Figure 2-5). It consists of two radio transmitters that connect to piezo-ceramic accelerometers (transmitter A and B), the correlator (the user interface device), correlation software, and headphones. The correlator device can be connected to a personal computer for software updates, downloading data, and to printout results. The correlator device has enough memory to record data for up to 10 segments. It is powered by a battery with an operational life of 12 hours. Each radio transmitter is powered by an internal battery with an operational life of 15 hours. All devices can also be externally powered using a 12-volt direct current car adapter or 110-volt alternating current power supply.

**Figure 2-5. Correlux HL6000X System (Courtesy of Vivax-Metrotech)**

The correlator system works by placing the two accelerometers (sensors) at either end of a pipe section (on valves, exposed pipe sections, or hydrants as the local conditions dictates). Table 2-6 shows the recommended sensor spacing based upon pipe type. The sensor spacing must be accurately measured for input into the correlator if a leak is detected. No information was

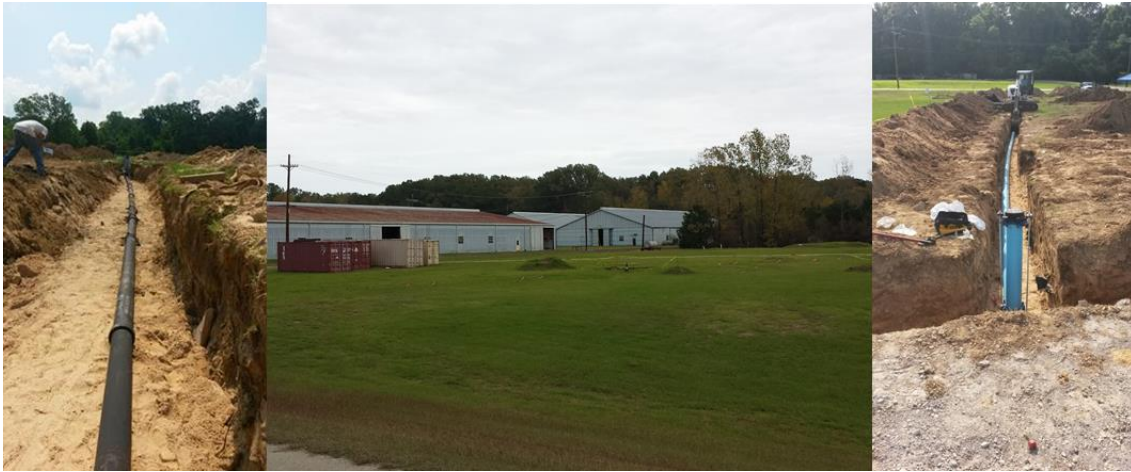
A 200-foot test bed was constructed for use in the project. The test bed consisted of 90 feet of 6-inch DI pipe and 110 feet of 6-inch PVC pipe. Risers were installed on the test sections to allow for the placement of the acoustic sensors including accelerometers and hydrophones. After test bed construction, 10 simulated leak locations were installed on the main line, along with one simulated leak on a nearby PVC lateral line. The 11 total simulated leaks were established using corporation valves and orifice plates with openings of various diameters (as discussed in Section

5.0). Several views of the test bed site are shown in Figure 4-4 from the installation process through final site restoration.

**Figure 4-4. Test Bed Installation and Configuration  
(From left: DI pipe, aboveground view, and PVC pipe)**

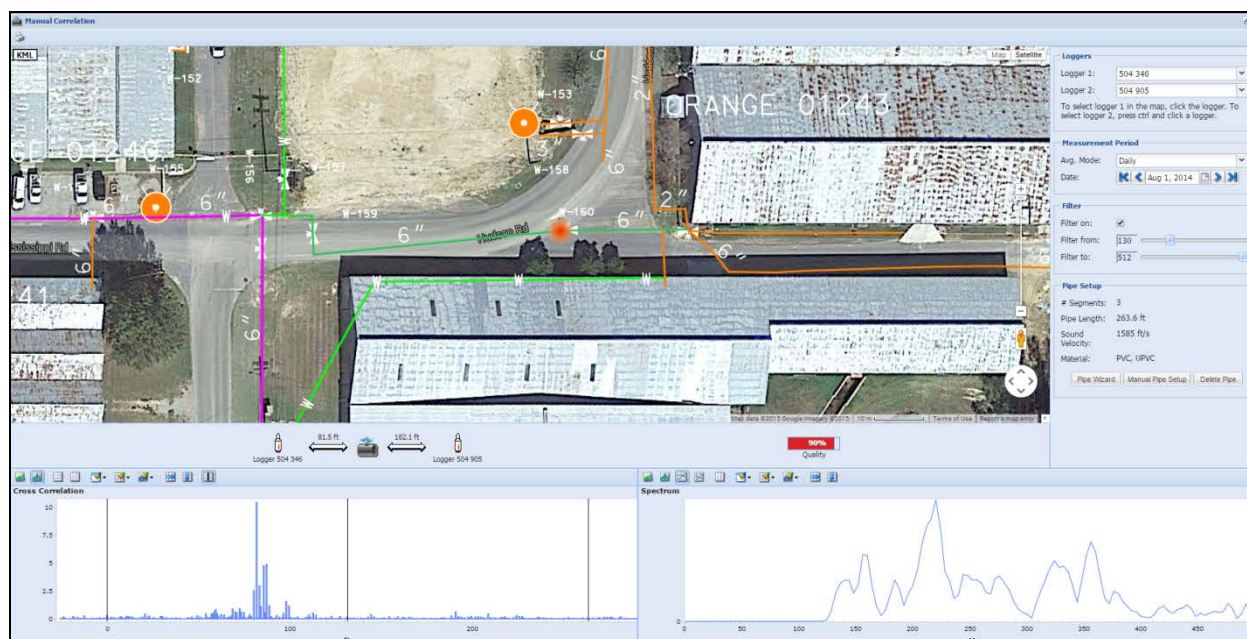
**Figure 6-4. Manual Correlation between Sensors 6 and 7 in Area B on August 1, 2014**
