## **Flow-Control Systems Proof of Concept for Snowmelt Runoff at McMurdo Station, Antarctica**

January 2017

Final Report

Under   Engineering for Polar Operations, Logistics, and Research (EPOLAR)  
EP-ANT-15-04, "Drainage Solutions Implementation"

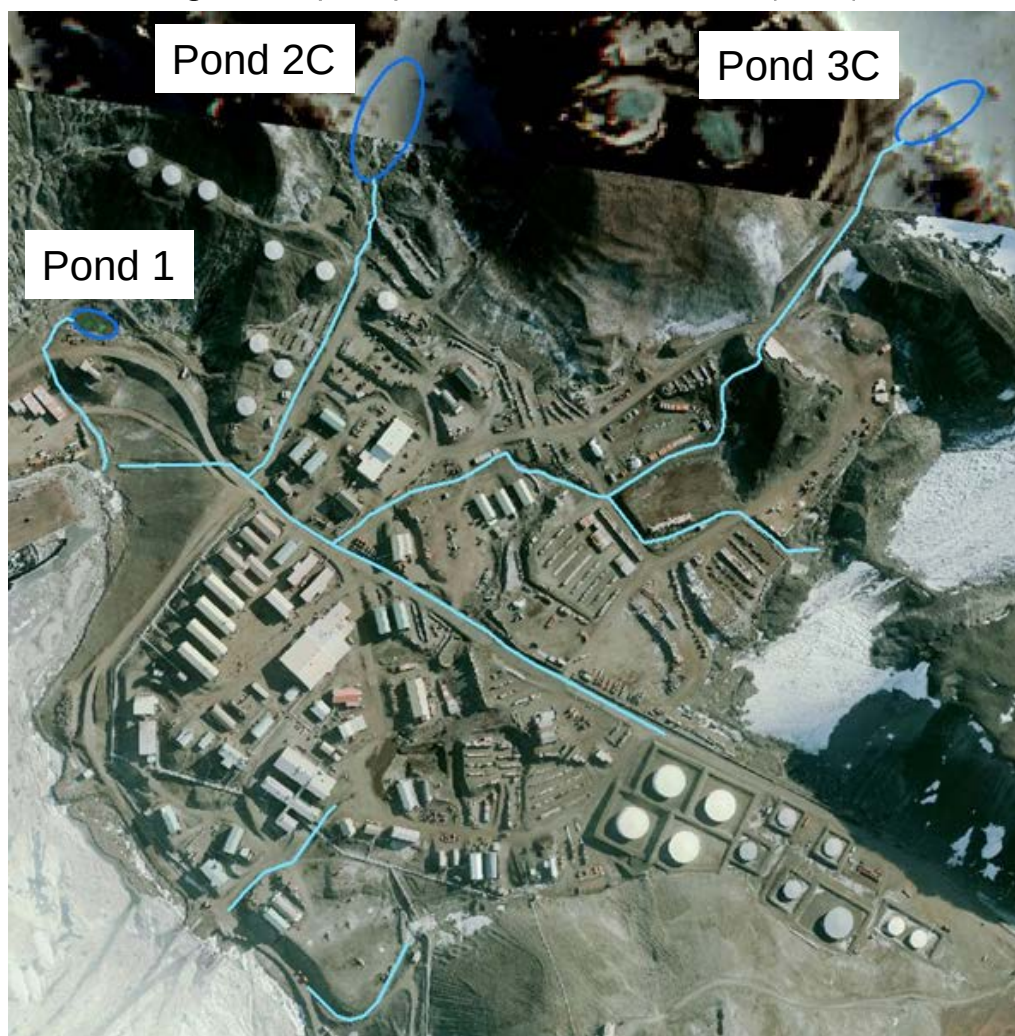
Figure 3. Proposed pond locations from Affleck et al. (2014c).

Ponds detain flow, attenuating the peak and allowing sediment to settle (Ferris 1983). The sediment ponds designed for McMurdo Station were located upstream of drainage paths to capture the snowmelt runoff from subbasins and to control the flow in the channels (Figure 3) (Affleck et al. 2014c). A typical pond would require a riser and outlet pipe; however, the use of a riser and a piped outlet in McMurdo conditions is infeasible due to maintenance requirements from ice accumulation. The design metrics for McMurdo were fully described in Affleck et al (2014c). The sediment ponds were designed to accommodate both water and ice accumulation with the notion that these ponds should be maintained on a regular basis to remove ice and sediment.

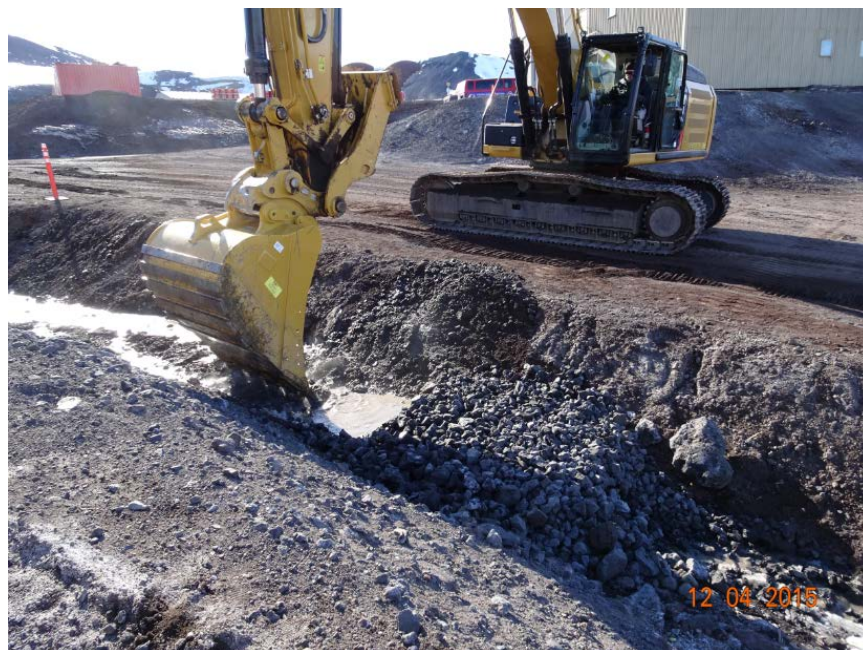
Figure 11. Rock weir using the 2 to 8 in. rocks. The excavator created a sump upstream of the weir.

It took between 3 and 4 hours to build all six rock weirs by using an excavator and a loader at the same time. The loader hauled the rocks and dumped the rocks in the selected location in the channels. The channels were previously shaped and cleared of snow and ice early in the season. The weirs used two rock size ranges: 2 to 8 in. rocks (Figure 11) and 8 to 12 in. rocks (Figure 12). Rock weirs using the 2 to 8 in. rocks were constructed along the channel near Building 175 and upstream along Gasoline Alley (Figure 11). The amount of rocks used depended on the width of the channel and the height of the weir. In upstream channels, rock weirs were built using 8 to 12 in. rocks (Figure 12). The height of the rock weirs (i.e., the height from the middle bottom of the channel to the top of the weir) depended on the channel cross section and ranged from 1.5 to 3 ft. A minimum height of 1.5 ft was used for shallow and wide channel. For narrow channels, a 3 ft rock weir height was used. The excavator was used to shape the weir, to compact the rocks, and to create a sump or depression upstream of the weirs.

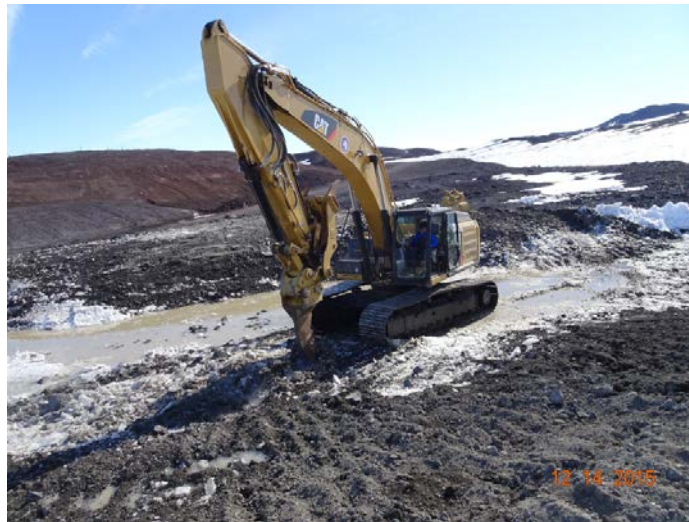
Figure 13. Digging the primary pond at Pond 3C.

An initial survey assessed the topography to determine the best location for Pond 3C. Based on the actual topography, the logical approach was to build adjoining ponds (primary and secondary ponds, Figures 13 and 14). These ponds were built as reservoirs or snowmelt settling ponds. The primary pond is located on a natural depression area. The excavator (with a bucket for digging materials and ripper and hammer, also called a hydraulic hammer or pecker, attachments for breaking the hard layer) was used for digging the pond. Building this pond included digging out a portion of the natural depression (Figure 13). Digging commenced on 12 December 2015 and continued for several days, encountering alternating layers of fractured basaltic boulders and gravelly sand deposits over massive ice layers. The fractured basaltic boulders and gravelly sand materials extracted in the pond area were placed and compacted to build up the top berm. Some boulders and rocks were set aside for building a French drain type of dike in the outlet. Downstream, the outlet is the secondary pond (Figure 14). The secondary settling pond was built to buffer the excess snowmelt from the upper pond. Constructing both the primary and secondary ponds for Pond 3C took 46 equipment hours, including final adjustments (Figure 15).

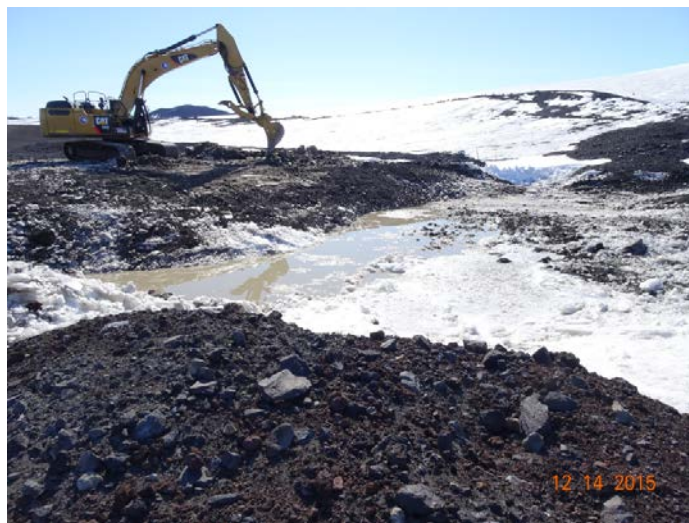
Figure 14. Digging the secondary pond.

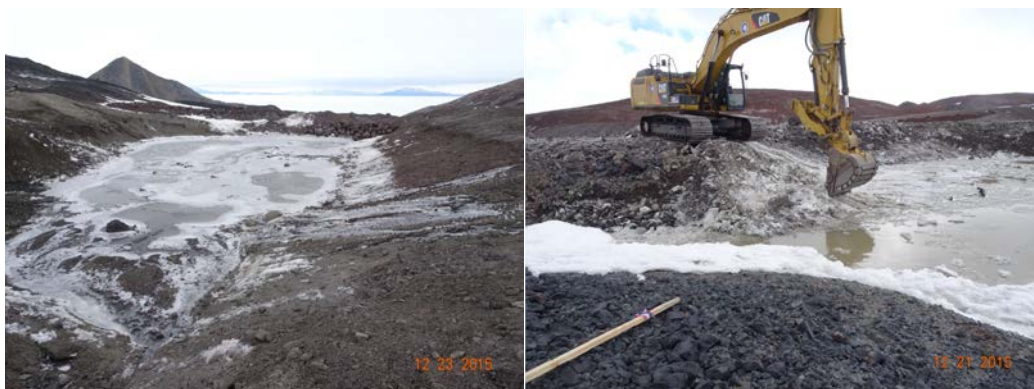
Figure 15. Fine-tuning the ponds. The *left* photo is secondary pond, and the *right* photo is the primary pond.

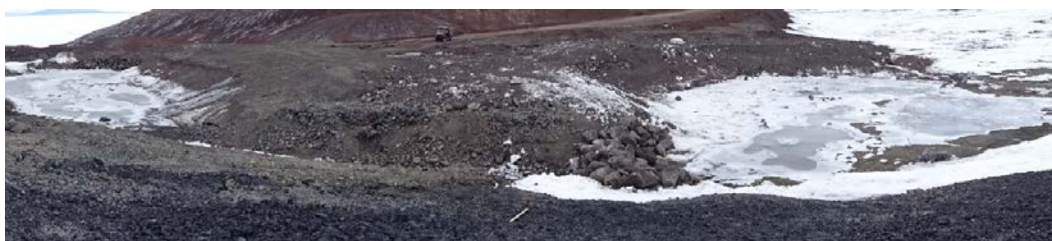
Figure 16. Perspective view of Pond 3C showing the final layout of the primary pond (*right*) and the secondary pond (*left*).

Figures 16 and 17 show the final layout of the ponds. A final survey after fine-tuning the ponds collected information about the final layout to determine the elevations, areas, and volumes. Table 3 summarizes the final sizes of the ponds, which were relatively shallow. The primary pond had a total volume of approximately 21,000 cu ft. The secondary pond covered half the size of the primary pond with a total volume of 11,000 cu ft. The total capacity was approximately 32,000 cu ft, which was significantly smaller than the minimum design for Pond 3C by a factor 15. The rationale for the limitations included that (1) the area had insufficient space to build the designed size; (2) the equipment had other projects to support and so had limited availability for this project; (3) and it was treacherous to dig deeper in ice and hard rock on unstable ground, creating safety concerns for the equipment (sliding and traction) and operator. The ponds built for Pond 3C will serve as experimental settling basins to determine whether the ponds will retain the snowmelt and whether the berm and spillway will hold up and attenuate the flow.

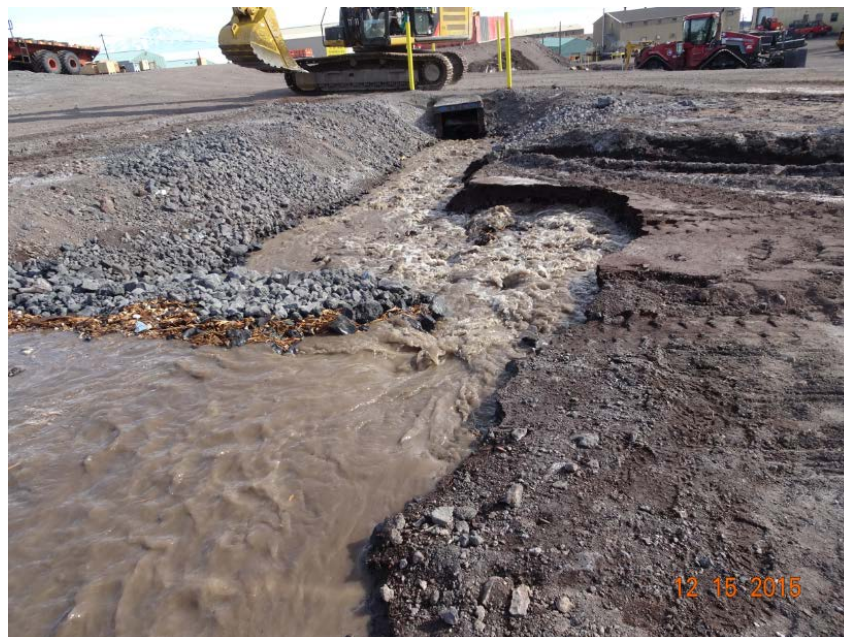
Figure 22. Example of a collapsed bank adjacent to the weir when excessive amounts of runoff occurred.

During peak and heavy runoff periods, failure in the form of erosion occurred along the bank edges next to the weirs, the massive water force eroding the material on the unprotected banks. Another reason for this failure was that the ice in the banks melted, creating space for water to flow. Bank instability was a common occurrence when excessive amounts of runoff passed through the weirs; especially banks with no stone lining or riprap were unprotected and vulnerable to failure (Figure 22).

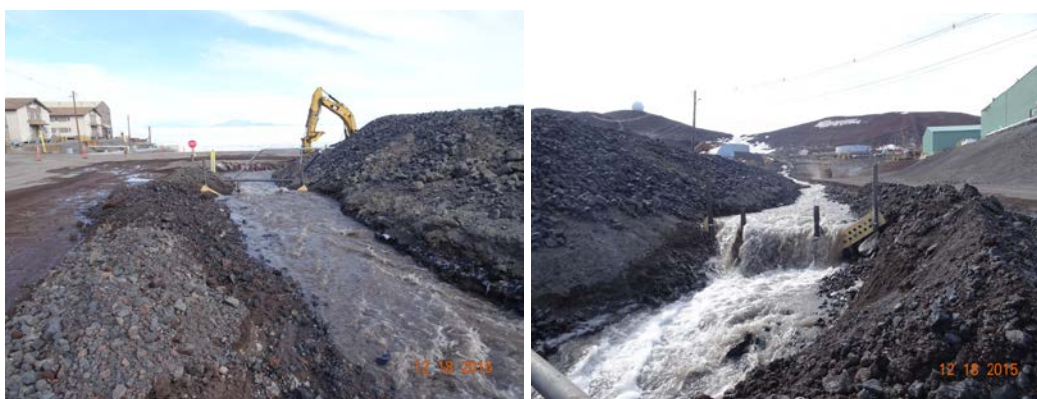
Figure 24. Extreme runoff around 3 p.m. in the drainage channel along Gasoline Alley. The *left* image shows upstream, and the *right* image shows downstream of the weir.
