## **Concrete Growth and Fatigue Analysis of Chickamauga Lock Miter Gate Anchorages**

Final report

Under Project 111274, "Structural Analysis of Chickamauga Lock Gate Anchor Rods"

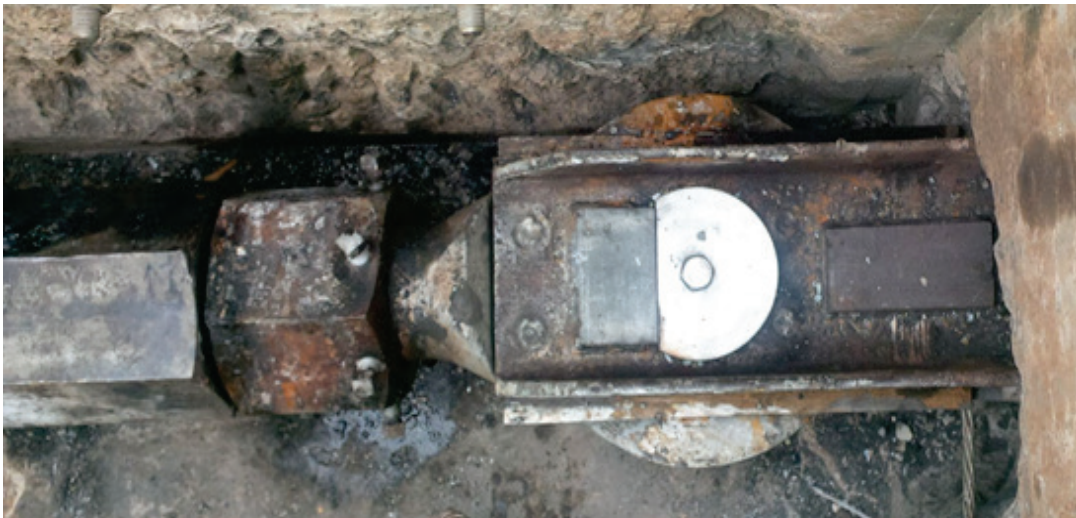
Figure 8. Repaired riverside miter anchorage channel.

The repair strategy started with the removal of all anchor pins and gudgeon linkages for the miter and recess anchors. Next, the doubler plate on the upper embedded miter anchor channel was removed to repair the crack, cutting a 1.25 in. wide slot in the damaged channel web around the crack with a torch. A replacement doubler plate was then installed by welding the new doubler plate to the anchor channel in the old rivet locations and sides of the plate to the side of the channel (Figure 8). Next, the slot where the crack was removed was welded and nondestructively tested to ensure a good weldment was present. New pins were fabricated and placed in new line-bored holes on both miter and recess gudgeon linkages. Several adjustments of the miter linkage were made to have a final resting quoin clearance of 0.027 in. at the top. During the adjustment phase after the repair, the gate remained at the same elevation with each gate cycle.
