A Review of Engine Seal Performance and Requirements for Current and Future Army Engine Platforms

Prepared for the
43rd Joint Propulsion Conference
cosponsored by the AIAA, ASME, SAE, and ASEE
Cincinnati, Ohio, July 8–11, 2007

Abstract

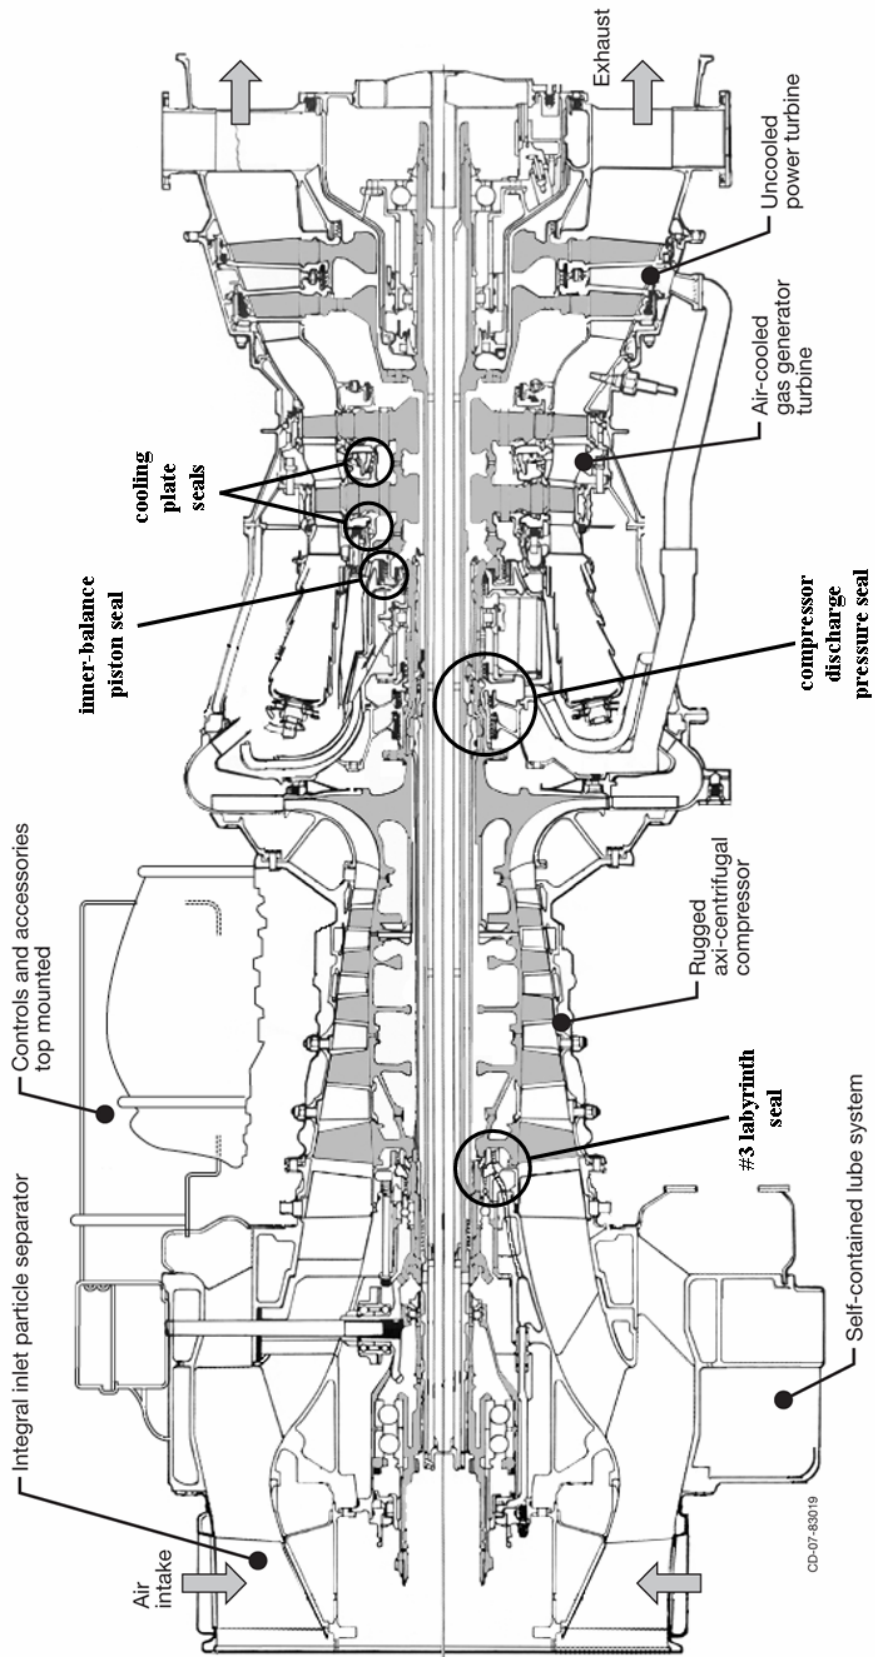
Figure 2.—T-700 Engine schematic showing locations of various labyrinth seals.

Data from 4 labyrinth seals taken from the T-700 overhaul facility at CCAD are discussed. They are the #3 labyrinth seal, the CDP seal, the IBP seal, and the labyrinth seals on the gas generator cooling plates, (fig. 2).

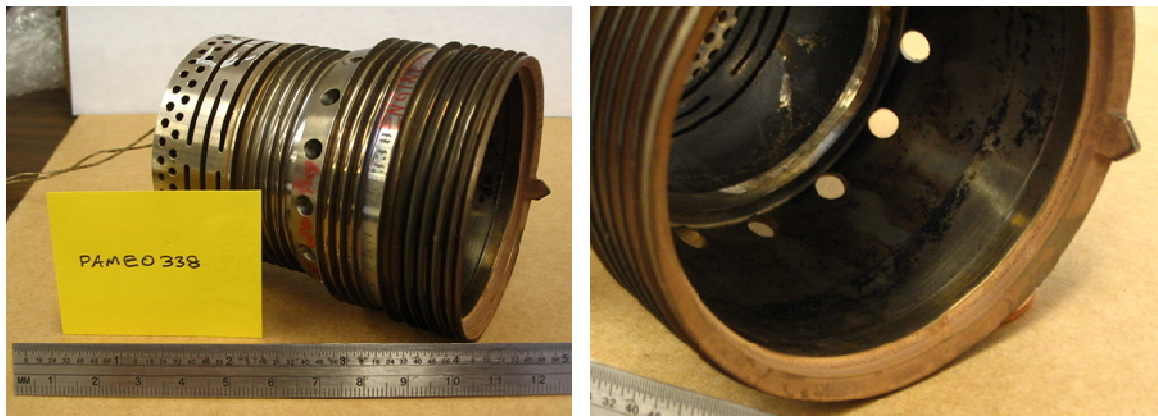
Figure 4.—Compressor discharge pressure seal with impacted sand.

The CDP seal (figs. 4 and 5) is composed of 3 sets of labyrinth teeth. CDP seal air leakage from the forward 7-knife labyrinth comes from impeller tip leakage and is ported to the turbine 4th stage shrouds. Fourth stage compressor bleed air feeds the cavity between the middle and rear CDP seal labyrinth teeth. This provides a positive air pressure to seal the forward end of the middle or B-sump. Air leakage from the middle labyrinth teeth is fed to the turbine 4th stage shrouds.

Three CDP seals were received from CCAD with operational hours ranging from 1600 to nearly 5000 hr. Evidence of impacted sand on the inner surface of the part is shown in figure 4 and in a modified CDP seal shown in figure 5. Sand was also observed in between the labyrinth teeth on the largest diameter of the CDP and modified CDP. It is most likely the sand was present in the air leakage from the centrifugal compressor tip since the labyrinth teeth adjacent to the inlet ports fed by the fourth stage compressor bleed air showed no signs of sand impaction. Micrographs shown in figures 8 and 9 give a rough indication of the size of sand particles taken from the CDP seals in figure 5. The CDP seal labyrinth teeth closest to the impacted sand exhibited some discoloration possibly due to heat exposure, but are otherwise smooth. Some of the remaining teeth on the CDP have nicks possibly due to handling. The modified CDP labyrinth teeth closest to the location of impacted sand are black and rough to the touch. Two of the teeth are slightly rolled-over at the tip.
