**Development of Key Technologies for Transitioning of Direct Digital  
Manufacturing for Repair and Remanufacturing of  
High Value DoD Components**

**R. P. Martukanitz and F. Lia**

**Applied Research Laboratory  
Pennsylvania State University  
P.O. Box 30, State College, PA, 16804**

**Army Aviation and Missile Research Development and Engineering Center**

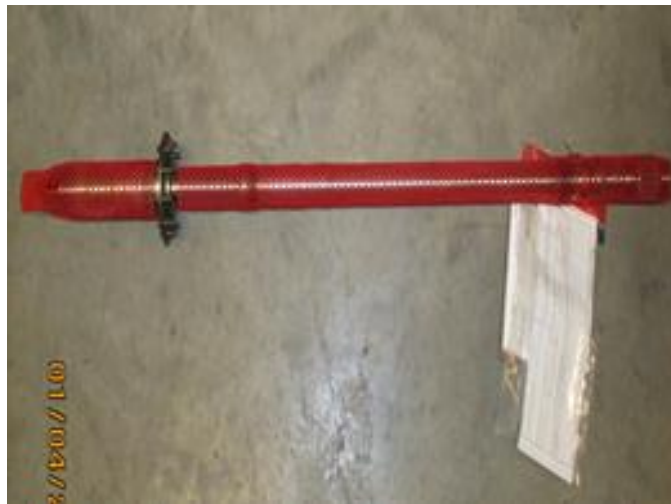
The Power Turbine (PT) Shaft (PN: 5125T92G01/RE, NSN: 2840-01-473-3556 & PN: 6043T35G01), shown in Figure 31, is founded in the T700 Engine Series used on H60 (Blackhawk, Pavahawk & Seahawk), AH-1W(Z – Cobra) and UH-1Y (Huey) Helicopter Systems serviced at Corpus Christi Army Depot (CCAD). This part is scheduled to be removed from the RECAP Kitting Parts Replacement Package and go to a 100% overhaul. Current repair turnaround time is 110 days. Current chromium electroplating repair is 50% of total overhaul cost (~\$8,000/ea.) for the part. The proposed application of DDM is to replace chromium electroplating for repair on various bearing journals and lands of the PT shaft, which has been determined viable by the Army. However, testing and authorization of DDM repair on this Critical Safety Item (CSI) is needed. Material and part repair testing at bearing contact/working surfaces would be required to approve this Non-Critical Safety Item (CSI). DDM represents an alternative repair to chrome at the seal journal to increasing repair damage tolerance limits beyond current repair process limits. Material and part repair testing at bearing contact/working surface are required for approval. The SAFR team estimates savings can be obtained if the part can be repaired or remanufactured by DDM. The Fedlog Part Cost is \$14,432.00, and repair cost savings of approximately \$2,000/ea is anticipated (i.e. 25% of Total PT shaft overhaul cost). An estimate of \$1 Million in Cost Savings is expected based on DDM repair of 50% of the SAFR inventory (1,000 ea.). The estimate cost savings for the CCAD US Army engine and power turbine module programs is at least \$300k/per program year, and would reduce CCAD overhaul by at least 10% (~10+ days). Implementation would reduce overhaul cost for this CSI, and would also result in an Environmental Waste Stream Reduction and associated handling and processing costs by eliminating chromium electroplating for repair.

Figure 31 – T700 Power Turbine Shaft for the H60, AH-1W, and UH-1Y.

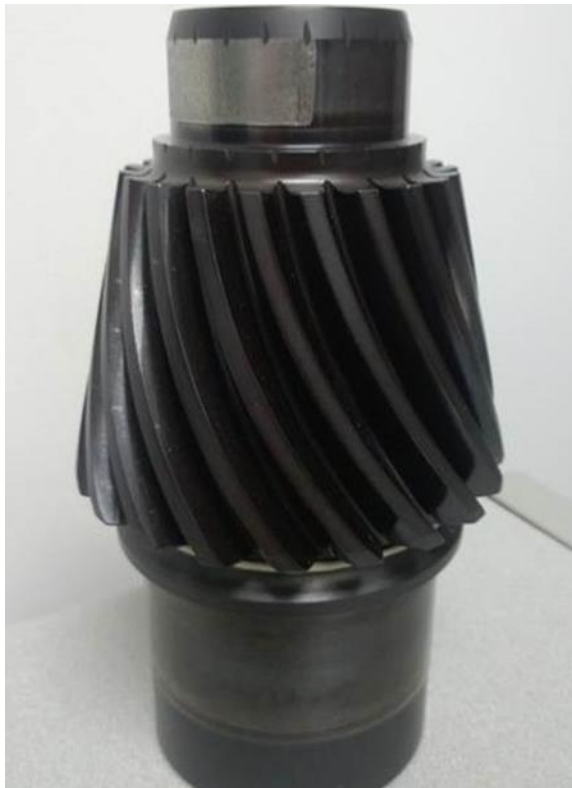
The Input Pinion (PN: 7-211310021, NSN: 1615-01-163-4573), shown in Figure 32, is a gear in the main transmission for AH64 Apache System. CCAD has identified this part as a Critical Parts Demand Item. The proposed repair would be to apply DDM to repair corrosion and micro-wear pitting at bearing journal and lands. Material and part repair testing at bearing contact/ working surface would be required to approve this Non-Critical Safety Item (CSI). DDM represents an alternative repair to chromium electroplating at the seal journal to increase repair damage tolerance limits beyond current repair process limits. Material and part repair testing at bearing contact/working surface would be required or remanufactured by DDM. The Fedlog parts cost is \$3,566/ea., and potential savings of \$1,212/ea., or \$64,273 for the 53 ea. In SAFR has been estimated. Implementation would also provide critical parts support relief and reduced scrap by developing, qualifying, and authorizing a repair using DDM for an area of the gear that no other repair process can achieve.

Figure 32 – Input pinion for AH64 identified by CCAD as a Critical Parts Demand item DDM repair.

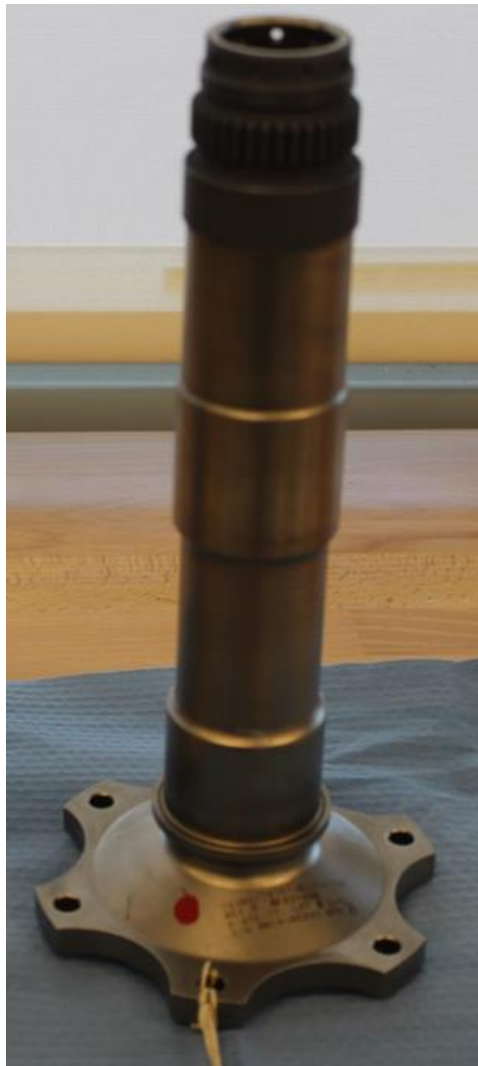
the seal journal to increase repair damage tolerance limits beyond current repair process limits. The SAFR team estimates savings can be obtained if the part can be repaired or remanufactured by DDM. The Fedlog parts cost is \$6,383.99/ea. Based on the acceptable “Rule of Thumb” repair cost threshold of 66% cost of part (\$4,213/ea.) the potential cost savings of \$2,169/ea, or \$26,330 for the 12ea. In SAFR is estimated.

Figure 33 – Cooling fan shaft for AH64 identified by CCAD as a Critical Parts Demand item DDM repair candidate.

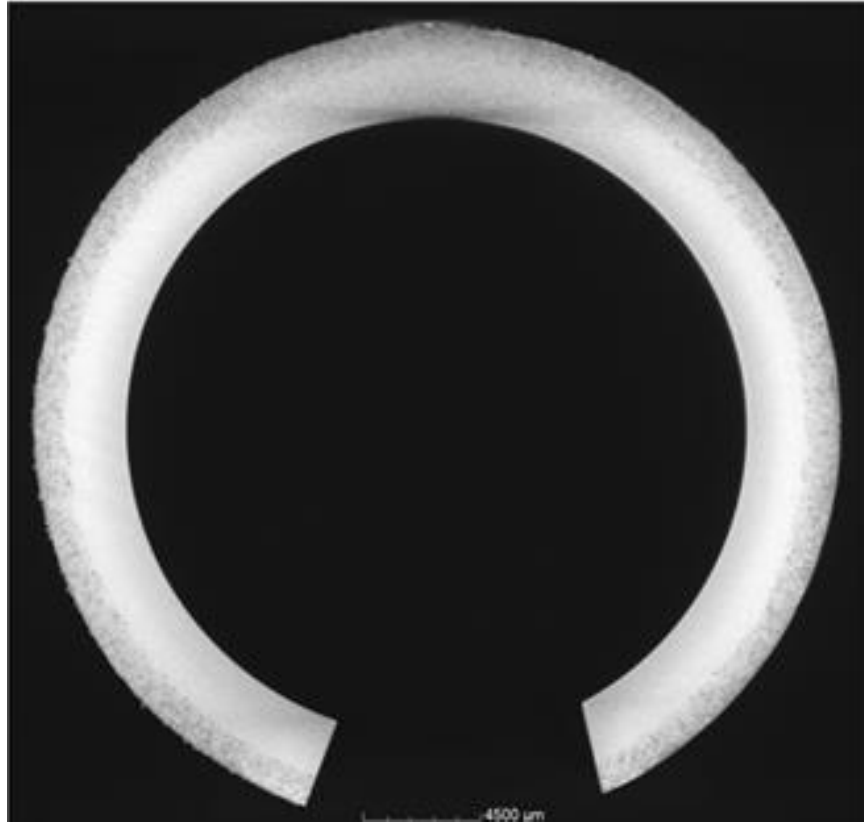
Figure 41 – Radiographic-based tomography of cooler fan shaft.

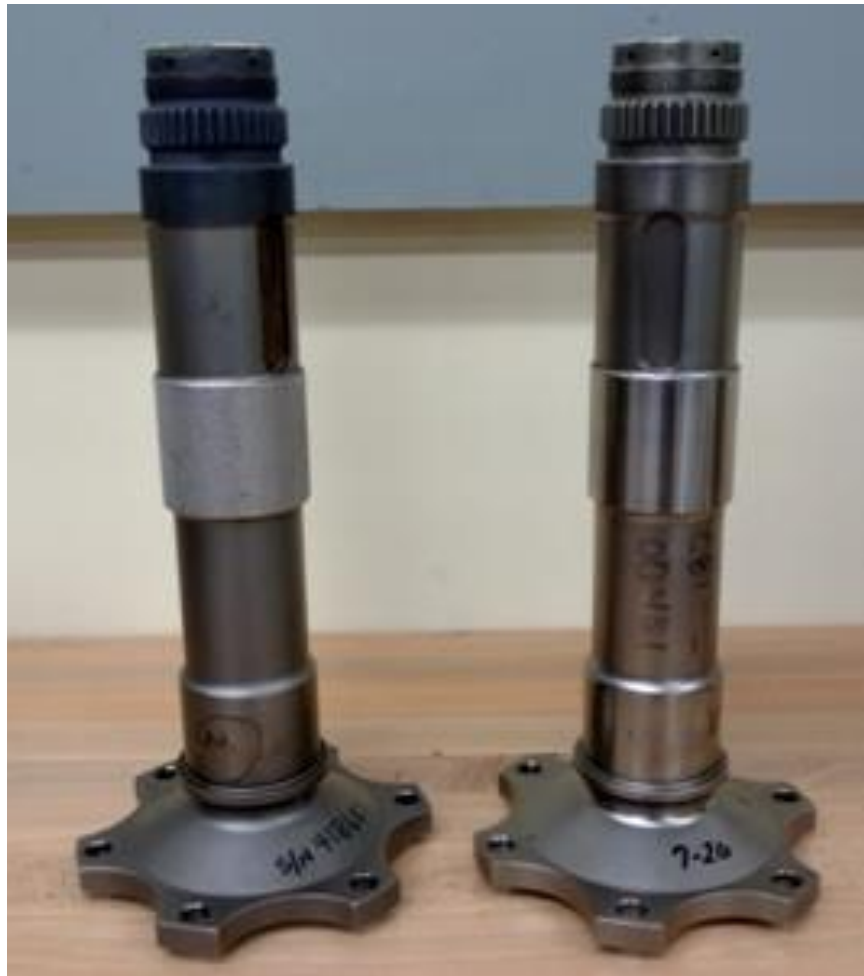
Figure 44 - Post-process machining and dimensional inspection cooler fan shaft.

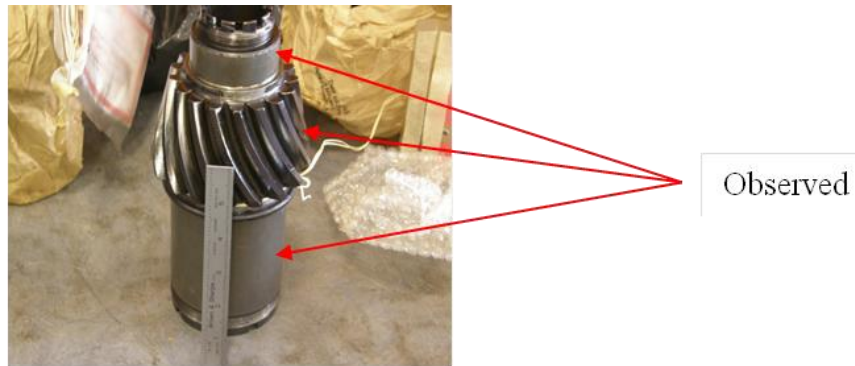
The technical data for the H60 Pinion Gear is found in DMWR-1-1615-371. There were multiple areas of faults found on the piece including gear teeth, pitting/scuffing, seal journal wear, and OD & shoulder wear, these faults are shown in Figure 46. The piece is composed of AMS 625 and each part costs \$4,447.13. Three components were evaluated initially for laser deposition repair. Table 17 shows the bearing surface diameter for each part upon initial evaluation. Each part had diameters less than 2.299 inches, which was the minimum specification requirement from the DMWR. Table 18 shows the process parameters that were decided upon for laser deposition for the H60 Pinion Gear repair. Powder flow rates in g/min differed among the different material choices but were the same at 1 cm<sup>3</sup>/min.

Figure 46 – H60 pinion gear faults.

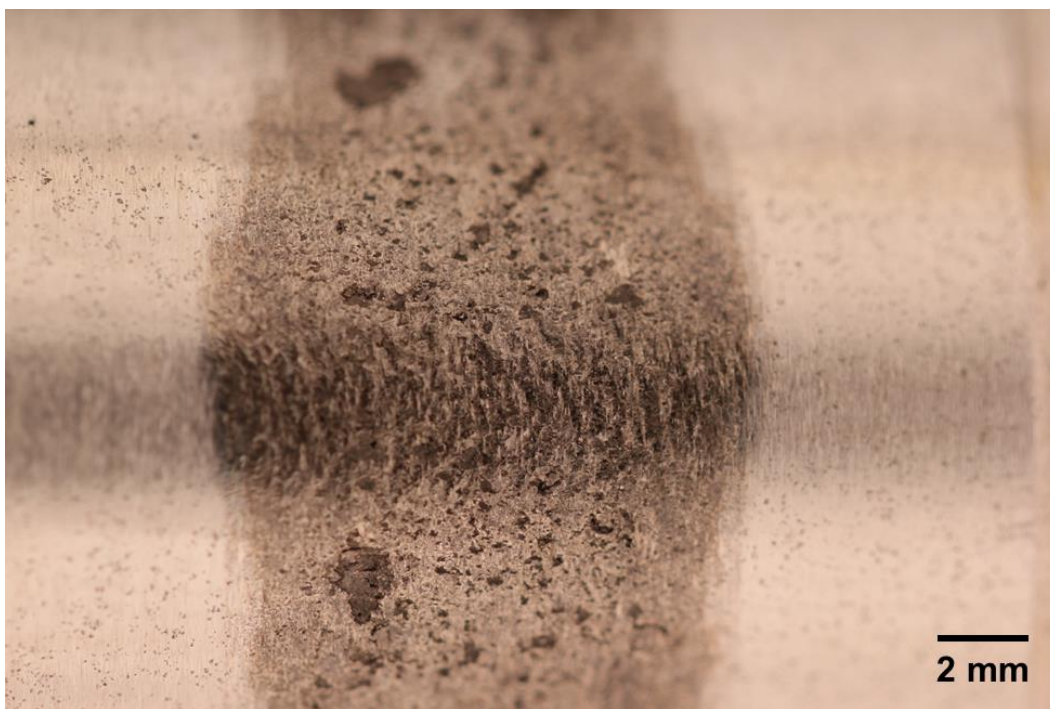
Figure 60 – RCF test results showing scuffing surface on the SS 431/20 TiC.

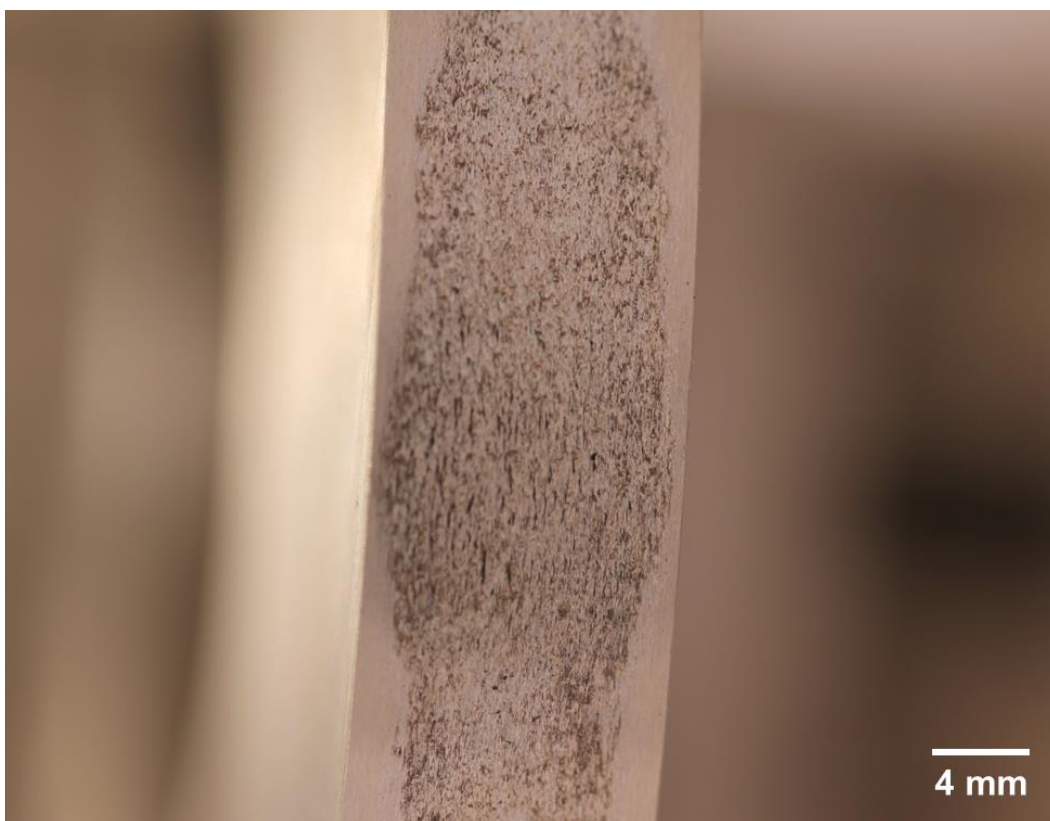
Figure 61 – RCF test results showing scuffing surface on the carburized 8620 steel roller.

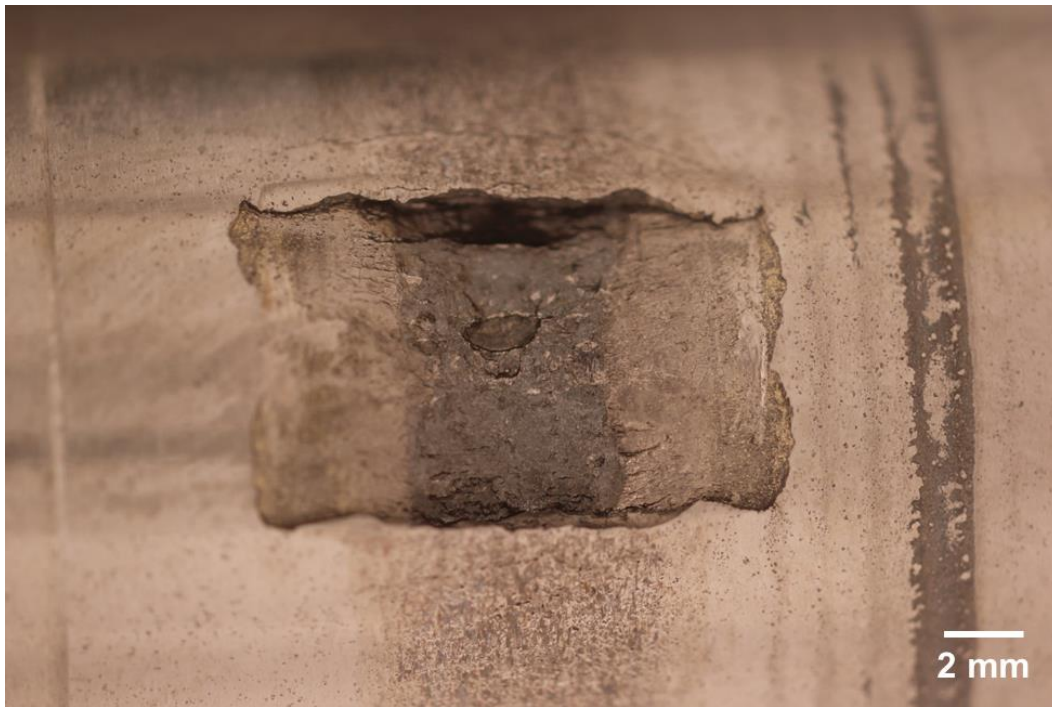
Figure 62 – RCF test results showing surface pitting on the SS 431/20 TiC specimen.

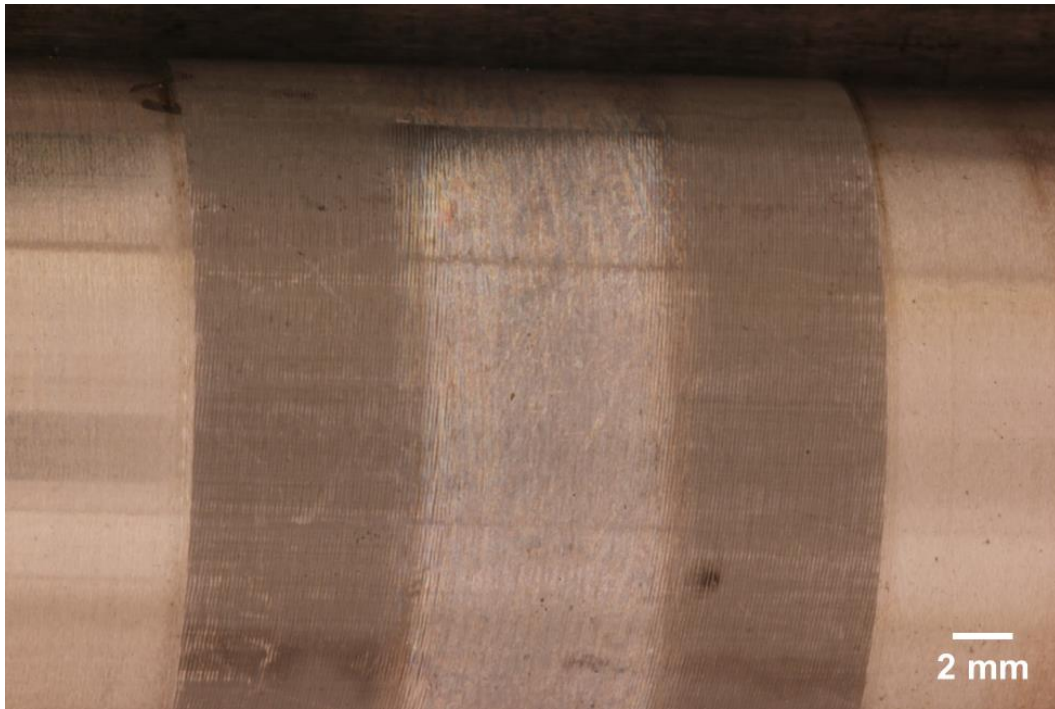
Figure 64 – RCF results of the carburized 8620 steel specimen without scuffing surface.
