AFRL-RX-WP-TR-2018-0062

**MICROSTRUCTURAL AND MECHANICAL
CHARACTERIZATION OF 2-D AND 3-D SiC/SiNC
CERAMIC-MATRIX COMPOSITES**

**23 FEBRUARY 2018
Final Report**

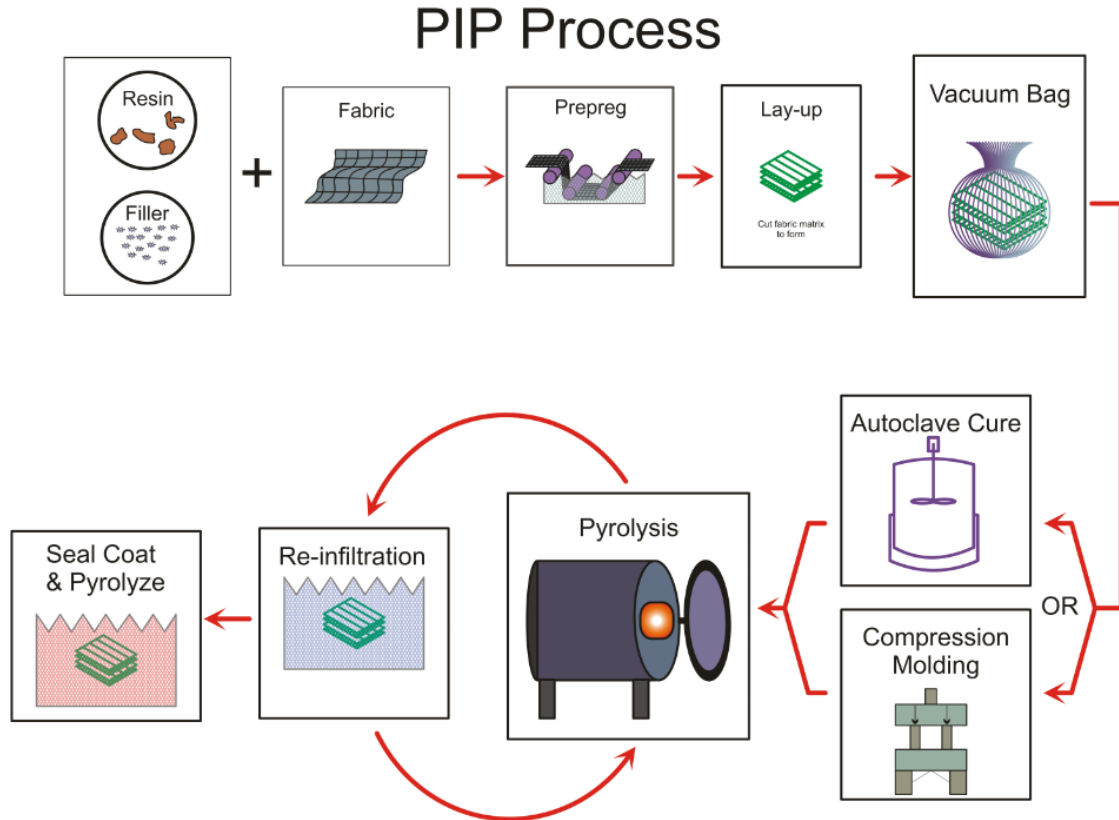
Figure 1. Simple Schematic of PIP Manufacturing Process Used to Manufacture CMC Panels Used in This Study

The manufacturing process for the CMC materials was as follows. Fibers were first woven into cloth or 3-D weaves to form a fiber preform. The preforms were then given a fiber coating of boron nitride (BN) and silicon nitride (Si_3N_4). The BN provides a weak layer to promote debonding while the Si_3N_4 protects the BN during subsequent processing. The coated fiber preforms were then infiltrated with a liquid ceramic precursor that contains a filler of Si_3N_4 powder. The infiltrated fiber preforms were cured with the standard processing methods of vacuum bagging, autoclave pressure, and heat cycling, which are used to make organic-matrix composites. These cured composites provided preforms for converting to a ceramic by heating the composite in a non-reactive atmosphere to pyrolyze the organic polymer. The result of the pyrolysis was a matrix containing silicon, oxygen, nitrogen and carbon. After this first pyrolysis cycle, the preform was infiltrated with only the matrix resin and then went through the PIP cycle. A total of approximately nine PIP cycles were used to reduce the porosity to under approximately 5%. COIC reported that the S200 composite has a reported bulk density of about 2.2 gm/cm^3 with an open porosity of about 5%, as measured by water immersion. A schematic of the PIP process is shown in Figure 1.

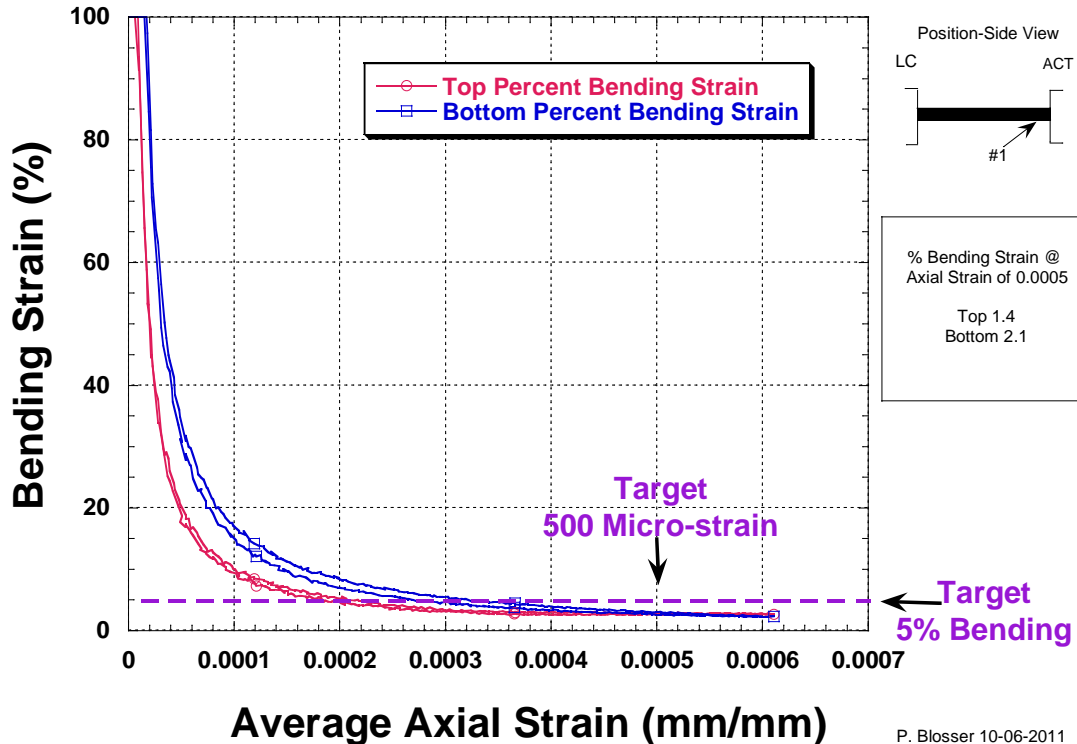
Figure 13. Plot of Bending Strain Versus Average Axial Strain for Alignment Check of SH#12

3.4.3 Verification of Alignment for Servo-Hydraulic Test Frame. The grip/load train alignment was verified using a highly ground, hard steel, straight-sided specimen instrumented with eight strain gages, as shown in Figure 12. The goal for alignment was to be within ASTM E1012-99 [9] specifications of less than 5% bending at 500 $\mu\epsilon$ displacement in all four specimen orientations. A plot of percent bending versus axial load is shown in Figure 13. Often, the percent bending at this ASTM specification was about only 2%.

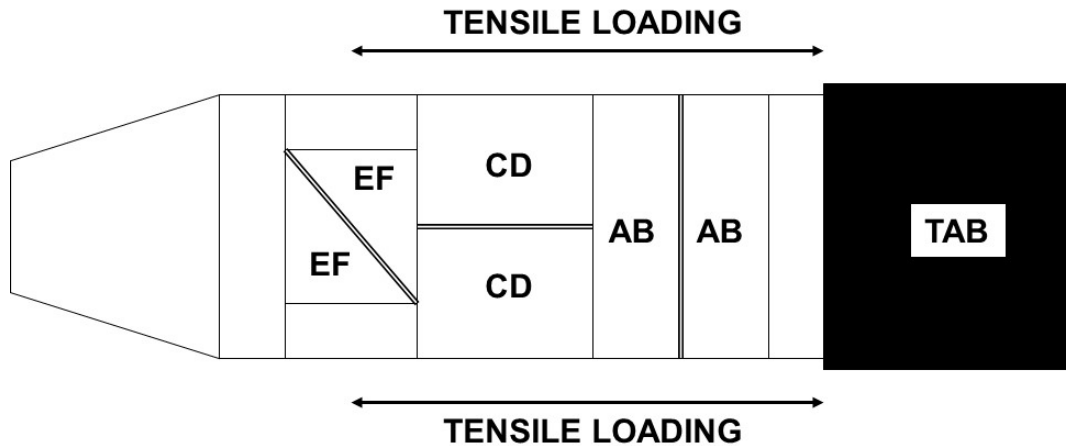
Figure 18. Schematic Showing Actual Test Specimens Sectioned for Microstructural Studies. Double Lines Indicate Surfaces Polished and Studied.

3.5.1 Cutting of Specimens For Microscopy. There was no extra material supplied with the test specimens. Therefore, tested specimens were sectioned for ceramography. For each material system, a tested tensile specimen was selected and sectioned on a diamond saw normal and parallel to the warp direction, and 45° to the warp direction. A schematic of a dogbone test specimen and the location of the sectioning cuts is shown in Figure 18. Specimens were cut on a slow-speed diamond saw using saw blades embedded with a low concentration of diamond. A saw speed of approximately 30 RPM with kerosene as a cooling and lubricating fluid was used. Very little weight was used on the saw arm to reduce damage to the matrix material and reduce the size of the burr that typically remains as the saw completes the sectioning. If a small burr remained, it was removed by lightly holding the burr against the side of the saw blade. Great care was taken to make sure no burrs remained on the cut surface, as they will cause a large amount of mounting material to flow between the specimen surface and the mounting press during the mounting process. If this happens, the specimen will polish unevenly, requiring a great deal more time or going to much coarser-grit polishing media.

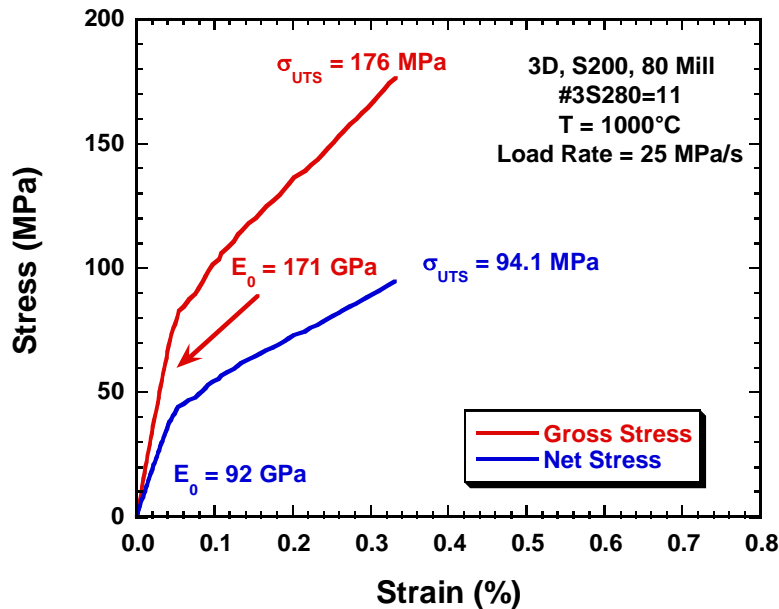
Figure 21. Change in Stress-Versus-Strain Behavior When Comparing Net Thickness to Gross Thickness

Figure 21 illustrates the difference in the UTS due to the difference in the specimen thickness. For specimen 3s280-11 (3-D, S200-1, 80 mil), the UTS increased from 94.1 MPa to 176 MPa, which is very close to a 100% increase. This method of determining thickness and calculating net stress more accurately measures the strength of the fill fibers and allows for a more accurate comparison between the five fill-fiber perform and the 10 fill-fiber preform.

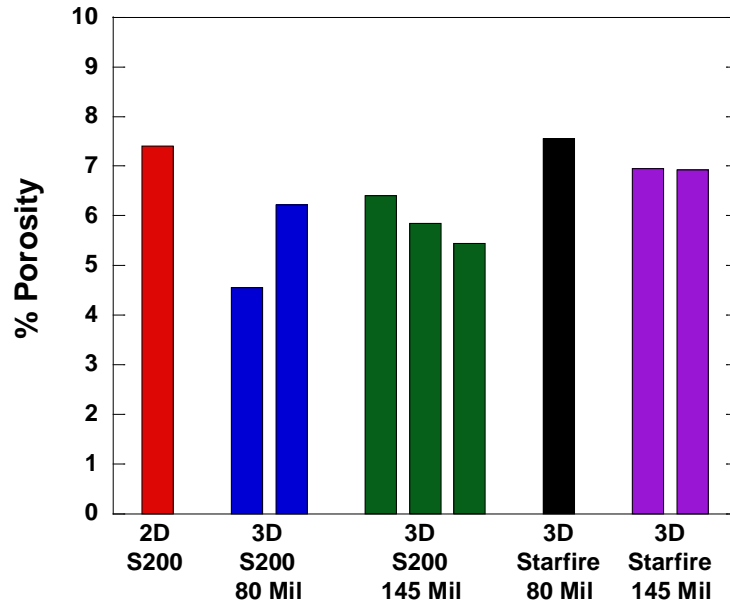
Figure 31. Bar Chart Showing Percent Porosity for 2-D S200 and 3-D SiC/SiNC Manufactured with S200 Resin and Starfire Resin

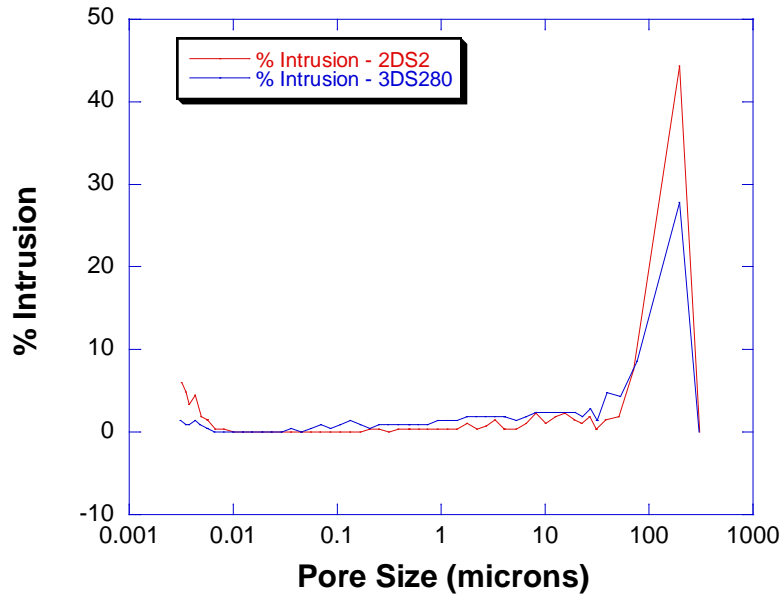
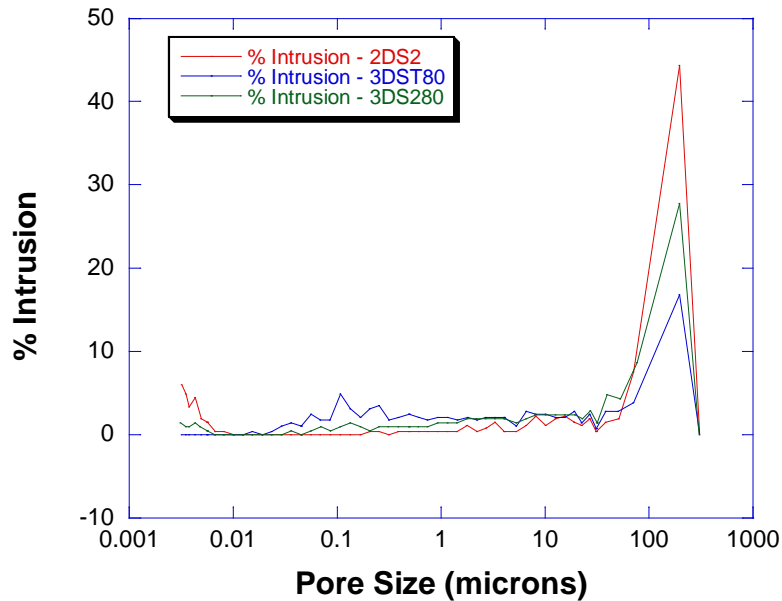
Figure 32. Porosity Pore Size Measurements for 2-D S200 6 Ply and 3-D S200 80 Mil Using Mercury Porosimeter

Figure 33. Porosity Pore Size Measurements for 2-D S200 6 Ply, 3-D S200 80 Mil, and 3-D Starfire 80-Mil Using Mercury Porosimeter

Figure 34. Porosity Pore Size Measurements for 2-D S200 6 Ply and 3-D Starfire 80 Mil Using Mercury Porosimeter

Figure 35. Porosity Pore Size Measurements for 3-D Starfire 80 Mil and 3-D Starfire 145 Mil Using Mercury Porosimeter

Figure 36. Porosity Pore Size Measurements for 3-D S200 145 Mil and 3-D Starfire 145 Mil Using Mercury Porosimeter

Figure 37. Porosity Pore Size Measurements for 3-D S200 80 Mil and 3-D Starfire 80 Mil Using Mercury Porosimeter

From the mercury porosimeter data, one can construct plots of percent intrusion versus pore size. These plots comparing the different SiC/SiNC CMCs are shown as Figures 32 through 38. It appears that, for pores around 100-200 microns in size, the 2-D material had over 40% intrusion while all 3-D materials had significantly less. The four 3-D systems were all very similar. It was observed that the 2-D S200 material had the largest medium-pore diameter, which is in good agreement with the porosimeter data.

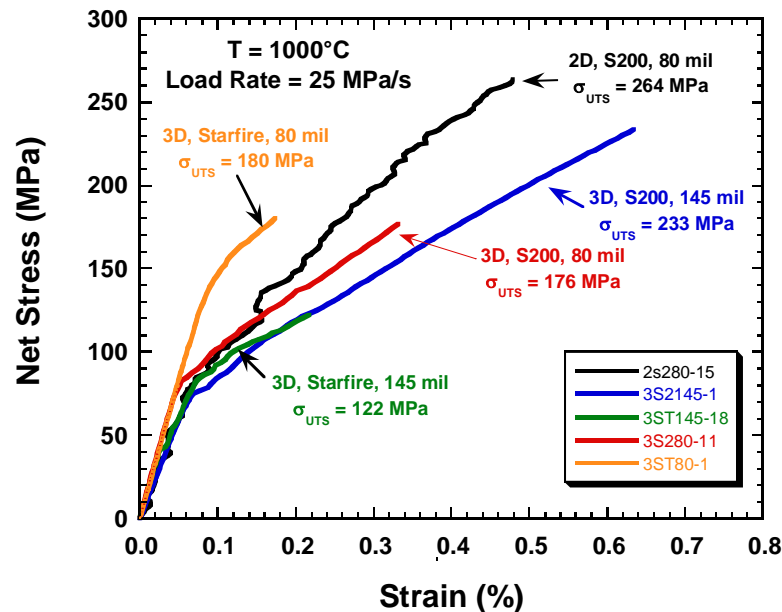
Figure 39. Tensile Stress-Versus-Strain Behavior for 2-D S200 and 3-D SiC/SiNC Manufactured with S200 Resin and Starfire Resin

To illustrate this difference in the 2-D and 3-D materials, a combination tensile plot was created using a representative stress-versus-strain trace for each material system investigated. Figure 39 clearly shows that the 3-D S200 systems' strength is only slightly lower than the 2-D material, but the other 3-D systems are substantially lower. As mentioned above, the 3-D Starfire systems did exhibit slightly lower strain-to-failure values, as can be observed in the figure.

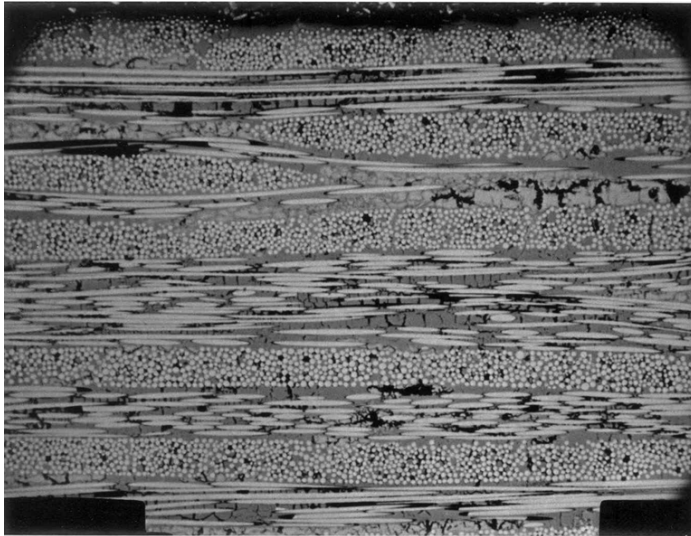
Figure A-1.1.3: Micrograph of 2-D S200, 80 mil @ 50x, AB. This figure illustrates the excellent infiltration of fiber tows in the 2-D material.
