**AFRL-RX-WP-TR-2018-0080**

## **EVALUATION OF A MELT INFILTRATED SIC/SIC CERAMIC MATRIX COMPOSITE**

**20 DECEMBER 2017  
Final Report**

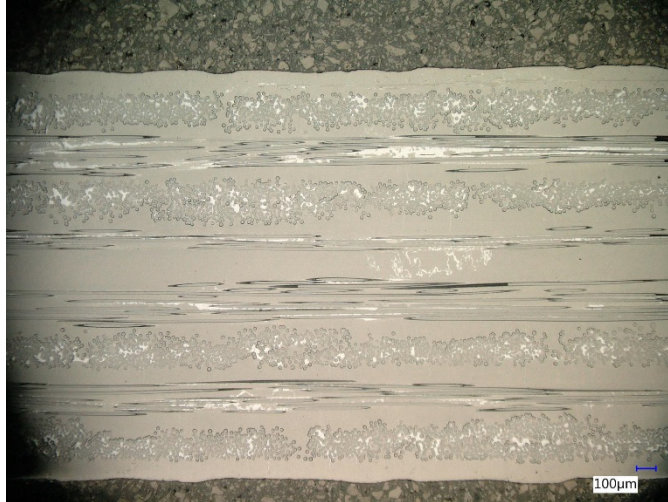
**Figure 2. Optical micrograph of HiPerComp™ Gen 1.1 Hi-Nicalon/SiC (0/90)2s showing a 0/90 cross-section at 100×**

An optical micrograph of the cross-section for the 0/90 orientation is shown in Figure 2 at a low magnification of 100×. The fibers appear circular for the 0° fiber plies and as cylinders for the 90° fibers. All eight plies can be easily identified in the image. Matrix-rich regions can be seen between all of the plies, and there are significant matrix-rich regions on both surfaces of the CMC. Figure 3 is an expanded view of Figure 2 and highlights the center section of the composite. From the image, the two 90° plies located at the center of the composite are clearly visible and the matrix region between the two center plies is very evident, even though these two plies are both 90°. Figure 4 is a 500× magnification image of the microstructure and focuses on one of the 0° plies, while Figure 5 is a much higher magnification (1000×) of a 0° tow. In Figure 5 one can see the fiber coating on the fibers, with the fibers near the outside of the tow having a thicker coating than those near the interior of the tow. The bright phase inside the fiber tows is residual silicon from the melt-infiltration process. The unreacted silicon fills up any voids or porosity. In this figure, one can also identify matrix cracks in the matrix-rich regions, which have also filled with silicon. It is the filling of pores and matrix cracks with silicon that results in a very dense matrix. Overall the composite microstructure is very uniform, and there is a complete lack of any observable porosity.

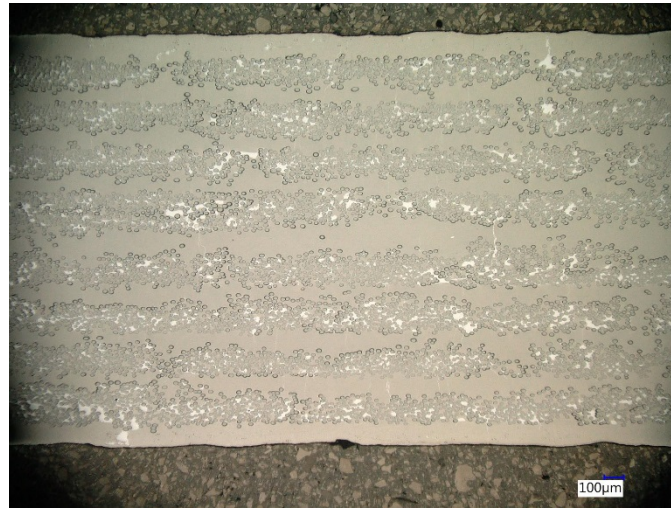
**Figure 6. Optical micrograph of HiPerComp™ Gen 1.1 Hi-Nicalon/SiC (0/90)2s showing a  $\pm 45$  cross-section at 100×**

A micrograph of the cross-section taken of the  $\pm 45^\circ$  orientation is shown in Figure 6 at a low magnification of 100 $\times$ . Since all fibers are oriented  $45^\circ$  to the polished surface, there is no fiber pull-out. The micrograph gives a true representation of the fiber distribution within the composite. Figure 7 is a 200 $\times$  image of the  $45^\circ$  microstructure, and one can observe that the fiber volume fraction in each ply varies significantly along the width. Figure 8 is a 500 $\times$  micrograph, and Figure 9 is a 1000 $\times$  micrograph of the  $45^\circ$  microstructure. It is apparent that some fibers have a much thicker fiber coating than others, and that there are a significant number of silicon-rich areas that are 1 to 5 fiber diameters in size. In Figure 9, one can clearly see that there was a processing crack that ran horizontally through this fiber bundle and that it has completely filled with silicon. Even at this extremely high magnification, there is no sign of any
