Rapid Airfield Damage Repair (RADR)

Evaluation of AM2 2-1 Lay Pattern Over a 25 CBR Subgrade

Nolan R. Hoffman, Lyan Garcia, and Timothy W. Rushing

April 2018

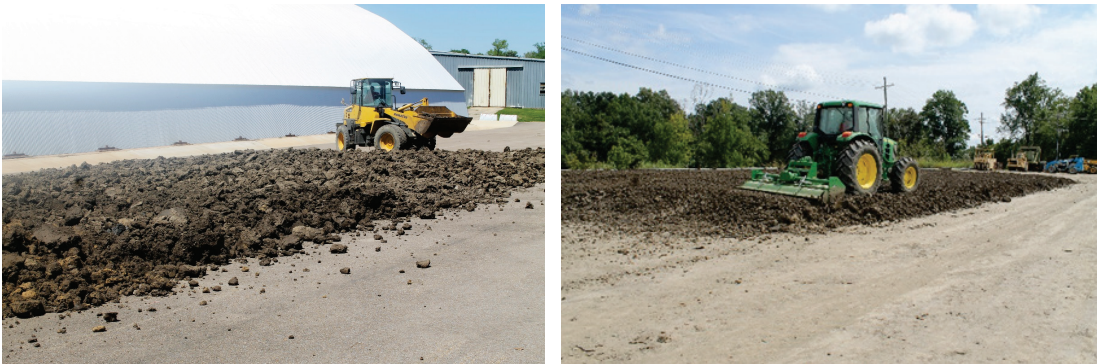
Figure 3.3. Laying out and pulverizing CH to improve moisture consistency.

The CH was processed at a nearby preparatory site by spreading the material to a uniform 12-in. depth, pulverizing the material with a rotary mixer, adjusting the moisture content, pulverizing the material again, and stockpiling it as shown in Figure 3.3. This was an iterative process necessary to achieve a uniform distribution of moisture throughout the material. Once the CH had been processed to the target moisture content, it was placed in the test section, spread by a bulldozer in 8-in. lifts, and

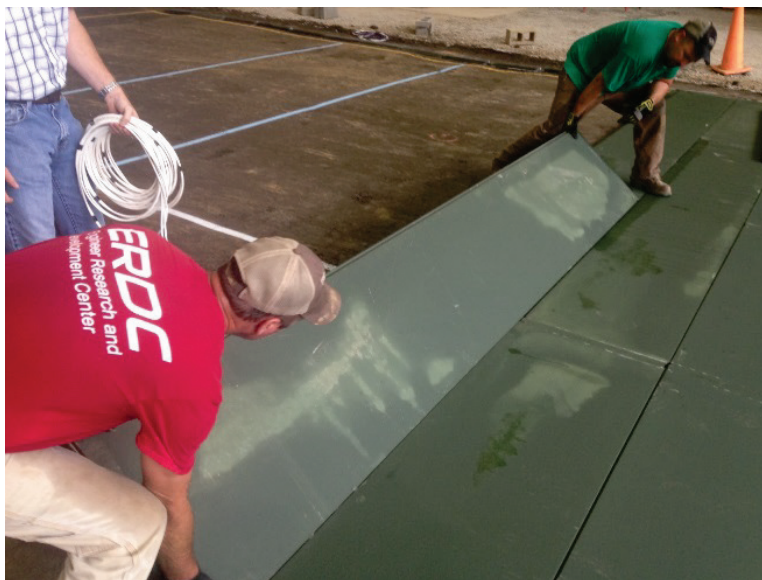
Figure 3.10. Hinging AM2 panel into place.

The first panel was placed flat on the ground in the southeast corner of the test section with the long dimensions perpendicular to the direction of traffic and with the male hinge connector facing north. The second panel was positioned adjacent to the 2-ft end of the first, allowing the overlapping end connector of the second panel to drop onto the underlapping end connector of the first panel. A rectangular slot was formed between the two end connector rails, allowing an aluminum locking bar to be inserted into the slot. This locking bar prevented the 2-ft ends of the panels from separating. This process was repeated until the first row was finished. For the second row, the female hinge connector was attached to the male hinge connector of panels from the first row, and the panel was pivoted into place, as shown in Figure 3.10. The next panel was installed by attaching the female hinge connector to the male hinge connector of panels in the first row and allowing the overlapping end connector rail to pivot over and connect to the underlapping end connector rail of the adjacent panel. An aluminum locking bar was inserted into the space provided to keep the panels from separating.

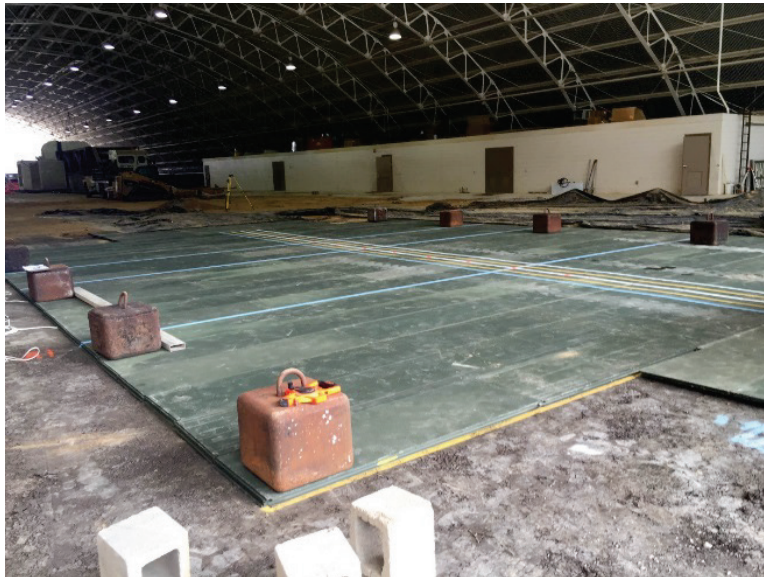
Figure 3.12. Assembled C-17 test item.

The following sections describe all mat breakage and the behavior of the AM2 airfield mat under simulated F-15E and C-17 traffic. General views of each item prior to trafficking are shown in Figures 3.11 and 3.12.

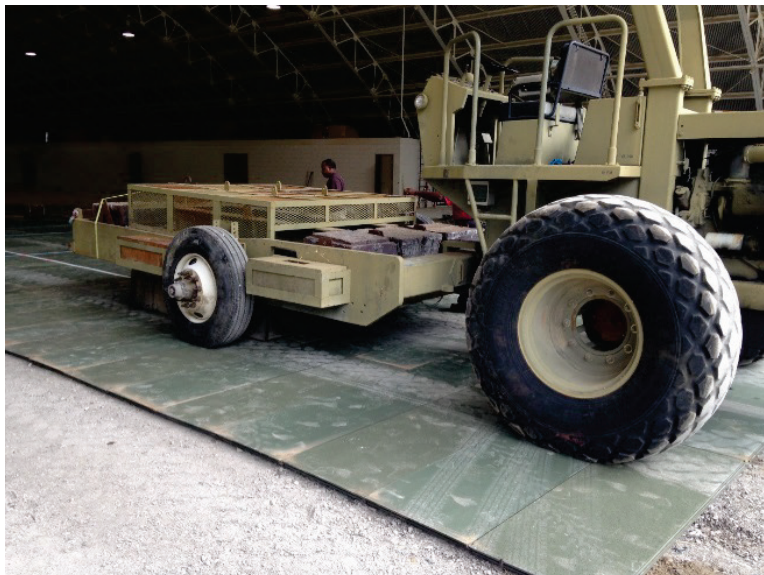
Figure 3.13. Photograph of the F-15E load cart.

A specially designed single-wheel load cart simulated F-15E aircraft traffic. The load cart was equipped with a 36-in. by 11-in., 30-ply tire inflated to 325 psi and loaded such that the test wheel was supporting 35,235 lb. The F-15E load cart was equipped with an outrigger wheel to prevent overturning and was powered by the prime mover of a case vibratory steel-wheel roller, as shown in Figure 3.13.

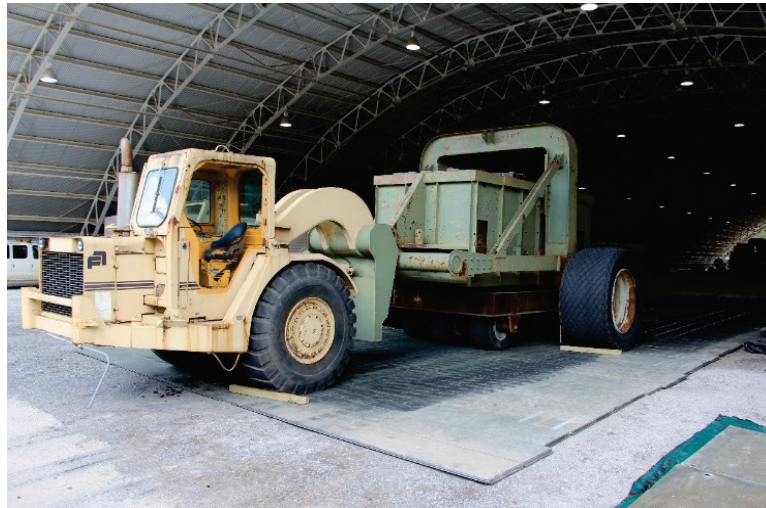
Figure 3.15. Photograph of the C-17 load cart.

The multiple-wheel C-17 load cart was designed to exactly match one full main gear of a C-17. The multiple-wheel C-17 load cart was equipped with six 50-in. by 21-in., 20-ply tires inflated to 142 psi and loaded such that the test gear was supporting 269,560 lb, with estimated individual wheel loads of 44,930 lb. The test cart was powered by the front half of a Fiat scraper, as shown in Figure 3.15

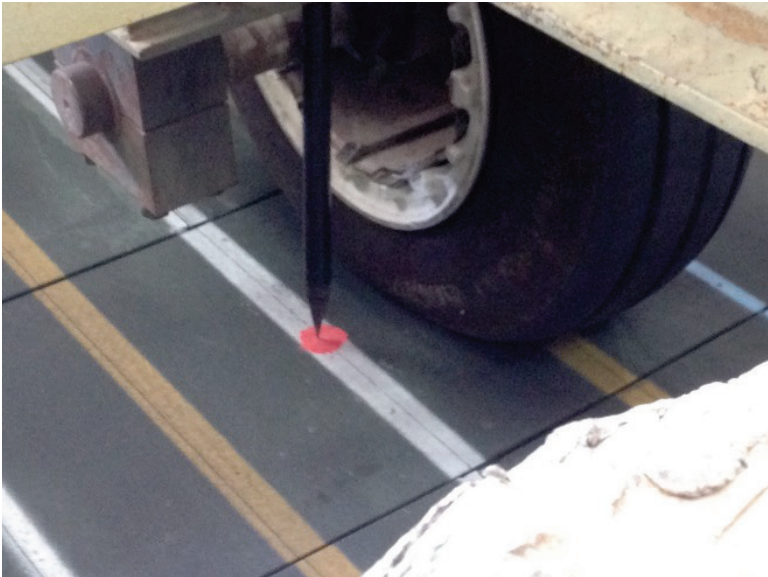
Figure 3.18. Elastic deflection measurement during trafficking.

Robotic total station elevation data collected at 1-ft intervals along the traffic centerline are labeled “centerline profiles” in this report. Dynamic elastic deflection data were collected by placing a survey prism next to the load wheel on the F-15E load cart, as shown in Figure 3.18, at the specified locations on the last pass of each pass interval. Data were then collected at the same locations on the unloaded mat surface. The amount of mat damage and the mode of failure were recorded during the traffic phase. Figures 3.19 through 3.21 show typical data collection activities for each test item.

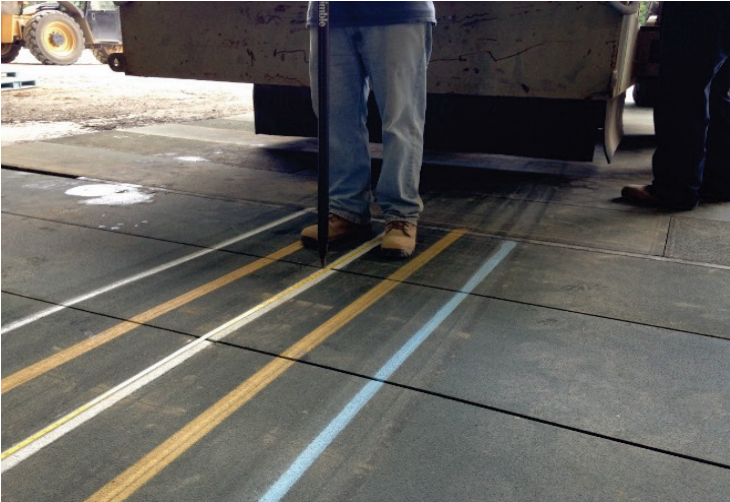
Figure 3.20. Loaded rut depth measurements.

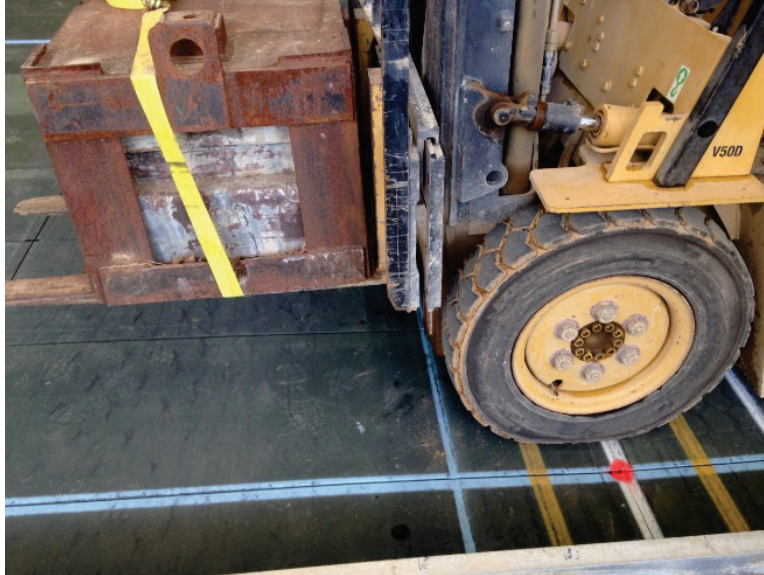
Figure 3.21. Surveying designated cross section.

Plots of the centerline profile data, as determined from robotic total station recordings, for the F-15E and C-17 test items are shown in Figures 4.8 through 4.11. Cross-section elevations collected along lines A1, A2, and A3, as seen in Figure 3.21, were averaged and used in Figures 4.12 through 4.17. Maximum deformation values for the unloaded, loaded, and subgrade cross sections were determined as the difference in elevation between the average heights of the elevated material on each side of the trough to the deepest point in the bottom of the trough.

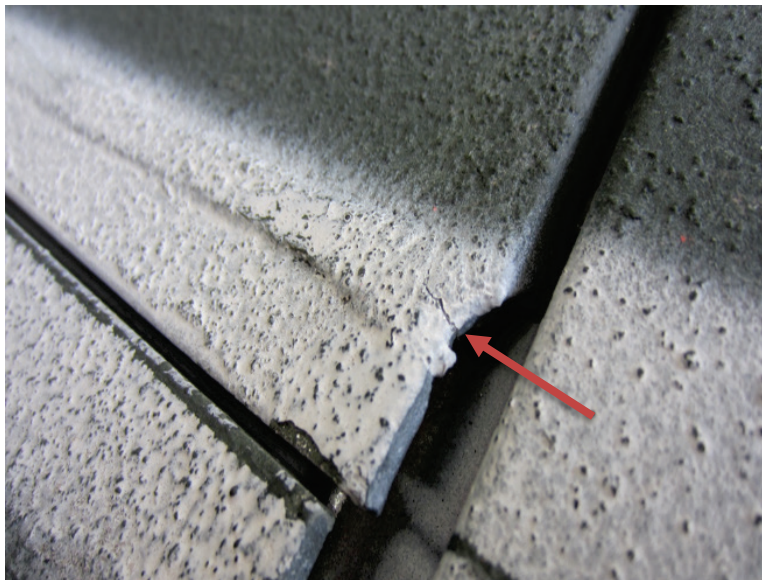
Figure 4.1. Hairline crack in panel 74 observed after pass 1,008.

Trafficking on the F-15E test item began 6 July 2016. The first damage noted on the AM2 surface was after 1,008 passes. A slight corner curl developed in panels 2, 3, 33, and 34 on their south edge. Panels 13 and 74 acquired a hairline crack along the weld between the female hinge connector and the overlap connector at the top skin, as can be seen in Figure 4.1.

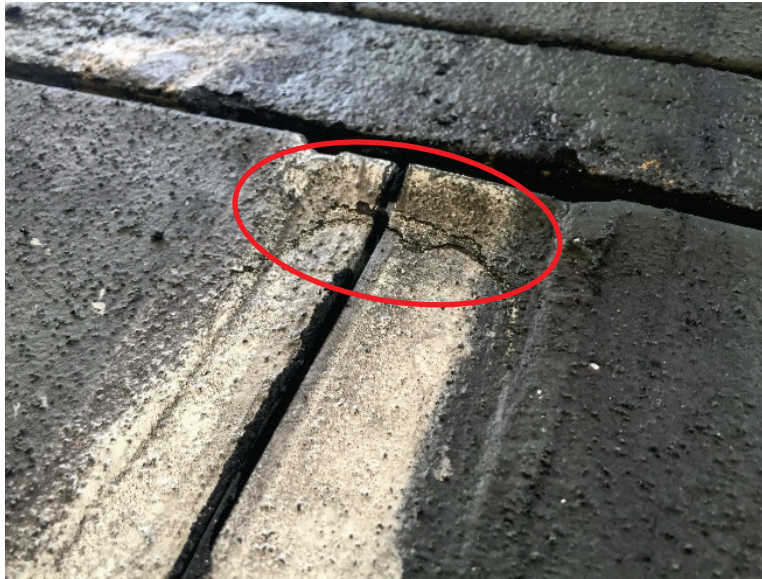
Figure 4.2. Corner curl cracks in panels 2 and 3 at 4,576 passes.

Inspection at pass level 4,576 revealed that the corner curls on panels 2 and 3 had cracked at the base of the curl and started to propagate along the top skin of the female hinge connectors, shown in Figure 4.2. At pass 5,600, panels 73 and 74 cracked at the base of the corner curls and the crack also propagated down the top skin of the female hinge connectors, similar to panels 2 and 3.

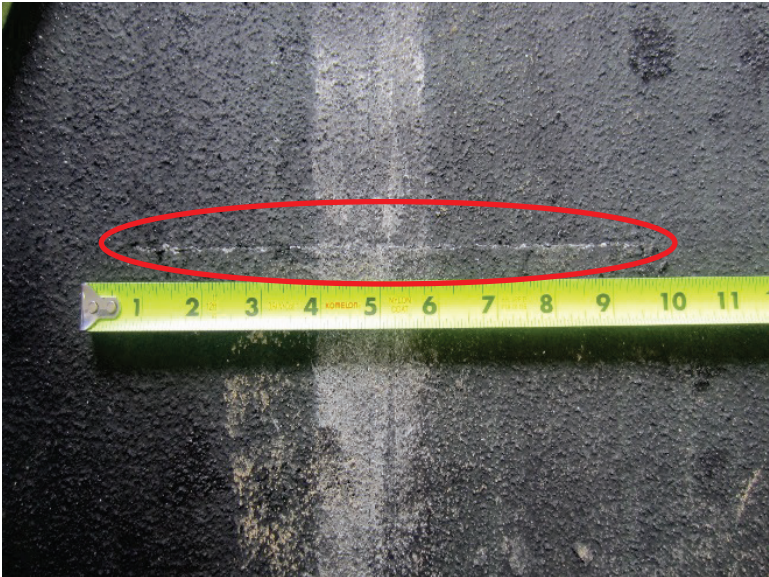
Figure 4.3. Top skin tear on panel 8 at 6,100 passes.

By pass 6,100, a skin tear that measured approximately 10 in. appeared in panel 8, shown in Figure 4.3. Panels 2 and 3 continued to crack along the female hinge connector (Figure 4.4). Additionally, panel 33 developed a new crack with a length of 1 in. between the male hinge connector and the overlap connector along the top rail. A photograph of panel 33 is shown in Figure 4.5. Panels 53, 133, and 134 each displayed a new crack at the top skin along the female hinge connector, most likely due to the corner curls.

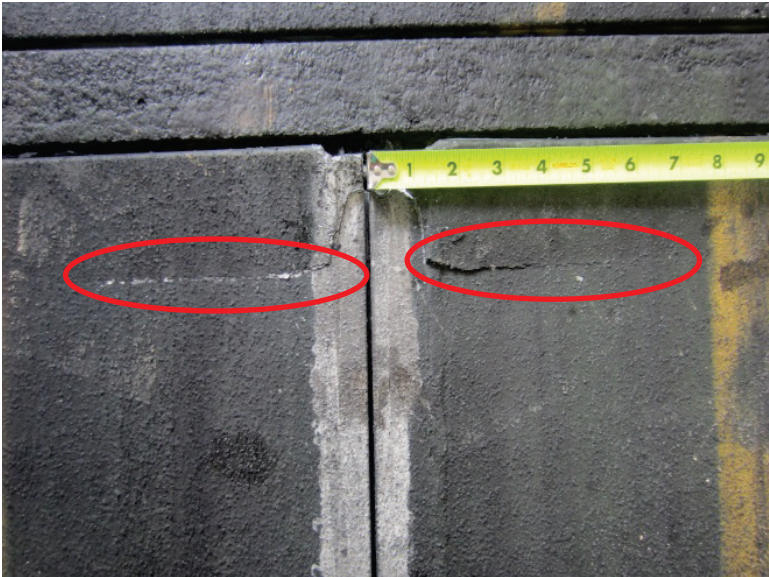
Figure 4.4. Cracks propagating in panels 2 and 3 at pass 6,100.

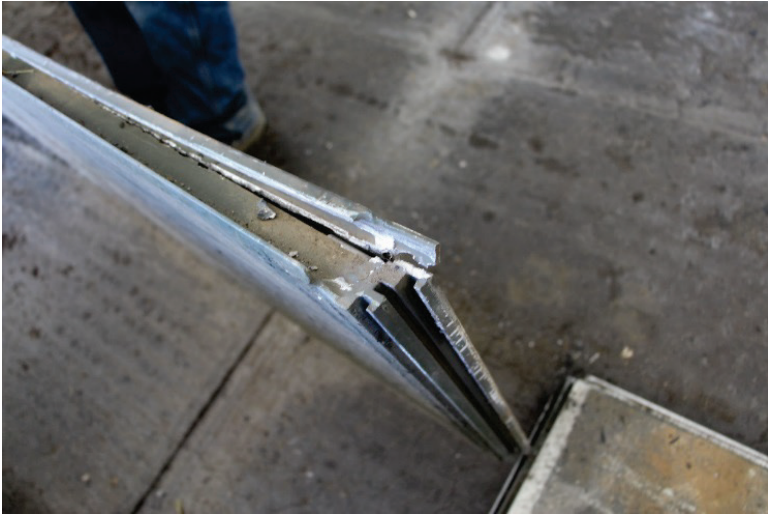
Figure 5.1. 17 in. female hinge crack on panel 2.

Photographs of the various damage types can be seen in Figures 5.1 through 5.7. All of the failed panels received damage in one of two modes. The most common mode was top skin tears along a vertical stiffener resulting from core damage. Similar damage was documented in previous AM2 tests using the same F-15E loads; however, the top skin did not always crack (Rushing and Tingle 2007, Garcia et al. 2014a). The second damage mode was the top skin tearing along the female hinge connector. This damage resulted from the flexibility of the joints due to the 2-1 lay pattern. The flexibility caused corner curls on the top skin where the overlap/underlap connectors met the female hinge connector. These corner curls cracked at their base and traveled toward the center of the mats along the female hinge connector.

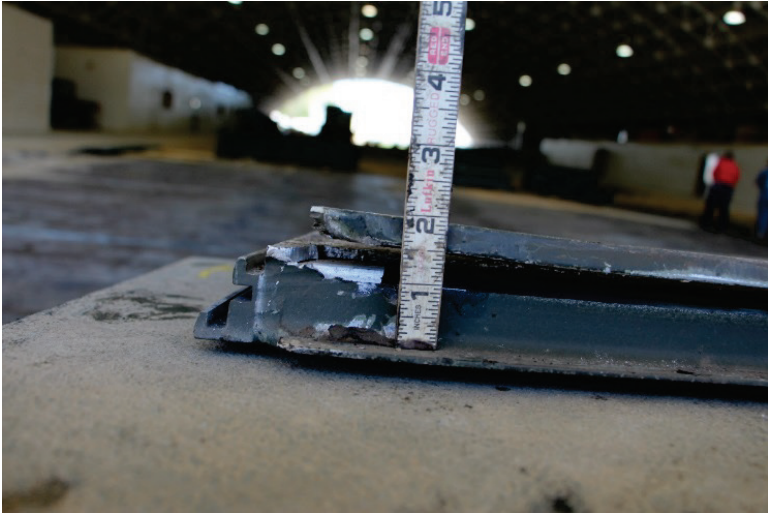
Figure 5.2. Female hinge crack in panel 3.

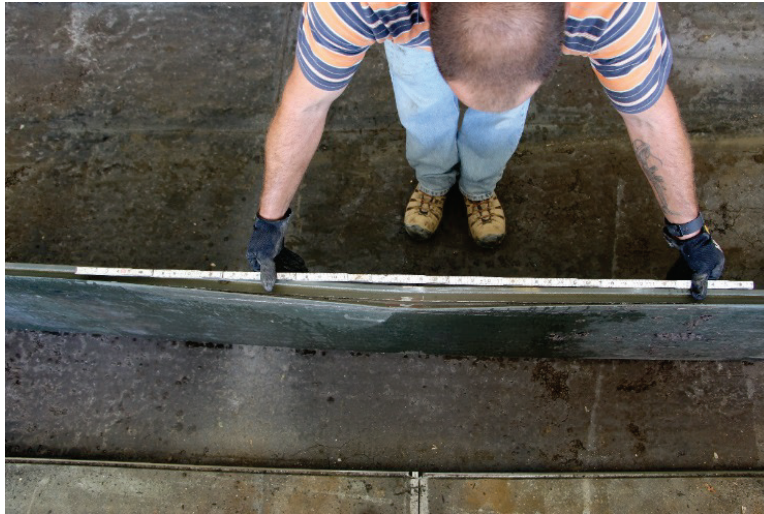
Figure 5.3. 54 in. female hinge connector crack on panel 8.

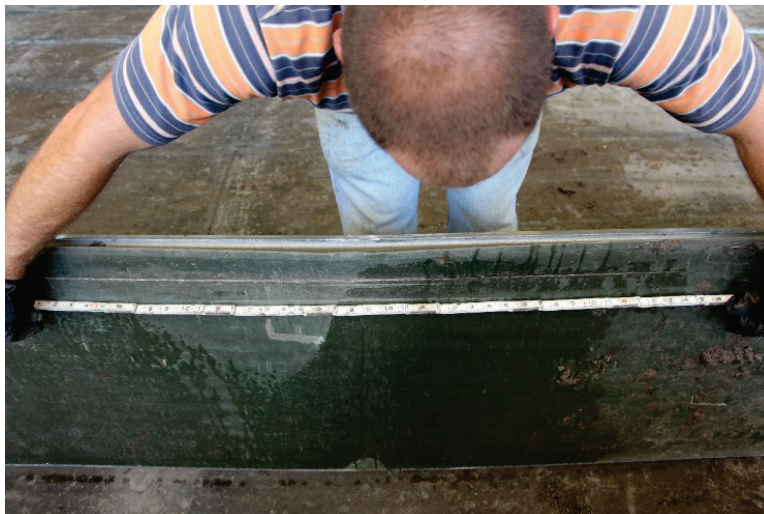
Figure 5.5. Top skin tear in upper rail of overlap connector on panel 53.

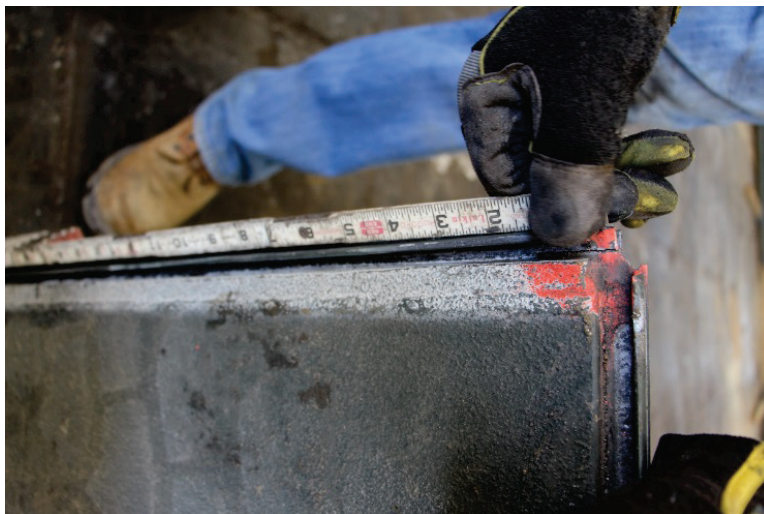
Figure 5.6. 4 in. crack in upper rail of underlap connector on panel 54.

Other types of damage noted were bottom skin tears, female hinge connector cracks, and overlap/underlap connector rail cracks. The bottom skin tears were always located directly underneath a top skin tear; most likely the result of a vertical stiffener buckling. The female hinge connector cracks noted here were located directly in the center of full panels and were typically found on panels with top and bottom skin tears. The female hinge connector failures were most likely associated with the buckling of vertical stiffeners as well. Finally, the underlap/overlap rail cracks were assumed to be caused by fatigue due to the stress concentration in the corners on the underside of the rails. All damage associated with underlap/overlap connector rails occurred in topmost rails only, regardless of whether it was the underlapping or overlapping joint.

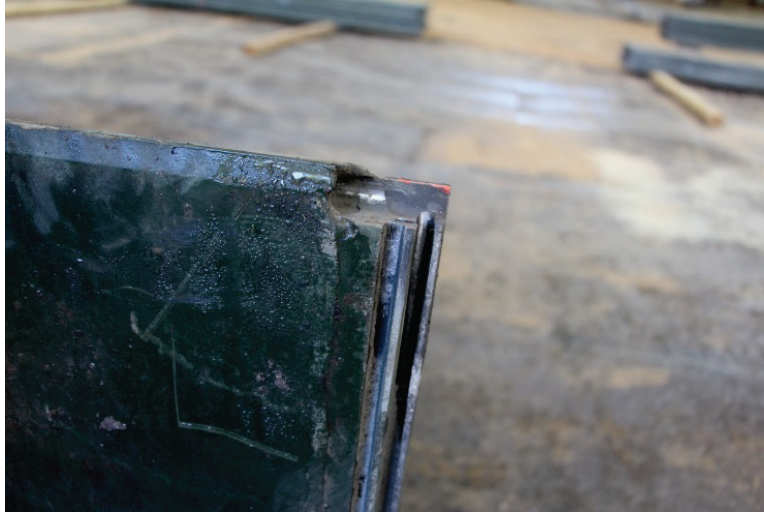
Figure 5.7. 1 in. crack on upper rail of underlap connector on panel 102.

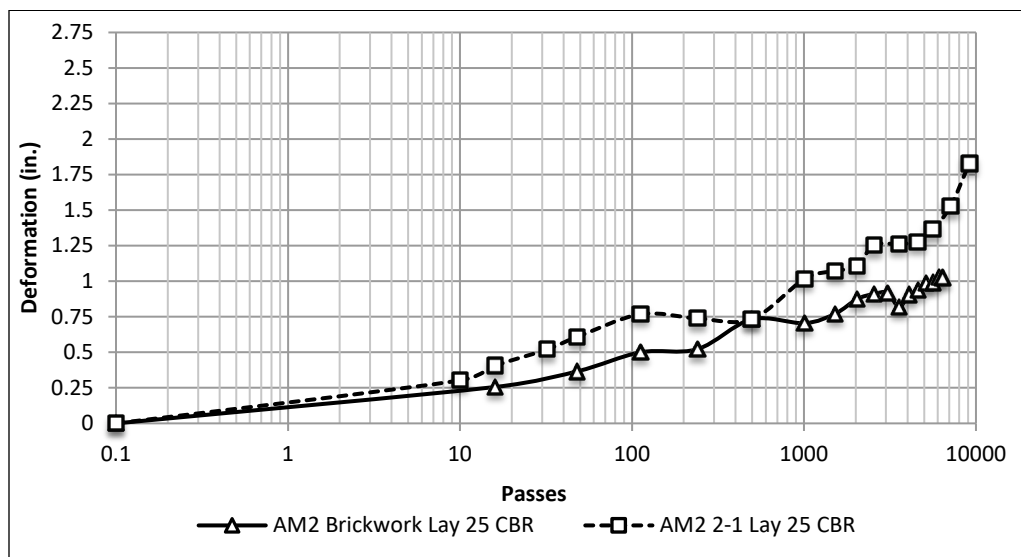
Figure 6.1. F-15E deformation versus number of passes for 25 CBR brickwork and 2-1 lay patterns.

Deformation values were also compared to see if any insight could be gained. Test results showed greater deformation values for the 2-1 lay pattern F-15E test item than for the brickwork pattern. A comparison between the average maximum deformations for both patterns can be seen in Figure 6.1. The deformation from the 2-1 lay pattern evaluation was greater than the brickwork pattern evaluation at virtually every pass level. The increased deformation was a direct result of the additional flexibility in the mat system caused by additional joint alignment associated with the rows of half panels that were included in the pattern.

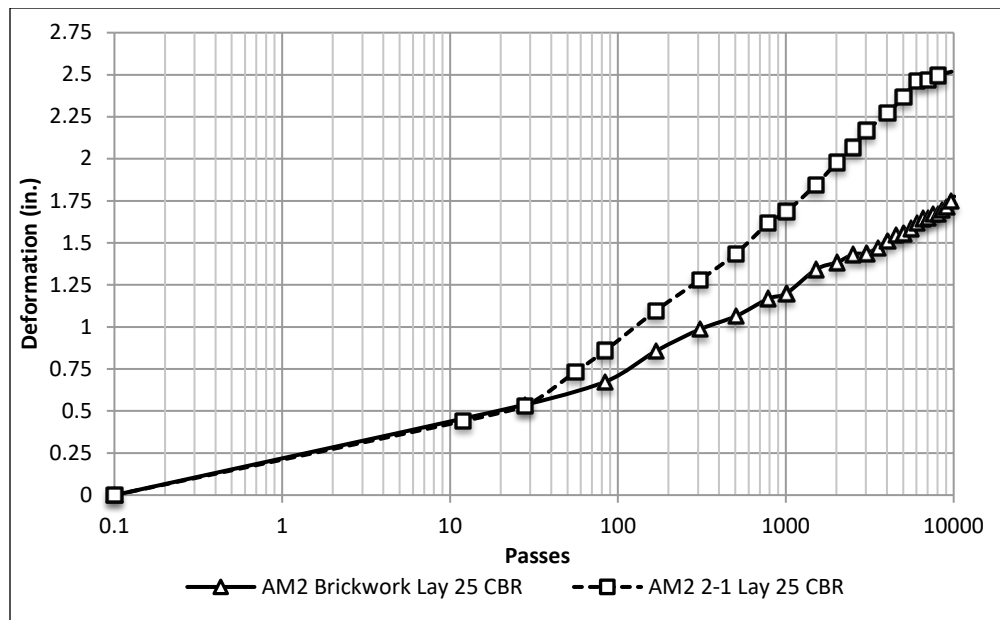
Figure 6.2. C-17 deformation versus number of passes for 25 CBR brickwork and 2-1 lay patterns.

Deformation values were also compared for the C-17 items to see if any insight could be gained. Similarly as seen for the F-15E items, test results showed greater deformation values for the 2-1 lay pattern C-17 test item than for the brickwork pattern. A comparison between the average maximum deformations for both patterns can be seen in Figure 6.2. The deformation from the 2-1 lay pattern evaluation was greater than the brickwork pattern evaluation at nearly every pass level. The increased deformation was a direct result of the additional flexibility in the mat system caused by additional joint alignment associated with the rows of half panels that were included in the pattern.
