Evaluation of Sludge Pump Clogging Issue for an Industrial Waste Pretreatment Plant in the Ceres Industrial Park, Vicksburg, MS

Victor F. Medina, Scott A. Waisner, and Michelle Wynter

April 2018

Final Report

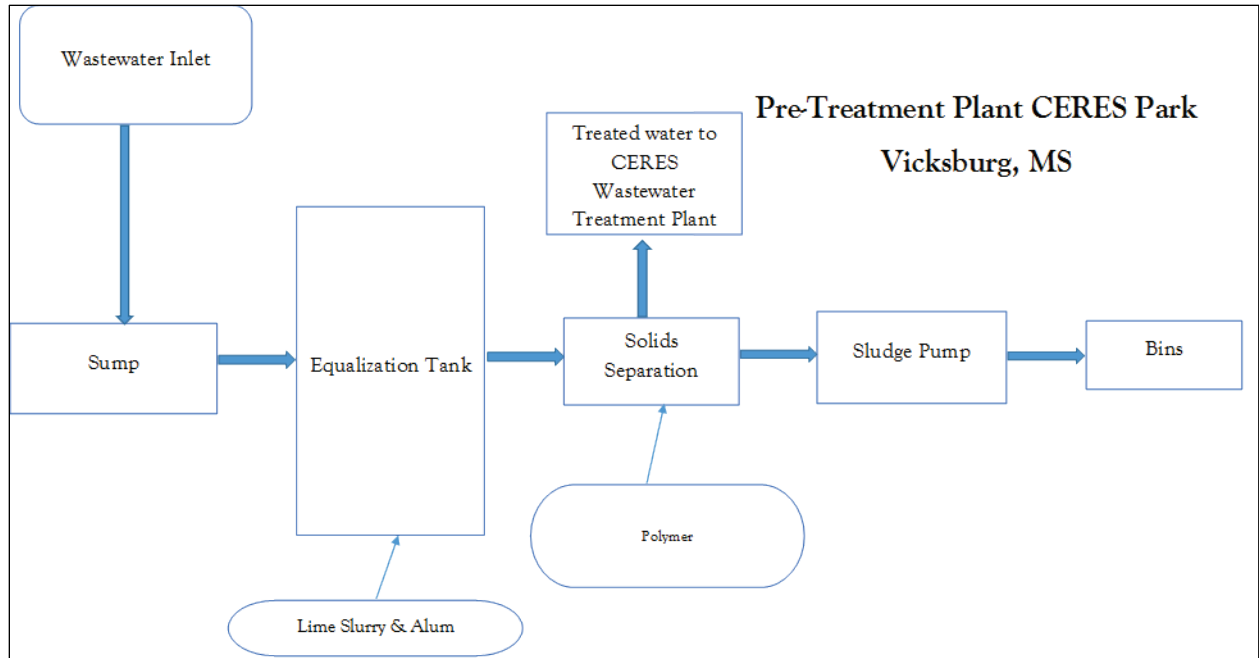
Figure 1. A schematic of the industrial wastewater treatment plant.

The treatment system under evaluation is relatively simple (Figure 1). Wastewater from the TanTec facility flows out of the plant and through a screen that removes large solids (Figure 2). Wastewater then flows via a waterway to a sump at the wastewater treatment site (Figure 3). Water is pumped into a large equalization tank, which also acts as an initial flocculation tank (Figure 4). In the tank, the wastewater is initially treated with a lime slurry to make the pH slightly basic (Figure 5). The water is then put into a sludge floatation system that separates the sludge from the water (Figures 6–8). The sludge is then augured (Figure 9) into a pneumatically operated, diaphragm sludge pump (Figure 10). The processed sludge is highly fibrous in nature (Figure 11). The sludge pump then pumps the sludge into outdoor bins, where it can dry in the sun and is eventually picked up for disposal or recycling.

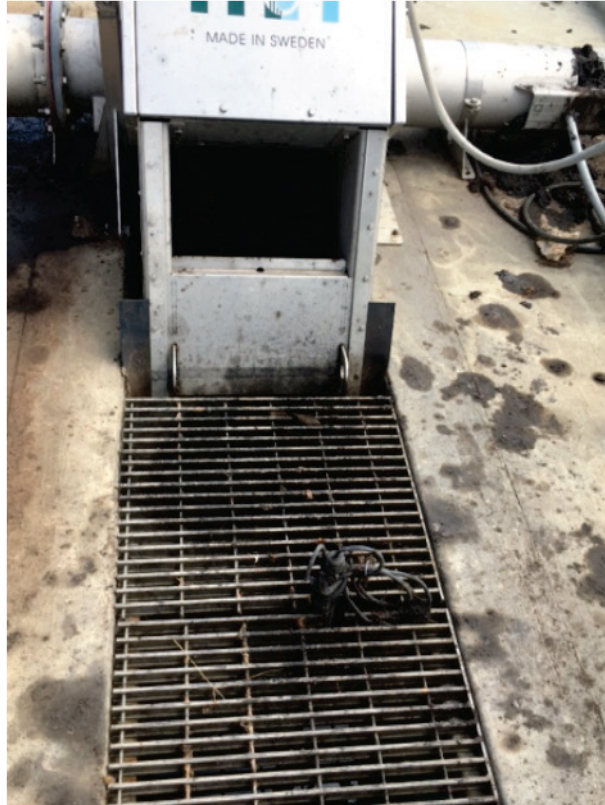
Figure 2. Discharge point from the TanTec facility showing the screen for removal of large constituents.

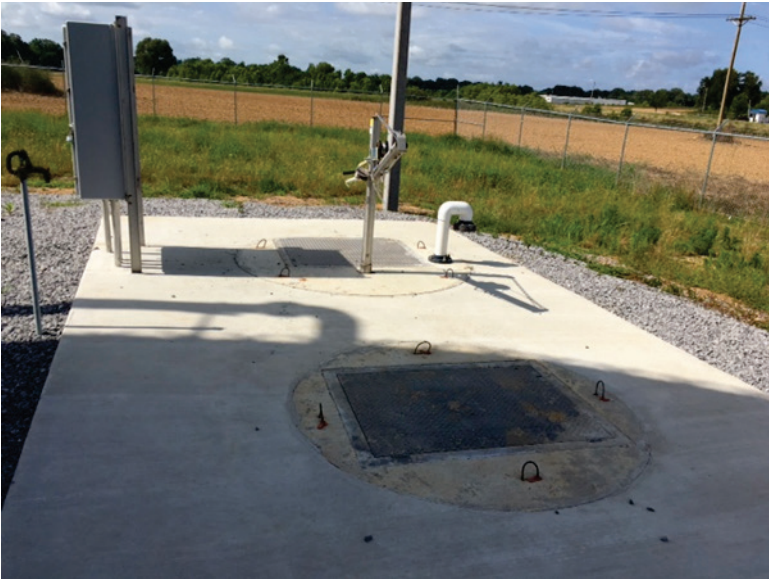
Figure 3. Collection sump.

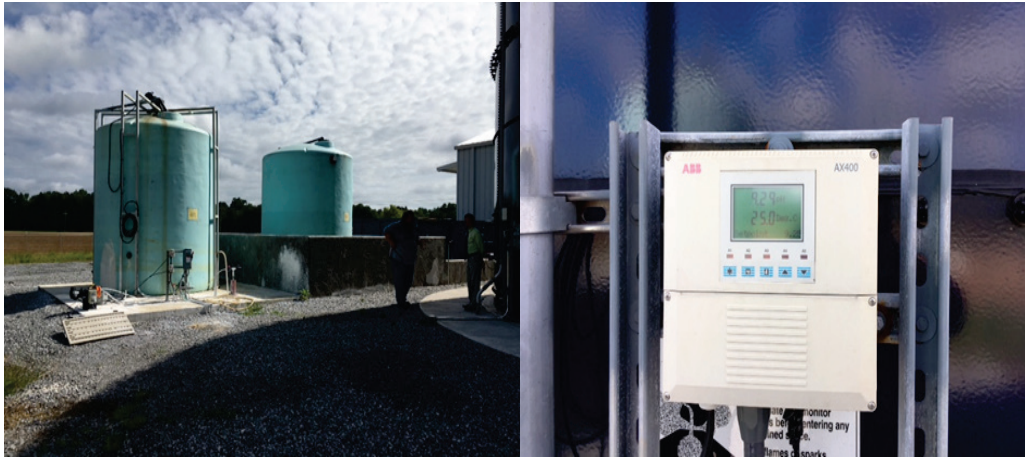
Figure 5. Lime slurry tank and pH meter on equalization tank.

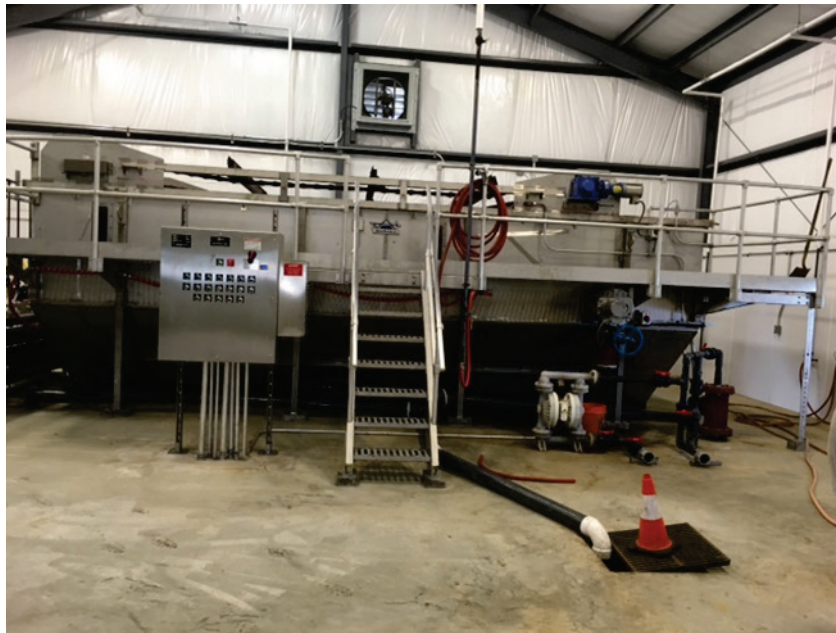
Figure 6. Sludge flotation reactor.

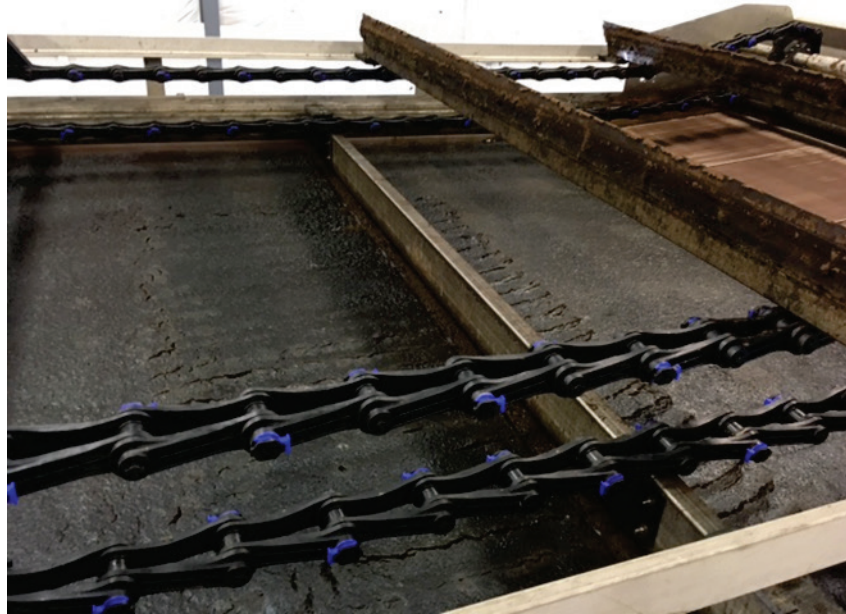
Figure 7. Sludge floatation.

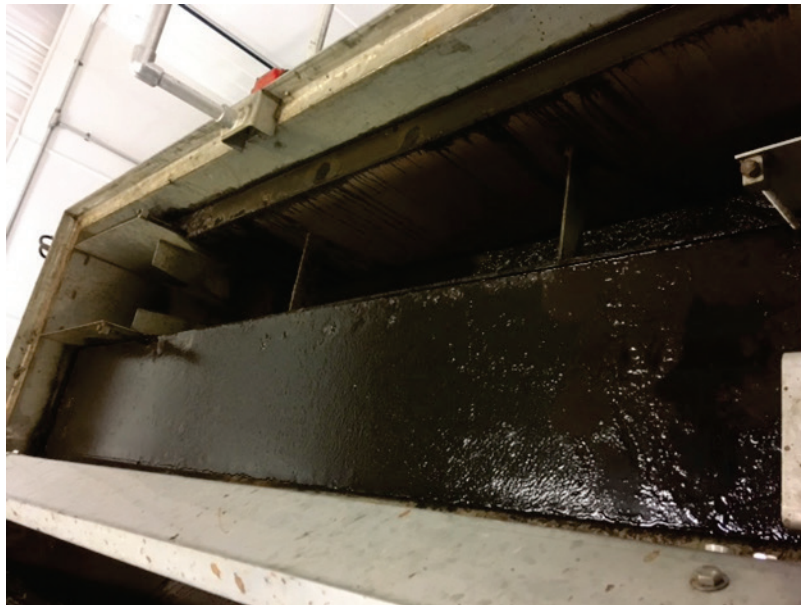
Figure 8. Sludge separation.

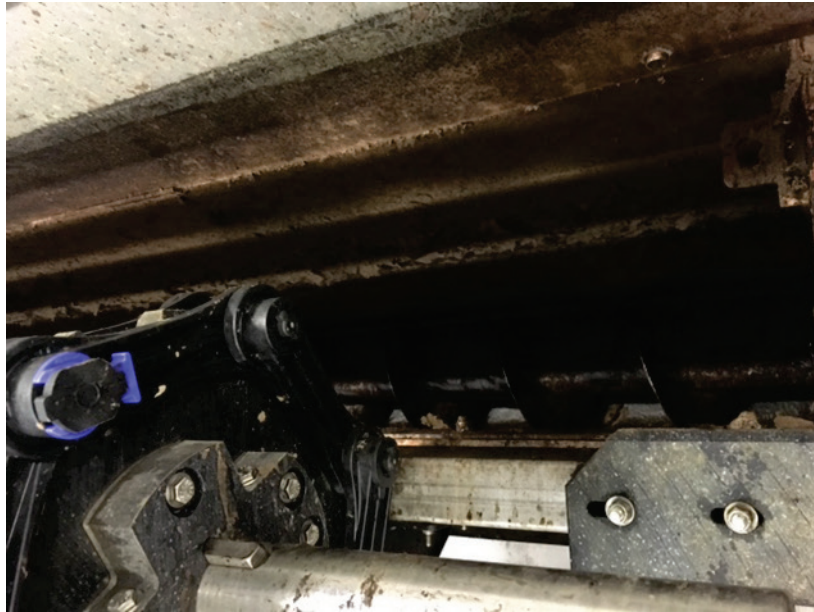
Figure 9. Sludge augur.

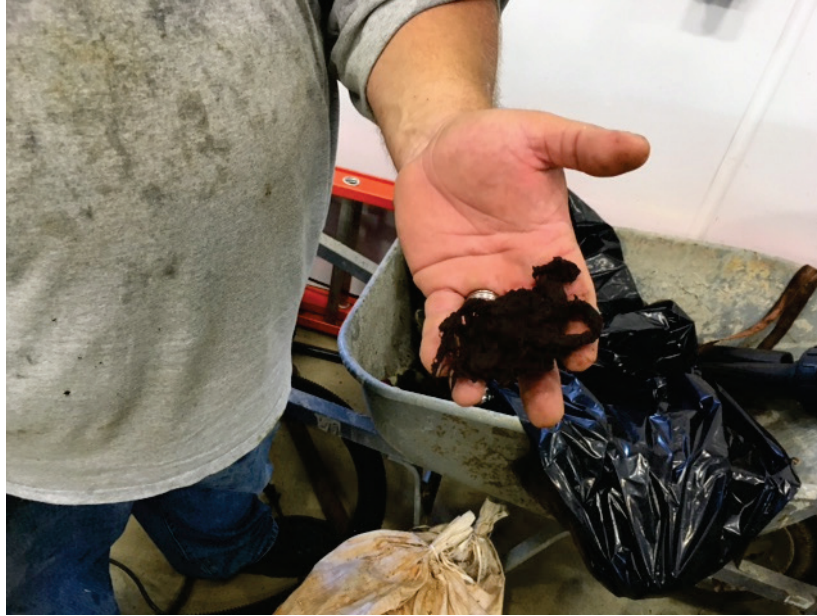
Figure 11. Processed sludge showing fibrous nature of the material.

However, in this case, the sludge appears to be highly fibrous. It is the teams' experience that grinder/shredder pumps are not effective for highly fibrous materials. Therefore, the use of a grinder or shredder pump is not recommended. It might be useful, however, to rent or lease one to evaluate operational effectiveness.

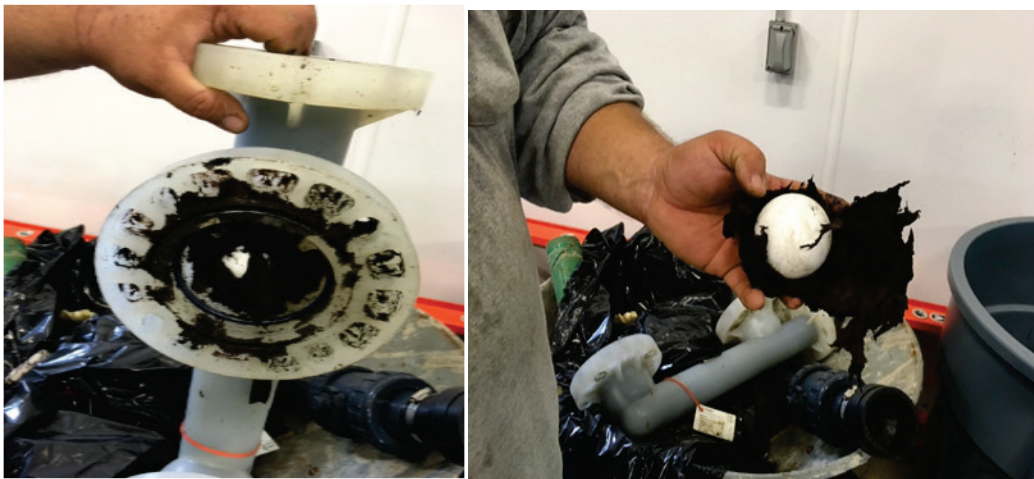
The operating issue is that the sludge pump routinely clogs. The operator showed the ERDC team a clogged pump (Figure 12). The sludge material accumulates around the ball that serves as the check valve, preventing proper operation (Figure 12). The caked material was difficult and costly to remove, causing system outages and adding repair time.

Figure 12. Clogging of the ball check valve in the pneumatic sludge pump.

The operator indicated that there has been an improvement in the frequent clogging since TanTec modified the screening treatment from the plant effluent. Previously, the screen had areas where water could flow

around it. However, this was modified, and appears to have helped. In addition, the operator communicated that clogging appears more frequent when the water level in the equalization tank reaches about seven feet. The possible reason for this is that the tank may contain sludge buildup, and at seven feet, entrainment of this sludge could occur. The ERDC team did not review any records to substantiate these claims. However, the assumption was that these claims were accurate.

As an alternative to the grinder/shredder pump, a positive displacement pump has been rented and used. The use of this pump requires water, and is counterproductive to the dewatering efforts made for the sludge. This pump did operate for long periods without clogging. A similar pump could be purchased and permanently installed or other types of sludge pumps could be evaluated.

The ERDC team also recommends that an alternative sludge pump would solve the pump clogging problem. There are many pump types better suited to moving high solids compared to the diaphragm pump currently used. These include progressive cavity, rotary lobe, hose, or screw pumps. Working with a reputable pump company that represents a range of pump technologies, or a consultant with a strong expertise in pump systems, is recommended.

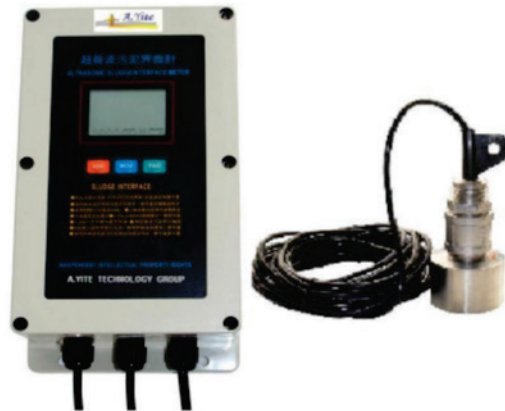
Figure 13. An ultrasonic sludge depth measurement system (<https://www.environmental-expert.com/downloads/ge-102s-ultrasonic-sludge-interface-depth-meter-399136>).

Frequent measurements of the sludge depth in the tank, coupled with detailed recordkeeping to determine if clogging is, in fact, more frequent when the water level approaches the sludge depth, are recommended. A method for measuring sludge depth would need to be developed and currently does not exist. A common method is to use a long rod that is inserted at the top of the tank, measuring where it hits the top of the sludge layer. It would be interesting to use this method to measure the sludge depth at this time. However, this is cumbersome and potentially dangerous as a routine method since the equalization tank is very high (estimated around 30 feet). There are sonic and optical options that could be retrofitted for measurement of the sludge in the tank (Figure 13). Last, pumping out the sludge at regularly timed intervals and recording the date and the amount of sludge that was removed from the tank would be beneficial. Recording plant operations (specifically clogging of the pump) in conjunction with this procedure is recommended.

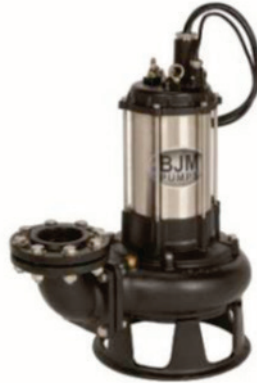
Grinder/shredder pumps are pumps designed to break apart agglomerating materials (Figure 14). Grinder pumps are generally applied to smaller size materials, producing a slurry-like consistency. Shredder pumps are used to break apart relatively large chunks, and are sometimes used as pretreatment for grinder pumps.

Figure 14. A shredder pump from SKG (marketed by BJM Pumps). A grinder pump is very similar looking.

Waisner and Medina (2012) used a grinder pump to reduce the size of solids prior to their input into a deployable wastewater treatment system, and the approach was highly effective. McCollum et al. (2016) describes a study in which a shredder pump was added online to a municipal wastewater treatment plant in Alabama to correct severe clogging issues at a pump station that was requiring unacceptably frequent cleanouts. The shredder pump solved the clogging problem very effectively.
